# Section 19 Flood and Water Management Act 2010

## Report Title: Northgate Street, Bury St Edmunds

CRNos. 371158, 372158, 287916, 286701 & 287916

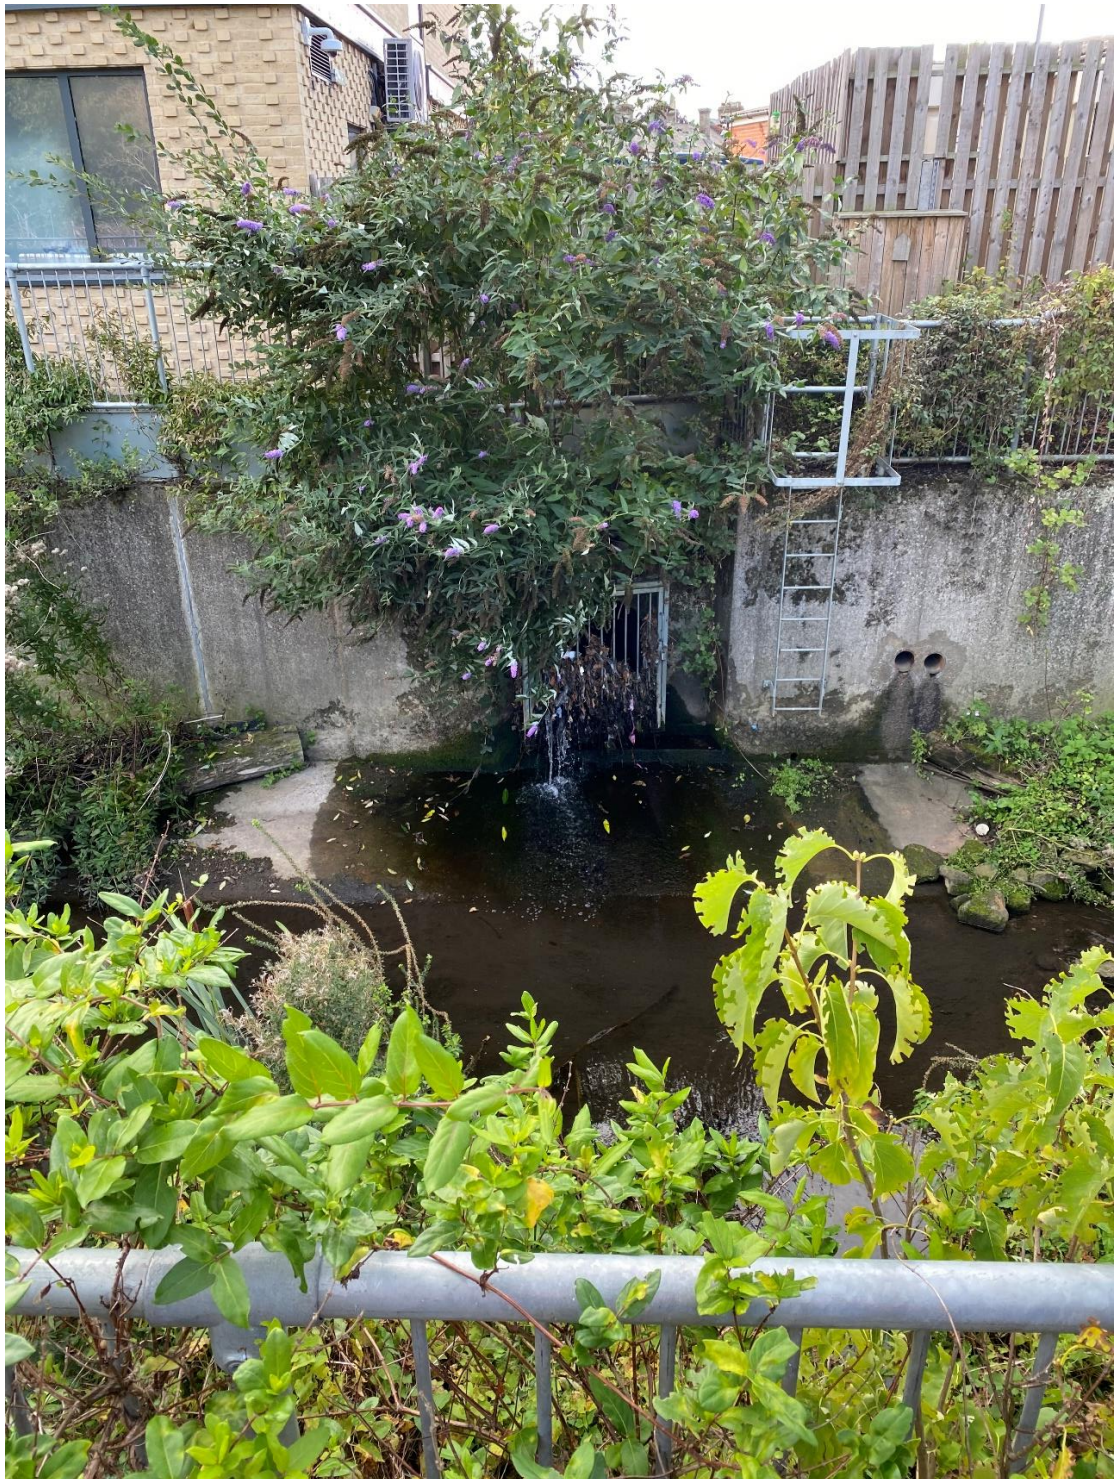
On inspection of the outlet behind the hotel on the 27<sup>th</sup> September 2022, there was a reasonable build-up of debris on the screen to the outlet which may

have reduced the flow of water into the river. It is unknown when the last inspection of this screen, owned by Anglian Water, was undertaken but an inspection history has been requested. See Image 1 below.

*Image 1: Partially blocked outlet pipe from Anglian Water Assets into the river Lark.*

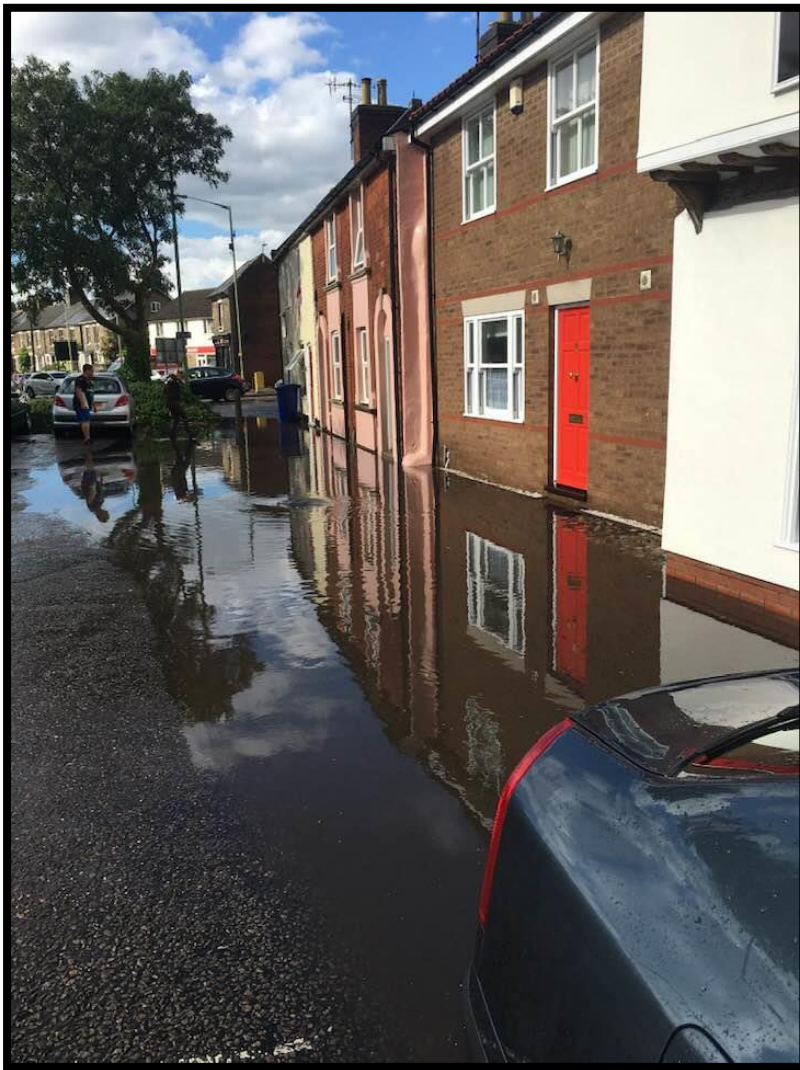
*August 25th shortly after the rainfall event*

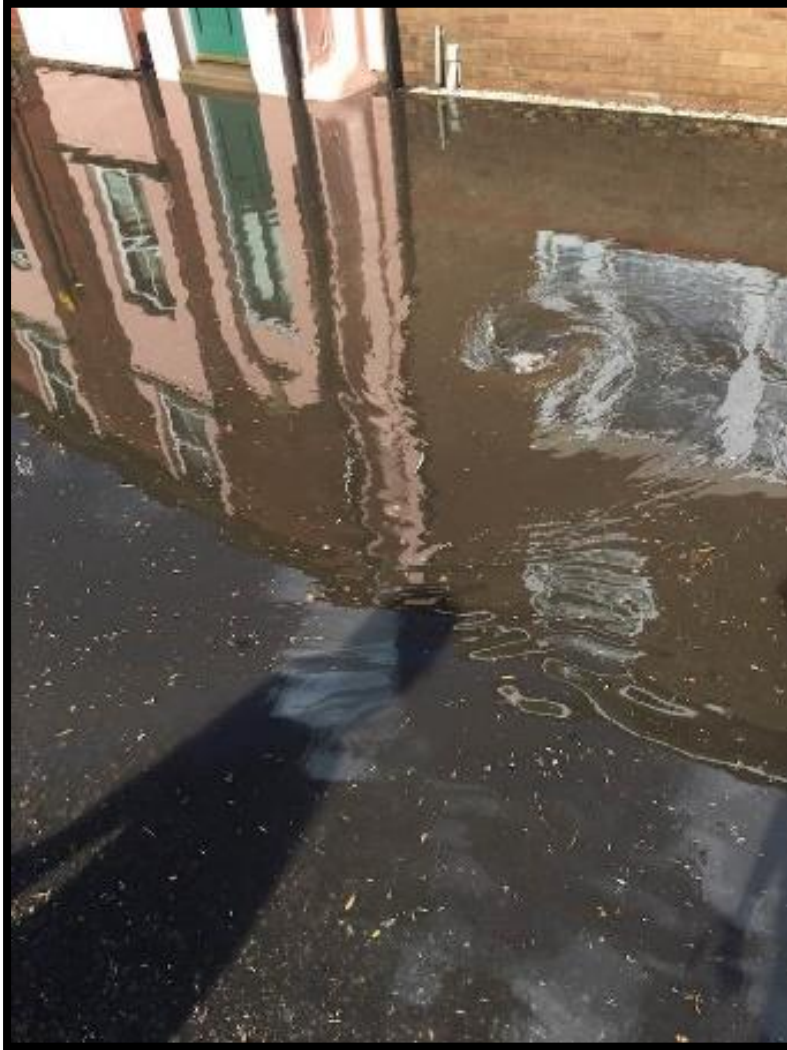
*August 25th shortly after the rainfall event, showing the vortex in the drain gully.*

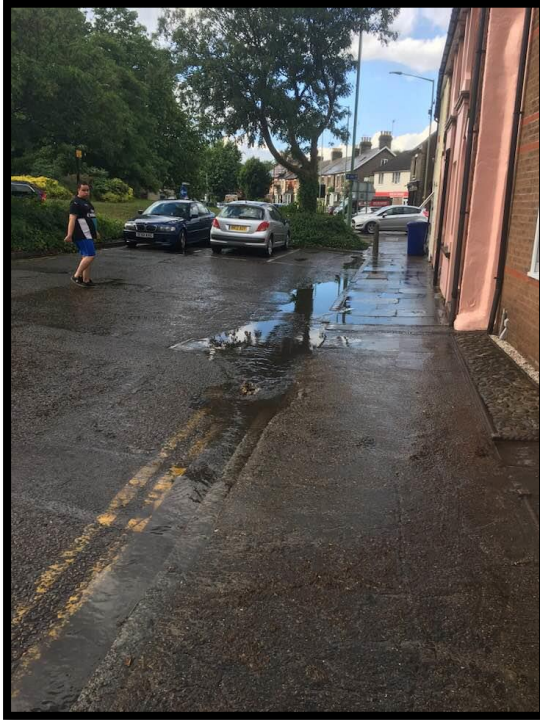
*August 25th – shortly after the rainfall event showing the water clearing from site.*

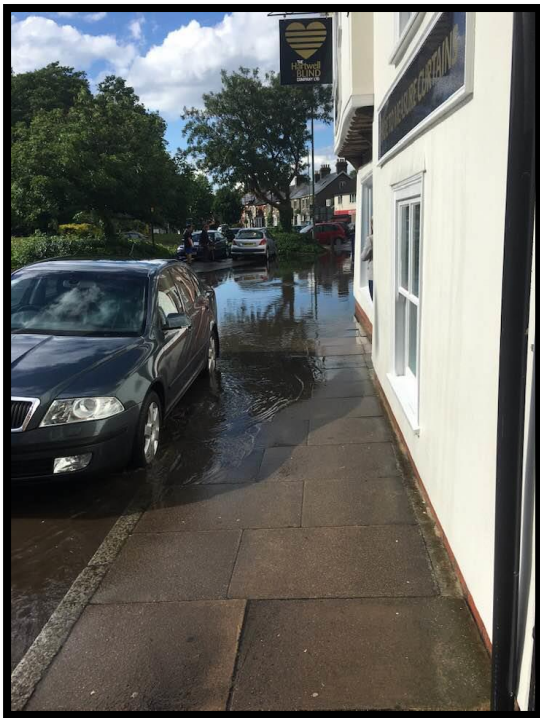
*August 25th – shortly after the rainfall event.*

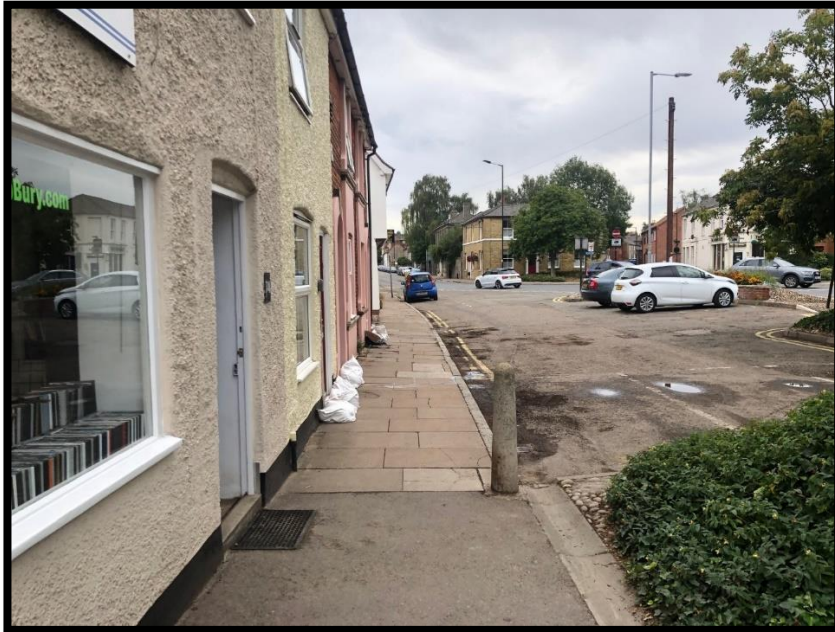
*September 5th – Site visit by the floods and water management team*

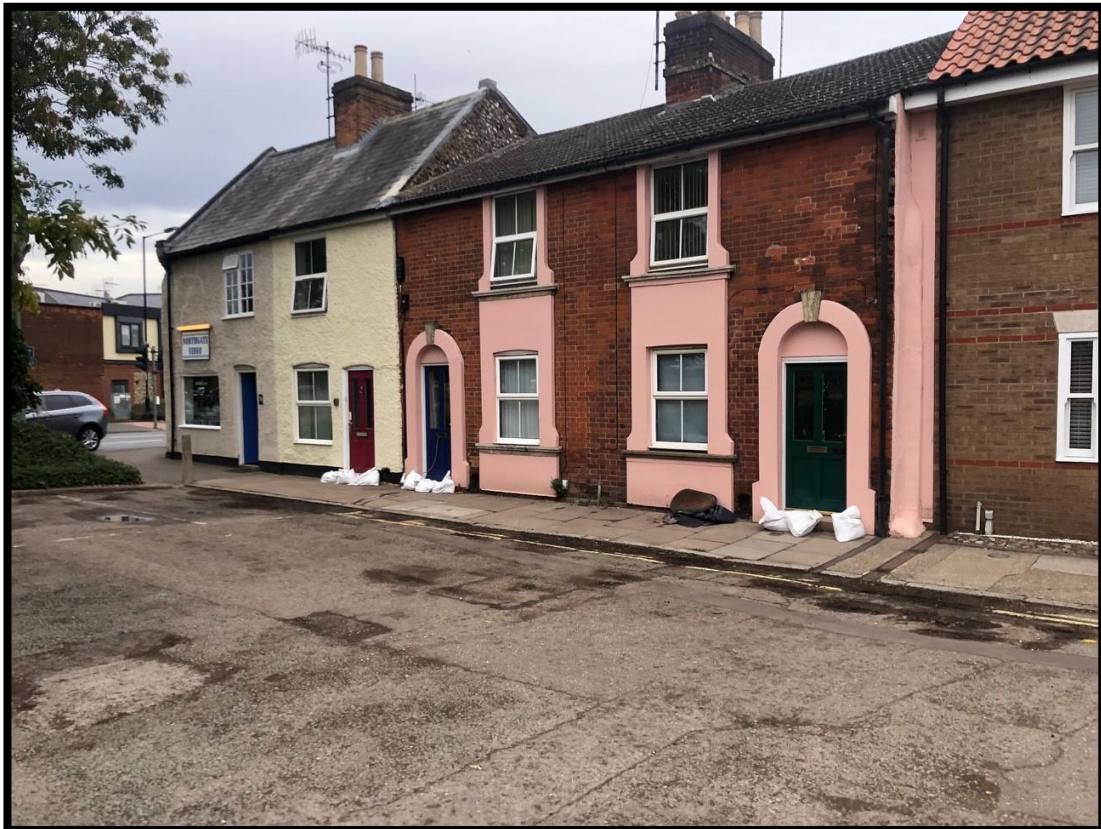
*September 5th – Site visit by the floods and water management team*
