## Section 19 Flood and Water Management Act 2010

### Bredfield Flood Investigation

#### Storm Babet 2023

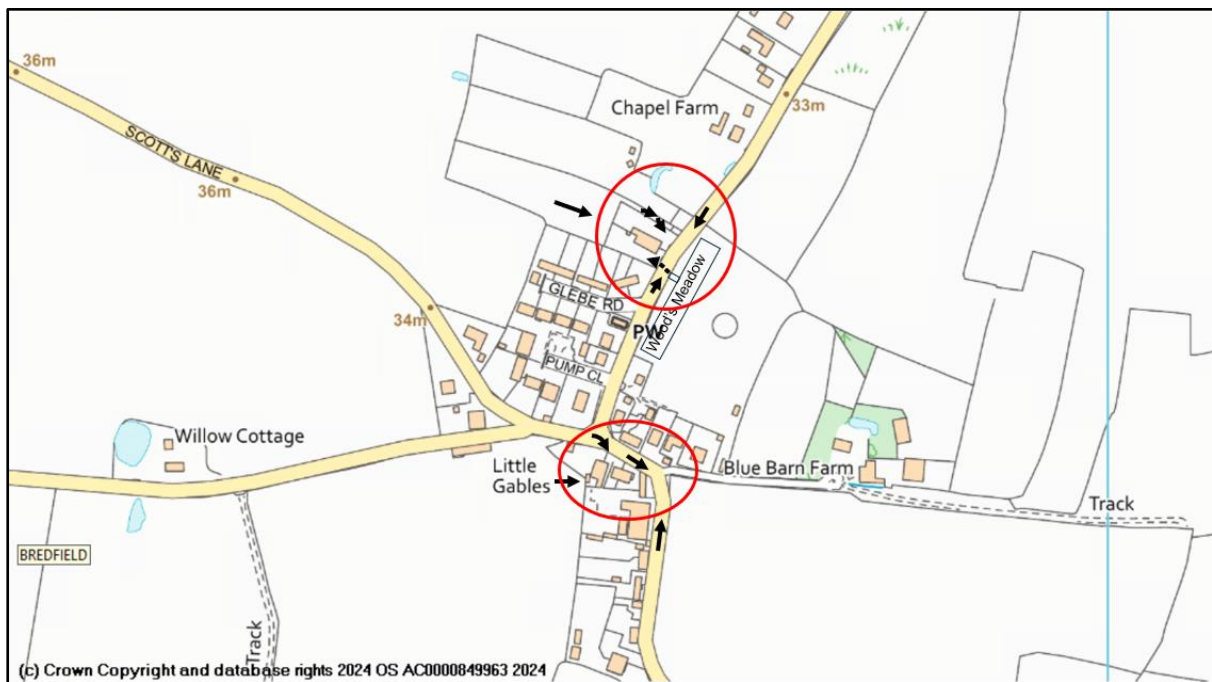
**Fig. 10. Approximate floodwater flow paths, Woodbridge Road**

In the southern part of Bredfield village, property was internally flooded to the south of Jubilee Meadow and west of Woodbridge Road. Further south, east of the junction between Scott's Lane and Woodbridge Road, property on the south side of Woodbridge Road was impacted by internal flooding. Four properties were reported to have flooded internally in the Woodbridge Road area. All affected property in this area was projected to be at high risk of surface water flooding and no risk of fluvial flooding.

Significant rainfall caused large quantities of surface water to flow from arable fields and field drainage ditches on the west side of Woodbridge Road. The pipe in a culverted watercourse, taking flow from a ditch on the south side of Jubilee Meadow towards Woodbridge Road was also reported to be broken, causing water to back up in the ditch and overtop close to Woodbridge Road. This ditch was reported to be silted up. (The broken pipe between Jubilee Meadow and Woodbridge Road has been repaired and the ditch adjacent to Jubilee Meadow has been cleared subsequent to Storm Babet. However, silt is reported to have then partly blocked the pipe under Woodbridge Road). A piped section of a watercourse on the east side of Woodbridge Road opposite this area was also reported to be blocked, causing water to back up and surcharge from a manhole in a garden on the west side of Woodbridge Road. (This blockage has been cleared since Storm Babet). Surface water also flowed west off Woodbridge Road into driveways that are situated lower than the highway. Flood water from fields to the west of Woodbridge Road, from the ditch on the south side of Jubilee Meadow and from the surcharging manhole merged together, causing internal flooding of property to a level of 6cm. Flooding of property in this location occurred

again in Storm Henk (2<sup>nd</sup> January, 2024). Gullies in the vicinity of this location were reported to be operational during Storm Babet.

In the area on the south side of Woodbridge Road, it was reported that surface water flowed off the fields at the rear of affected property and water flowed off the road at the front of property. This was exacerbated by driveways being a lower than the highway. Floodwater was reported to have entered houses in this area at 11am. and floodwater reached internal levels of 25cm. Drains were reported to be blocked. However, all gullies in the vicinity were checked during cyclical maintenance and found to be operational in the last visit before and first visit after Storm Babet. The extreme rainfall conditions caused the drainage system to be overwhelmed and exceed capacity.

Sewage was also reported to be in floodwater south of Woodbridge Road. However, Anglian Water did not receive reports of this, but the extreme rainfall may have caused the combined sewers to surcharge.

- Intense and prolonged rainfall exceeded the capacity of field ditches and surface water flowed across fields from the west of Woodbridge Road.
- A pipe in a culverted watercourse flowing from a ditch south of Jubilee Meadow towards Woodbridge Road was broken, blocking flow.

- This caused the water to back up, overtopping the ditch, which was silted up.
- Subsequent pipe repair between Jubilee Meadow and Woodbridge Road released silt which may have then blocked the pipe under Woodbridge Road.

- A piped section of watercourse on the east side of Woodbridge Road was blocked, causing water to back up and surcharge a manhole in a garden on the west side of Woodbridge Road. This blockage has been cleared subsequently.

- Flood water from fields west of Woodbridge Road, from the ditch on the south side of Jubilee Meadow and from the surcharging manhole merged together with floodwater flowing west off Woodbridge Road into lower level driveways to flood property internally.

- Floodwater from fields to the south of Woodbridge Road merged with surface water flowing down lower level driveways to flood property south of Woodbridge Road.

- Sewage was reported to be present in floodwater south of Woodbridge Road. No reports were received by Anglian Water but this may have been due to the combined sewer surcharging.

- Residents to install Property Flood Resilience (PFR) via grant funded scheme.
- SCC Highways to investigate potential blockage in piped watercourse under Woodbridge Road in the vicinity of Jubilee Meadow.

- Landowners to carry out watercourse maintenance to reduce flood risk as necessary in accordance with their riparian responsibilities.

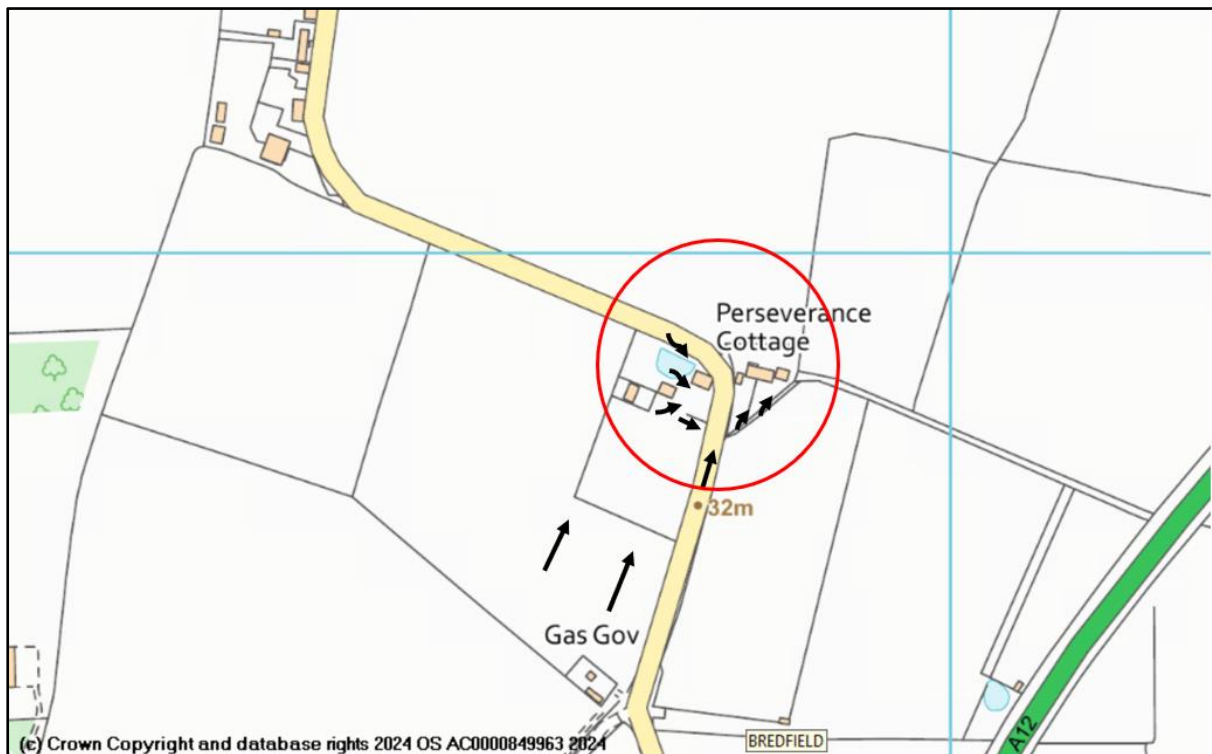
**Fig. 11. Approximate floodwater flow paths in Potash Corner (C309)**

Affected property in this area on the west of the road C309 is projected to be at high surface water risk of flooding. On the east side, affected property is projected to be at low risk of surface water flooding, ie. at risk during extreme rainfall events. Neither are at fluvial (river) flood risk. Two properties were affected by internal flooding on the east and west side of road C309.

A pond adjacent to property on the southwest side of the road C309 at Potash Corner receives surface water from highway gullies and fields to the south. Pipes for inflows to the pond are reported to be larger than the outflow. The pond overtopped due to a combination of extreme quantities of surface water runoff from fields and the highway causing the drainage system to exceed capacity. Surface water also flowed from the south down the highway to this low-lying area. Floodwater on the corner of the road C309 at Potash Corner reached approximately 15cm at 1.43pm on 20<sup>th</sup> October. All gullies in the vicinity were operational at the time, with the possible exception of one. However, grips were partly overgrown. Fully functional grips, particularly on the north side of the road where land adjacent to the road is at a significantly lower level, would have enabled some more water to flow away more rapidly from the highway. Floodwater from the overtopped pond combined with further surface water flowing

directly from the fields and the highway to flood property on the west side of the highway to an internal level of approximately 30cm.

Excess water from the pond flows into a ditch which continues eastwards through a small diameter piped culvert under the road and into another ditch flowing east at the rear of property on the eastern side of the road C309. This small ditch overtopped and combined with surface water runoff from fields on the east side which had exceeded the capacity of field drainage systems. Some drainage ditches in the vicinity were reported not to have been kept clear prior to Storm Babet.

- Surface water from highway gullies and fields to the south drain into a pond on the southwest side of the road C309.
- Pipes for inflows to the pond are reported to be larger than the outflow.

- The pond overtopped due to a combination of extreme quantities of surface water runoff from fields and the highway causing the drainage system to exceed capacity.

- All of the gullies in the vicinity were operational at the time, with the possible exception of one.
- Excess water from the pond flows into a ditch which flows east through a small diameter pipe under the road C309 and past the rear of properties on the east side of the road.

- This ditch overtopped, adding to further surface water flowing directly from fields which had exceeded the capacity of field drainage systems and also surface water from the highway which both flowed from the south to this low-lying area.

- Some field drainage ditches in the vicinity were reported not to have been kept clear prior to Storm Babet.

- Residents to install Property Flood Resilience (PFR) via grant funded scheme.
- Landowners to carry out watercourse maintenance to reduce flood risk as necessary in accordance with their riparian responsibilities.
- SCC Highways to recut grips flowing to lower field  
SCC Highways to investigate ditch ownership and action works to ditch levels accordingly.

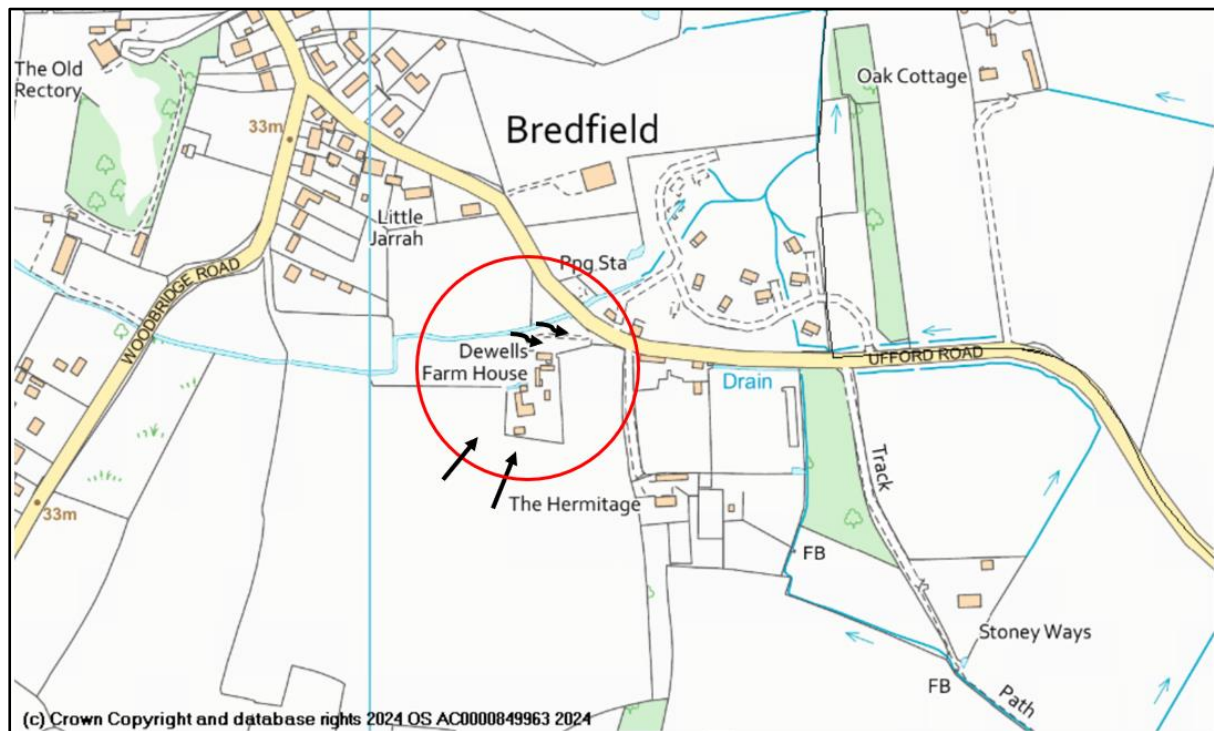
**Fig. 12 Approximate floodwater flowpaths, Ufford Road**

The northernmost area where property was affected by internal flooding was on the south side of Ufford Road, close to Byng Brook (Fig. 12). One property is known to have internally flooded. Affected property on Ufford Road is projected to be in a high risk area for both surface water and fluvial flooding. Byng Brook is reported to have

overtopped its banks and fluvial water flowed south, combining with surface water flowing from the southwest from fields. Flood water had entered property by 12.09 on the 20<sup>th</sup> October and reached a level of 30cm. It had receded by 5pm.

- Intense and prolonged rainfall caused Byng Brook to overtop its banks and fluvial water to flow south.
- This fluvial water combined with surface water flowing northeast from fields.

- Residents to install Property Flood Resilience (PFR) via grant funded scheme.
- Landowners to carry out watercourse maintenance to reduce flood risk as necessary in accordance with their riparian responsibilities.
