Section 19 Flood and Water Management Act 2010

Worlingworth Flood Investigation – Storm Babet October 2023

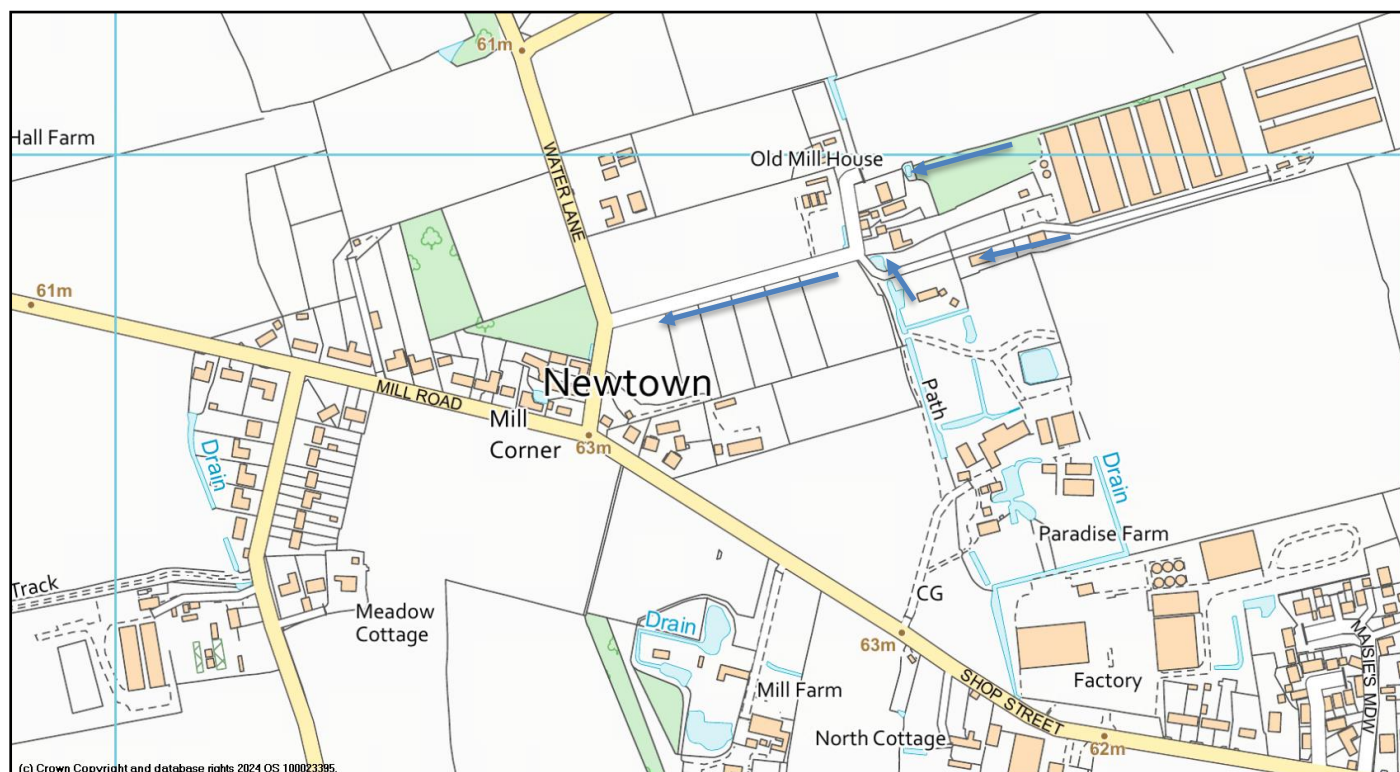
Figure 12 - Flow routes of water in west Worlingworth

Reports from Newtown suggest that there are several issues, many of which relate to maintenance of watercourses, ponds and other water management features. Due to the flat nature of the ground in this area, it is particularly important that water management features are well maintained to allow for water to flow away in a timely manner or to be held safely in attenuation features such as ponds or wetlands, and again these will need to be well maintained to ensure a sufficient capacity. Many of the reports received and conversations with the residents suggested that debris and fallen trees in the channels of watercourses contributed to blockages, causing water to backup and overtop the features. This excess water then flowed to the lowest points, which in this location were often houses.

There are several ponds in the proximity of Newtown and some reports suggest that a lack of maintenance of these features has reduced their holding capacity through siltation and sedimentation, which may have exacerbated the severity of the event. However, due to the saturated conditions of the preceding months and severity of the rainfall event, it is likely that these features would have exceeded capacity anyway, although any increase in their capacity would have helped even if only in a small way.

There are several watercourses in the area which border the highway, properties and fields which are present to provide a route for water flow. These channels were reported to have been blocked or poorly maintained for some time which may have prevented effective water egress adding to flood water and worsening the event.

Highways drainage records show a gully on the junction with Water Lane and Newtown, (an unclassified road leading to the nearby farm), which was ineffective and slow draining upon the last two cyclical inspections. This gully could have caused the draining of the water in the area to slow down, although, as it is some distance from the properties affected, it is unlikely to have been a significant factor in the flooding experienced.

- Significant rainfall onto already saturated ground caused high levels of overland surface water flow, resulting in ponding of water in isolated low spots.
- Overwhelmed water management features, such as ponds, watercourses and wetlands caused and added to surface water flows.
- Poorly maintained water management features in the area may have exacerbated the issue.

- Report issues to relevant RMA or landowner/parish where known blockages or issues have occurred for relevant RMA/landowner to carry out remedial works where required.
- Highway authority to resolve slow draining gully asset on the junction with Water Lane and Newtown.
- Increase maintenance frequency of water management features in the area.
- Residents to install Property Flood Resilience (PFR) via grant funded scheme.

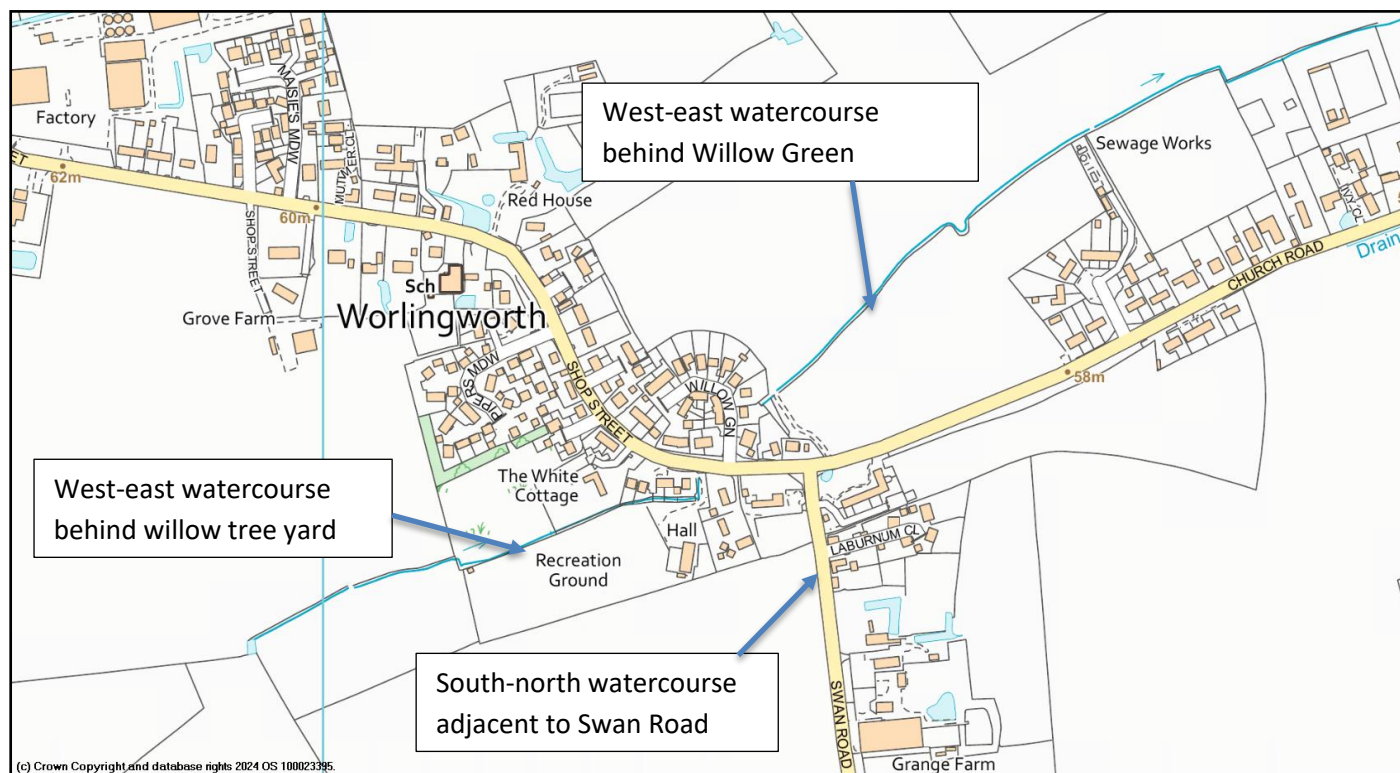
Figure 13 - Map of local watercourses

Flood water also came from overtopped watercourses within the area. Watercourses are located behind Willow Tree Yard; Willow Green and an additional watercourse runs roughly south to north down Swan Road and joins the west to east watercourse just on the northside of Church Road.

Several ordinary watercourses surround the housing developments on the south side of Shop Street, most of which convey water into the larger watercourse running between the recreation ground and Willow Tree Yard. This is where the first significant flooding event occurred on the day. The current level of maintenance of these smaller watercourses is unknown, although due to sheer volume of water during Babet, maintenance of these is unlikely to have been a significant issue.

Where the watercourse reaches the highway, it is then culverted and flows towards Willow Green. Reports from the day suggest this culvert was very quickly overwhelmed with volume of water, causing significant overtopping, which added to the flood water on the highway already coming up through the drainage infrastructure. The current outfall of this piped section of watercourse is not clear, although there are outfalls located north of Willow Green in the watercourse which appear to be likely. The watercourse then continues to the east although the gradient of the land is much shallower this way and as such the waterflow is slower.

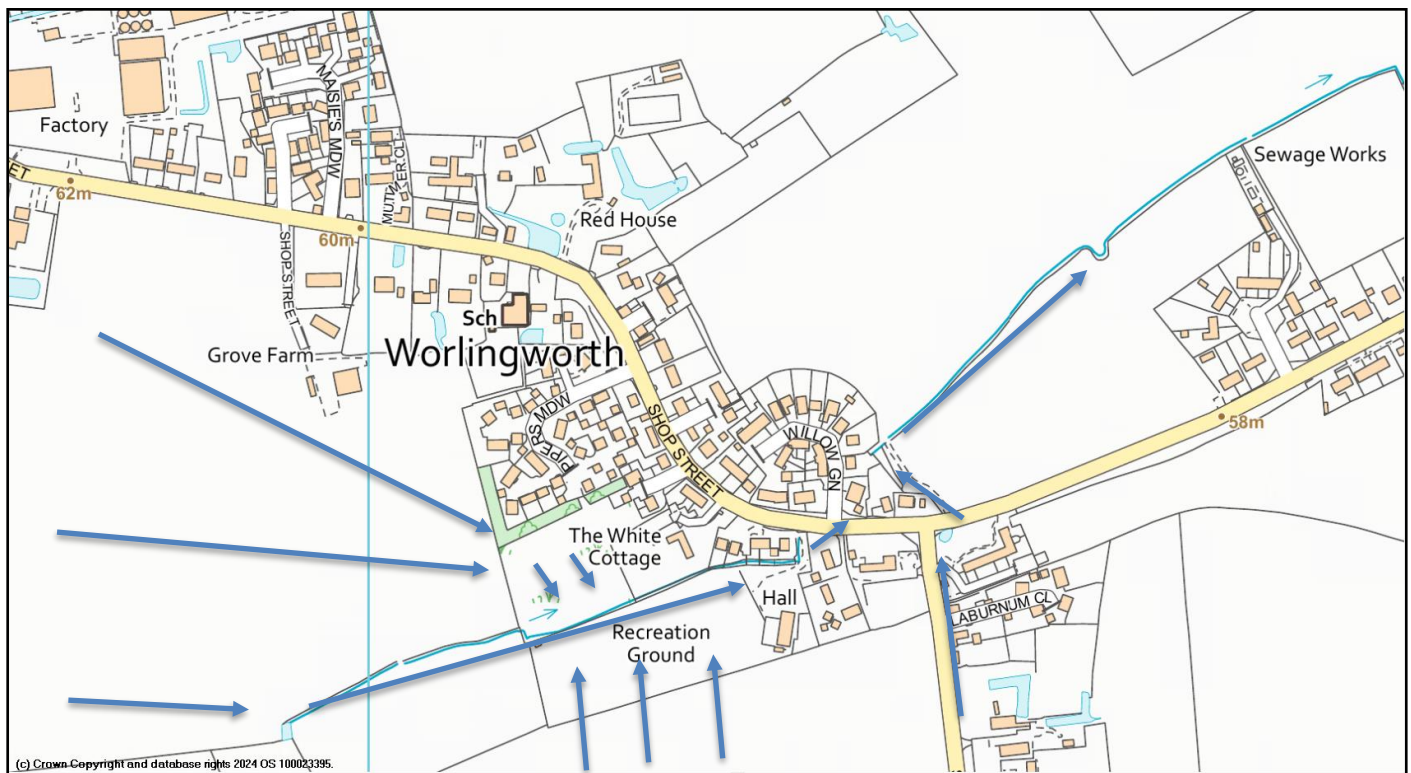
Figure 14 - Flow routes of water in central Worlingworth

Water flowed primarily from the west and south as runoff from the surrounding fields and down the watercourses. As it reaches the centre of the village the before mentioned issues of capacity and change in topography result in the water pooling and causing significant flooding to residential homes and businesses. Internal flooding reached levels of 37cm, and external flooding was considerably higher. Internal flooding was severe enough in several properties that even six months after the event, residents are yet to return home.

- Significant rainfall and saturated ground caused high-level of overland flow towards the centre of the village, overwhelming water management features and spilling out at the pinch points near the community centre.
- Change in topography in the village centre causes water flow to slow down at this point adding to the overcapacity systems.
- Watercourses exceeded capacity and saw water flow out of bank, contributing to overland flows within the area.
- Highways and Anglian water assets were overwhelmed, and water was forced back up manhole covers adding to the flood water.

- Investigate possibility of natural flood management scheme in watercourses to the east and south of the village to try and slow the rate at which the water reaches the village centre.
- Investigate the possibility of attenuation/infiltration 'overspill' areas on the recreation ground (south of Shop Street) and agricultural land (east of Willow Green).
- Investigate the possibility of incentivising the retrofit of SuDS or rainwater harvesting systems for properties which currently drain roof water into the foul system. These can reduce surface water runoff and help to ensure the foul system is not overwhelmed during rainfall events.

- Anglian Water to investigate potential ground water intrusion into the foul sewer and plan works to reduce the occurrence of any related foul water flooding.
- Investigate the feasibility of increasing the capacity of existing drainage networks belonging to both highways and Anglian Water.
- Residents to install Property Flood Resilience (PFR) via grant funded scheme.

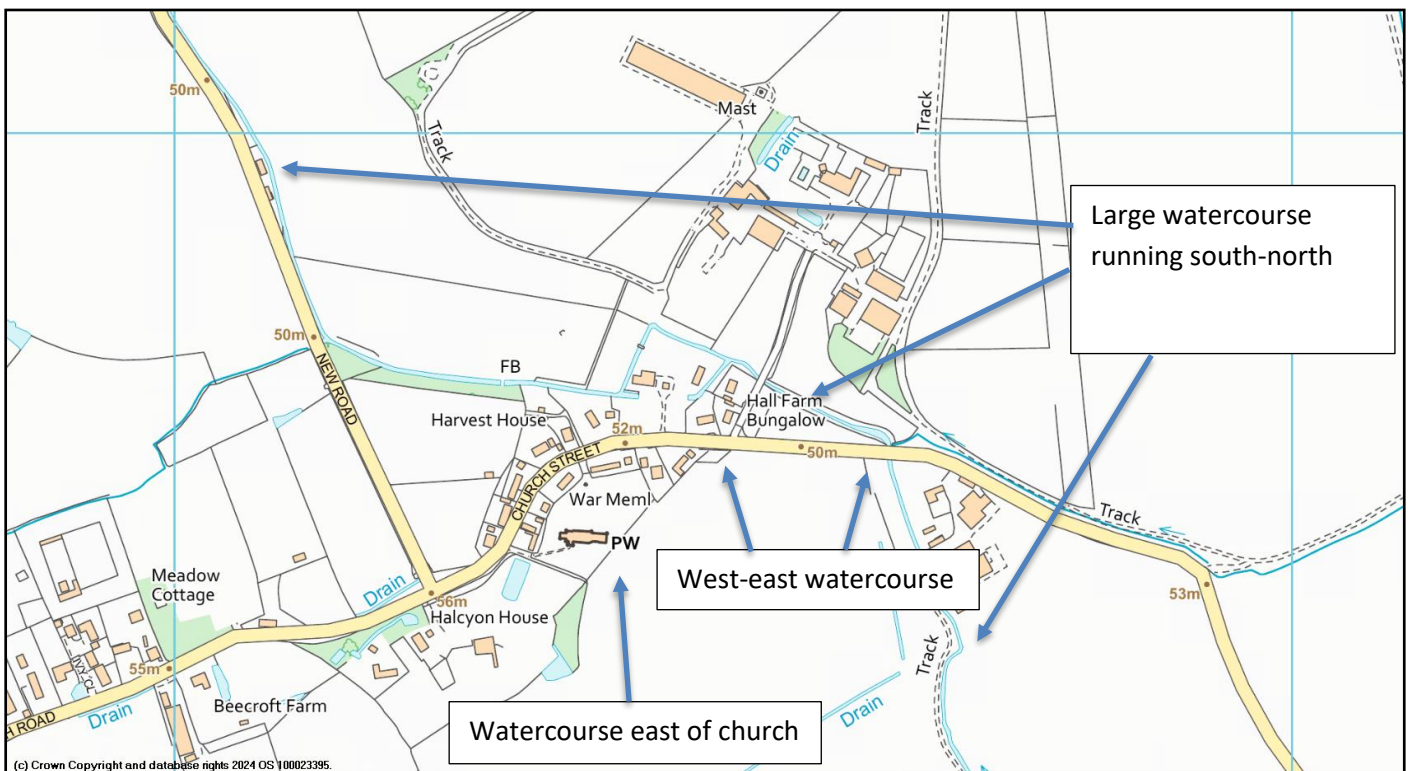
Figure 15 - Map of watercourses in east Worlingworth

According to residents there is a watercourse which runs south to north along the eastern edge of the church grounds. This comes to an abrupt stop as it meets the properties north of the church and there is no visible sign of a piped continuation of the watercourse. Reports from the event suggested that as surface water runoff from the surrounding fields to the south and east flowed down this feature, it pooled at the northern end and eventually overtopped, and water flowed south through the gardens and outbuildings of the surrounding properties. Once it reached the highway it pooled at the lowest point and flowed into properties off the highway. There are several highway drainage assets in the area all of which were recorded as working on the inspection prior to the event (September 2022), these were again inspected in December of 2023 and said to be working, it is therefore likely that the drainage system was overwhelmed due to significant rainfall rather than a localised blockage being an issue.

There is a further watercourse which appears to run west to east along the south side of Church Road. This feature runs into a culvert near to the Anglian Water pumping station and runs the length of the adjacent field and outfalls into the river to the east. An onsite inspection showed that a further culvert in the north bank of the watercourse runs through a pipe under the road and into the front gardens of houses on the north of the road. This culvert outfalls to the watercourse which runs behind the properties north of the road.

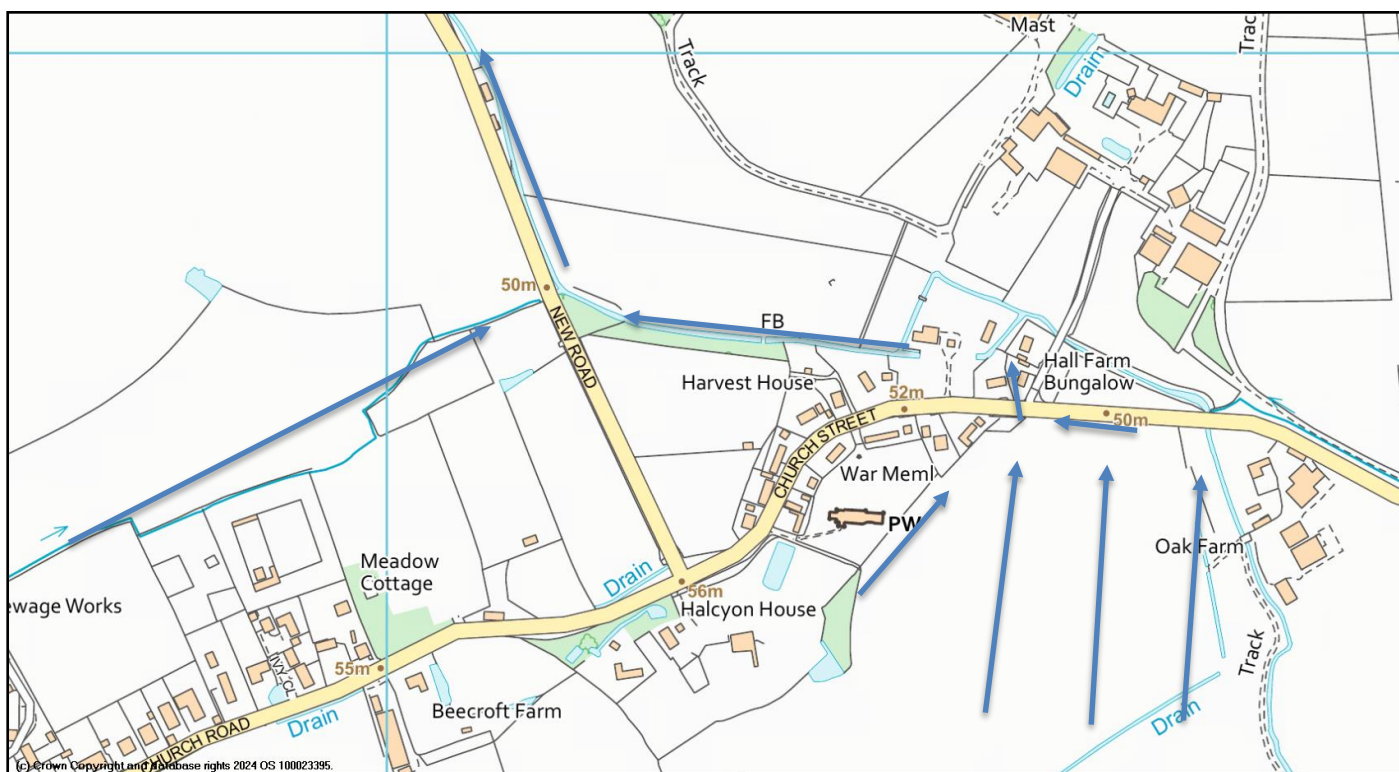
Figure 16 - Flow routes of water in east Worlingworth

Properties on the north side of Church Street were affected predominantly from water flowing off the highway due to the overland surface water flow and overtopped watercourses as described above. However, further to the north, the watercourses in the area provide a natural boundary between properties. Reports from residents suggest that this watercourse could be blocked by overgrowing trees which could have caused a backup of water flow resulting in the overtopping of the banks of the watercourse due to prevention of effective water egress.

Additionally, as you travel further north along the watercourse, it borders 'New Road' on the east side and residents have suggested that a newly formed culvert along this section of watercourse has caused water to back up more frequently which may have had some impact on the day by preventing water egress at a suitable rate. As the new culvert described above is some distance to the north of the properties, it is difficult to say if it is affecting the flood risk in the area, however the restriction of a watercourse here would have been unlikely to receive land drainage consent due to the high risk of flooding. SCC LLFA records show no Land Drainage Consent has been applied for in this area.

- Significant rainfall and overland flows caused watercourses to overtop and localised low spots to quickly fill with water.
- Watercourses and water management features in the area may have been lost or incorrectly maintained over time resulting in a loss of capacity in the channels or ineffective flow paths for water to egress.
- Highways drainage assets were overwhelmed most likely due to sheer volume of water.

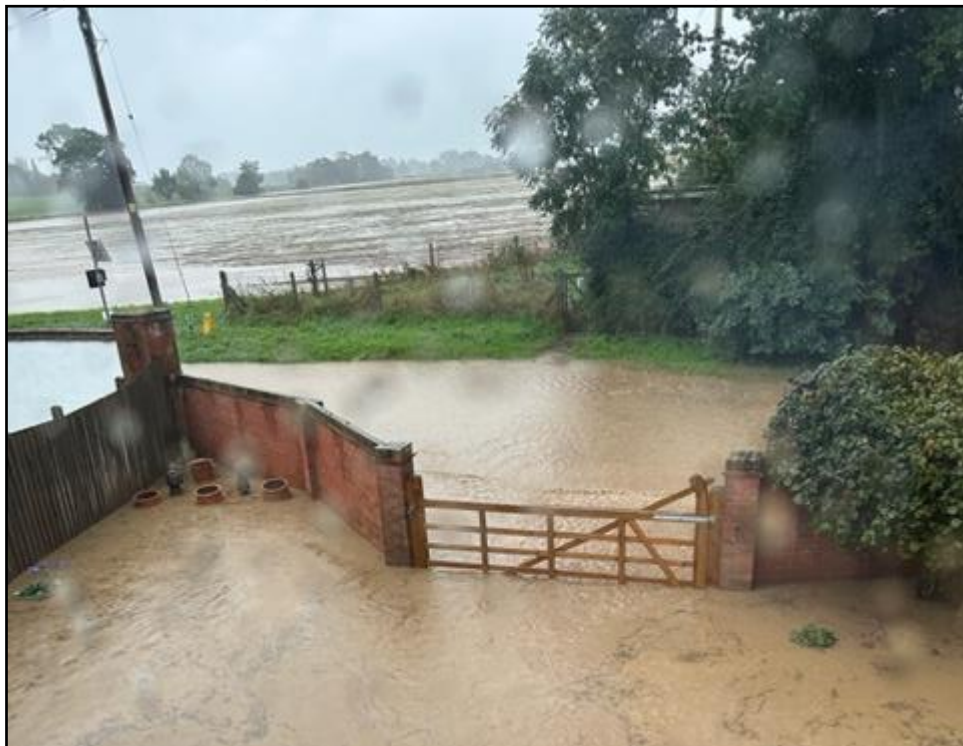
Image taken during the event from Eastern Worlingworth

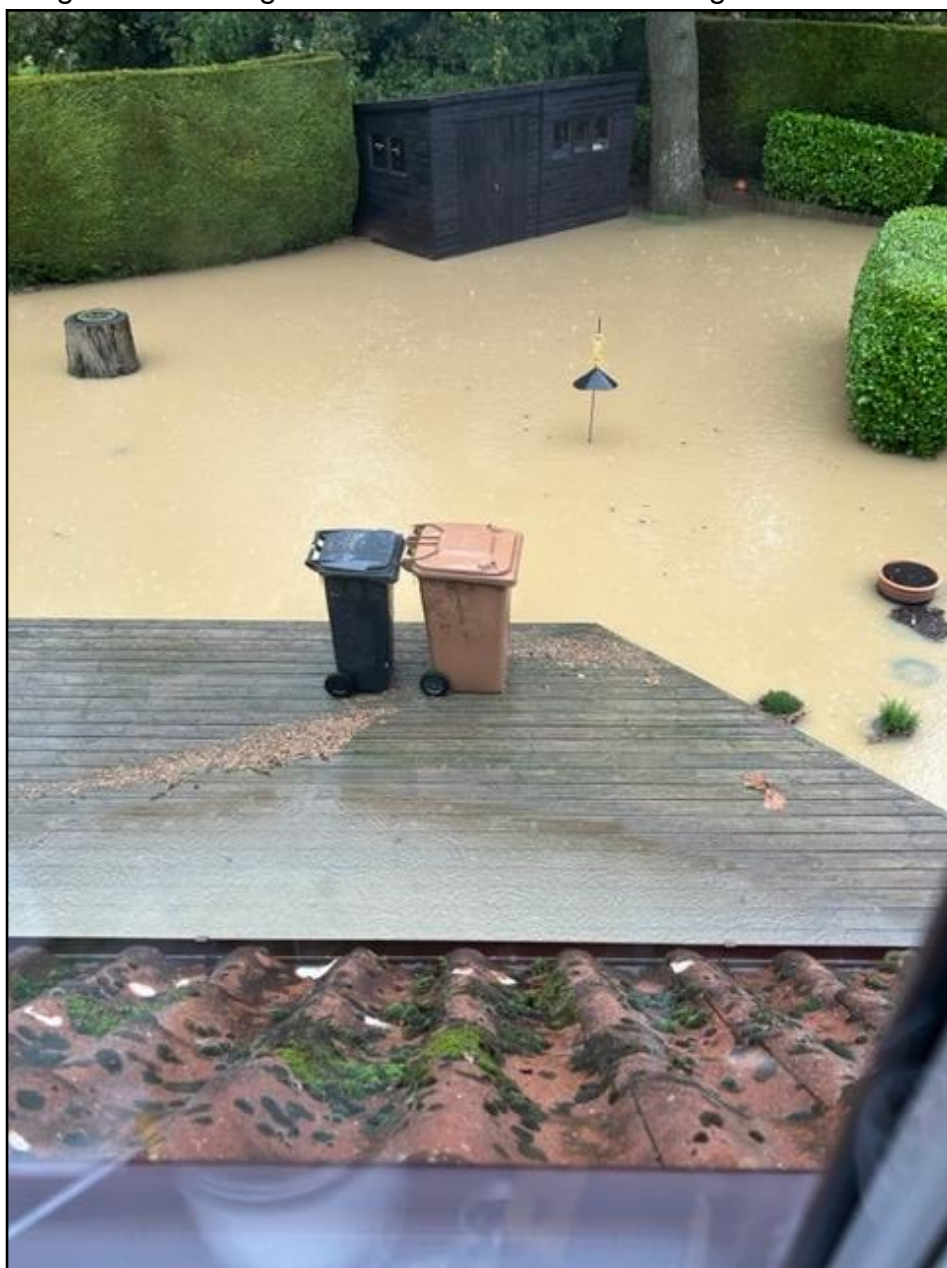
Image taken during the event from Eastern Worlingworth

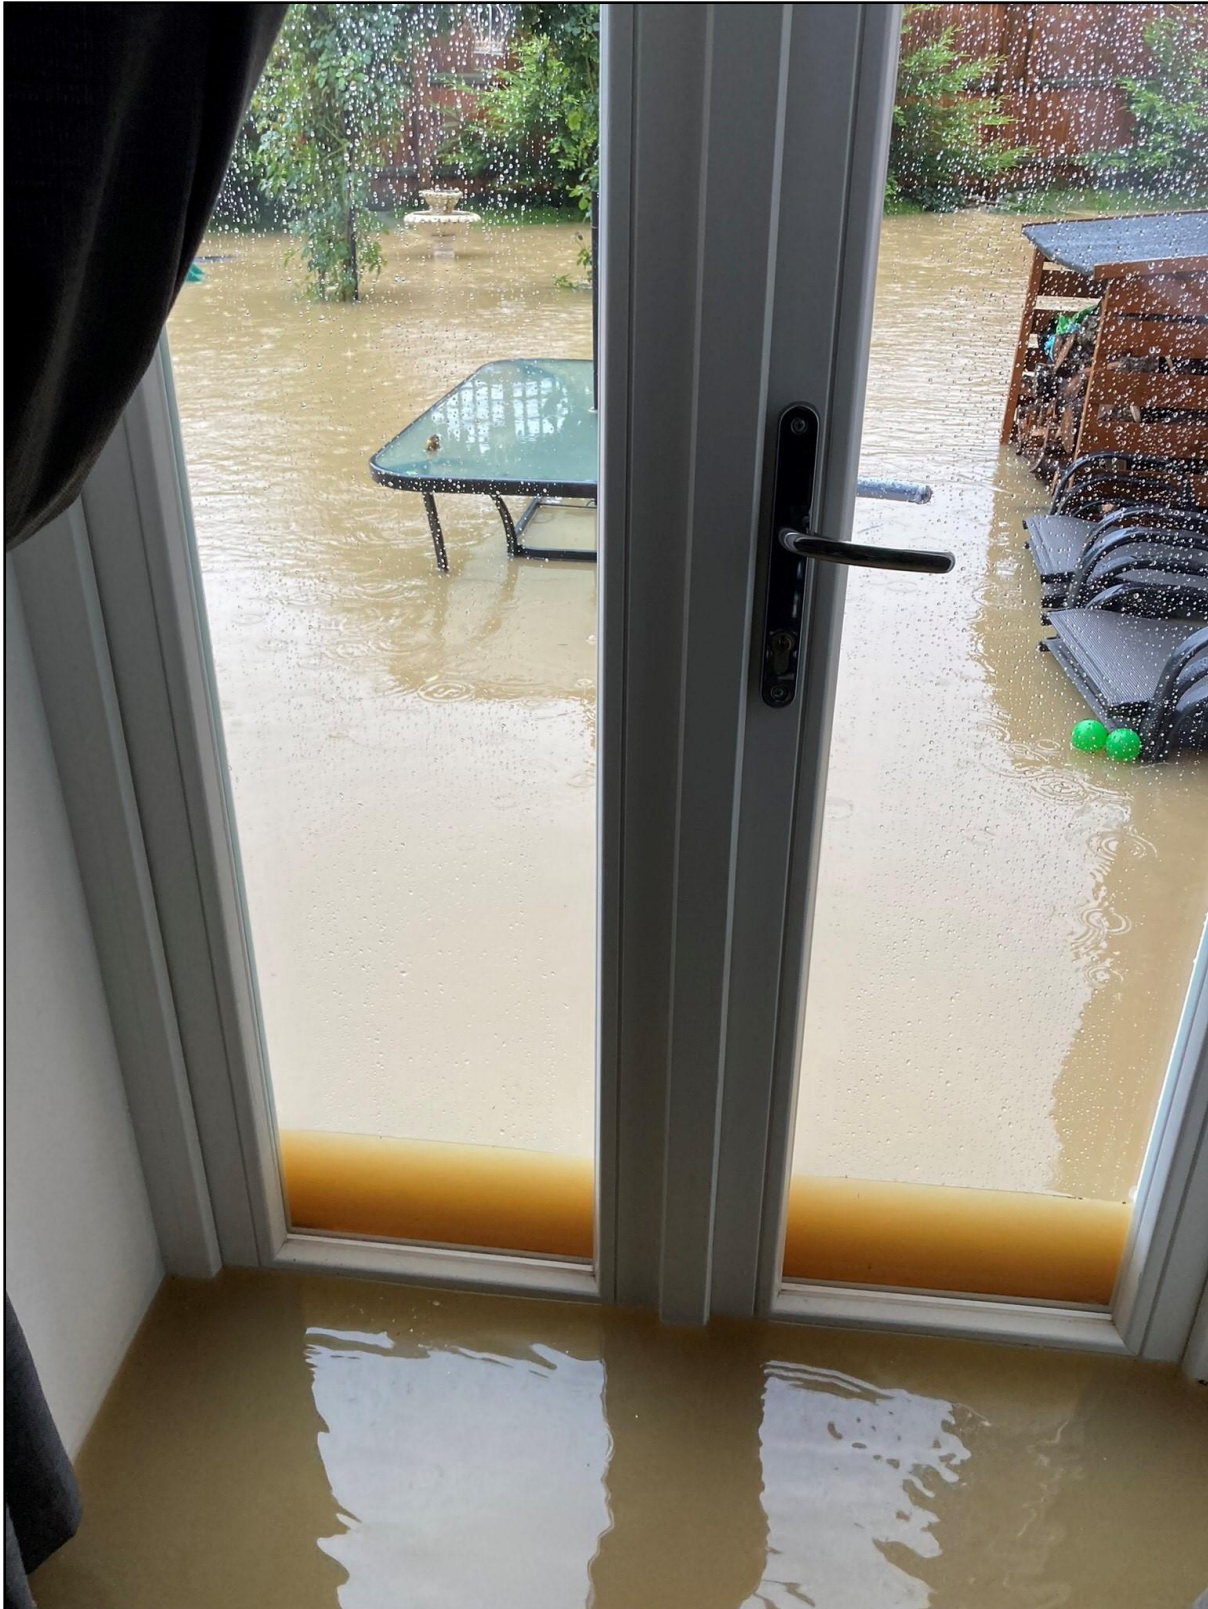
Image taken during the event from Eastern Worlingworth

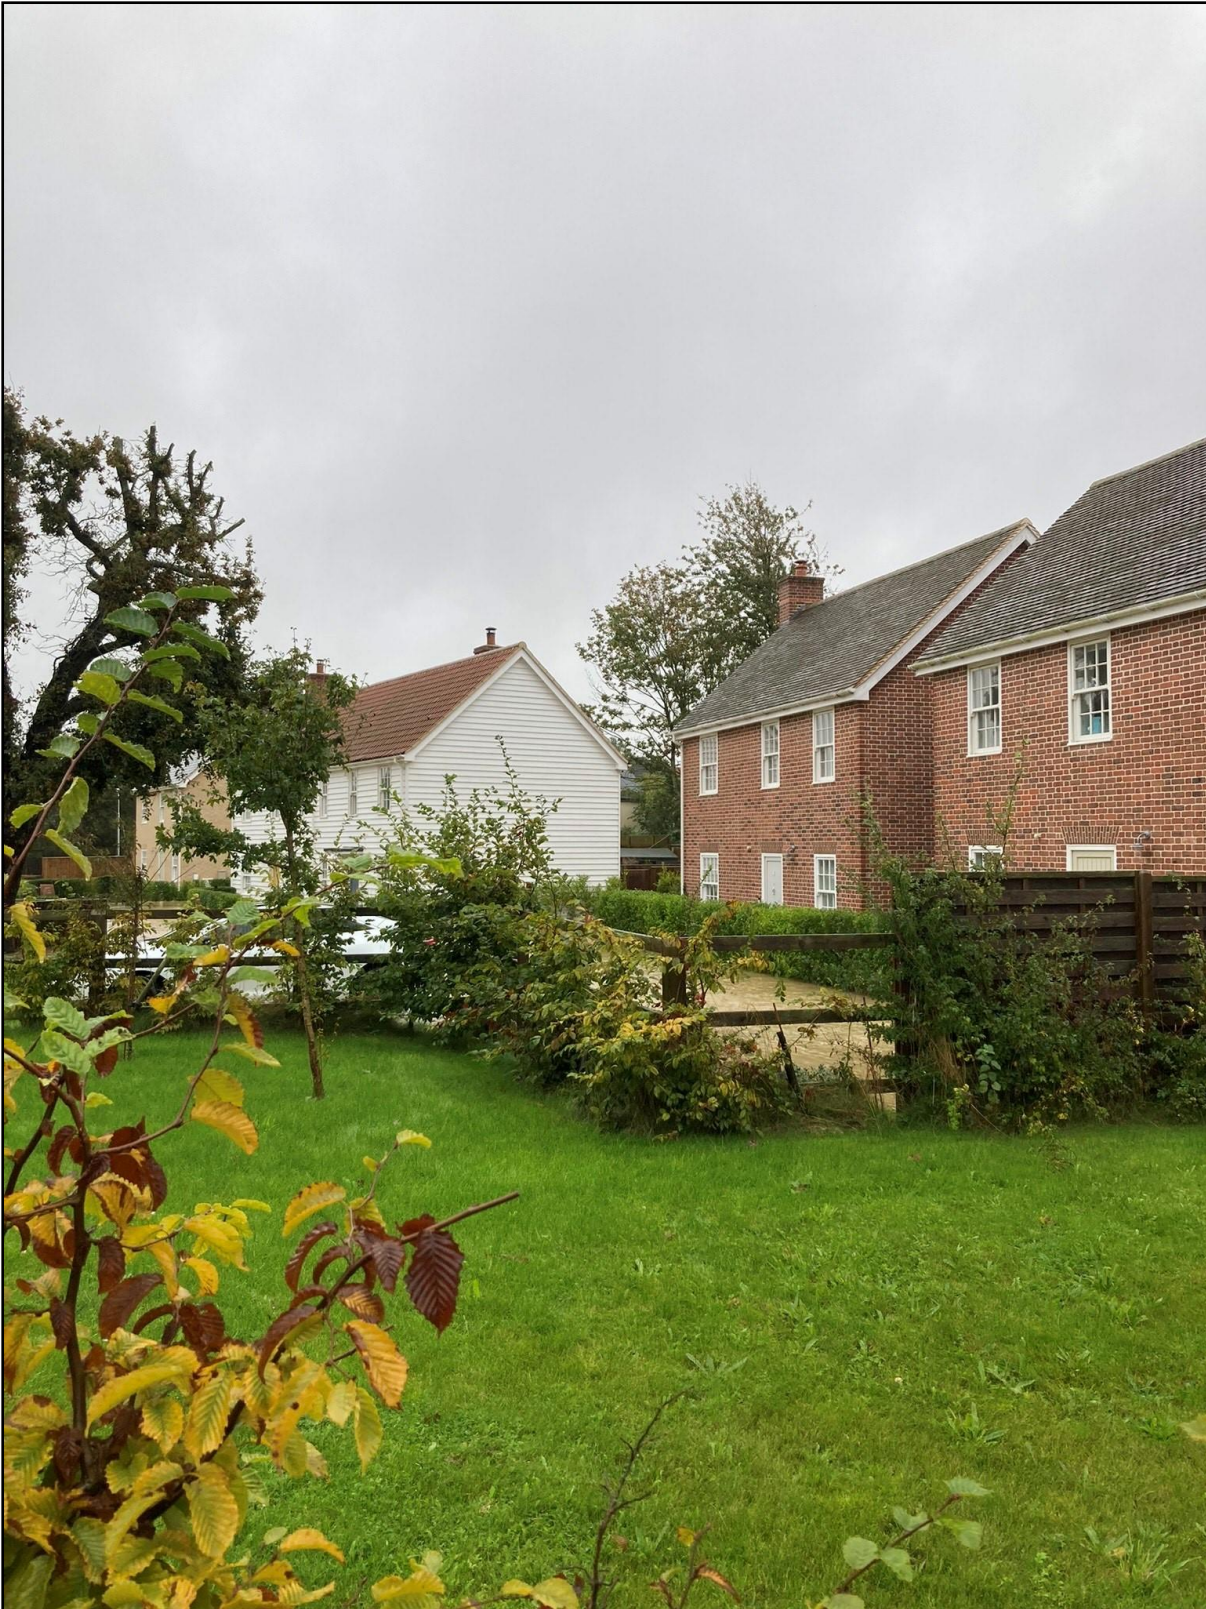
Image taken during event from central Worlingworth

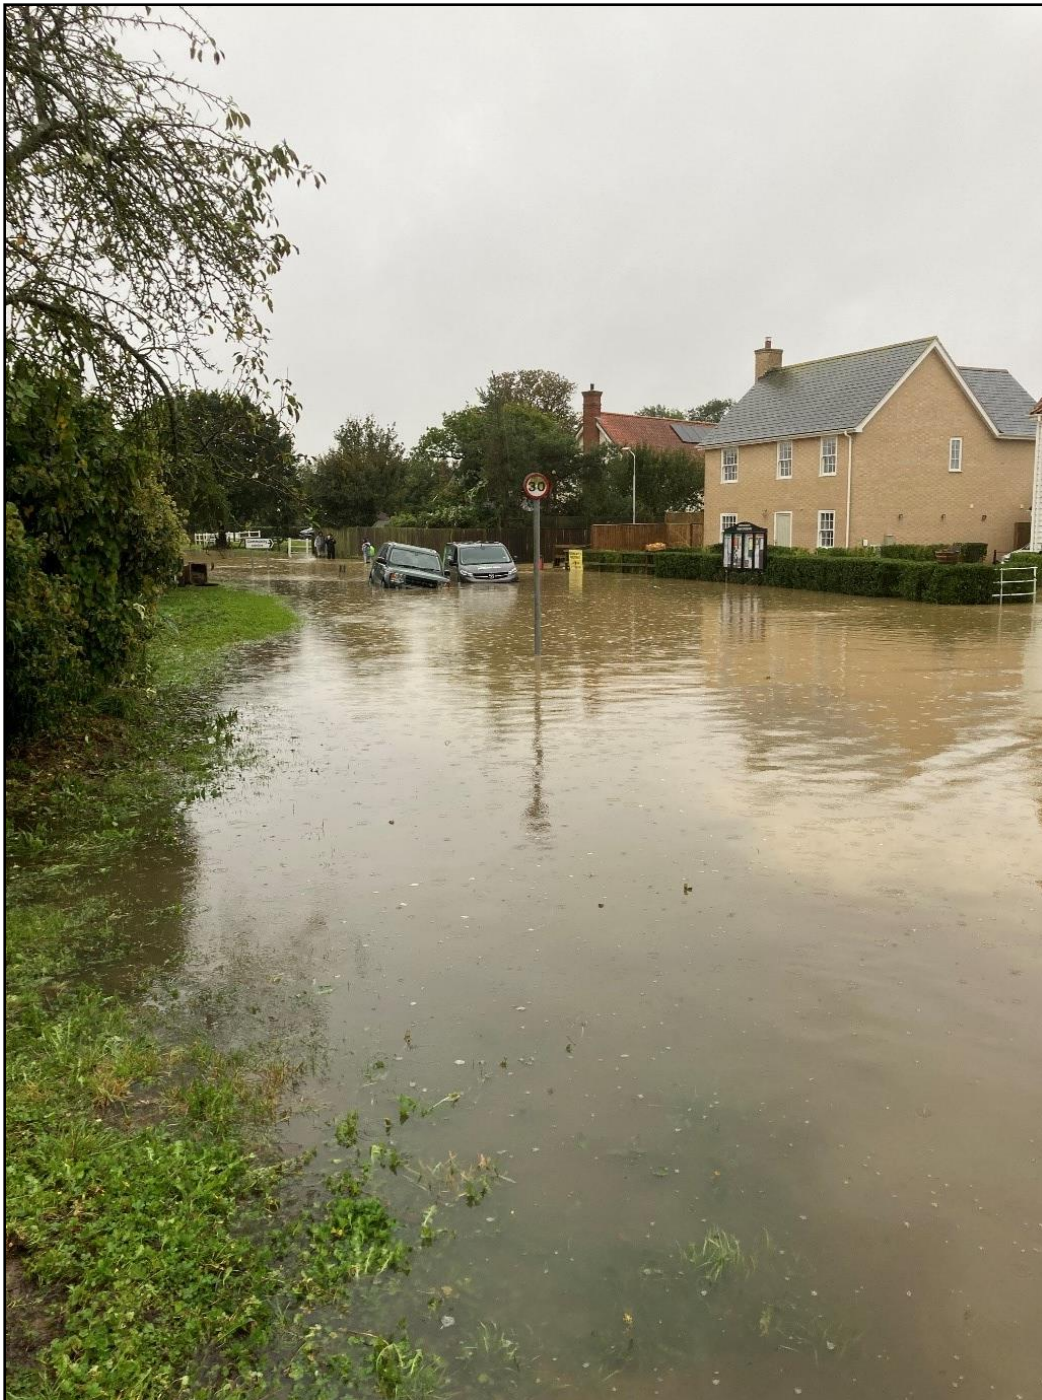
Image taken during the event in central Worlingworth

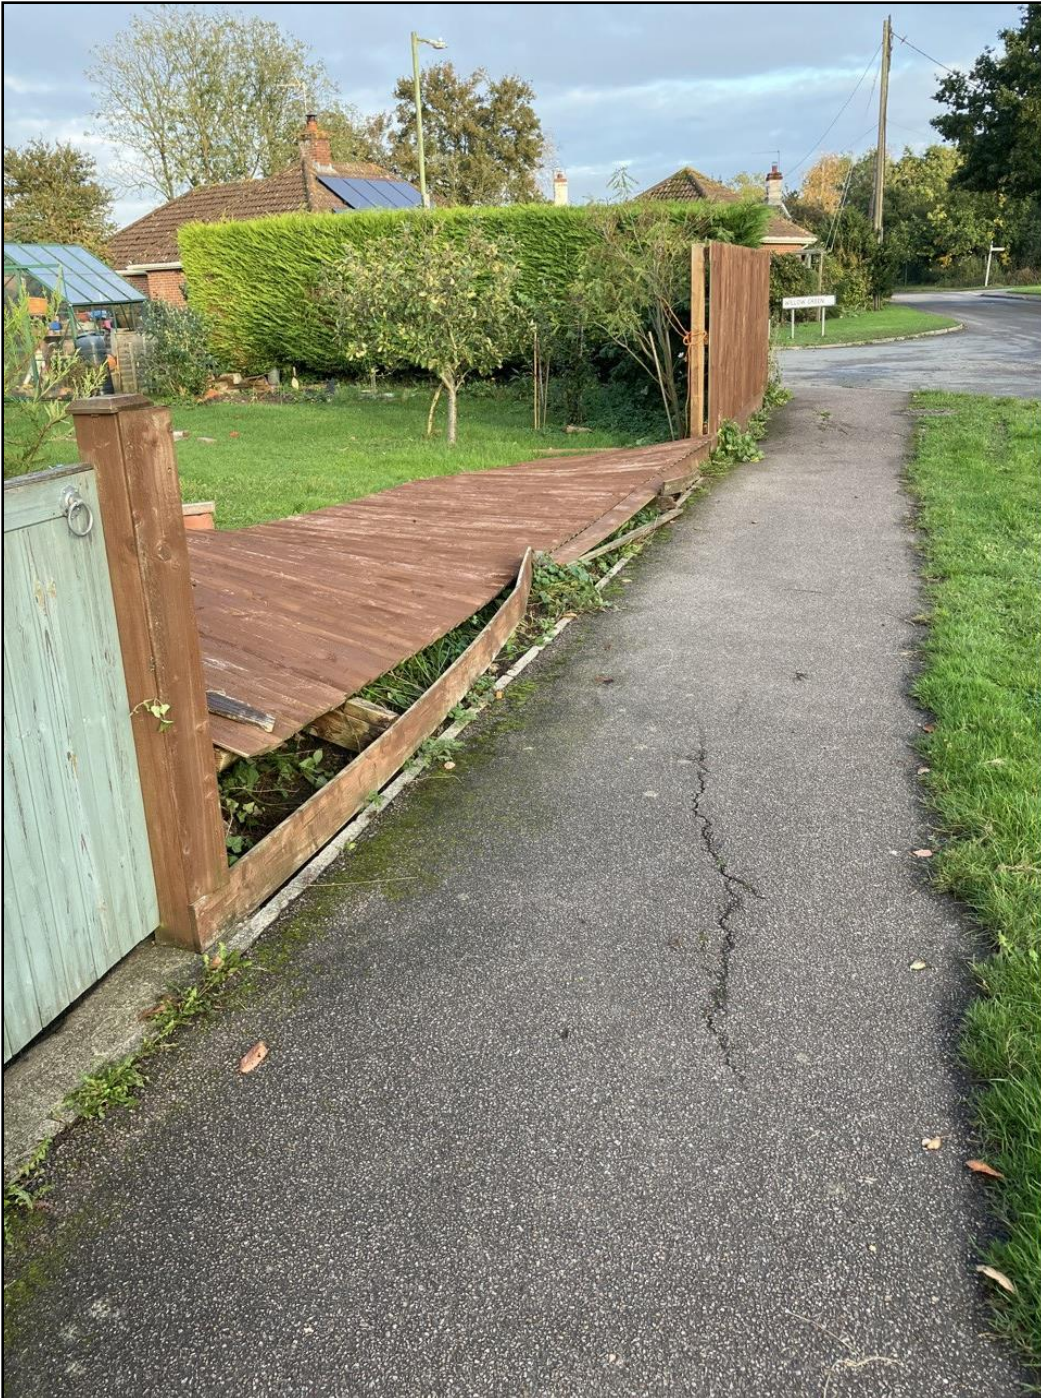
Post event damage to property

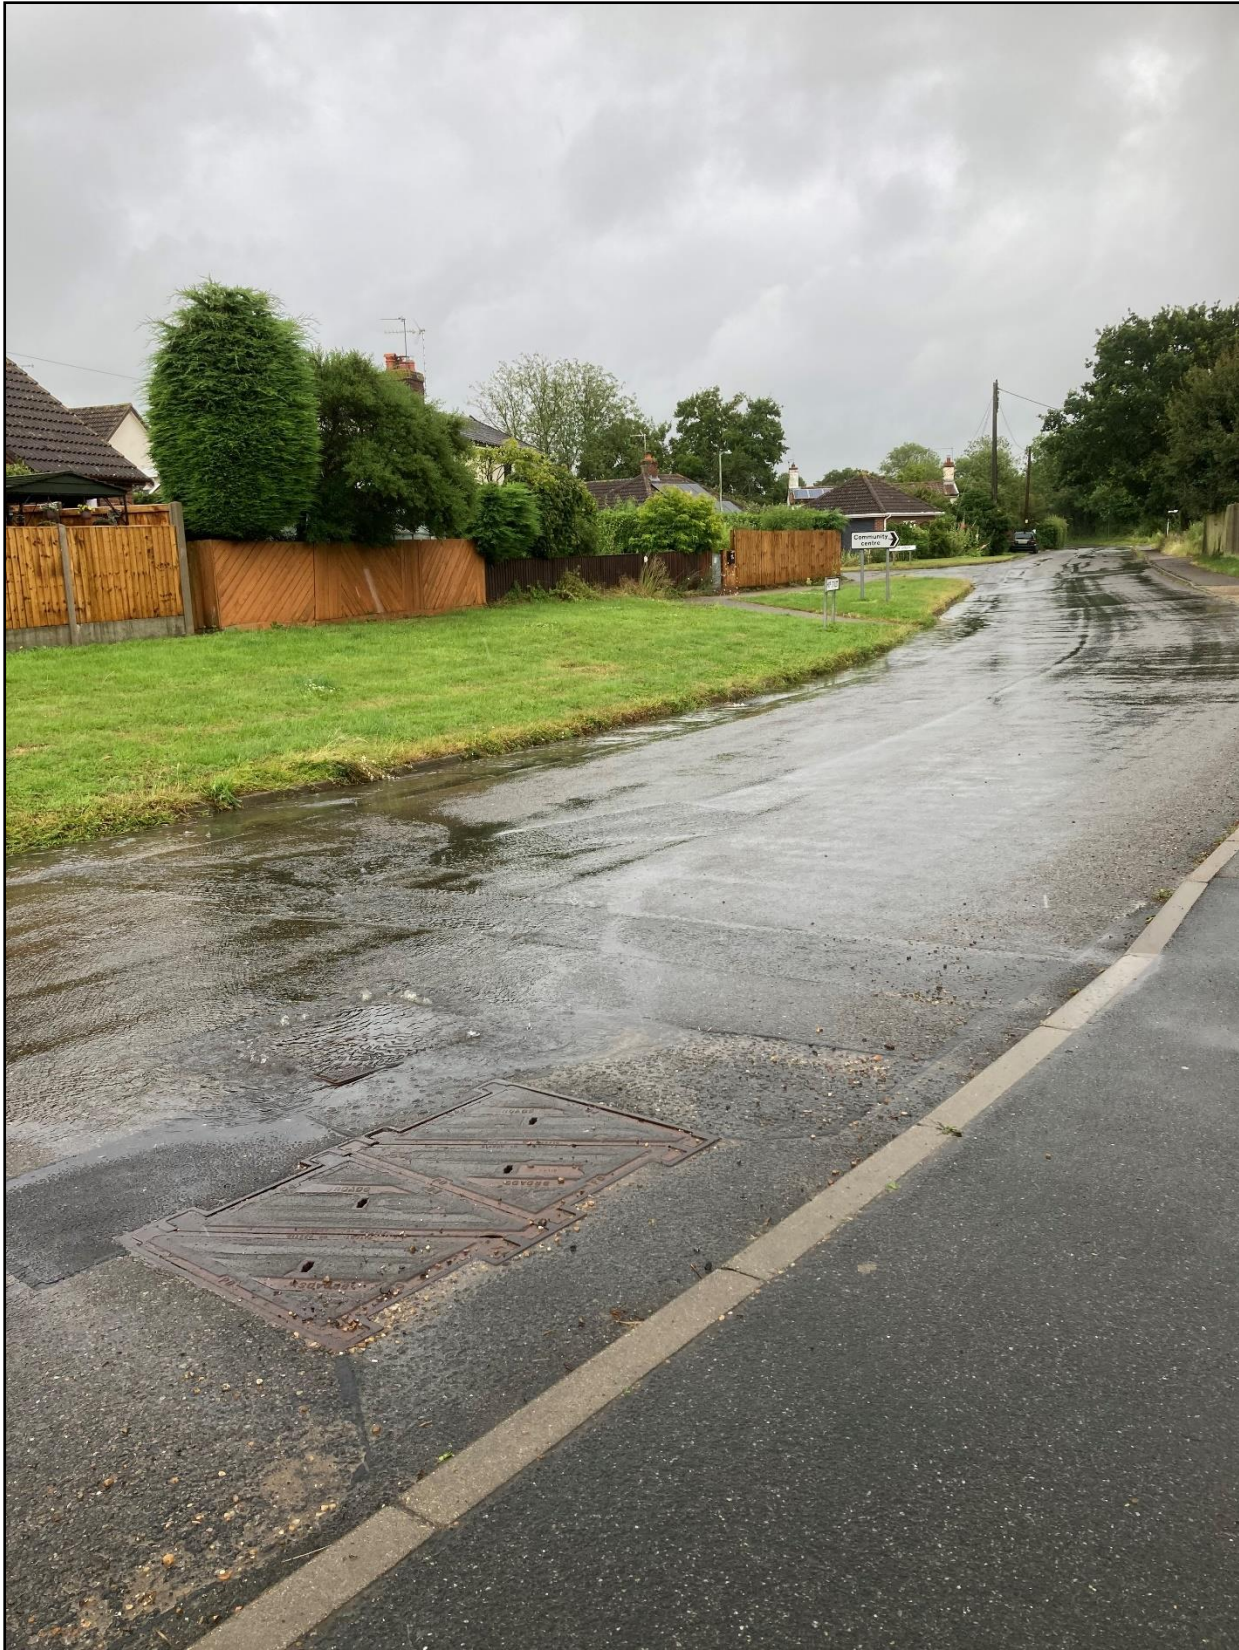
Image of the Sewerage network being overwhelmed by surface water (not taken during Babet)
