Section 19 Flood and Water Management Act 2010

Charsfield Flood Investigation – Storm Babet 2023

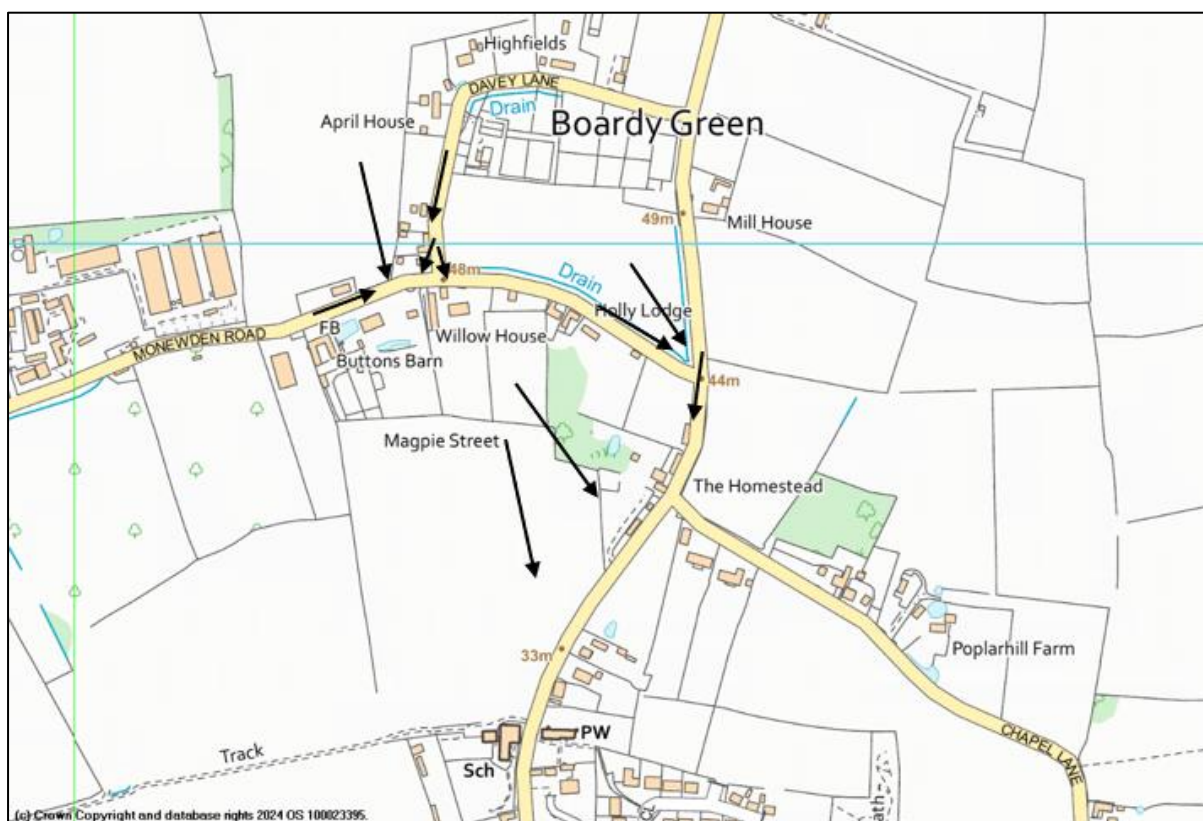
Figure 11 - Approximate flood water flow routes on Monewden Road

Monewden Road experienced flooding from surface water run-off from the adjacent fields to the north, combining with surface water flowing down the highway on Davey Lane (see Figure 11). Parts of Davey Lane are shown as being at High Risk from surface water flooding on the national predicted flood risk mapping. There is a lack of highway drainage assets along the length of Monewden Road and the gullies that are present were overwhelmed by the intensity of the rainfall on the morning of 20 October. Several of the properties along Monewden Road are situated lower than the road with downward sloping driveways which could facilitate flowpaths for the flood water. The internal flooding was reported to have occurred before midday which corresponds with the intense morning rainfall shown in the rainfall gauge data across the county. The flood water in this area is reported to have receded by early evening.

- High rainfall resulted in large amounts of surface water run-off coming from fields to the north on to Monewden Road.
- Surface water also flowed down Davey Lane onto Monewden Road impacting properties from the front.
- The limited number of drainage assets on the highway were temporarily overwhelmed.

- Landowner to undertake any required maintenance of the ditch on the north side of Monewden Road to reduce flood risk as per riparian landowner responsibilities.
- Ensure the completion of the existing highway drainage asset cyclic maintenance on Monewden Road.
- Investigate if the capacity and condition of the existing highway drainage assets on Monewden Road are sufficient.
- Maximise the take up of the £5k PFR Grant currently available to residents.

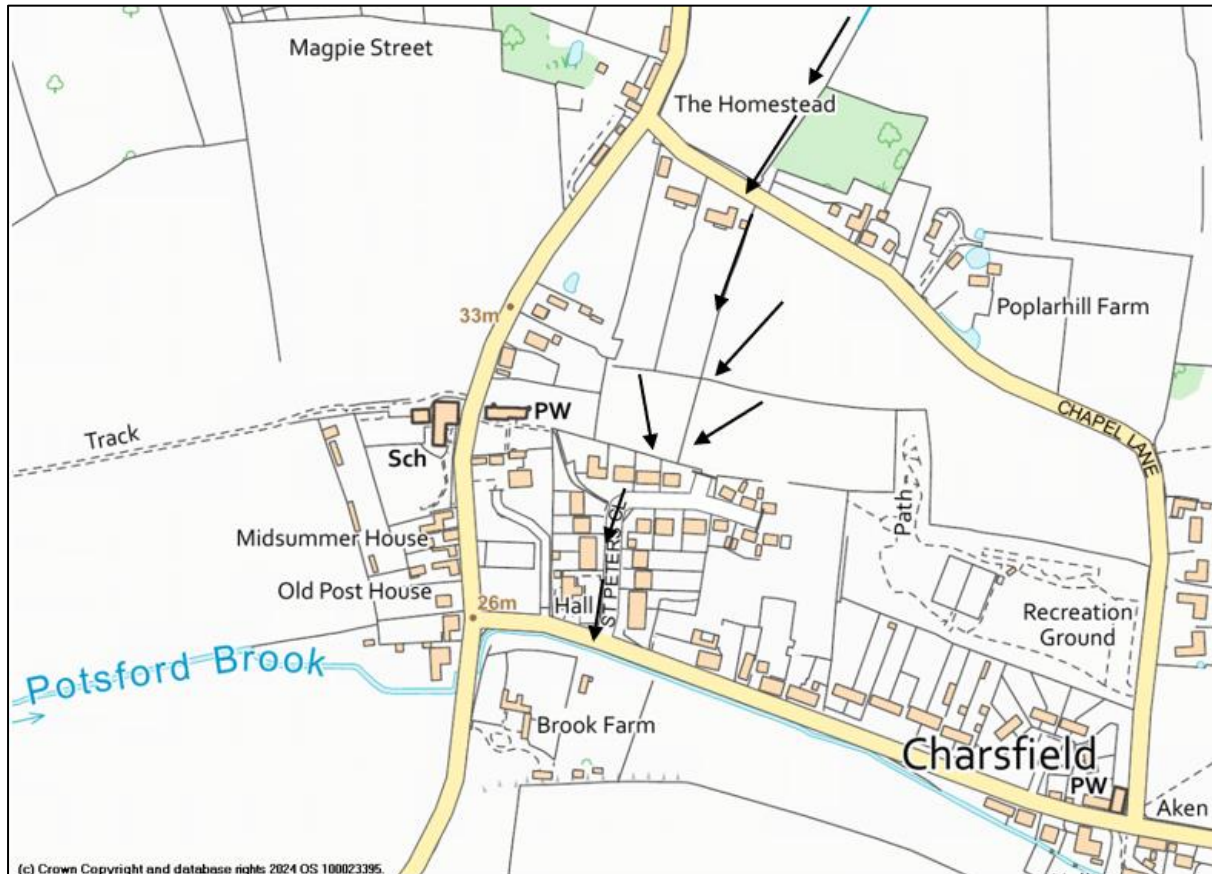
Figure 12 - Approximate flood water flow routes towards and through St. Peter's Close

Residents reported that the floodwater flow path continued south of the western section of Chapel Lane across the fields towards St Peter's Close (see Figure 12). Properties at the top of St Peter's Close were impacted directly to the rear by the surface water coming down the ditch. The ditch feeds into a pipe which was unable to cope with the volume of water. The capacity of the ditch and pipe behind the houses were very quickly overwhelmed and overtopped, coming through and around the gardens and then flowing down the length of St Peter's Close like a torrent. The flooding seen on St Peter's Close during Storm Babet mirrored the previous flood event experienced earlier in the year on 9 May 2023. On that occasion an intense rainfall event produced localised flooding and was concluded to be from surface water run-off from the fields to the north.

- High rainfall resulted in large amounts of surface water run-off coming from fields to the north of Chapel Lane and St Peters Close.
- Existing field ditches and the piped watercourse were overwhelmed when the floodwater exceeded their capacity.
- Floodwater followed the predicted flowpath along the downhill gradient and impacted properties from the front (Chapel Lane) and rear (St Peters Close).
- Drainage assets on the highway were overwhelmed as the floodwater accumulated at the bottom of St Peters Close and on The Street.

- Investigate potential Natural Flood Management (NFM) projects and funding opportunities which aim to attenuate water and 'slow the flow' in the upper catchment north of Charsfield, including the ditch north of St Peters Close.
- Investigate the options to extend the ditch or introduce tree planting or a hedgerow buffer zone along the north side of Chapel Lane.
- Ensure the completion of the existing highway drainage asset cyclic maintenance on St Peters Close and the western end of Chapel Lane.
- Investigate if the capacity and condition of the drainage assets at the western end of Chapel Lane and on St Peters Close are sufficient.
- Landowner to investigate if the capacity of the piped watercourse above St Peters Close can be increased.
- Maximise the take up of the £5k PFR Grant currently available to residents.

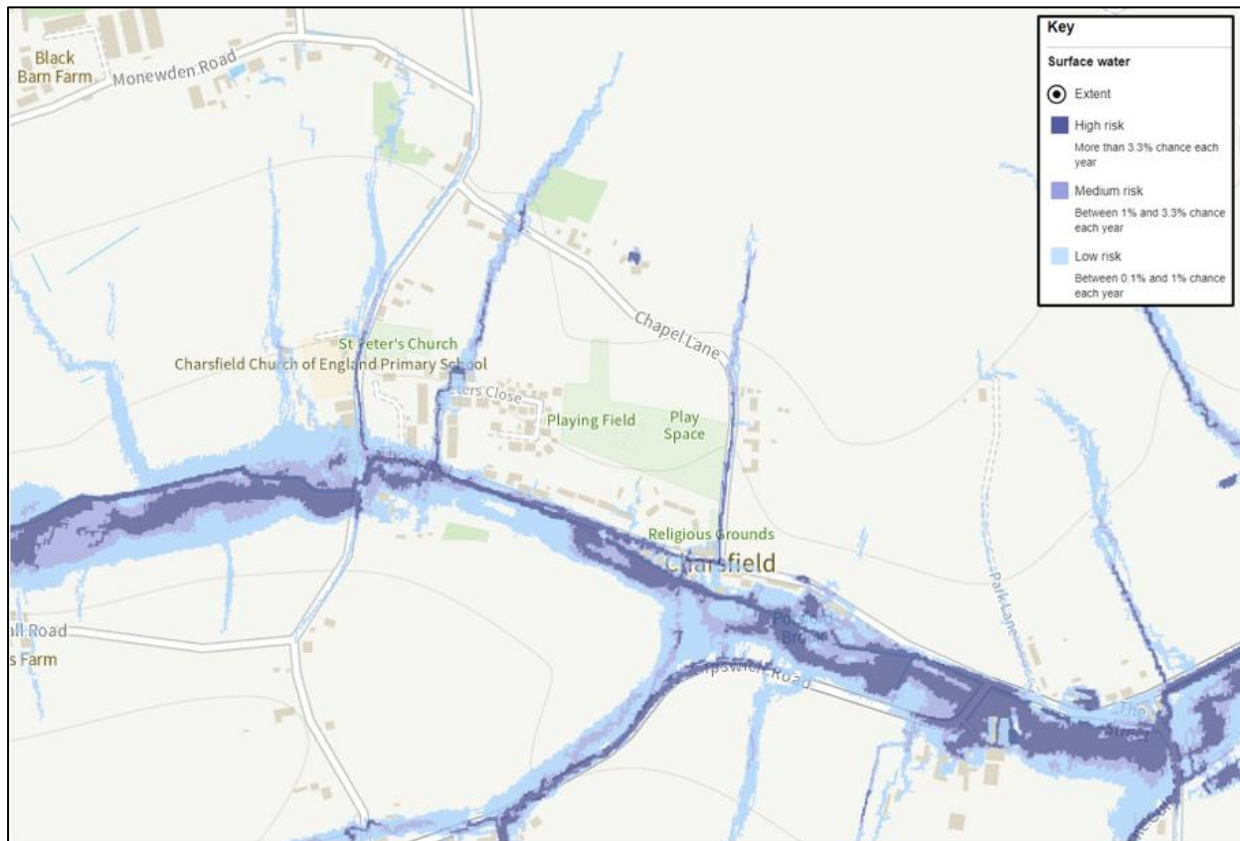
Figure 13 - Predicted surface water flood risk for Charsfield

Floodwater was accumulating at the bottom of St Peters Close from 7:00am onwards, making it one of the earliest sites of flooding in the village (Image 5). Internal flooding on St Peters Close was reported from 8:00am onwards with no sign of lessening until late afternoon. The observed floodwater flow path seen on Chapel Lane and St Peters Close is consistent with the predicted surface water flood risk which is defined as Medium to High in this location (see Figure 13).

There is a significant flow path identified along Chapel Lane, as outlined in Figure 13, with flood flows merging at the junction with The Street. There are a series of 'grips' to allow water to flow off the road and into the adjacent watercourse. These have become silted up and are last recorded to have been formally inspected in 2019. Whilst there is a minor watercourse running parallel to Chapel Lane, floodwater mainly flowed down the highway, which is relatively steep, collecting in large volumes at the southern end of Chapel Lane where it meets The Street (Image 3). At this point the watercourse is piped for a short section before out falling into Potsford Brook. However, as the pipe is relatively small (approx. 300mm in diameter) and most of the floodwater was within the highway rather than the upstream watercourse, this indicates the pipe could not accommodate the flow. The piped section has less capacity than the original open channel and has likely reduced the volume of water that could be safely conveyed from the bottom of Chapel Lane into Potsford Brook during a storm event.

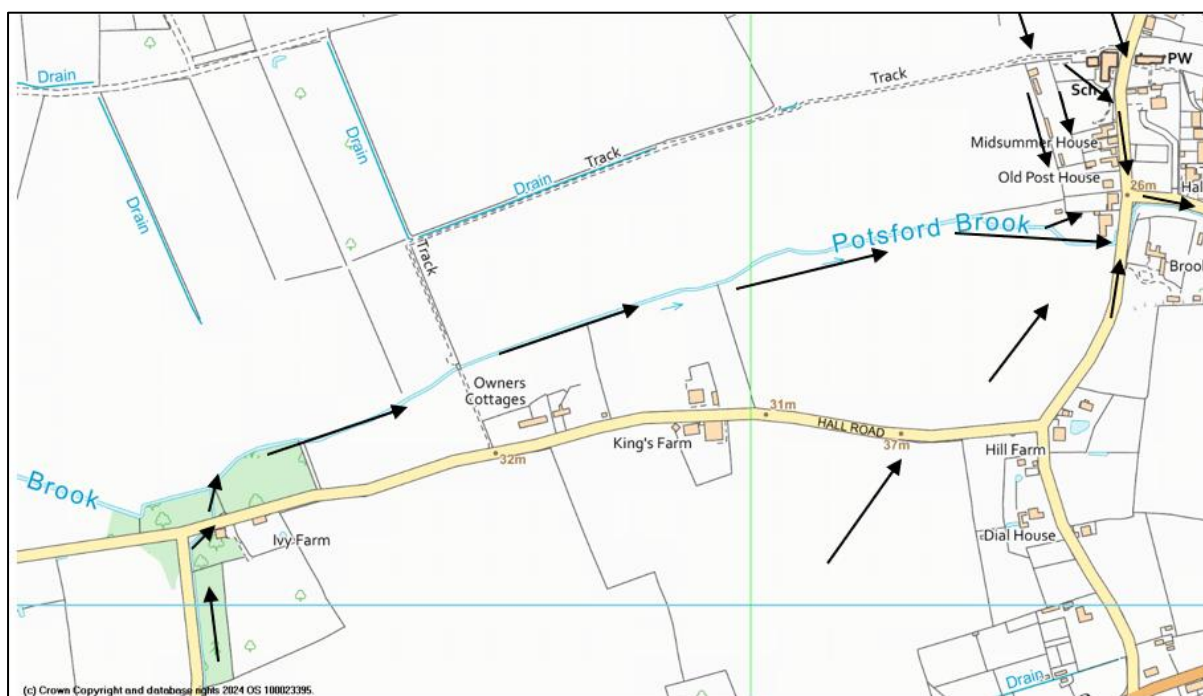
Figure 14 - Approximate flood water flow routes on Church Road and Hall Road

With the amount of water flowing into the Brook from fields north, south and the catchment further west, its capacity was completely overwhelmed and floodwater spilled onto Church Road. Properties were internally flooded from 10am onwards. Residents reported flood debris, including straw from the fields, building up and snagging at the road bridge under Church Road. The capacity under the bridge simply could not cope with the volume of water, which backed up, flooding the highway and nearby gardens (Image 4). Suffolk Highways are aware of a number of pre-existing issues at this location which may have reduced capacity at the road bridge.

At this point Church Road was acting as a secondary river channel, carrying floodwater downstream, which overflowed into The Street. The Street is amongst the lowest points in Charsfield and acted as the central basin into which the floodwater was accumulating. The roadside drainage assets were completely overwhelmed. Outfalls for highway drainage were quickly submerged as they fell below the peak water level in the Brook and were unable to discharge fully into the Brook causing the water to back up further.

On Hall Road, internal flooding occurred when surface water off the fields to the south merged with floodwater on the road at some of the lowest points on the road. The small streams and drainage ditches overflowed with the large volumes of water coming down the slope of the fields. The internal flooding occurred in the morning of 20 October, around 10am and by the next afternoon the floodwater was reported to have dispersed.

- High rainfall resulted in large amounts of surface water run-off coming from fields to the west of Church Road and along the highway from north and south.
- Potsford Brook was completely overwhelmed, the fields upstream of the road bridge were inundated with floodwater.
- Floodwater overtopped from the Brook at the road bridge as the capacity underneath was exceeded. Accumulated debris and pre-existing damaged Highways drainage infrastructure may have contributed to the problem.
- Drainage assets on the highways were overwhelmed.

- Any observed blockages at the road bridge on Church Road to be reported to Suffolk Highways.
- Ensure the completion of existing highway drainage asset maintenance on Church Road and Hall Road.
- Investigate the known Highways drainage issues at the road bridge on Church Road.
- Maximise the take up of the £5k PFR Grant currently available to residents.

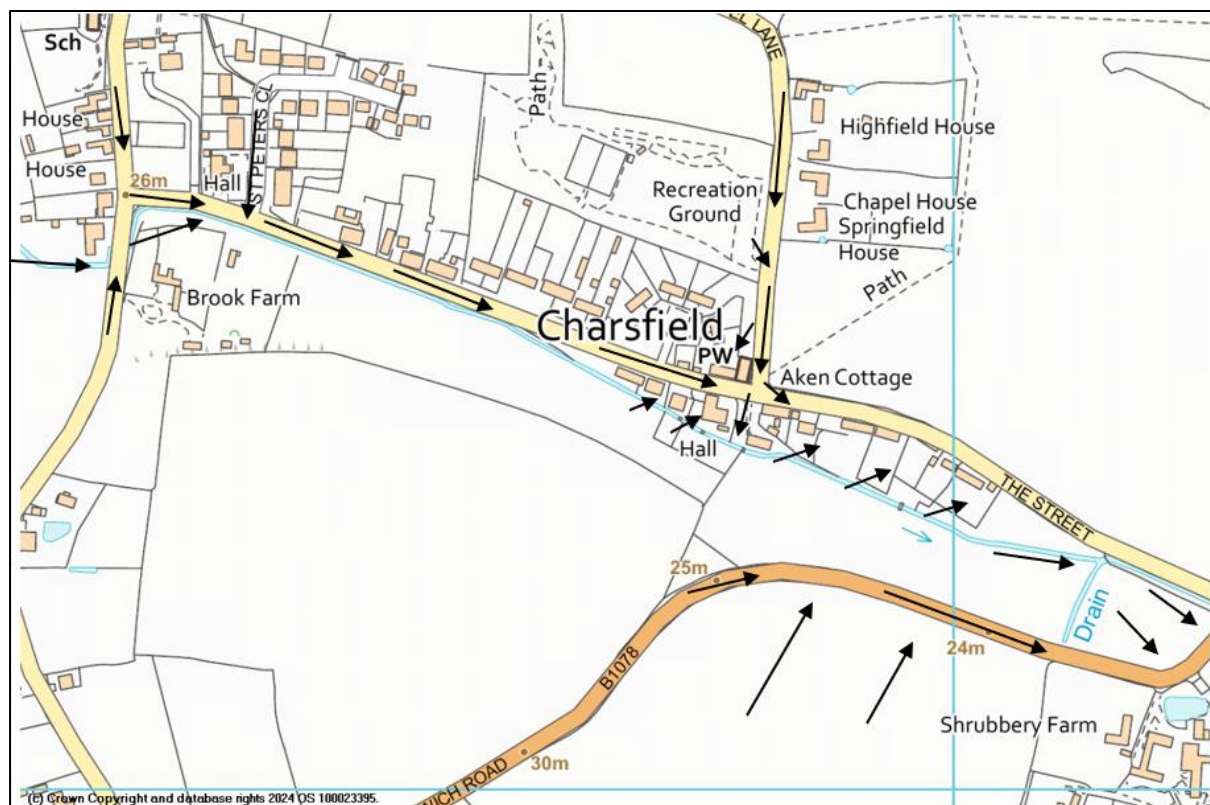
Figure 15 - Approximate flood water flow routes on The Street

Further along The Street, some residents suffered additional flooding to the rear of their properties as the water level in the Brook continued to rise and eventually overtop into gardens and houses from behind. There was a time lag between the initial onset of surface water to the front and water levels in Brook exceeding capacity. Fluvial floodwater rapidly filled the rear gardens. The properties were caught in the middle, surrounded by flood water from both sides. Consequently, as the drainage assets on the highway were overwhelmed, the flood water on the road could not discharge into the river, creating a large expanse of water around the properties.

Similar internal flooding had occurred previously at this location in May 2023. During that event, the floodwaters flowed down Chapel Lane and accumulated on The Street to a depth where it breached property thresholds. The majority of the properties located near the junction of Chapel Lane and The Street experienced water ingress into the ground floors.

Suffolk Highways are aware of pre-existing drainage issues at the junction of Chapel Lane and The Street. Highways records show instances of water surcharging from inspection chambers and water frequently pooling on the road surface. Further investigation is needed to fully understand the causes and likely solution to the problems.

- Investigate potential NFM projects and funding opportunities which aim to attenuate water and 'slow the flow' in the catchments to the west and north of Charsfield, targeting the flowpaths that feed into Potsford Brook.
- Any observed blockages within the main river section of Potsford Brook to be reported to the EA.
- Ensure the completion of existing highway drainage asset maintenance on Chapel Lane and The Street.
- Re-cut the grips on Chapel Lane
- Investigate the known Highways drainage issues at the junction of Chapel Lane and The Street.
- Maximise the take up of the £5k PFR Grant currently available to residents.

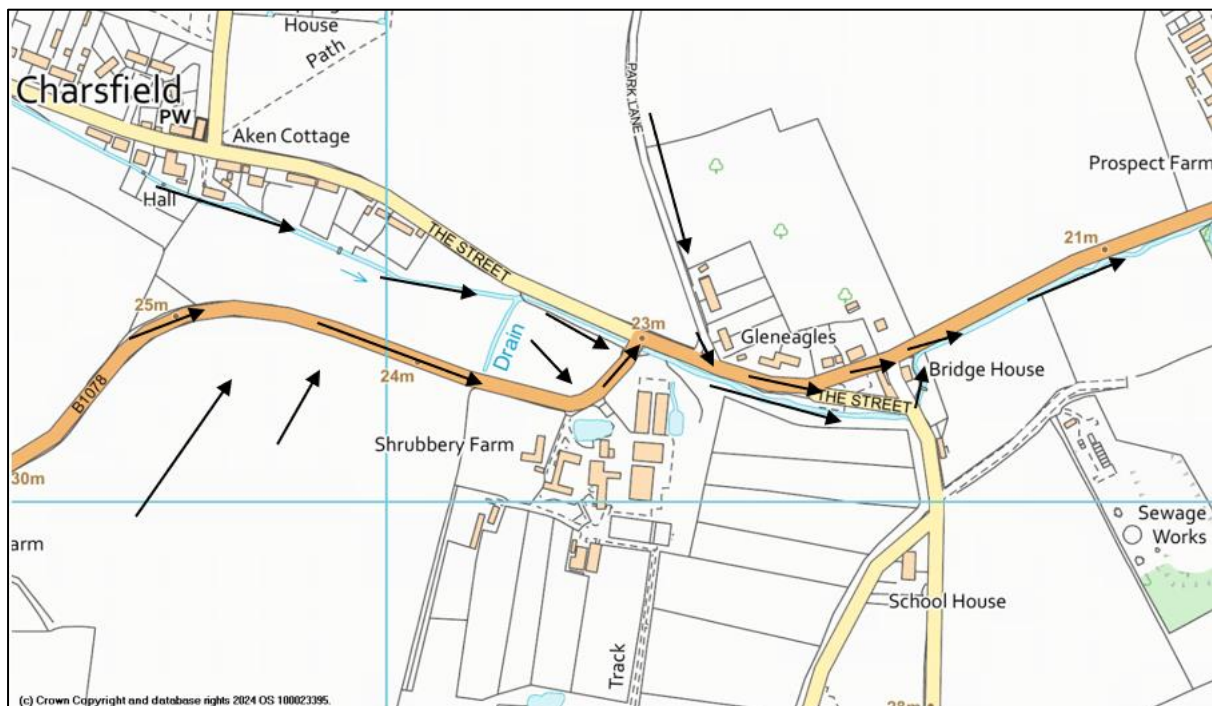
Figure 16 - Approximate flood water flow routes on Wickham Market Road

On the east side of Charsfield, a number of properties on the Wickham Market road were impacted by internal flooding. Large amounts of floodwater were reported to be flowing along the road surface from the junction of the B1078 and The Street (Image 8). The floodwater on the B1078 originated as run-off from the fields to the south. There was also fluvial flooding from the Potsford Brook as the water levels rose out of bank, water in the channel backed up at the road bridge as it was partially blocked and silted up on the upstream side. It then merged with the expanse of floodwater on the road with additional flows coming from the fields to the north down Park Lane.

The properties were flooded to the front from the road. The flooding in this area is reported to have occurred between 11am and 1pm, slightly later than other parts of the village presumably indicating the time taken for the peak flow to travel through the village from the west.

- Investigate potential NFM projects and funding opportunities which aim to attenuate water and 'slow the flow' in the fields south of the B1078, and north of Park Lane.
- Any observed blockages within the main river section of Potsford Brook to be reported to the EA.
- Any observed blockages at the B1078 road bridge to be reported to Suffolk Highways.
- Ensure the completion of highway drainage asset maintenance on along the B1078 and The Street.
- Maximise the take up of the £5k PFR Grant currently available to residents.

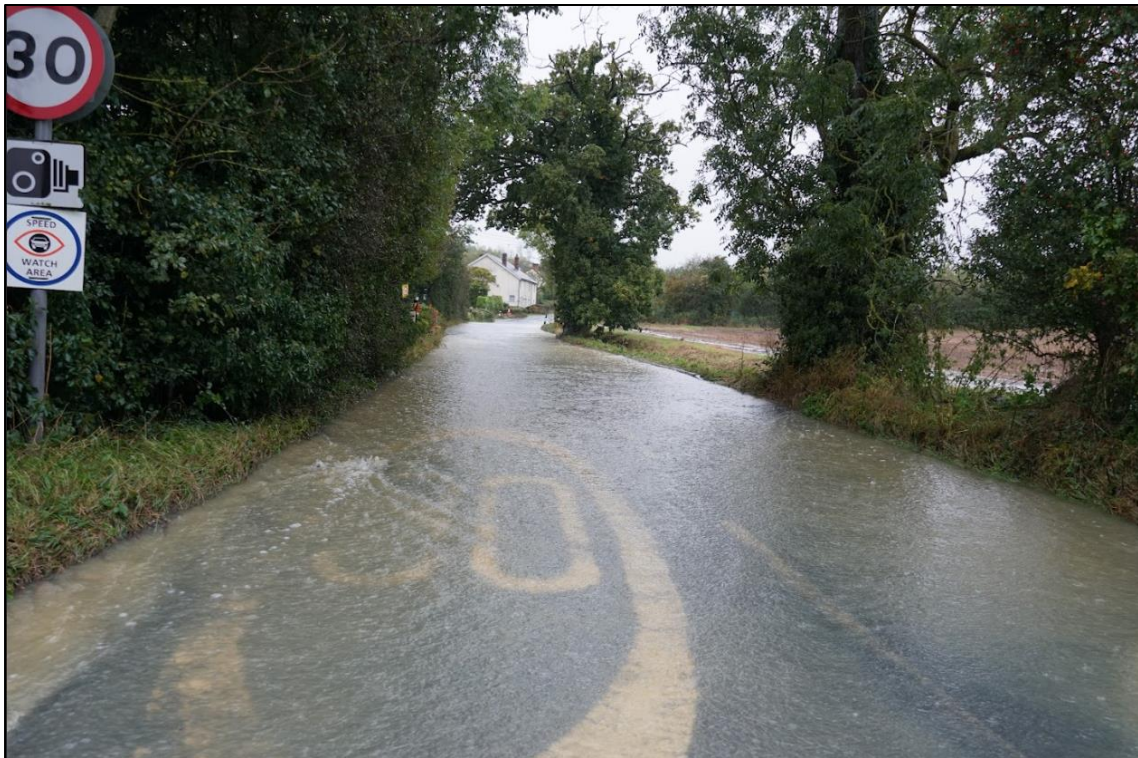
Image 1 - Church Road junction looking toward The Street

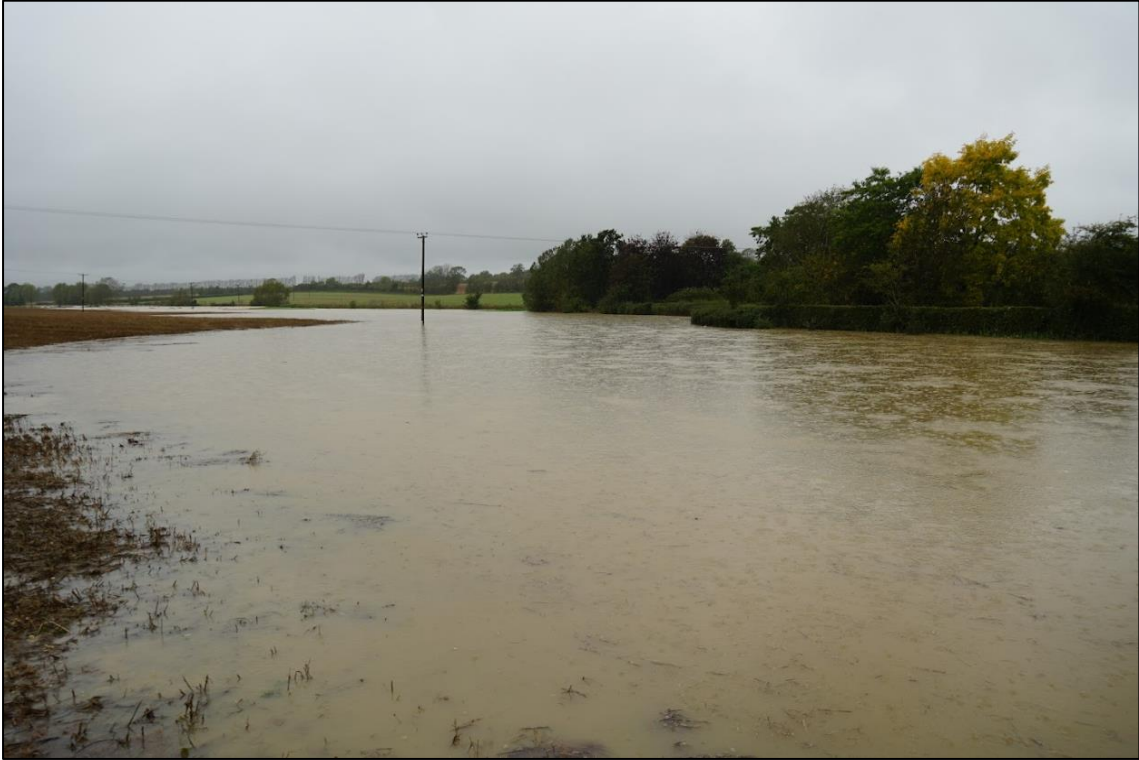
Image 2 - Looking upstream of Church Road bridge

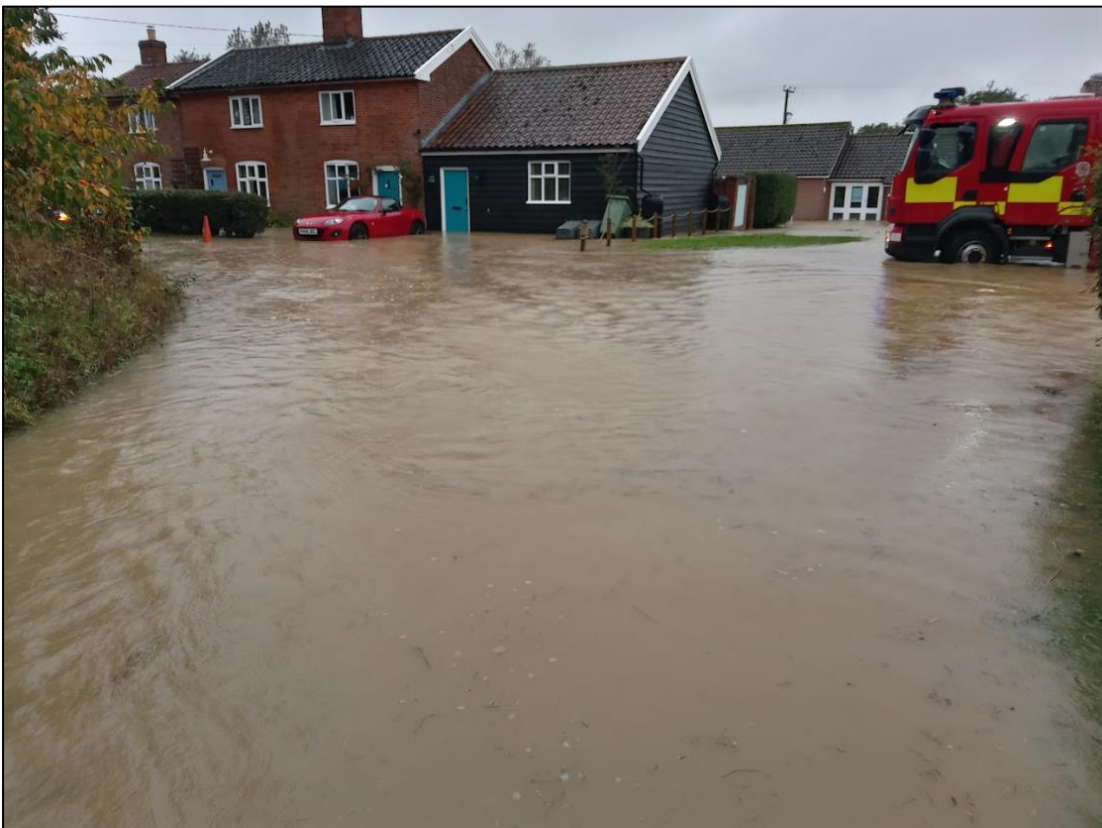
Image 3 - View from Chapel Lane toward The Street

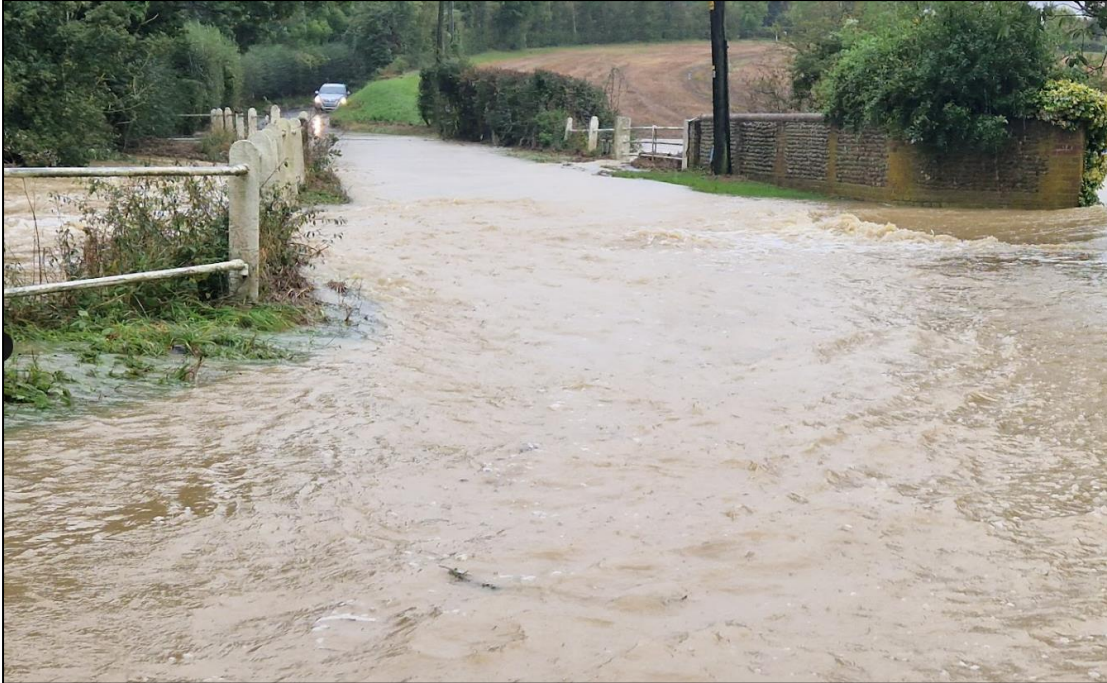
Image 4 - Flooding on Church Road bridge

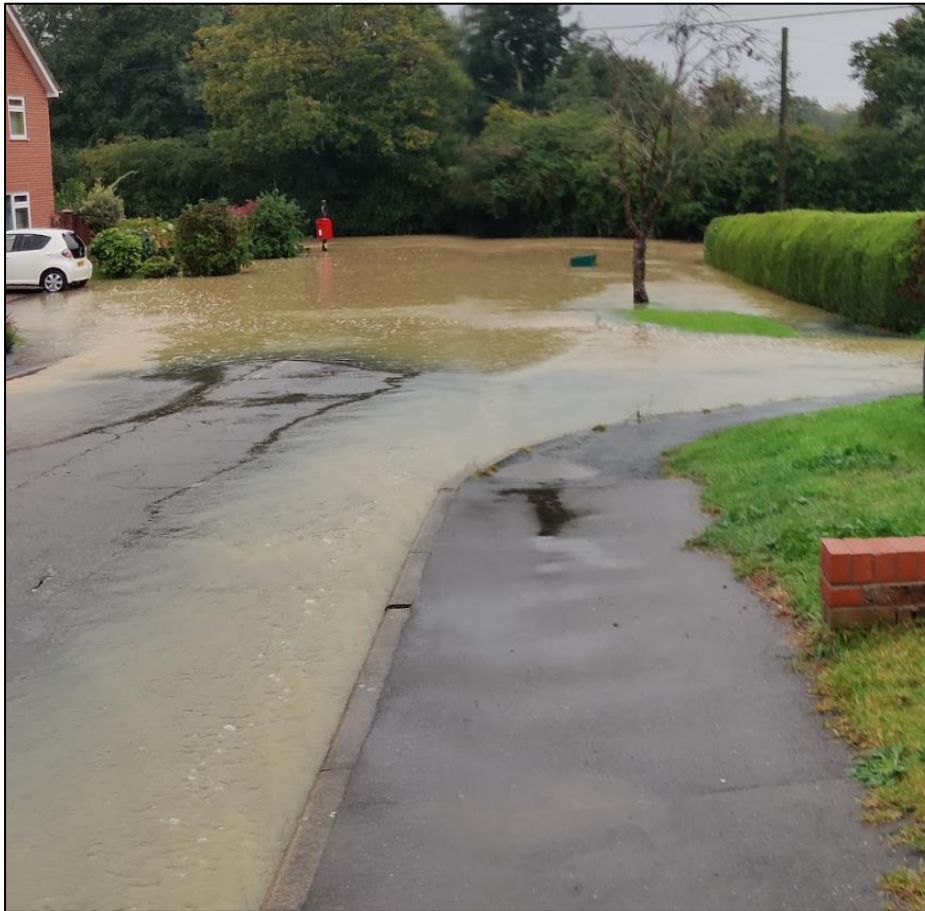
Image 5 - Looking south on St Peters Close toward The Street

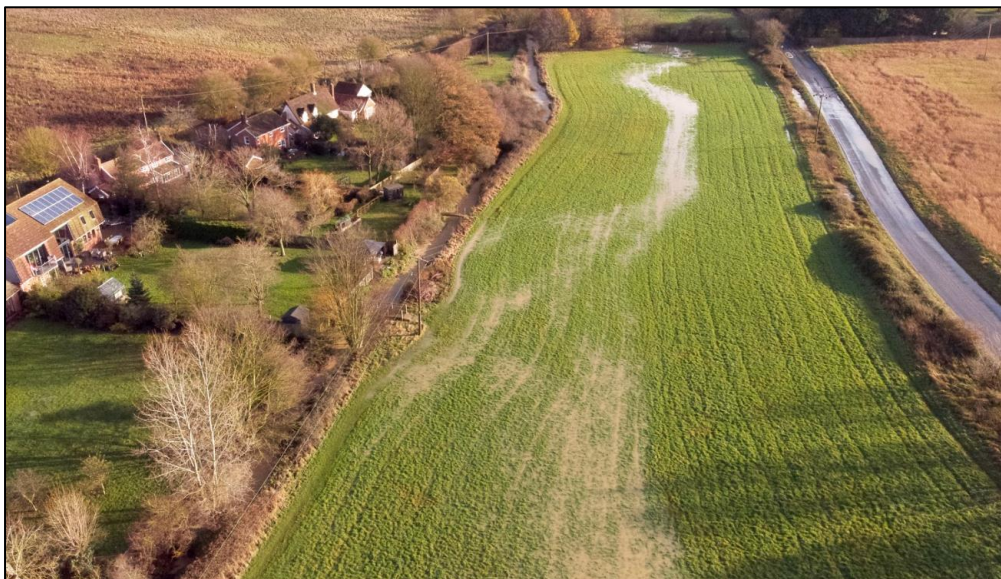
Image 6 - View over Longmeadow showing Potsford Brook and possible former river channel

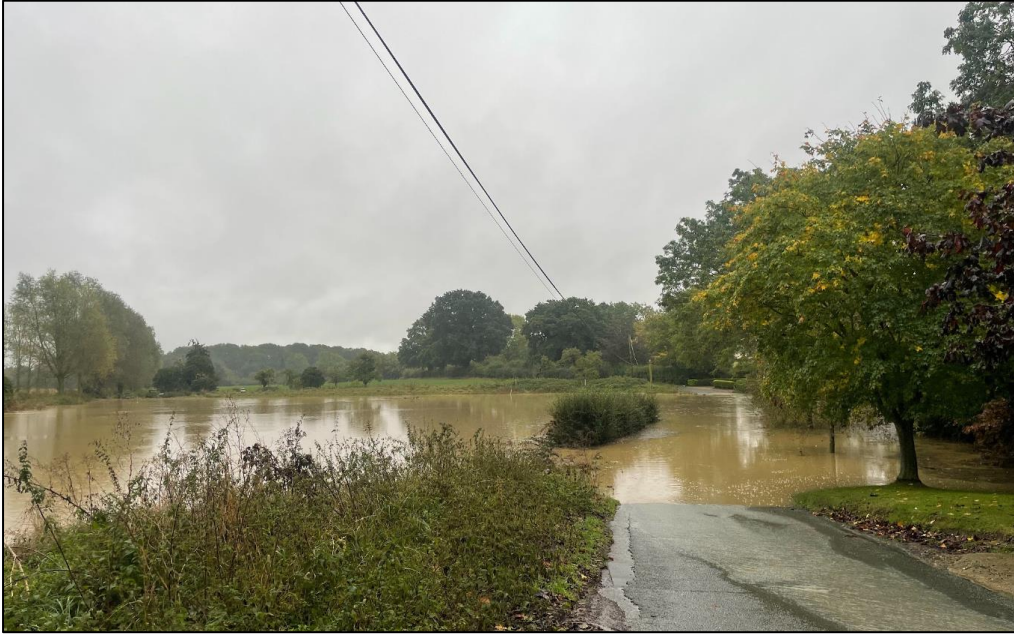
Image 7 - Flooding on Hall Road

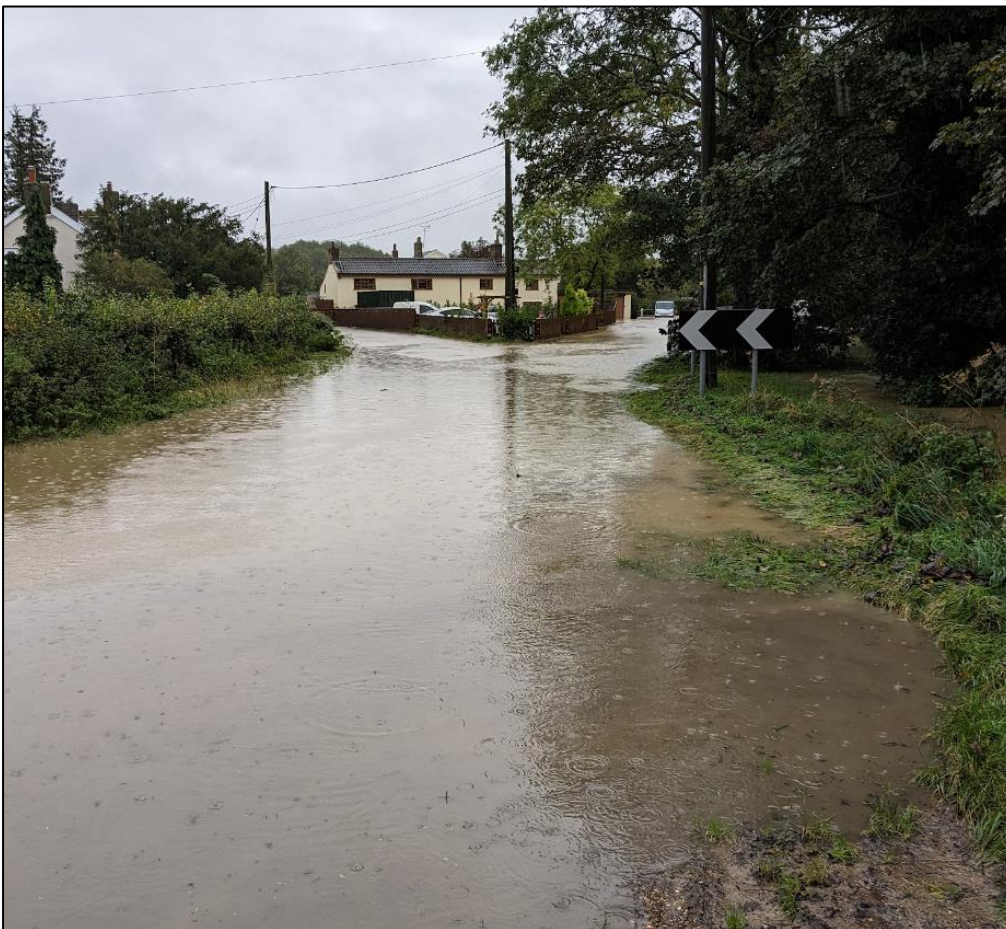
Image 8 - View from The Street looking towards Wickham Market Road

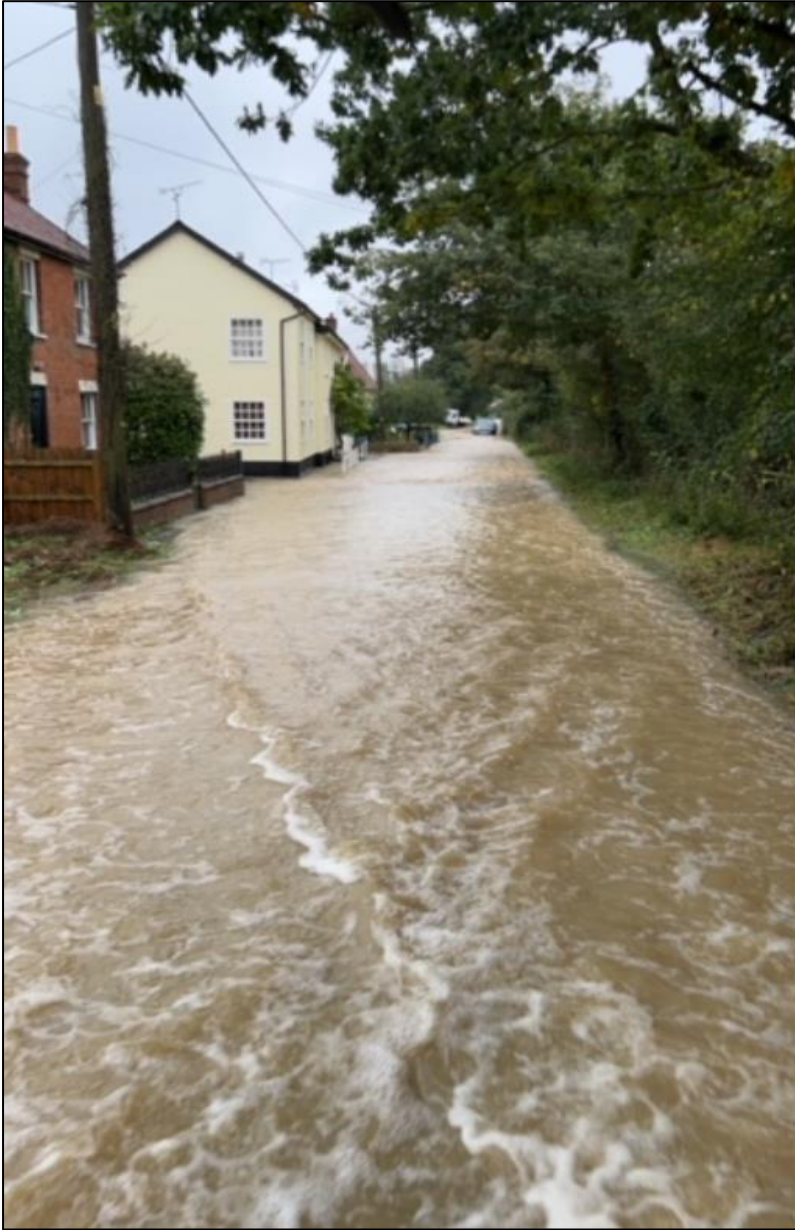
Image 9 - Flooding on The Street
