Section 19 Flood and Water Management Act 2010
Wetheringsett-cum-Brockford Flood Investigation – Storm
Babet 2023

Name	Date
Report Author	John Jousiffe	
Responsible Officer:	John Jousiffe	
Checked by:	Ellie Beecroft	17/09/2024
RMA Review:		08/10/2024
Approved by:	Matt Hullis	08/11/2024
Date Published		11/11/2024
Date Report Closed

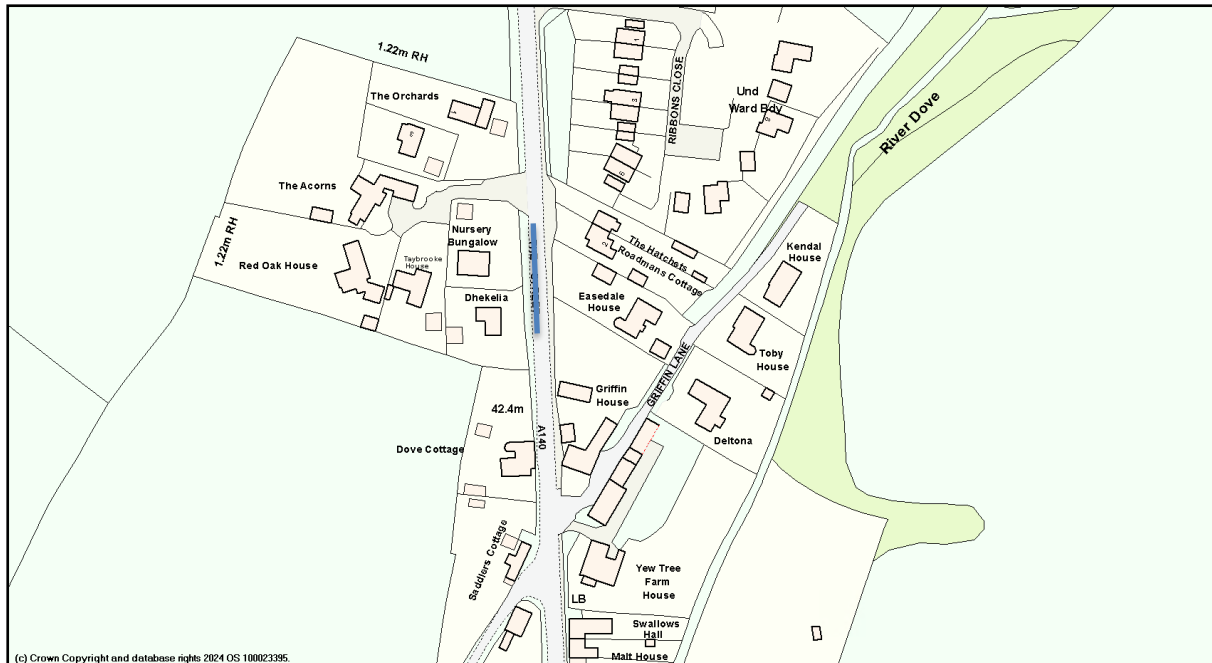
There is a short section of open watercourse to the north of the main affected area, which borders the A140 to the west (see figure 13). This section of watercourse was reported to have been quickly overwhelmed and caused water to spill onto the highway where it flowed south towards the river. Following a site investigation, this section of watercourse appears to be piped to the north, but no continuation to the south was visible upon inspection. It is presumed that once the capacity was reached, the water

had no continuation route and consequently overspilled onto the highway before continuing down the road.

This watercourse appears to be a Suffolk County Council Highways asset, And following consultation with the Highways Authority, maintenance of the feature is planned to take place. There are several outfall pipes situated in the western bank of the watercourse, likely to be servicing the housing to the west by means of a surface water or sewage discharge points. Modern development standards are required to attenuate water on site and only discharge it at rates the same or lower than predevelopment and as such, it is unlikely that the new development on the western side of the highway was a significant contributing factor. Most Highways drainage assets in the area were shown to be working on the last inspection (July 2022), except one non-operational gully, which should be draining into this watercourse. It is unlikely however that this individual gully would have had any significant impact on the flooding event due to the rainfall experienced. The highway authority has maintenance planned for this short section of watercourse, but timescales are not confirmed.

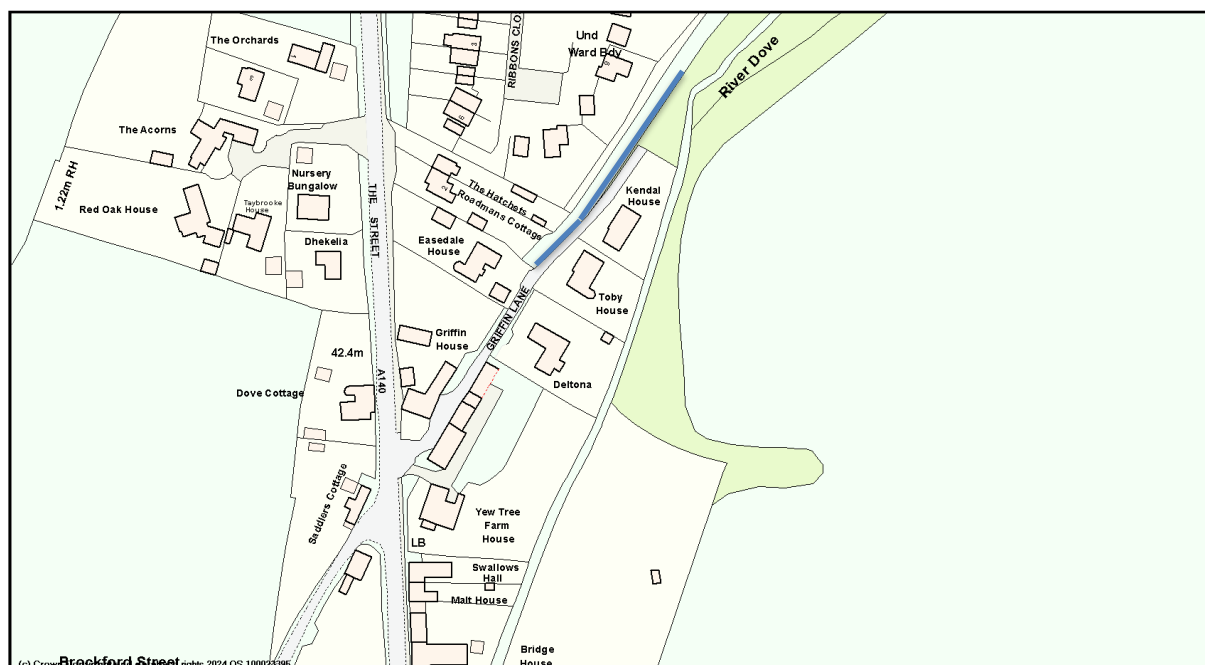
Figure 14 - Griffin Lane watercourse

Properties on Griffin Lane were reported to have been affected by the over topped river Dove, and another smaller watercourse running parallel. The river is located east of the properties and the watercourse is located west of the properties with Griffin Lane situated between the two features. Floodwater came from both sides, from the Dove

River to the east, and from the ordinary watercourse and A140 to the west, it travelled across griffin lane and into properties. The main flow of the water was heading southeast in order to rejoin the river.

— Approximate location of ordinary watercourse west of Griffin Lane

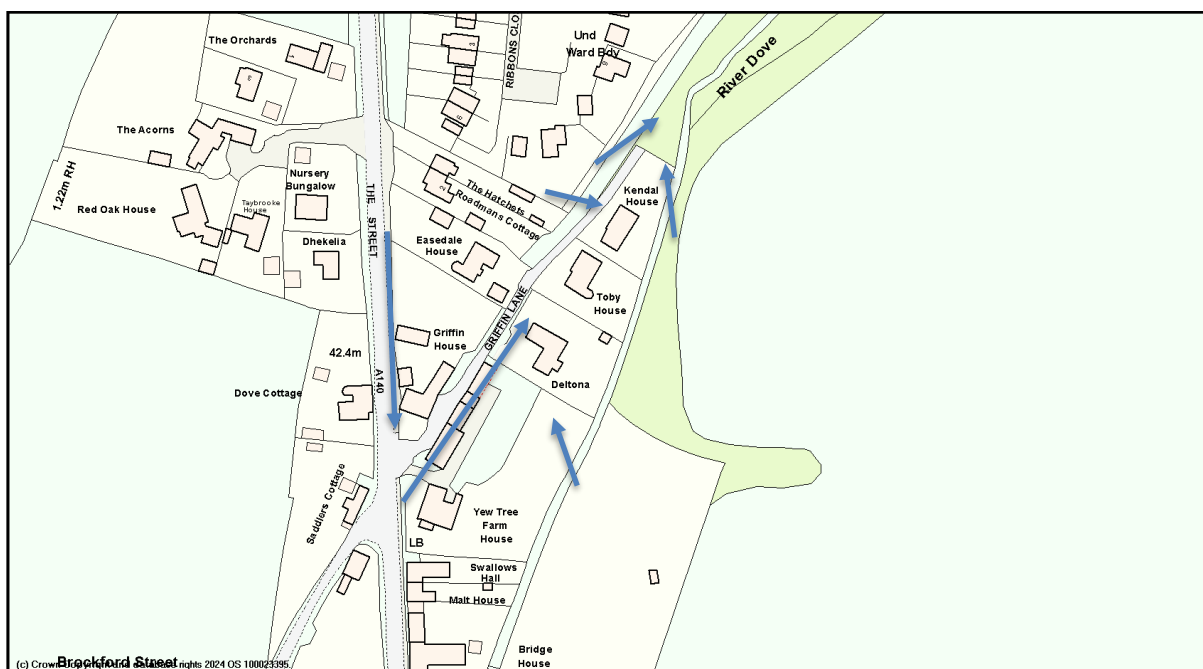
Figure 15 - Waterflow paths in north Brockford Street

Reports taken from community feedback is that there have been some tree felling activities further to the north which may have left debris in the Dove River, possibly causing an impedance to the flow of water. It is possible that this blockage caused the water to back up faster than is natural and as such, cause the river to overtop it banks earlier, although given the scale of the event, it is likely that the river would have overtopped anyway, although the impacts may have been less severe. Following consultation with the Environment Agency, they were made aware of the felling activity in June 2023 and larger branches were found to have been left in the river, however due to the location of the activity (distance from properties, gradient of the channel and capacity of the surrounding floodplain), it was evaluated as not to contribute to increased flood risk to Brockford Street and no further action was taken.

Immediately south of the junction with Griffin Lane, there is a small bridge which allows the river Dove to pass underneath the A140. Reports from the community suggest the capacity of the bridge crossing was not of sufficient size to allow the volume of water to pass underneath and during the event, this resulted in a significant portion of the water flowing out of the channel upstream and by the bridge abutments. This water flooded onto the road and surrounding properties on the west side of the A140.

Consultation with the Suffolk Highways have confirmed that the structure is a single span masonry arch structure with a width of 2.7m and is believed to have been constructed circa 1881. Confirmation that the bridge was the main restriction in this area is not possible to quantify and instead is likely to be a combination of factors. Whilst the bridge can cater for the vast majority of flow conditions in the river, there will be instances during extreme events when water flow is greater than capacity, which might lead to a restriction in flow in the river at the bridge. The bridge is one of the lower lying points in this area and is therefore susceptible to breaches if water volumes and/or blockages impede the flow of water. The bridge is subject to biennial inspections, the last one being undertaken in May 2024, at which there was no blockage.

Further reports have suggested that recent works on the bank close to the bridge need some repair, with rocks from the Gabion Baskets spilling out and further reducing the capacity under and close to the bridge. However, recent inspections by the structures team from the Highway Authority, suggest that the gabions are in good condition and it was noted that some material was laid in the bed of the river as part of these works for scour protection. It is possible that the rocks noted by the residents were part of this scour protection and as such are unlikely to have a significant impact on capacity.

Clearance of debris from a watercourse or river is an activity that the riparian owner can undertake and the LLFA would encourage issues such as this to be reported to the relevant landowner who can then remove obvious debris and blockages as part of their riparian maintenance duties.

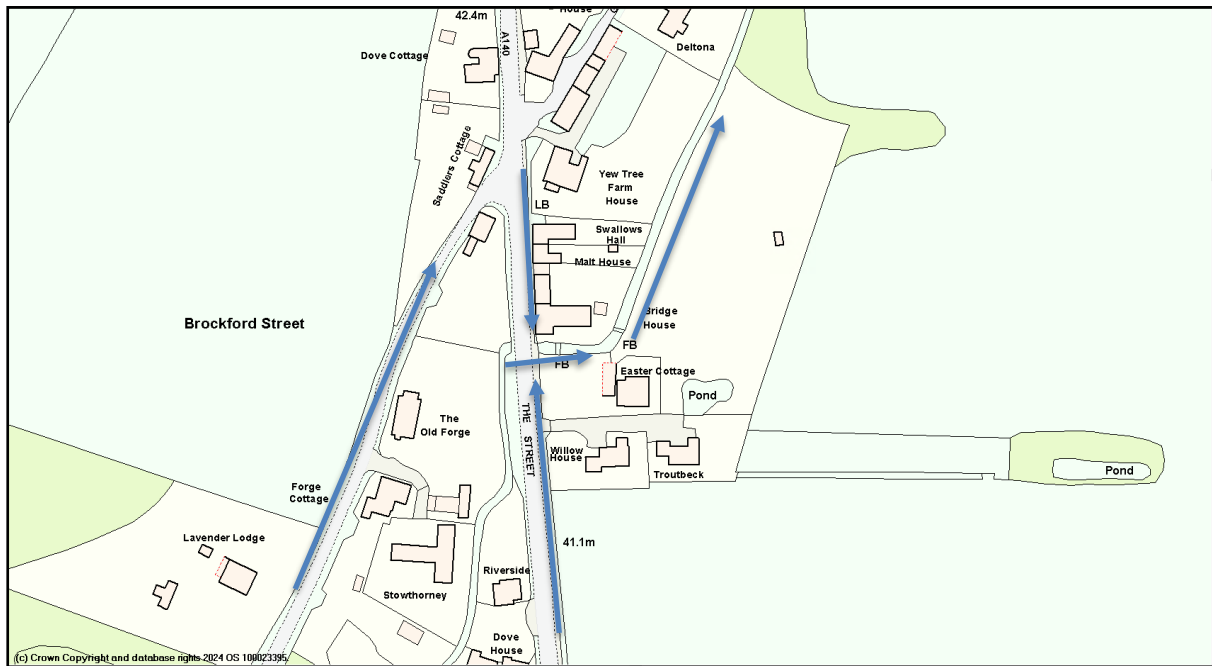
Figure 16 - Waterflow paths in south Brockford Street

Sewage was reported as being present in the flood water in this area and continues to be an issue going forward with reports of toilets backing up regularly during rainfall events. There are no Anglian Water assets in the area and instead sewage systems are considered to be private, managed and maintained by individual property owners.

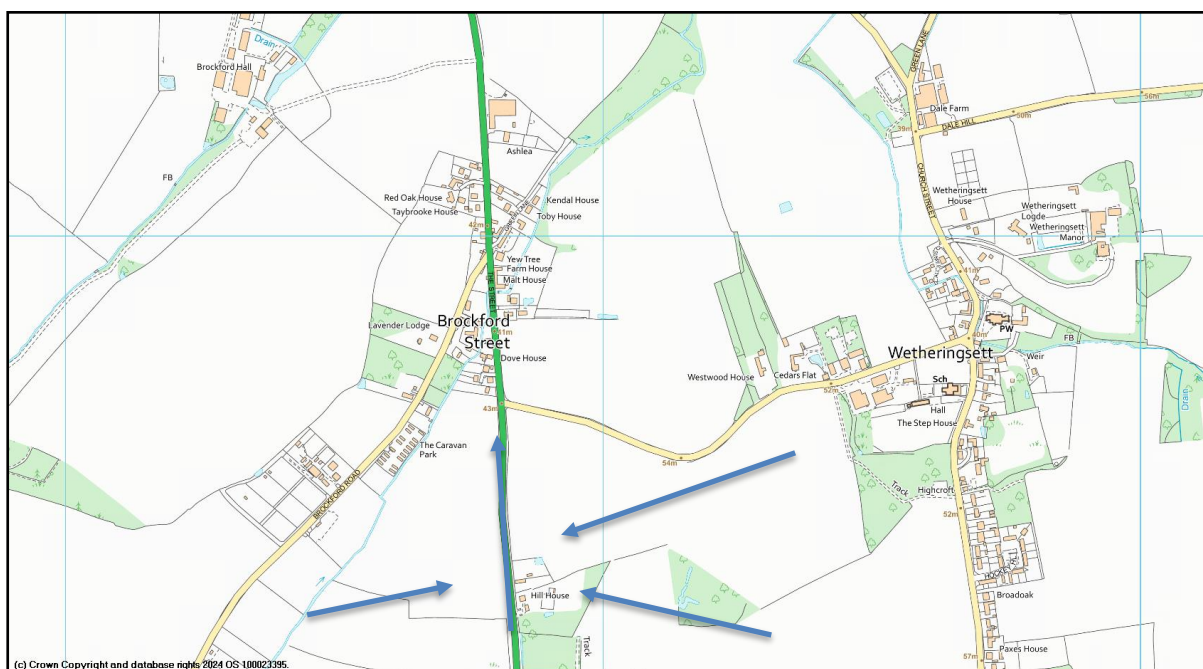
Figure 17 – Flow path map of south of Brockford Street

South of the bridge, properties have been reported to have been affected by significant surface water runoff from surrounding fields to the east and south. There have been reports from the residents that some possible infilling of a watercourse has taken place in this area. A loss of watercourse features could have exacerbated the impacts within this area. The lead local flood authority has visited the area to investigate the possible infilling and have sent letters detailing landowner riparian responsibility to all possible owners of the watercourses in question.

- At least 13 properties reported internal flooding to depths of approximately 600mm.
- A140 road was closed and impassable for a period of time.
- Significant rainfall onto saturated ground caused local watercourses to become overwhelmed.
- Overtopping of the river Dove added to surface water runoff from highway and surrounding fields affecting properties.
- Private sewerage works in the area continue to be affected in months following the event by high water levels.
- Possible infilling and/or lack of maintenance of watercourses in the area prevented water egress.

outfall pipe is present/operational, and carry out repair/maintenance of the non-operational gully which feeds into this watercourse.

- Ensure the completion of highway drainage asset cyclic maintenance.

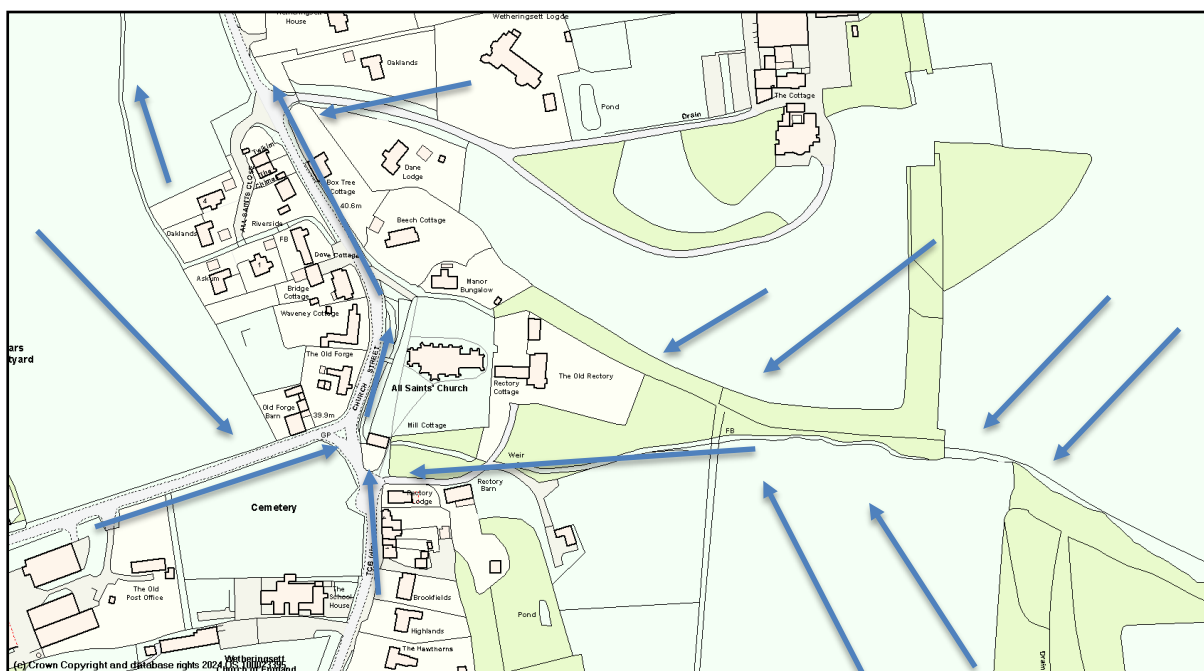
Figure 18 - Flow path map in Wetheringsett

The watercourse which travels into the village from the east, is of sufficient size and can accommodate substantial flood flows. However, as it enters the residential areas in Wetheringsett, its capacity is reduced, with shallower banks and a number of constrictions, including a weir, two small brick arch bridges, a culvert passing under the old mill, followed by an engineered turn through nearly 90°, turning the watercourse north where it meets the highway. The sharp changes in direction of the channel and small capacity structures were observed to have exacerbated localised flooding.

Reports from the community suggest that the watercourse in this area overtopped early on during the event. At the points where the waterflow met a restriction, the water was observed to force its way around or over the top of the constrictions, adding to flood water on the highway and in surrounding properties. Additionally, reports from the north of the village suggest some sections of the watercourse as it leaves the village, require some maintenance to ensure a suitable flow. It is possible that unmaintained watercourses may have reduced capacity within the channel, impeding the flow of water through the village during the event.

The central part of the village has a junction, serving 3 routes from the south, west and north. The southern and western access roads have a significant gradient which caused surface water to travel across the highway at high speed. Reports from the event described a torrent of water coming down both sections of the highway with the extents of the flooding reaching several meters up the road from the watercourse in both directions. There is a watercourse on the eastern side of the highway on the

southern road (Hockey Hill) which manages the water flows until it reaches the culvert at the entrance to the primary school where, once capacity is reached, it overtops into the highway. To the north, the road has a small increase in height before flattening out, so while little water was being added to the flood from this direction, the small rise in the highway was causing the water to attenuate in the low spot in the centre of the village.

Houses on Hockey Hill (south and east) and Church Street (north) were affected by flood water entering their properties from the highway, this water was the combination of surface water runoff from the surrounding fields and overtopped watercourse.

- Increase maintenance of the watercourse throughout the village to ensure a good flow is always possible.
- Look into possible natural flood management features to the east of the catchment to capture water upstream and reduce the intensity of the water getting to the village.
- Carry out repairs to highways drainage infrastructure to allow for water movement to nearby watercourses unimpeded.
- Ensure the completion of highway drainage asset cyclic maintenance.
- Community to consider uptake of Suffolk Highways Community Self-Help Scheme to deploy flood warning signs.

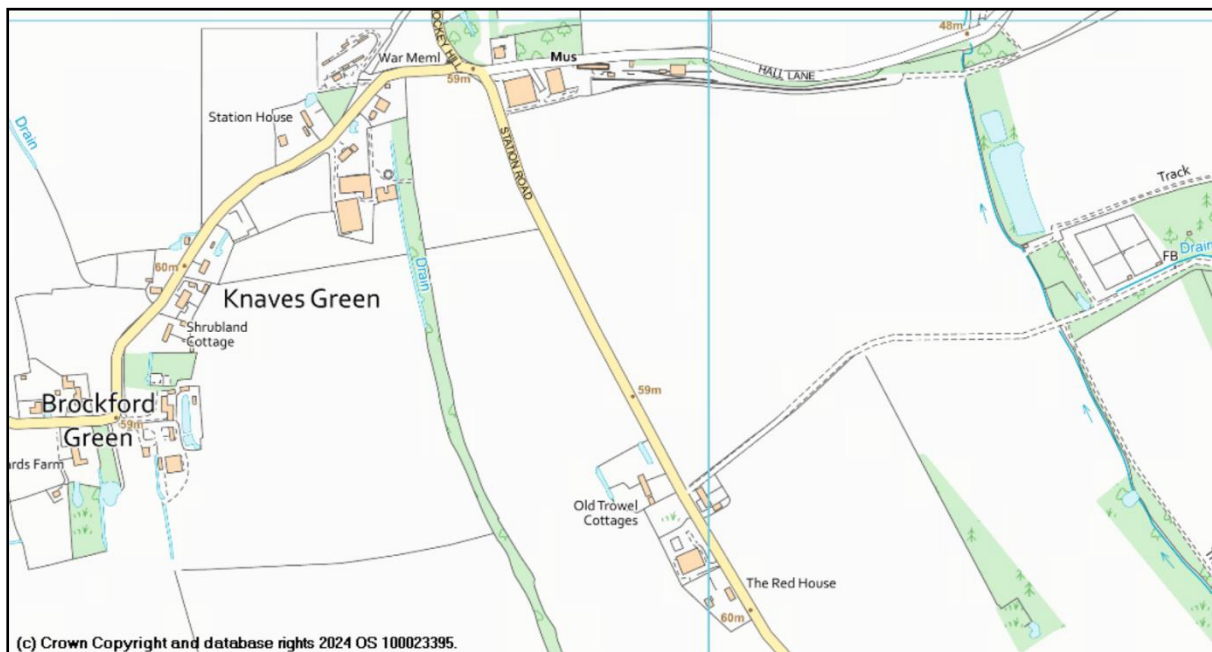
Figure 19 - Map of station road

The flooding at Station Road was different to the other locations, instead being an isolated incident in which surface runoff came from the surrounding fields, and flooded a single property located in a dip in the road. The event caused the shared septic tank to flood and overflow into the garden. Reports suggest the watercourses in the nearby fields may not have been maintained possibly exacerbating the event.

Reports from the community suggest maintenance of these watercourses has since been undertaken and the flooding issue has not reoccurred.

- Significant rainfall caused surface water flows to pool in low spots causing internal flooding.

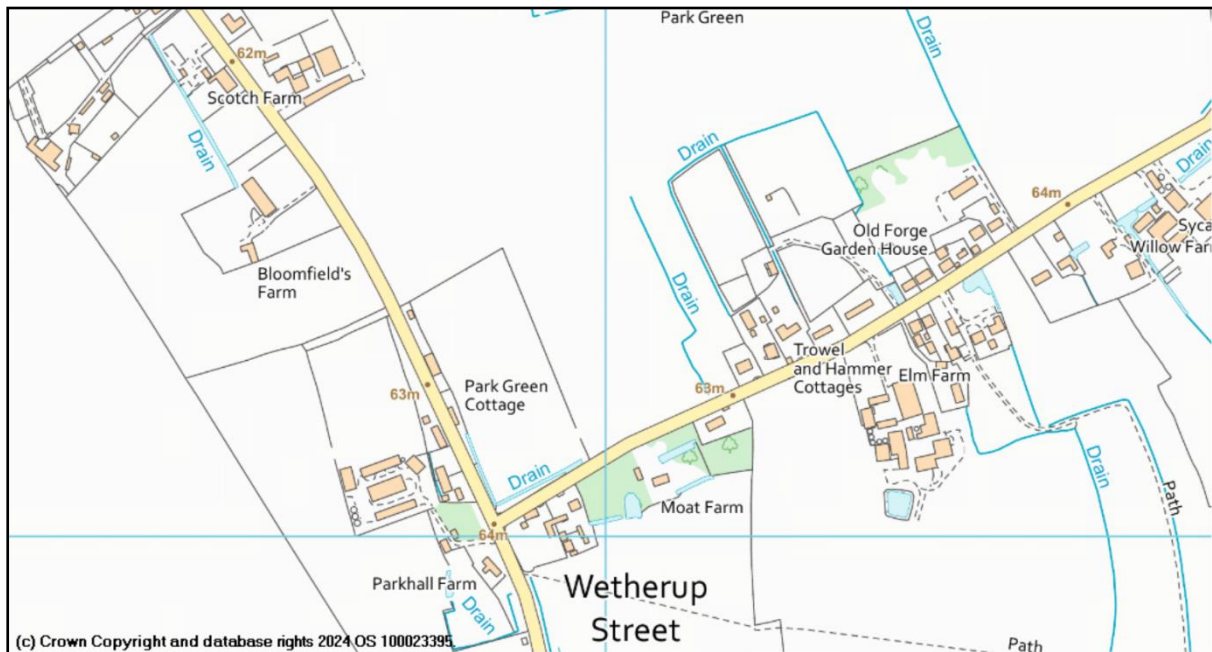
Figure 20 - Map of Park Green and Wetherup Street

Reports from the community in Park Green suggested high levels of surface water overwhelmed the drainage systems and surface water ingress into homes was a combination of runoff from both the highway and surrounding fields as saturated ground could not cope with the volume of rainfall.

Reports from Wetherup Street suggested similar issues with the addition of watercourses and ponds also overflowing. The area contains no mains drainage and agricultural land around the affected properties was already saturated, resulting in watercourses flooding and the village pond, located to the west of the affected properties, being unable to cope with the volume of water. Due to the prolonged precipitation event, flood water began to pool in the isolated dips and flood water ingress was through the floorboards of the affected properties.

- Significant rainfall caused surface water flows to pool in low spots causing internal flooding.

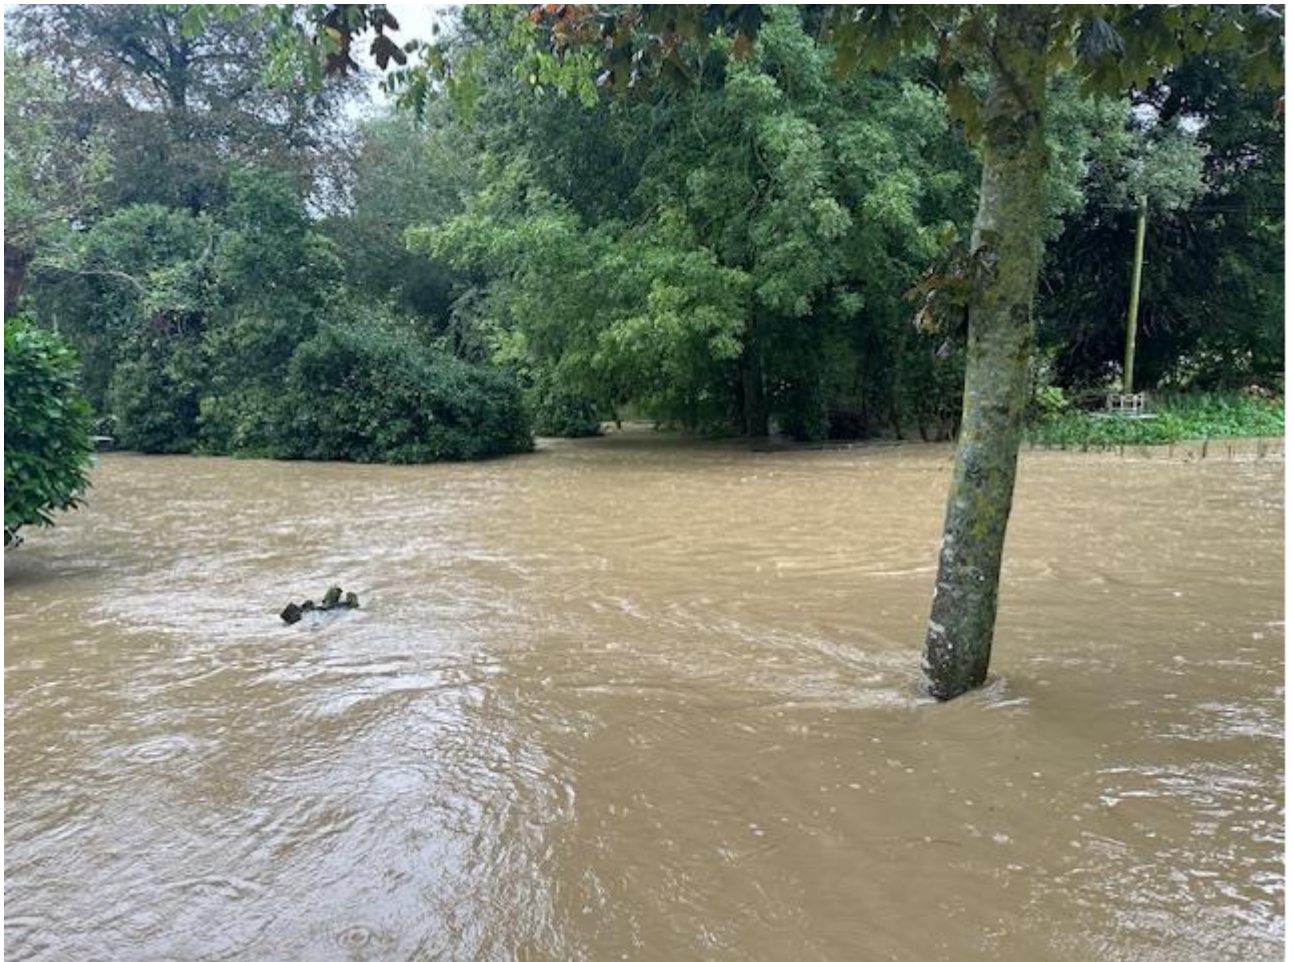
Flooding event in east Wetheringsett

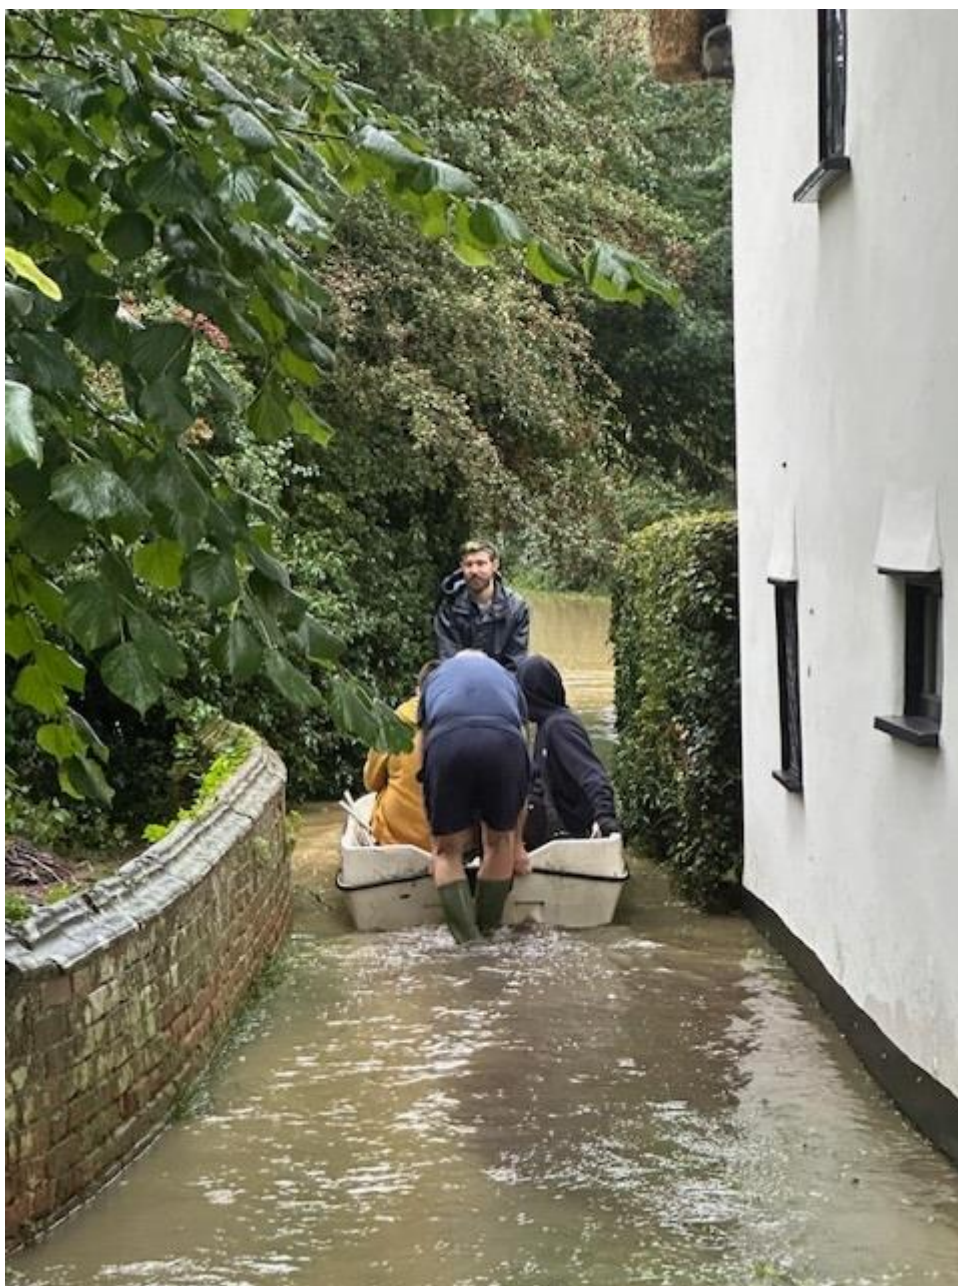
Flooding close to the church in Wetheringsett

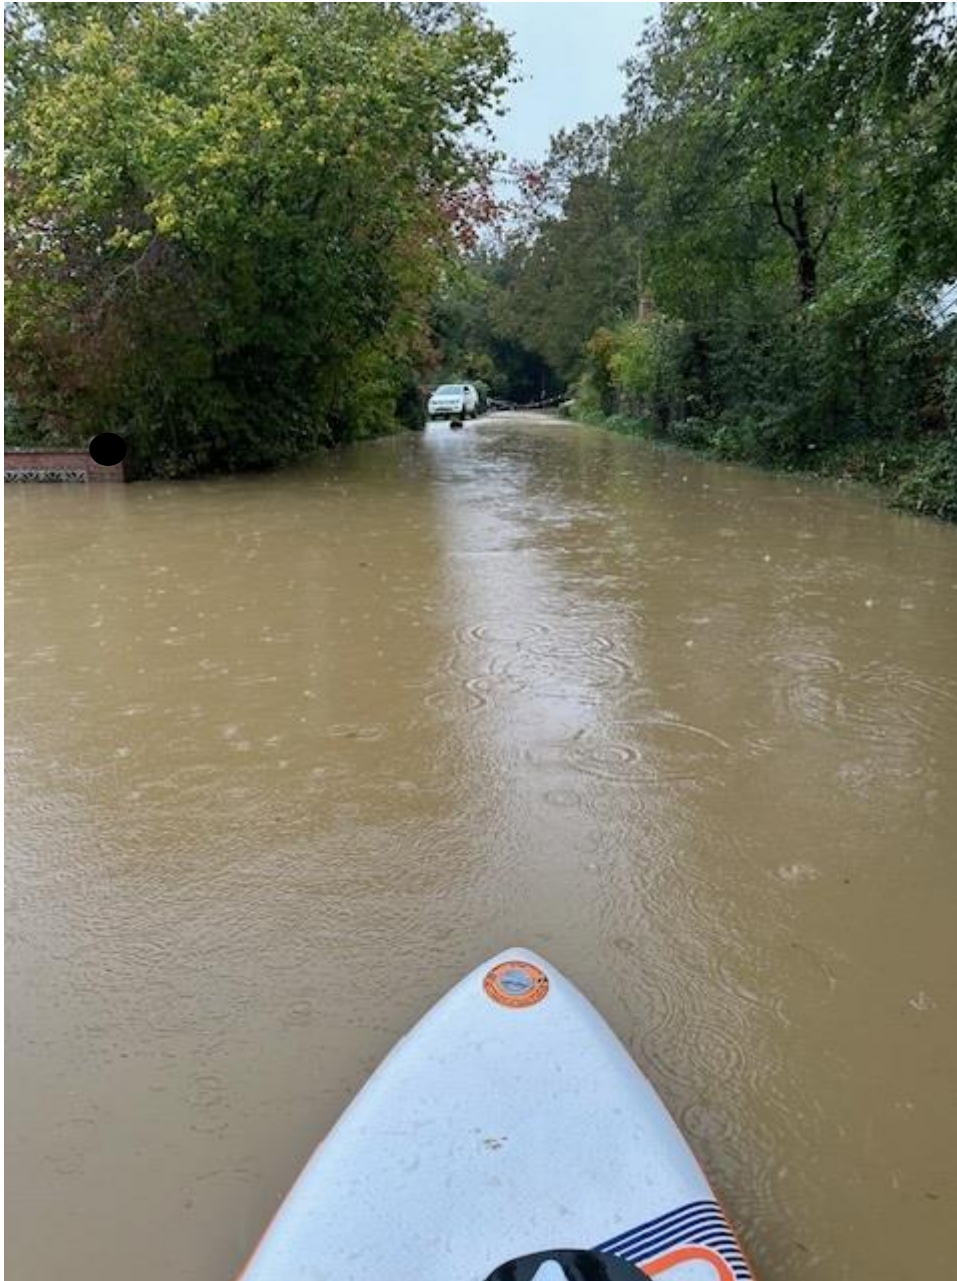
View of Church Street during the event

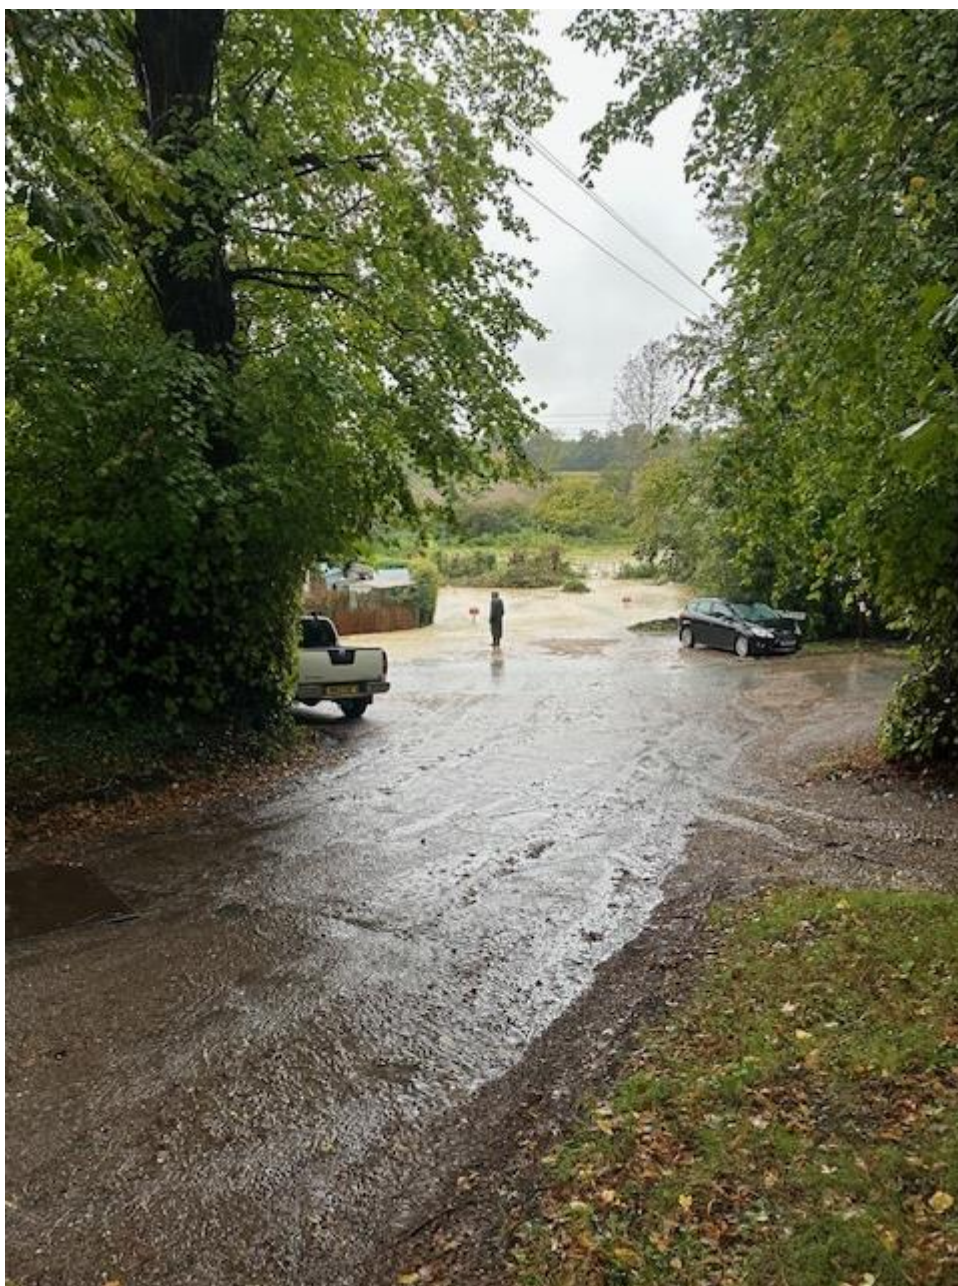
View down Manor Drive during the event
