## Section 19 Flood and Water Management Act 2010

### Claydon Flood Investigation

Name	Date
<b>Report Author</b>	Arinaitwe Byamukama	
<b>Responsible Officer:</b>	Arinaitwe Byamukama	
<b>Checked by:</b>	Ellie Coleby	03/11/2025
<b>RMA Review:</b>		
<b>Approved by:</b>	Hannah Purkis	12/11/2025
<b>Date Published</b>		12/11/2025
<b>Latest Update</b>		19/05/2026
<b>Date Report Closed</b>

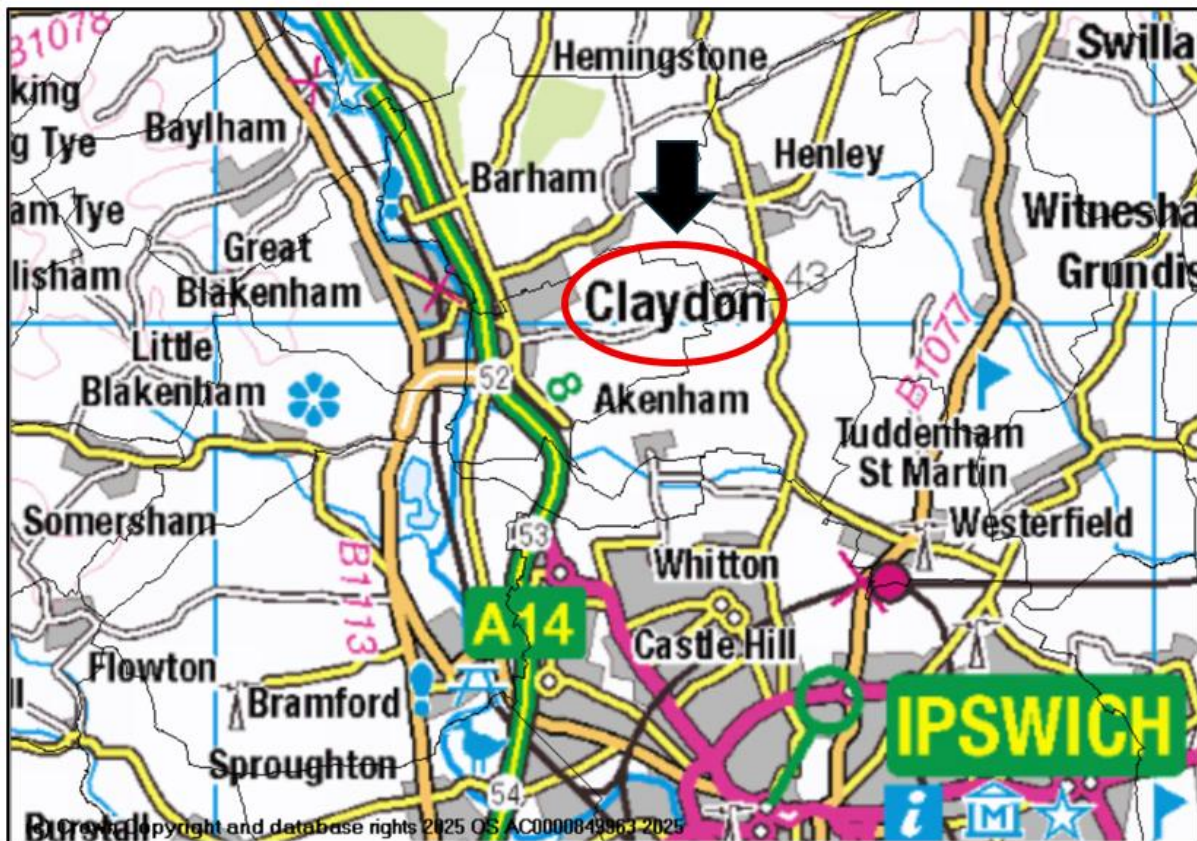
Figure 1: Investigation area map.

The area of investigation is an educational facility situated in the village of Claydon, approximately 4.8 miles northeast of Ipswich town centre. The site lies east of the A14, within the jurisdiction of Babergh and Mid Suffolk District Council (see Figure 1).

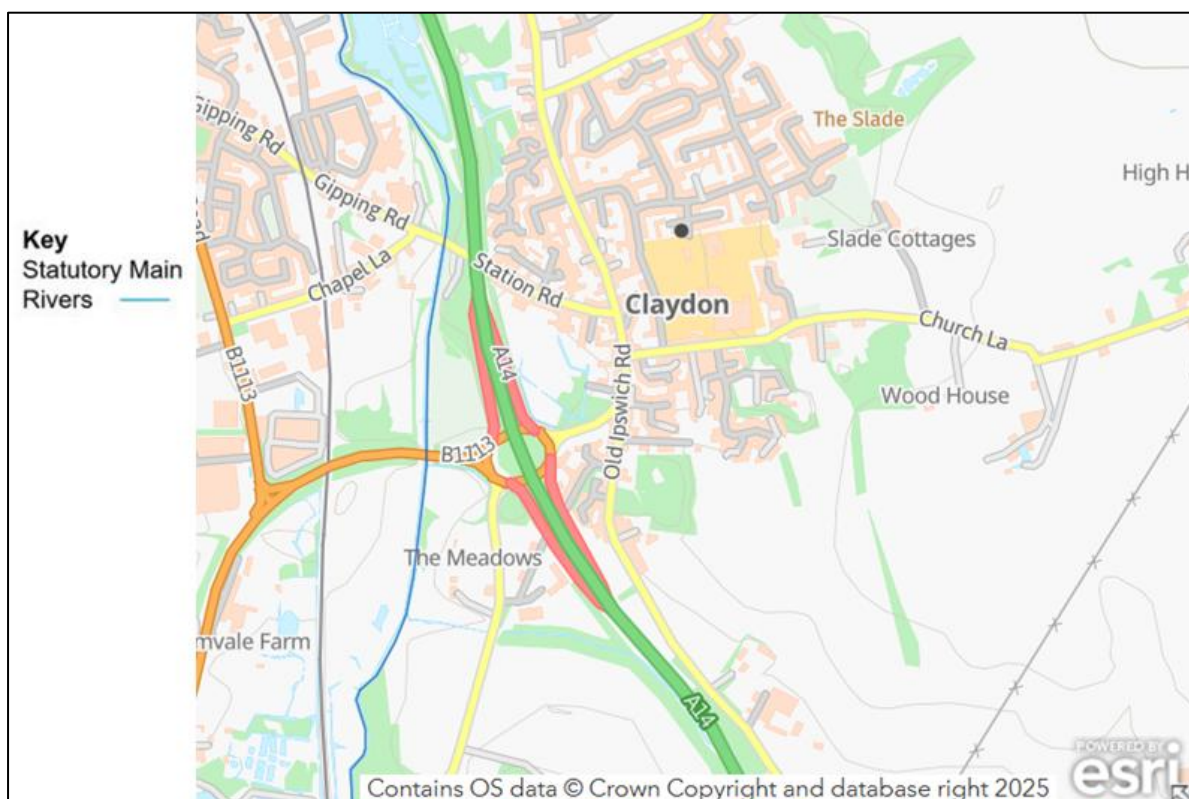
**Figure 2 shows the most significant watercourses in and around Claydon.**

Figure 2 shows the location of main river (River Gipping) and significant unnamed ordinary watercourses in the vicinity of Claydon. Neither of which have a role in the observed flooding.

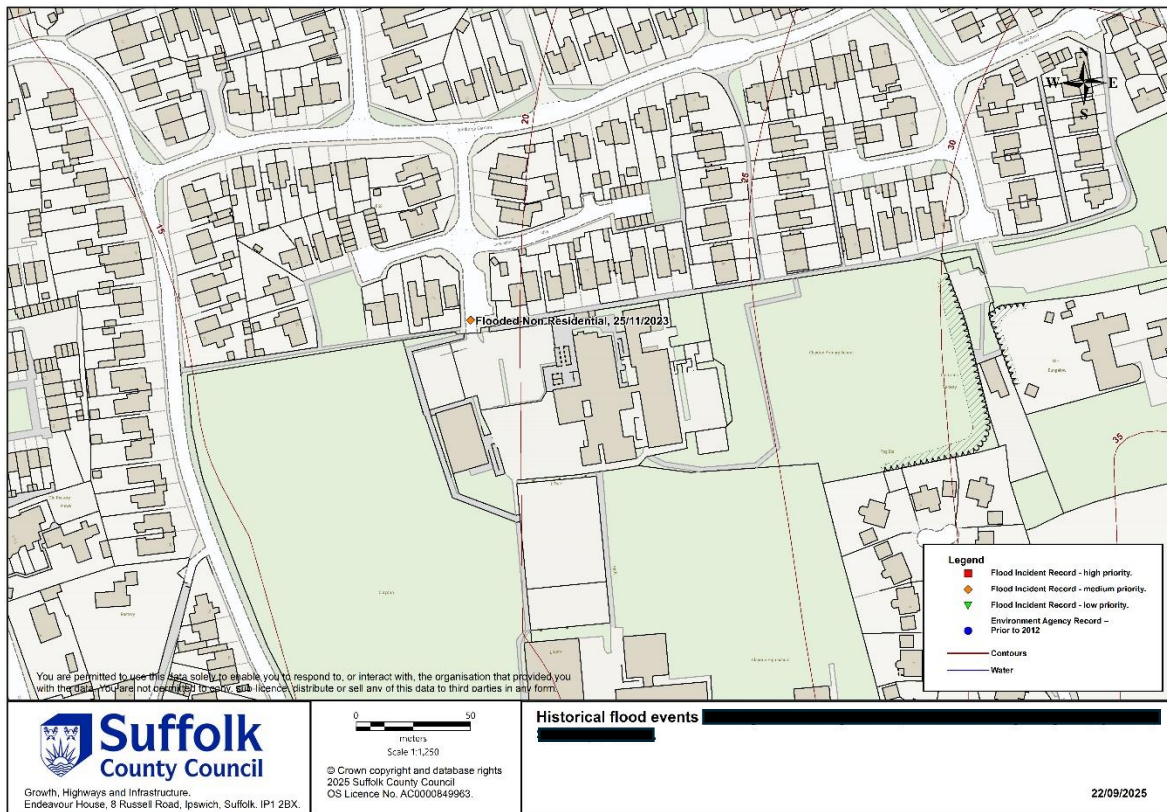
**Figure 3: Recorded historical flood event near the location as at 22/09/2025.**

However, no official records of flooding in the surrounding area are held by the LLFA, as shown on the map of historic incidents in Figure 3.

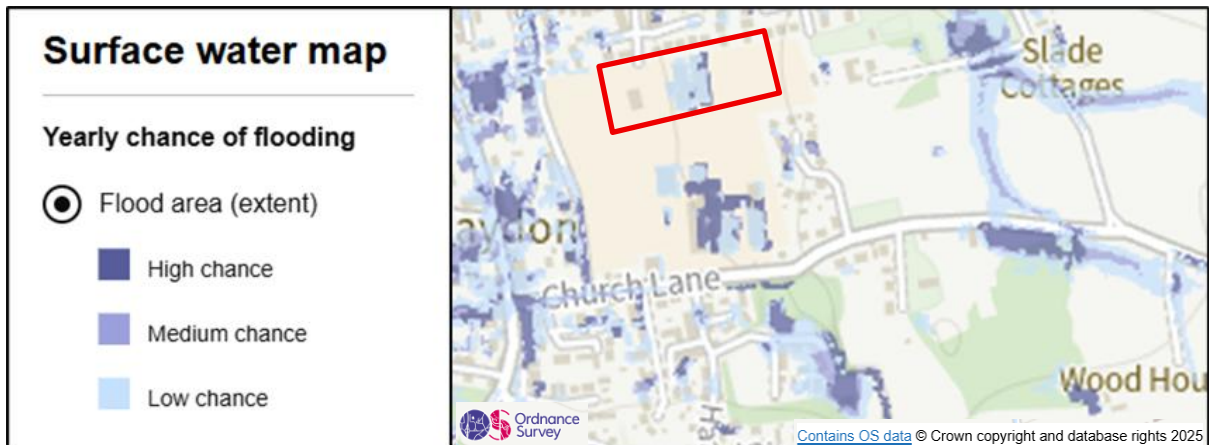
**Figure 4: Predicted flood risk from surface water (pluvial)**

Figure 4 highlights the predicted pluvial flood risk in the area. There are isolated areas of surface water flooding across the site, however the site is characterised as having a low probability of flooding each year. A low flood risk rating indicates a yearly flood probability between 0.1% and 1%. A small area of high flood risk is located behind the original building, as shown in Figure 4.

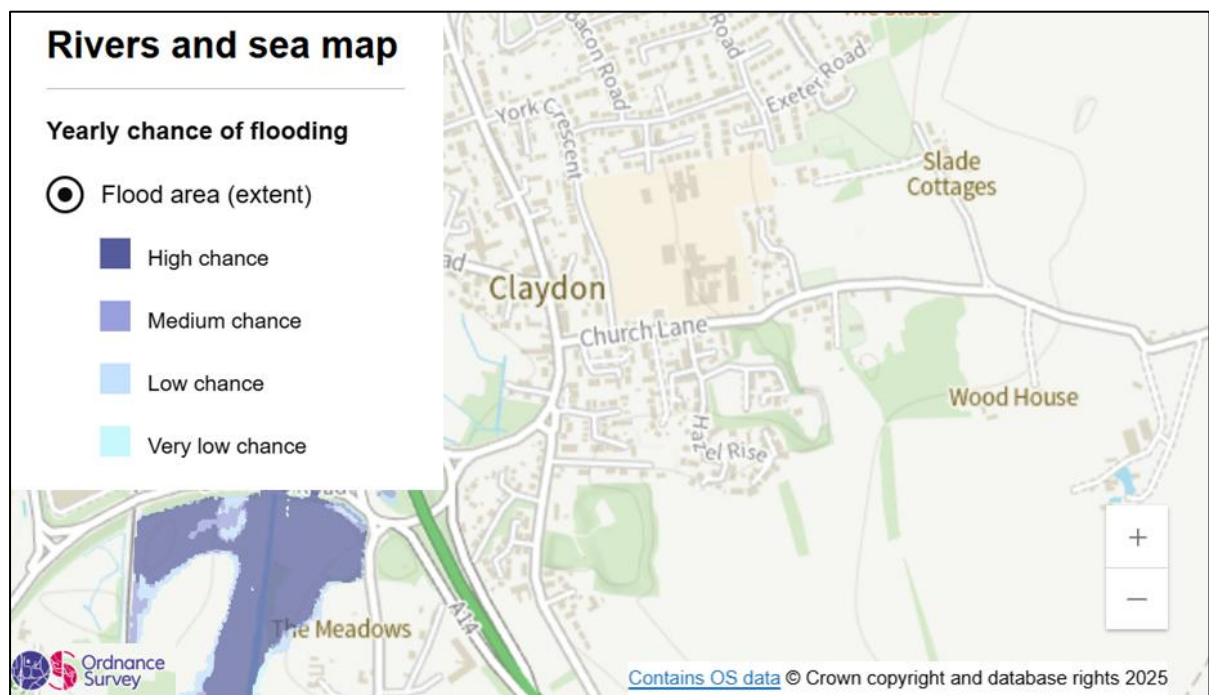
**Figure 5: Predicted flood risk from rivers.**

Figure 5 shows the projected fluvial (from designated main river and ordinary watercourses) flood risk in Claydon. The entire site is predicted to be at very low risk of flooding from rivers and the sea and was not a cause of internal flooding at this location.

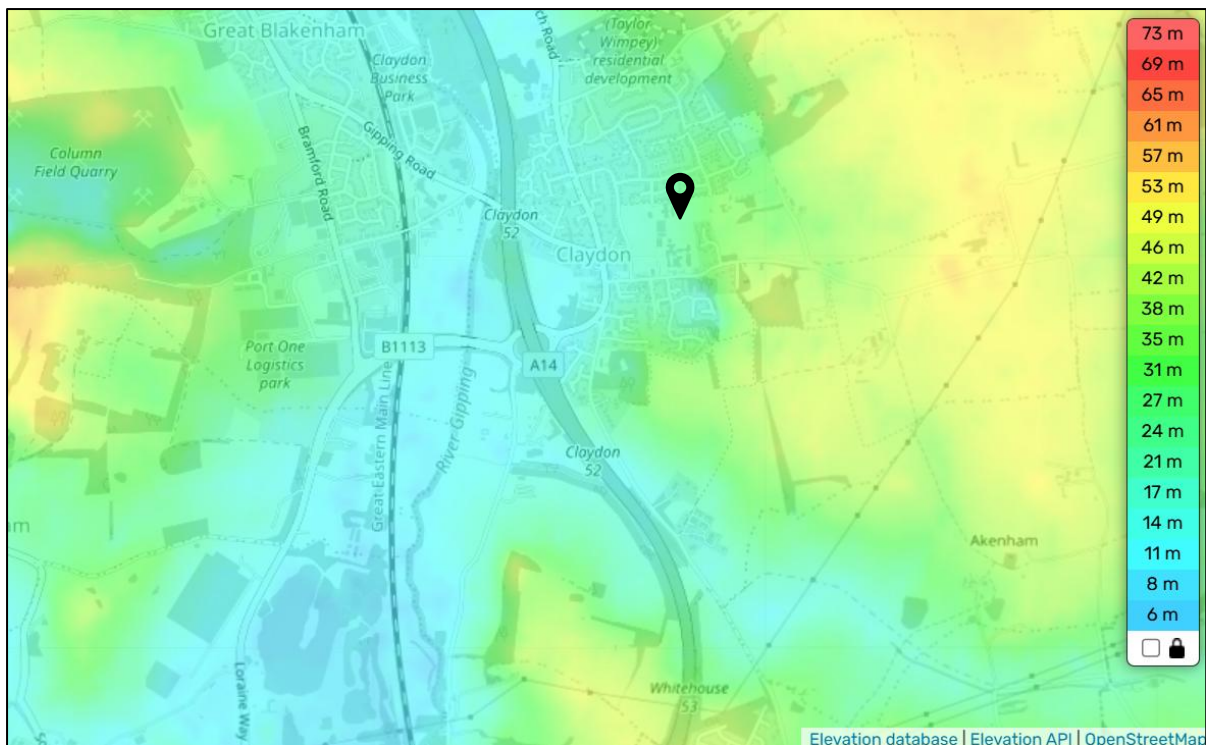
**Figure 6: Claydon and surrounding topography (TessaDEM as cited in topographic-map.com)**

Figure 6 shows the topography surrounding Claydon with gradient changes across the parish. The gradient slopes from east to west, towards the River Gipping. There are topographic changes across the impacted site with the newer building being situated at the lowest point within the site boundary. The car park areas slope moderately towards the new building, and surface water naturally flows across the site from east to west.

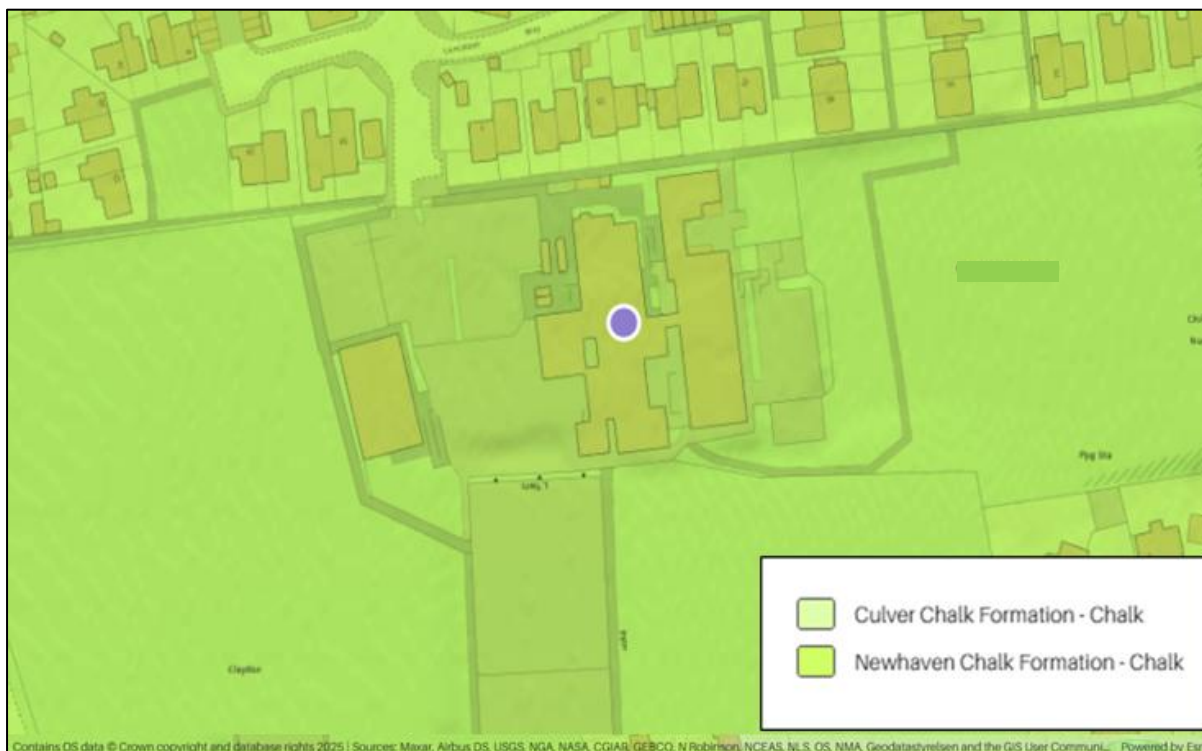
**Figure 7: The underlying/bedrock geology at the location.**

The bedrock geology consists of the Newhaven Chalk Formation (see Figure 7). While this formation is known to function as a good aquifer, its capacity for surface water infiltration may vary depending on site-specific conditions. Infiltration testing conducted during the planning application for the newly constructed building confirmed that the site is suitable for infiltration-based drainage (Drainage Strategy 15-0363).

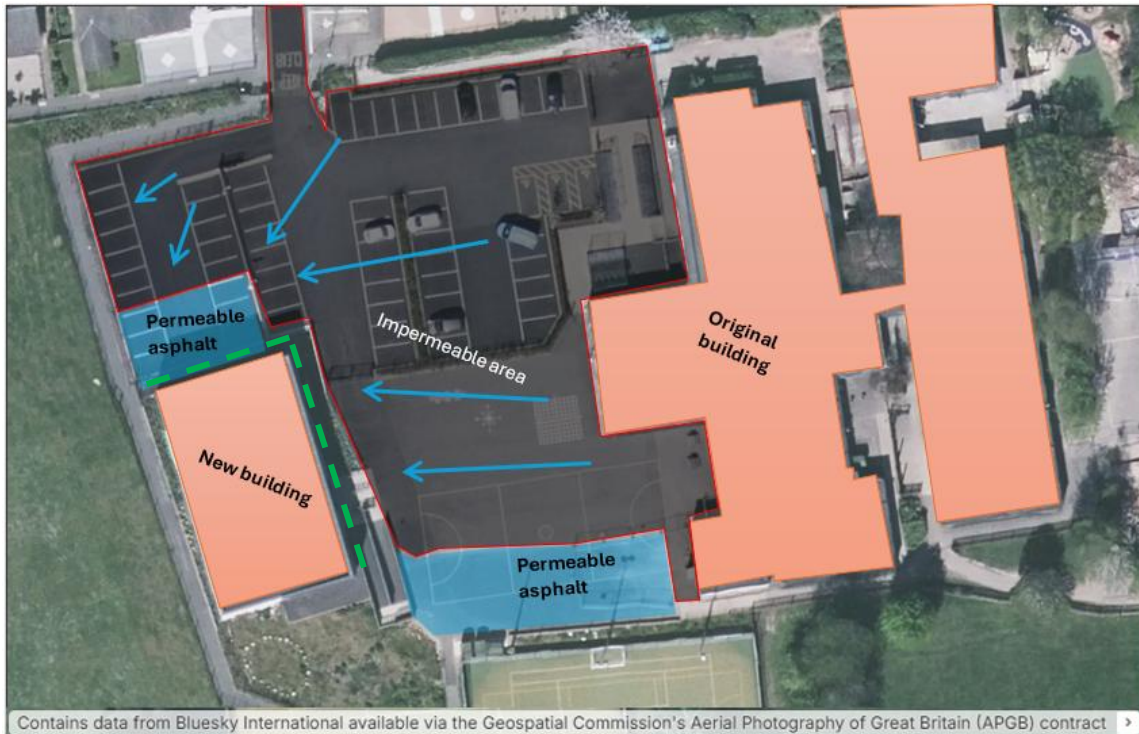
**Figure 8: Land cover at the location highlighting areas with permeable and impermeable surfaces.**

The types of land cover within the property boundary are predominantly artificial, consisting mainly of buildings and paved surfaces, including the car park. Most of these surfaces are impermeable, except for two areas identified in the drainage strategy (produced to support the design of the recent additions to the site) as being constructed of porous asphalt (see Figure 8). As a result, most of the site is considered largely impermeable and therefore generates large amounts of surface water runoff.

As previously noted, the site is predominantly impermeable, with extensive paved areas including the car parks. Rainfall on these surfaces runs off rapidly towards the site's lowest points, as illustrated by the blue arrows in Figure 8. According to the approved drainage strategy, some areas are surfaced with porous asphalt. Approximately 22% (110 m<sup>2</sup>) of the car park adjacent to the new building is porous, while the remaining 390 m<sup>2</sup> is impermeable asphalt (Figure 8).

The newly constructed building is equipped with ACO drains along its sides as represented by the green dashed lines in Figure 8. These drains are designed to collect roof and surface runoff before it reaches the building and convey it via pipework to a soakaway located beneath the impermeable section of the car park. However, anecdotal evidence suggests that surface water runoff from the car park flows toward the site's low points where the new building is situated, overwhelming the ACO drains and entering the building through the main entrance and emergency exit doors.

The section of the building located adjacent to the porous asphalt area (Figure 8), is the most frequently affected part of the building, with floodwater entering through the emergency exits. In theory, the porous asphalt should infiltrate most of the runoff, with any excess directed into the ACO drains, thereby preventing flooding. However, this does not appear to be occurring in practice.

A preliminary (non-standard) on-site test of the porous asphalt involving pouring a bucket of water and timing infiltration, revealed that the surface was not functioning as a permeable one. As a result, it is unlikely to have been capable of absorbing surface runoff or preventing water from reaching and flooding the building.

- Facility operator to undertake further testing of the porous surfaces to determine to what extent they are functioning as designed and if confirmed to be underperforming then consider remedial works to restore full functionality.

- Facility operator to replace the areas meant to be covered by porous asphalt with a suitably graded surface to encourage infiltration of surface run-off.

- Facility operator to investigate options to disconnect large contributing roof areas of all buildings i.e. rainwater harvesting and upgrading of existing impermeable surfaces with permeable materials, to encourage infiltration across the site and reduce surface water run-off.
