## **Environmental Information Regulations – Response - 27703**

# Asset Location History Report Aurora

Location: Street : Castleton Way Eye, Suffolk

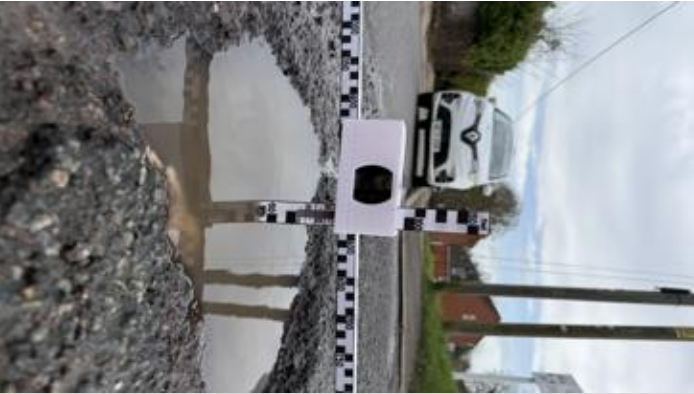
IMG\_2178:

| Location: | The main road into the police station, hospital and care home |
| Description: | There are 3 big potholes. You cannot avoid them. This is the main entrance to the hospital, police station and care home |

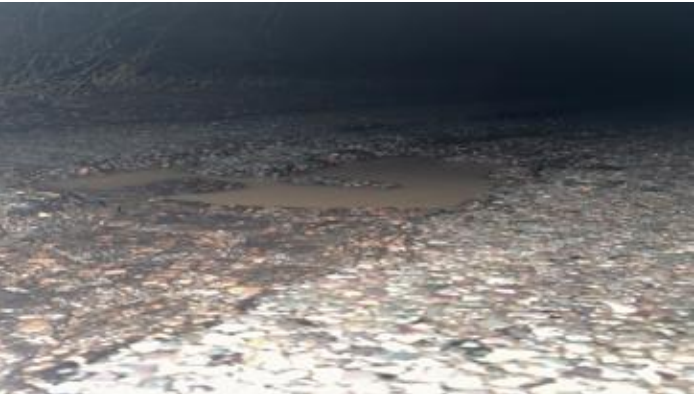
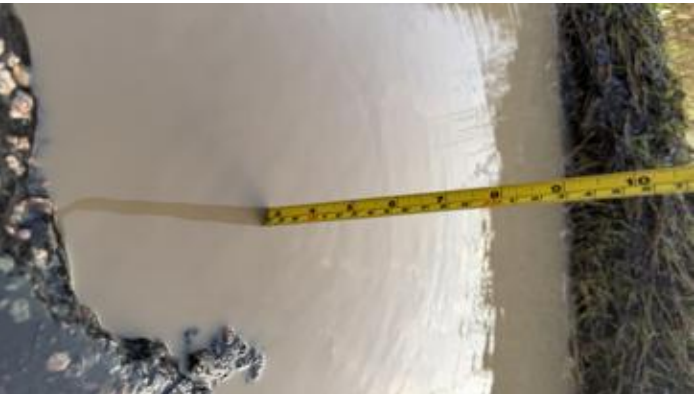
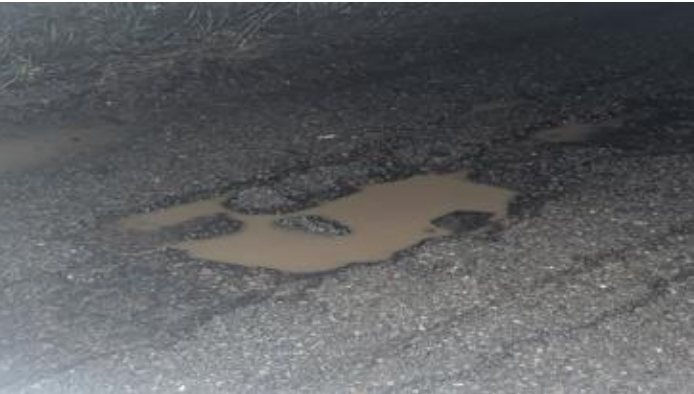
PWPFile-8d01cb65-074e-4271-a81e-9435b166b995.jpeg:

Location: carselton way, Eye, suffolk

Description: the pothole is 65mm deep and is 5meters long. at approximately 10:30 at night on thursday 19th of february i was driving along this stretch of road doing 30mph as it was dark and wet when i entered this extremely deep and long pot hole. as soon as i hit it i had an instant message appear on my car saying low tyre pressure on the front left wheel i pulled over as soon as it appeared i could hear and see the tyre deflating. fortunately i had a spare wheel in my car and had to change the wheel on a dangerous place as i couldn't move the car. Today i've had to have the wheel and tyre replaced at my expense this is why i am reporting this claim to yourselves. i've been back today to measure the pothole which includes the width depth and length
