Section 19 Flood and Water Management Act 2010

Framsden Flood Investigation – Storm Babet 2023

Name	Date
Report Author	Susie Clark	
Responsible Officer:	Susie Clark	
Checked by:	Ellie Beecroft	17/10/2024
RMA Review:		08/11/2024
Approved by:	Matt Hullis	27/11/2024
Date Published		29/11/2024
Date Report Closed

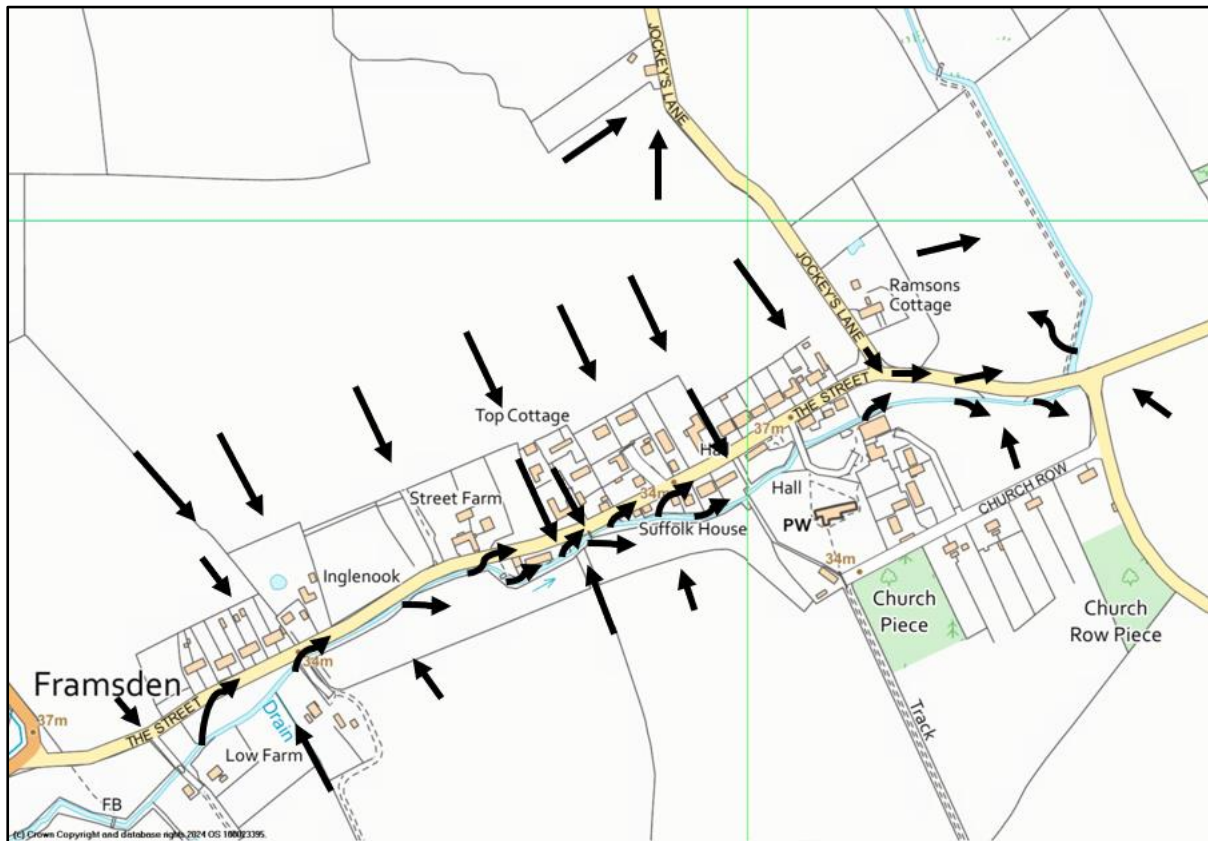
Figure 10. Approximate floodwater flow paths, The Street and Jockey's Lane

Incidents of property flooding were first reported when significant rainfall caused large quantities of surface water to flow from the fields, impacting the rear of properties on the north side of the eastern end of The Street. Reports describe this as not having

been observed for 34 years. Floodwater also flowed between some of the properties and began to collect on The Street, subsequently entering properties on the north and south side from the front, particularly those with driveways and properties at lower levels than the highway (Image 1). The road was reported as flooding by 10.15am on the 20th October.

There are no ditches currently within the fields to the rear of the properties on the north side of The Street, having been reported to have been removed when field drainage was installed 70 years ago. Mole drains had been redone 2 years prior to Storm Babet but the drains were described as having been overwhelmed by the volume of water. Fields were ploughed across slopes (horizontally), rather than down slopes (vertically) which is beneficial in slowing surface water flow but would have had a relatively small effect in the intense rainfall of Storm Babet. There is currently no means of attenuating the flow of surface water from these fields if the drainage network exceeds capacity.

Witnesses describe that after properties on the north side of The Street were flooded by surface water from fields, reported to have happened by 10.15am on the 20th October, Framsden watercourse overtopped its banks and began to impact the rear of properties on the south side of The Street (Image 2). The fluvial flood water merged with surface water, already present on the highway and further exacerbated the flooding of properties on the north side of The Street. Internal flooding of property on the north side of The Street was reported to have reached approximately 23cm.

- Intense and prolonged rainfall exceeded the capacity of field drains and surface water flowed across fields to the north and south of the Street towards Framdsen watercourse.
- Surface water from fields to the north flowed into and between properties on the north side of The Street and collected on the highway.
- Initially surface water from the fields on the south side of the river joined the river flow.
- Later, the river overtopped its banks flooding properties on the south side of the Street from the rear.
- Fluvial water merged with surface water, contributing to further flooding of properties and the highway.

- Report observed blockages, such as fallen trees, in Framsdén watercourse to the Environment Agency
- Report observed blockages of debris under highways bridges to Suffolk Highways authority.
- Residents to install Property Flood Resilience (PFR) via grant funded scheme.
- Explore potential natural flood management measures (eg. leaky dams and attenuation ponds) to “slow the flow” and attenuate water on surface water flow paths and ditches on fields south of Framsdén watercourse.
- Explore potential natural flood management (NFM) measures (eg. rough buffer strips, bunds, and/or ponds) for attenuating excess surface water flows from the fields on the north side of the eastern section of The Street.
- Explore potential NFM measures which aim to attenuate surface water in the upper catchment of Framsdén watercourse (eg. storage ponds and wetland areas).

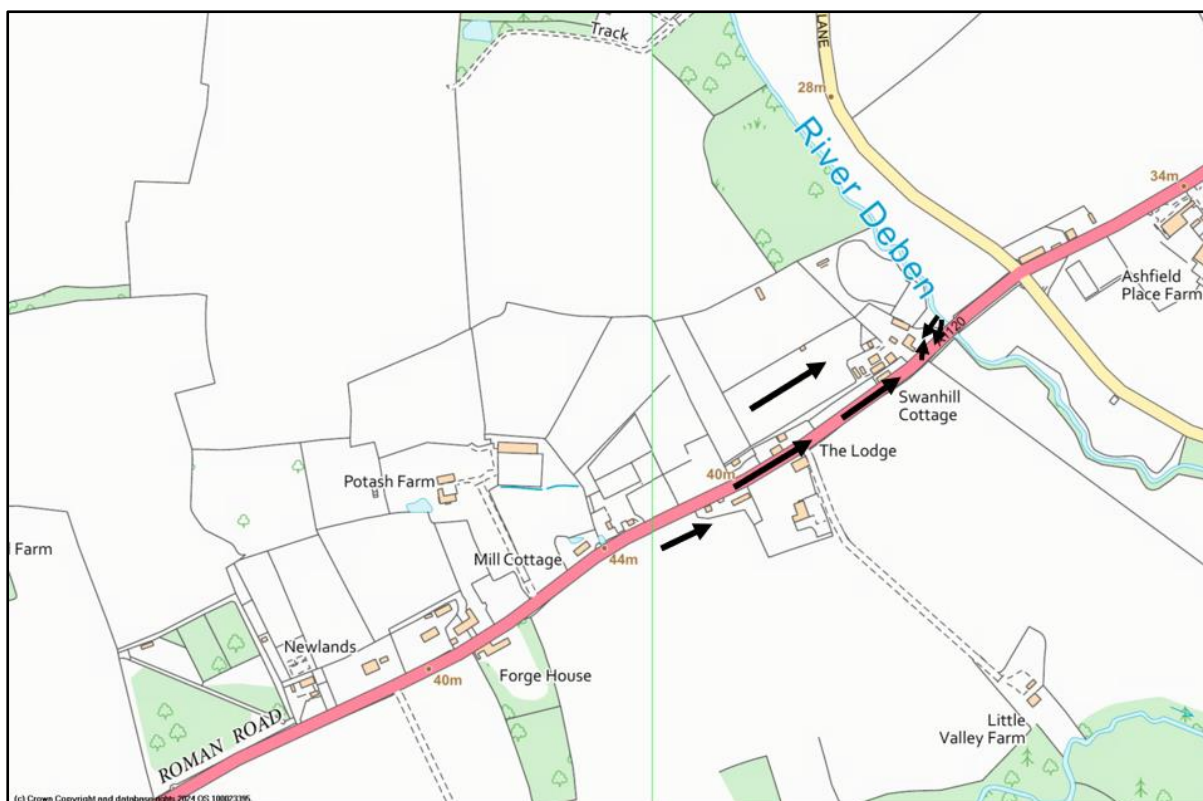
Figure 11. Approximate floodwater flow paths Swan Hill, A1120

Property on the A1120, further west up the slope (Swan Hill) from the River Deben reported to have experienced internal flooding at approximately 9:30am, with flood water depths up to 15cm. Property in this location has since flooded again on 24th May 2024. The highway is elevated at this location and therefore surface water flowed from the highway towards the River Deben, entering property driveways which are at a lower elevation than the A1120 (Images 4 and 5).

At 12.30pm water continued to rise in the River Deben and at 2.30pm property close to the River Deben was flooded, reported to be primarily from fluvial water from the River Deben overtopping its banks. The bridge on the A1120 over the River Deben was unable to accommodate all the river flow and was reported to have exceeded capacity. This caused water to back up on the north side of the bridge, with the river level close to the top of the wall. This contributed to flooding of property in the vicinity of the bridge whilst the flood plains to the south of the bridge remained relatively clear (see Image 3).

Fluvial floodwater was supplemented by surface water from the highway. Drainage assets were overwhelmed. Concerns have been raised by residents that gullies on this stretch of the A1120 are frequently blocked from mud deriving from heavy vehicles eroding the highway verges (Images 6 and 7). SCC Highways are aware of gullies on Swan Hill that are not fully functional and anticipate investigating and resolving this.

- Surface water and groundwater caused internal flooding to properties close to the top of Swan Hill on the south side.
- Surface water on the A1120 flowed east down the highway on Swan Hill towards the River Deben, entering properties via driveways at the bottom of the hill. This was supplemented by surface water from fields.
- Storm drains on Swan Hill on the A1120 were unable to cope with the volume of surface water on the highway.
- The capacity of the bridge over the River Deben on the A1120 was exceeded, contributing to water overtopping the banks on the north side of the bridge which merged with surface water and flooded adjacent properties.

- Increase frequency and ensure completion of maintenance cycle for gullies on Swan Hill.
- Investigate/resolve non-operational gullies to west of river on Swan Hill.
- Report observed blockages of debris under the River Deben bridge to Suffolk Highways authority.
- Residents to install Property Flood Resilience (PFR) via grant funded scheme.
- Explore the potential for NFM measures to reconnect the River Deben with the floodplain between Debenham and the A1120 to allow for greater water attenuation on the floodplain.

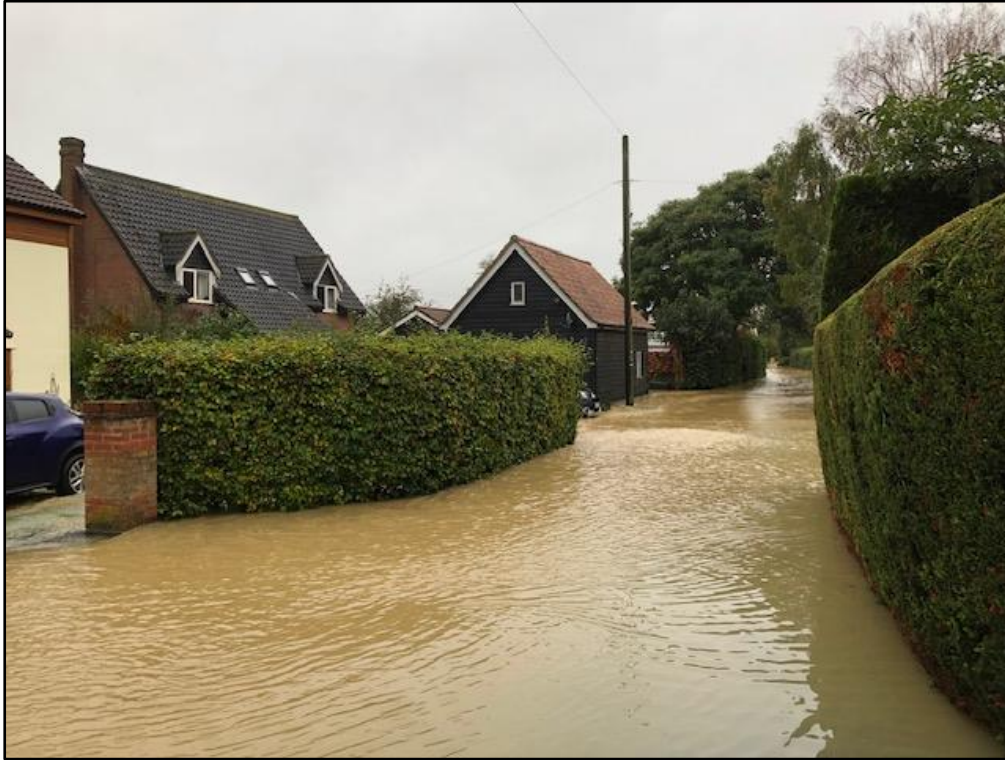
Image 1. View west along The Street during Storm Babet

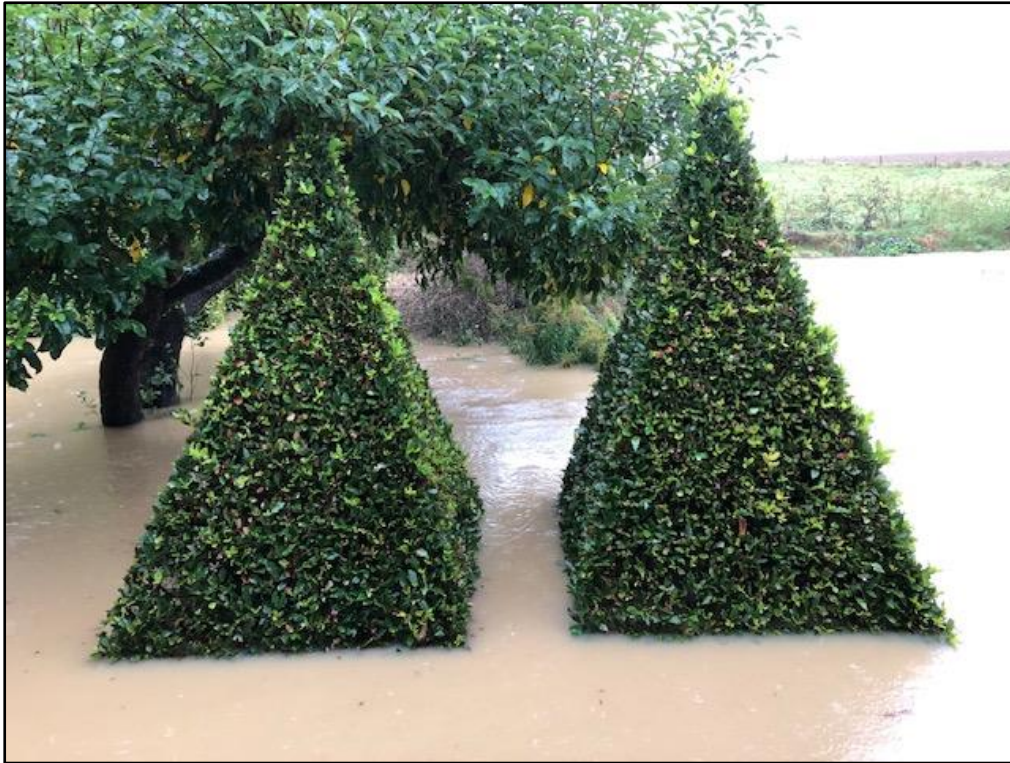
Image 2. View looking south across gardens and Framsdan watercourse to the far bank of the watercourse from property on the south side of The Street during Storm Babet

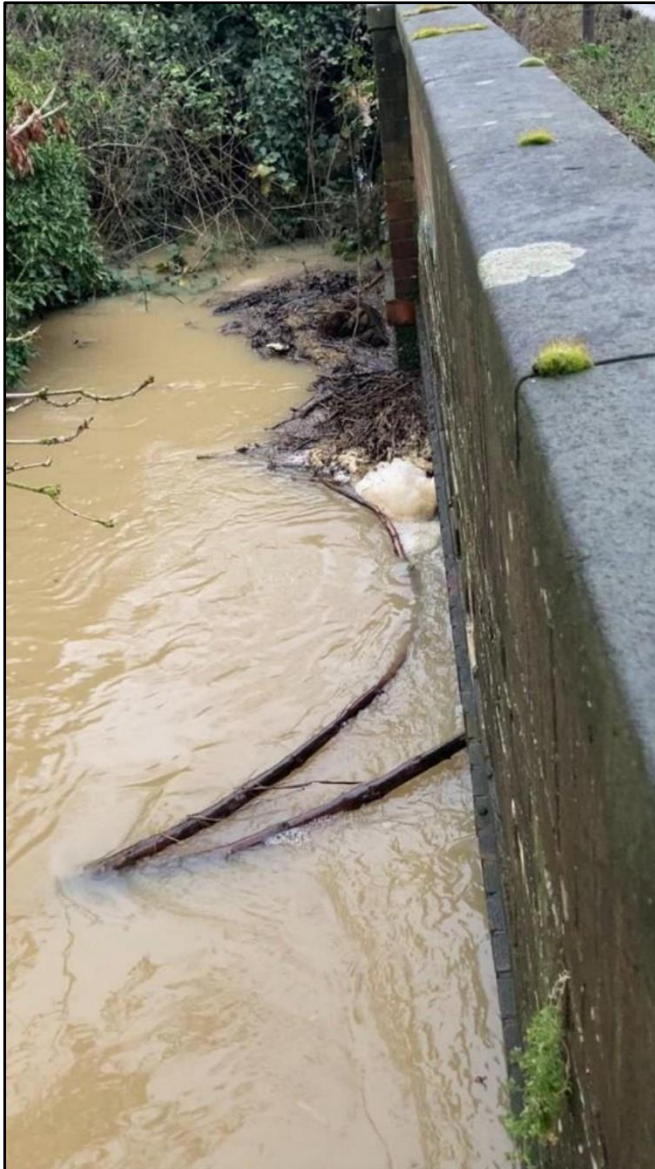
Image 3. North side of River Deben bridge at the bottom of Swan Hill, A1120, during normal winter river flow

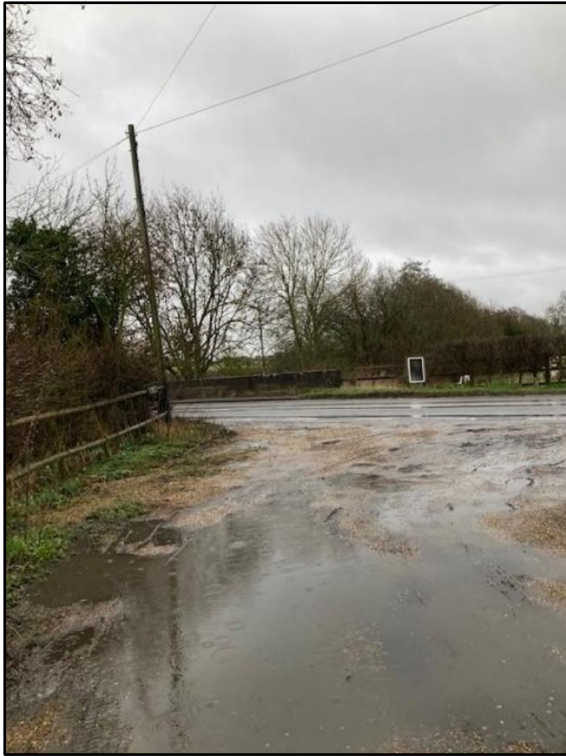
Image 4. Flooding from the highway entering a driveway at the bottom of Swan Hill, A1120 on 21st February 2023, after a couple of hours of light rain

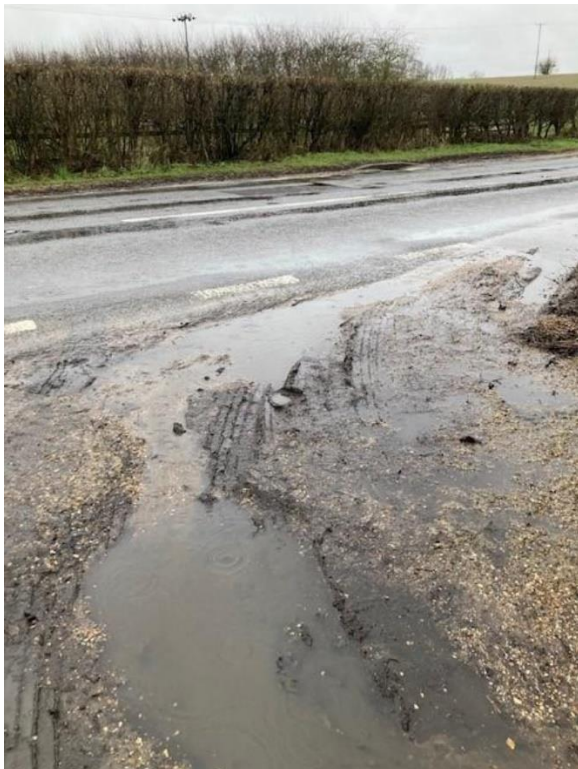
Image 5. Surface water pathway from the A1120 on to property at the bottom of Swan Hill

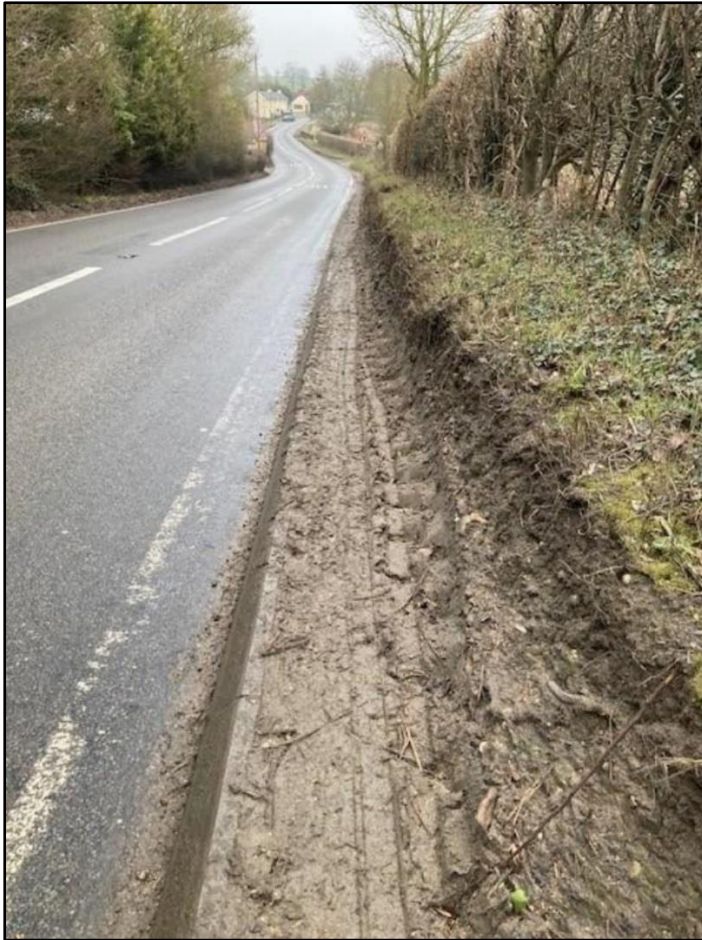
Image 6. View down Swan Hill, A1120, showing erosion of verge

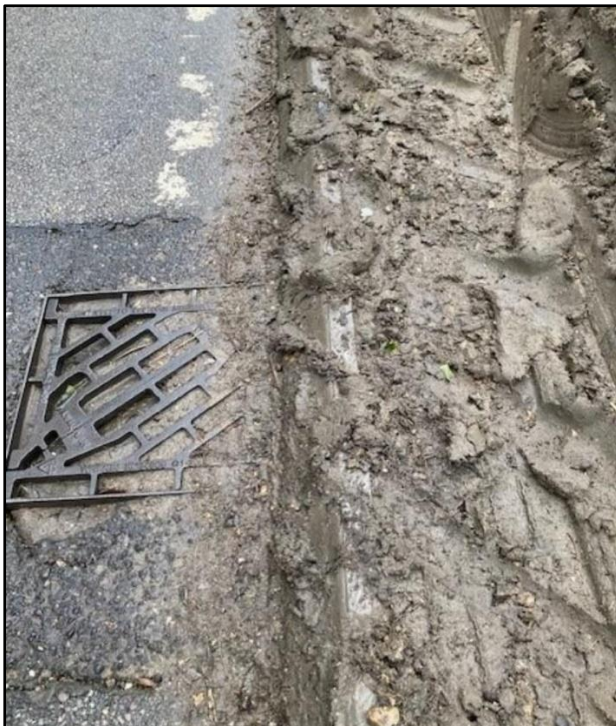
Image 7. Gully on Swan Hill, A1120, blocked by erosion of verge

Review cleansing frequency of gullies along Swan Hill, A1120	Suffolk County Council Highways Authority	Cycles have been reviewed and frequency increased so that all gullies are cleansed annually
--	---	---
