## Section 19 Flood and Water Management Act 2010

### Hoxne Flood Investigation – Storm Babet 2023

Name	Date
Report Author	Stephen Quinn	
Responsible Officer:	Stephen Quinn	
Checked by:	Ellie Beecroft	16/09/2024
RMA Review:		08/10/2024
Approved by:	Matt Hullis	24/10/2024
Date Published		28/10/2024
Date Report Closed

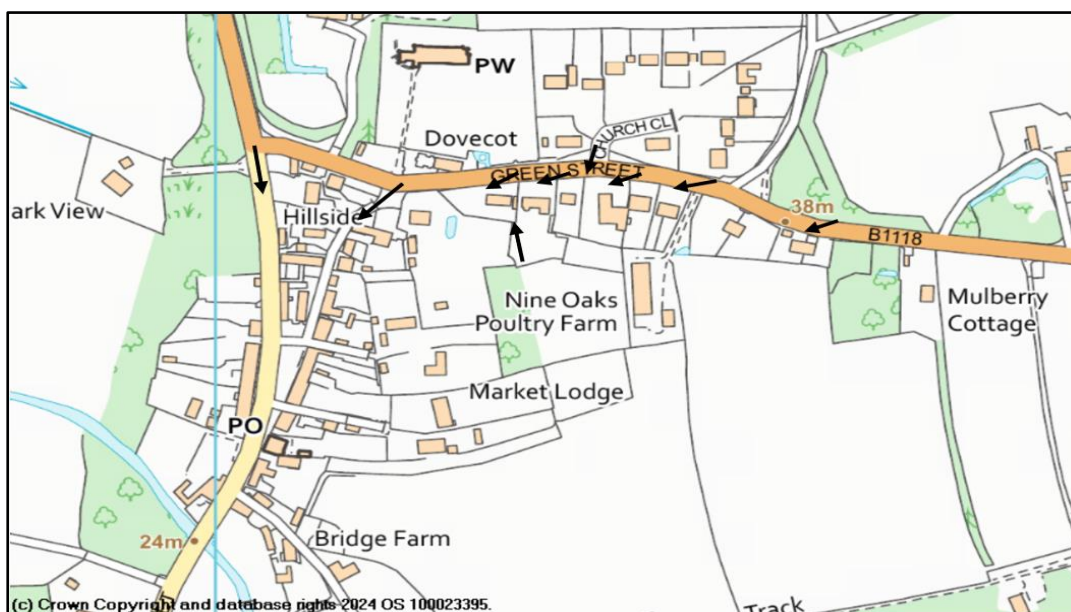
Figure 10. Approximate floodwater flow routes on Green Street

Following prolonged heavy rainfall on the morning of 20 October large amounts of surface water began pooling on the highway along Green Street near to the entrance to Church Close. Houses were flooded internally, primarily from the front due to the sheer amount of floodwater flowing off the highway towards properties over the low kerbs and across driveways (see Figure 10). Some of the properties also experienced additional flooding from the rear as surface water flowed from higher gardens south of Green Street. The large volume of floodwater on the road likely meant that the existing highway drainage assets were overwhelmed.

Suffolk Highways are aware of historic flooding on the carriageway and footway on Green Street. Previous flooding has been known to take several days to clear. Initial investigations have indicated a possible break between a drainage gully and manhole. Further work to improve the situation at this location is in Suffolk Highways future programme.

- Intense and prolonged rainfall resulted in excess surface water flowing off the highway towards several properties.
- Existing drainage assets on the highway were overwhelmed.
- Known issues with highway drainage assets in the area may have contributed to the problem.

- Residents to install Property Flood Resilience (PFR) via grant funded scheme.
- Suffolk Highways future works programme to locate and repair / replace damaged drainage assets on Green Street to be carried out.
- Investigate highway drainage infrastructure on Green Street generally to ensure capacity and condition are sufficient.

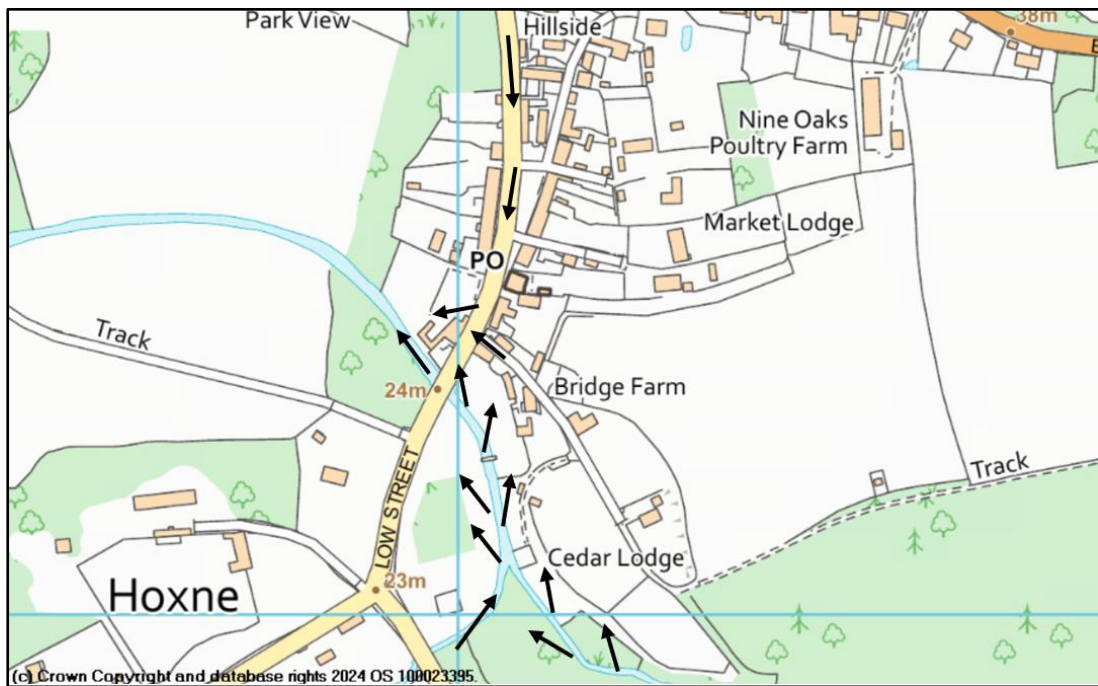
Figure 11. Approximate floodwater flow routes on Low Street

Excess surface water from the rainfall flowed down the gradient from the north end of Low Street towards the Swan bridge area. The highway gullies on the west side of Low Street were seen to be clogged with fallen leaves inhibiting drainage. On 20 October from 9:30am water was surcharging from the manhole in front of the Swan pub indicating the surface water drainage system was already reaching capacity and/or may have become blocked with the floodwater debris. This surcharging water was merging with the surface water flowing down Low Street, pooling across the highway to the pub, swan bridge and along Sandpit Lane (see Image 3).

The Gold Brook watercourse overtopped its banks with the fields and areas either side of the watercourse upstream of the bridge extensively flooded (see Figure 11). Swan bridge acted as a constriction to the large volume of water flowing down the catchment from the Gold Brook and Chickering Beck watercourses. The floodwater flowed across gardens with multiple properties suffering internal flooding ranging from 10 to 45cm deep. As the floodwater continued to back up at Swan bridge, a torrent of water flowed from Sandpit Lane across Low Street and into the Swan pub carpark (see Image 4). By 4:00pm the entire area was submerged as the floodwater extended and merged with the surface water from the highway. The highway drainage assets and infrastructure in this location were overwhelmed and could not discharge into the already overfull watercourse. Residents have reported that the flood water level on Low Street peaked around 8:30pm and at 9:15pm the electricity on Low Street went off.

The floodwater began to recede during the night of 20 October and by the morning of Saturday 21 October the water on Low Street was gone. Some of the properties on Low Street reported to have flooded internally again during Storm Ciaran (1 - 2 November 2023).

- Intense and prolonged rainfall resulted in excess surface water flowing down the highway on Low Street, merging with surcharging water from a manhole and pooling around the Swan pub and bridge area.
- The Gold Brook watercourse overtopped its banks whilst the high flows in the channel backed up at Swan bridge.
- By late afternoon, a wide area was entirely submerged as the floodwater flowed in a torrent across Sandpit Lane and into the Swan pub carpark.
- Existing drainage assets on the highway were overwhelmed.

- Residents to install Property Flood Resilience (PFR) via grant funded scheme.
- Investigate the capacity and condition of highway drainage infrastructure and Anglian Water assets on Low Street, particularly the area in the vicinity of the Swan pub.
- Report any observed blockages below Swan bridge on the Suffolk Highways Online Reporting Tool.
- Landowners to carry out watercourse maintenance to reduce flood risk as necessary as per their riparian responsibilities.

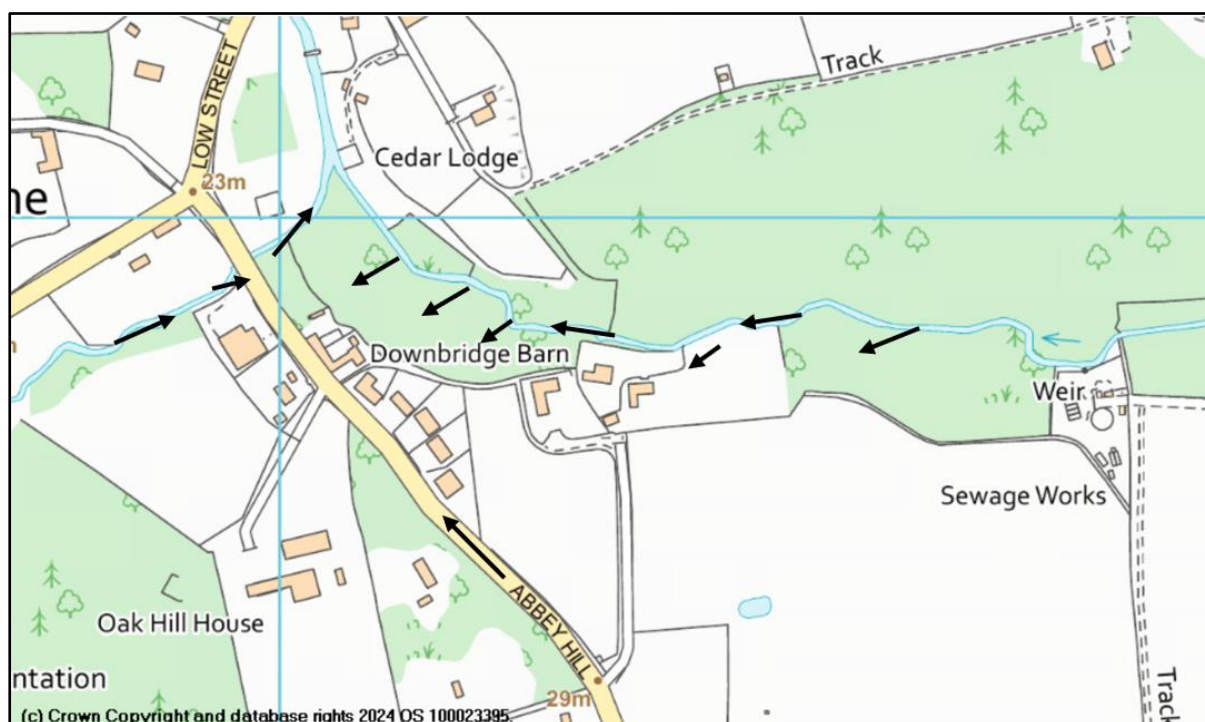
Figure 12. Approximate floodwater flow routes on Abbey Hill

Abbey Hill was predominantly impacted by fluvial flooding from the Chickering Beck and Gold Brook watercourses, the confluence of both is just north of Abbey Hill. Chickering Beck on the morning of 20 October was swollen by heavy rainfall and overtopped towards the properties to the south. Floodwater flowed across gardens from approximately 11:30am and started to enter houses from the early afternoon onwards (see Image 2). The Gold Brook also overtopped across the surrounding fields and flowed onto Abbey Hill, effectively surrounding properties in floodwater and additionally flooding some houses internally from the front. Surface water on the highway running down the hill also contributed to the flooding. National flood risk mapping indicates parts of Abbey Hill to be at medium risk (between 1% and 3.3% chance each year) from fluvial flooding and at high risk (more than 3.3% chance each year) from surface water flooding.

The increasing volumes of floodwater on the road meant that the highway drainage assets were overwhelmed and could not drain the water away. Residents have reported that the gullies were ineffective due to silt build-up and blockages.

Suffolk Highways are aware of pre-existing problems on the carriageway along Abbey Hill with gullies frequently blocking and root ingress being a known problem. Investigations carried out by Suffolk Highways post Storm Babet found multiple silted gullies that required clearing.

- Intense rainfall resulted in Chickering Beck and Gold Brook watercourses exceeding their capacity and overtopping.
- Floodwater spread across surrounding fields and gardens impacting multiple properties along Abbey Hill.
- Surface water on the highway flowed down Abbey Hill towards properties.
- Existing drainage assets on the highway were overwhelmed.
- Pre-existing issues with highway drainage assets in the area may have contributed to the problem.

- Residents to install Property Flood Resilience (PFR) via grant funded scheme.
- Investigate potential NFM projects to 'slow the flow' and attenuate water on overland flow paths (leaky dams, restoration of watercourses, etc.) east of Abbey Hill.
- Report any observed blockages below Gold Brook bridge on the Suffolk Highways Online Reporting Tool.
- Landowners to carry out watercourse maintenance to reduce flood risk as necessary as per their riparian responsibilities.

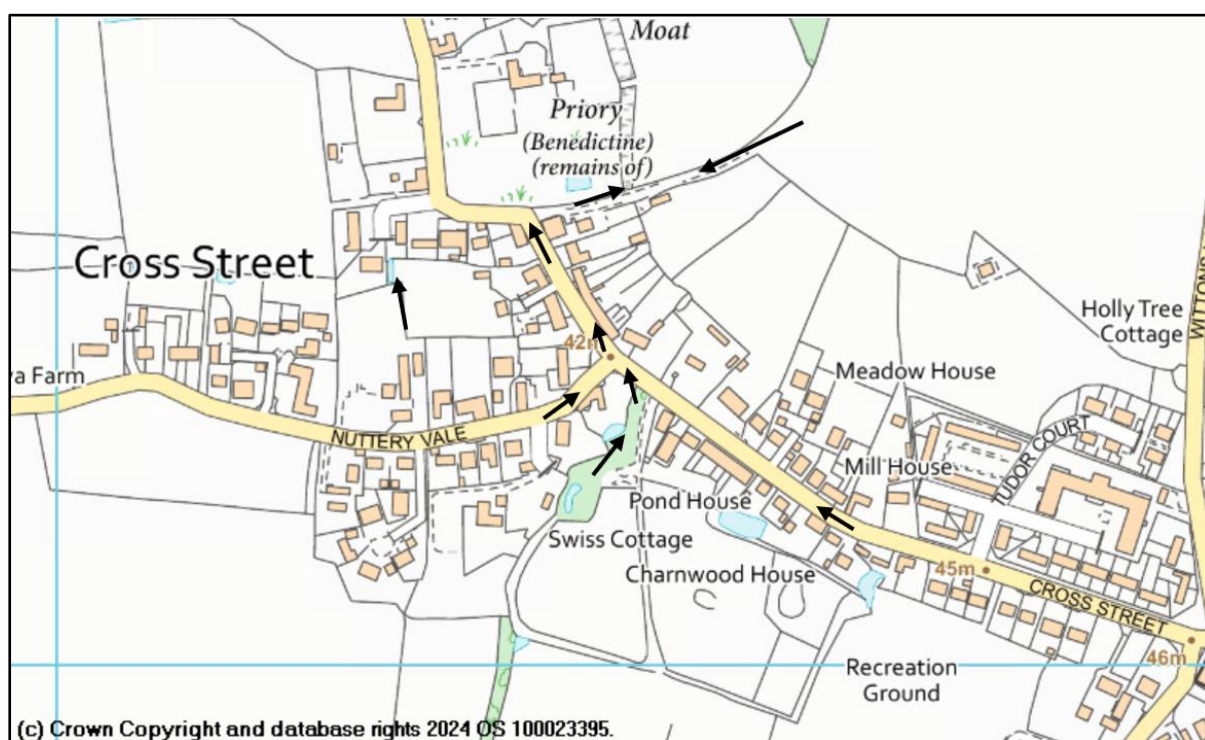
Figure 13. Approximate floodwater flow routes on Cross Street

On Cross Street multiple properties were impacted by surface water flooding. During the morning of 20 October heavy rainfall resulted in large volumes of floodwater pooling on the road in different locations as the highway drainage gullies and sewer infrastructure reached capacity.

Residents reported a number of manholes on Cross Street were surcharging and bubbling up with a mixture of foul water and rainwater in the middle of the street. Several reports indicated that almost all the roadside gullies were blocked and/or overwhelmed and failed to drain the increasing amounts of surface water from the highway.

- Residents to install Property Flood Resilience (PFR) via grant funded scheme.
- Investigate potential NFM projects to 'slow the flow' and attenuate water on overland flow paths (leaky dams, restoration of watercourses, etc.) north of Cross Street.
- Ensure the completion of highway drainage asset cyclic maintenance on Cross Street.
- Landowners to carry out watercourse/ditch maintenance to reduce flood risk as necessary as per their riparian responsibilities.
- Investigate highway drainage and sewer infrastructure on Cross Street generally to ensure capacity and condition are sufficient.

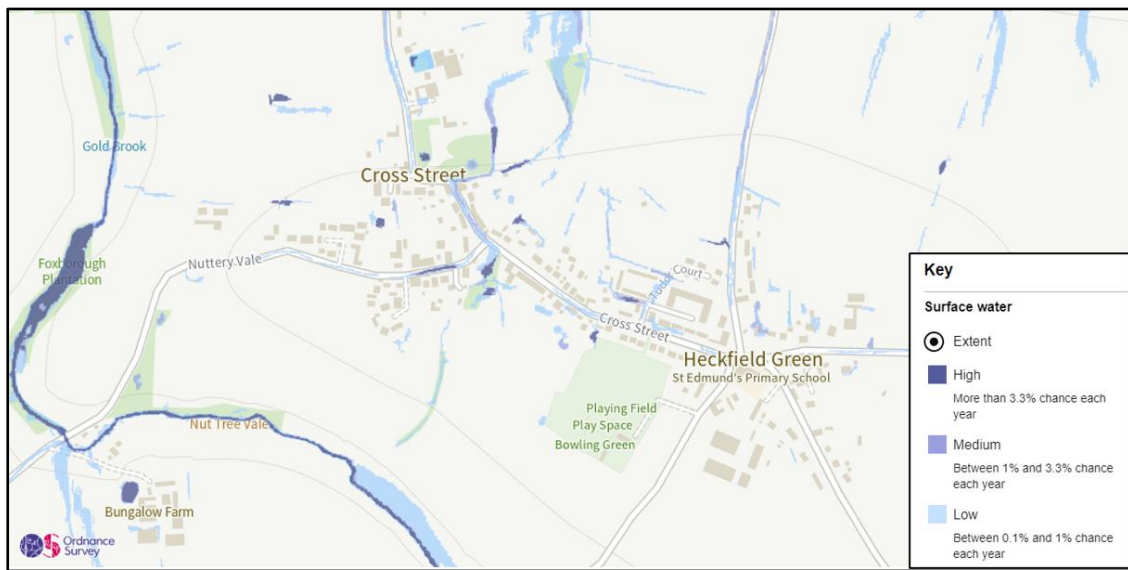
Figure 14. Surface Water flood risk on Cross Street and Nuttary Vale

Additional surface water flows originating from the fields to the northeast flowed into the ditch behind the properties to the north of Cross Street. This surface water run off filling the ditch reduced the effectiveness of the highway drainage assets and added to the flooding. The national flood risk mapping shows large sections of Cross Street and the adjoining Nuttary Vale to be at medium to high risk of surface water flooding (see figure 14).

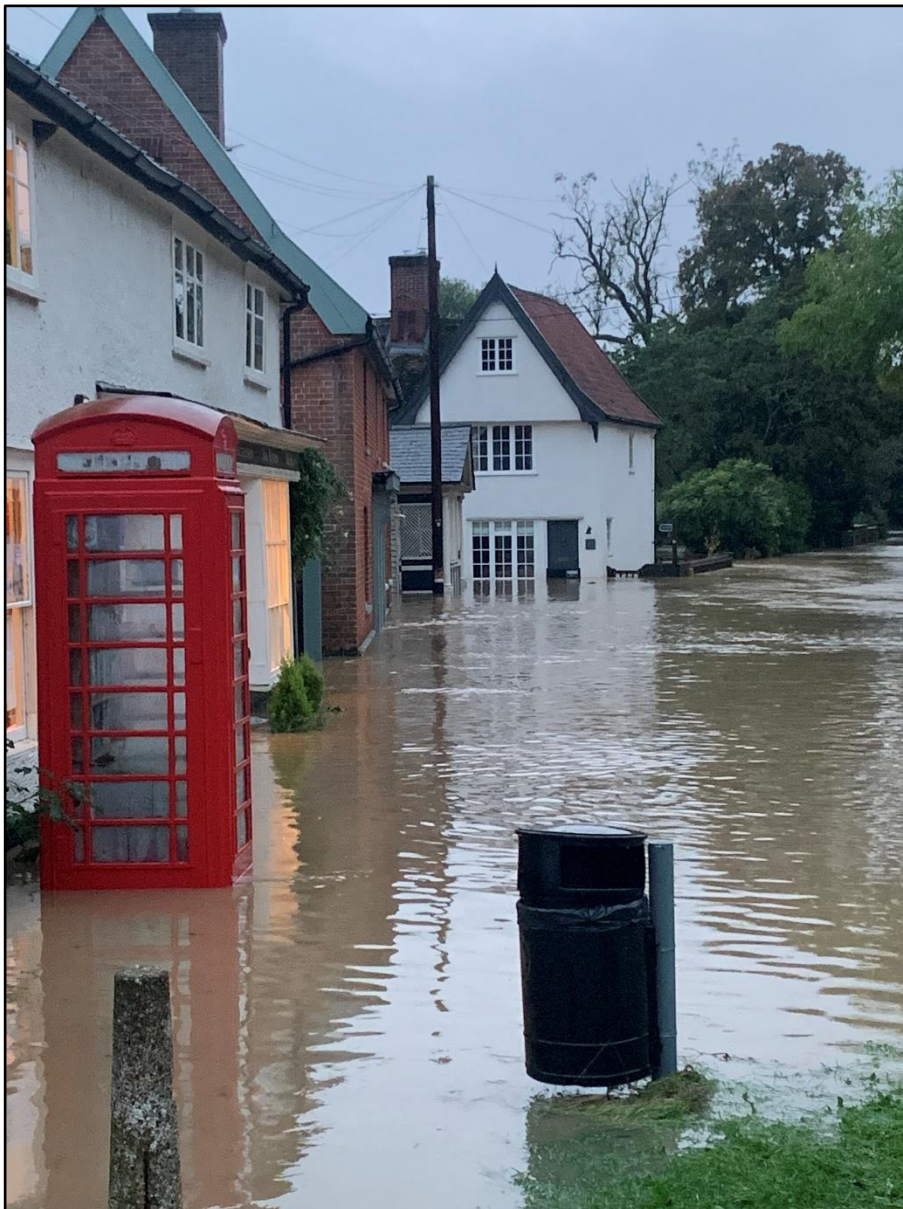
*Image 1. Flooding outside the Post Office on Low Street*

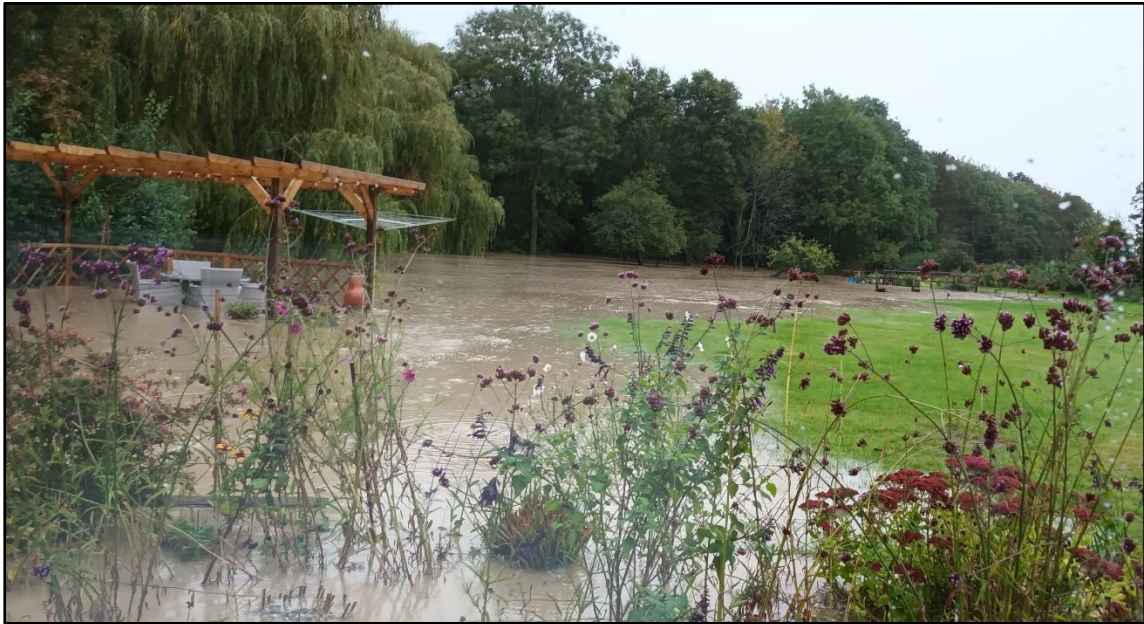
*Image 2. Flooding from Chickering Beck watercourse*

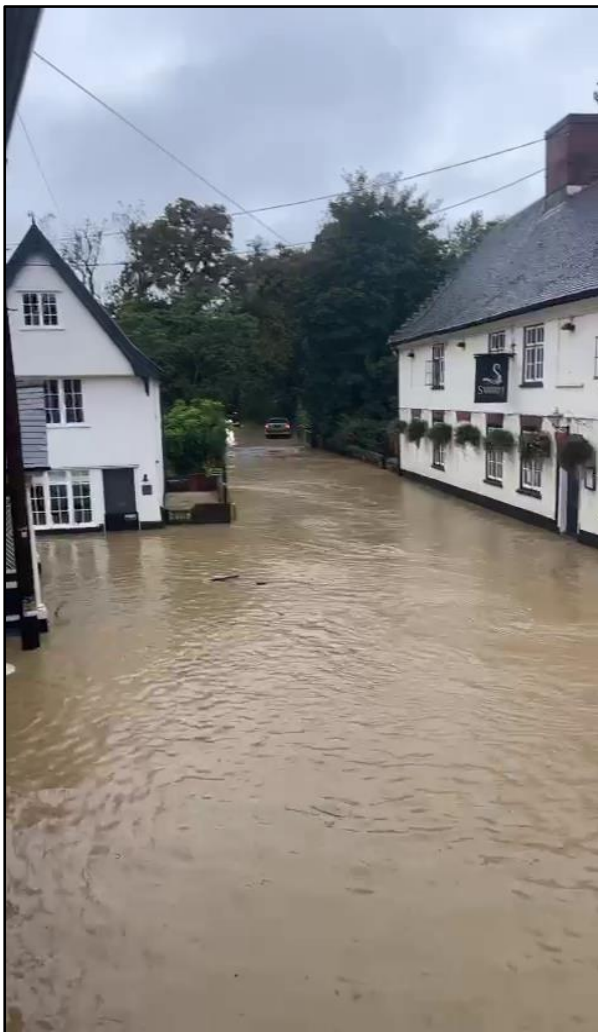
*Image 3. Looking towards Swan bridge*

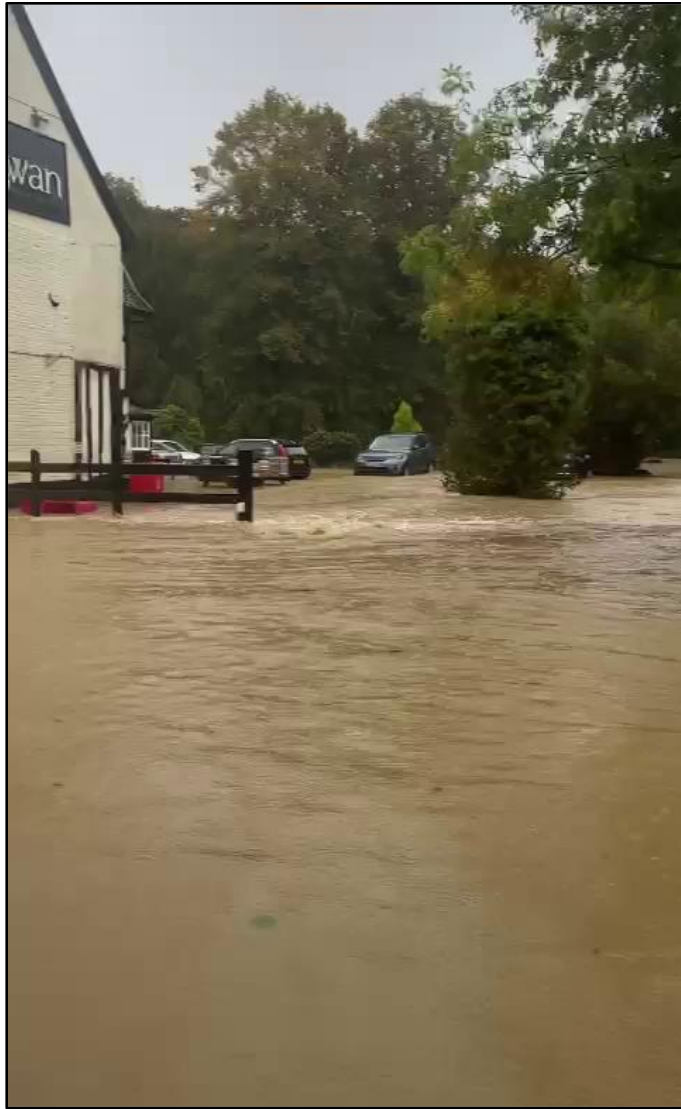
*Image 4. Looking towards the Swan pub carpark*
