Section 19 Flood and Water Management Act 2010

Hundon Flood Investigation –

Storm Babet 2023

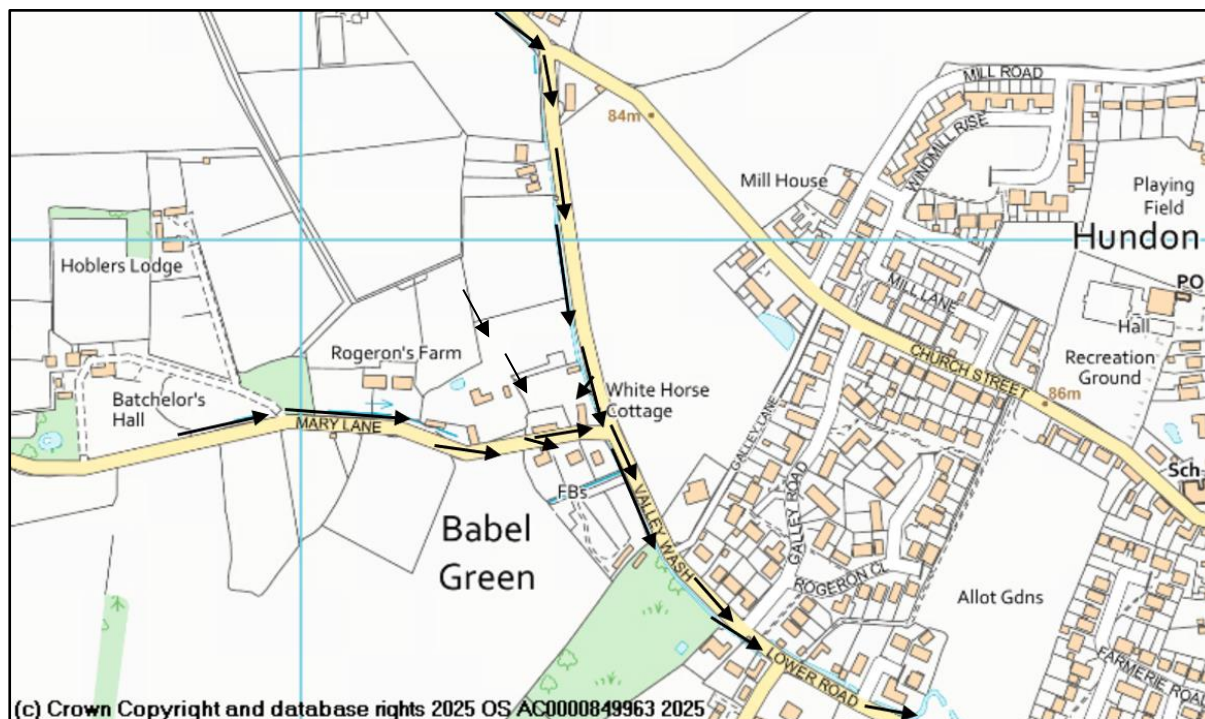
Figure 10. Approximate flood water flow routes along Mary Lane and Valley Wash

A torrent of water flowed down Valley Wash (see Image 1) towards the junction with Mary Lane. Some properties in this area were flooded directly from the overwhelmed Chilton Brook. The situation was compounded by additional surface water flows coming in an easterly direction on Mary Lane and from the adjacent ditch (see Figure

10). Sections of this ditch have been filled in and built over historically, meaning the majority of the floodwater flowed along the highway towards the Valley Wash junction.

A culverted section of the watercourse and the road bridge at this location may also have held up some floodwater as their capacity was exceeded. Additionally, there was a section of coir matting on the roadside bank displaced into the channel of the Brook on Valley Wash and there may have been some subsequent bank erosion, reducing its capacity and ability to convey the floodwater.

Residents reported floodwater depths of up to 30cms around the junction of Mary Lane and Valley Wash, with flood water impacting properties mainly from the road as the highway drainage systems were unable to cope. Multiple reports mention blocked drains, and drains being overwhelmed by the sheer amount of floodwater as the highway was completely submerged in places. The highway drainage assets in this area were last cleansed prior to Storm Babet in February 2022, with the gullies recorded as being operational.

- Residents to install Property Flood Resilience (PFR).
- Increase awareness of riparian landowner responsibilities with regard to watercourse management across Hundon.
- Riparian landowners to carry out appropriate watercourse maintenance to reduce flood risk as necessary as per their riparian responsibilities.
- Identify where works could be considered to improve flow through the village to reduce risk within this location, in particular on Valley Wash and Mary Lane.
- Explore potential NFM projects to 'slow the flow' and attenuate water on overland flow paths west of Mary Lane and north and west of Valley Wash, E.g. leaky dams, woody debris installation, restoration of watercourses, storage ponds, wetland areas.
- Suffolk Highways to ensure the completion of highway drainage asset cyclic maintenance on Valley Wash and Mary Lane.

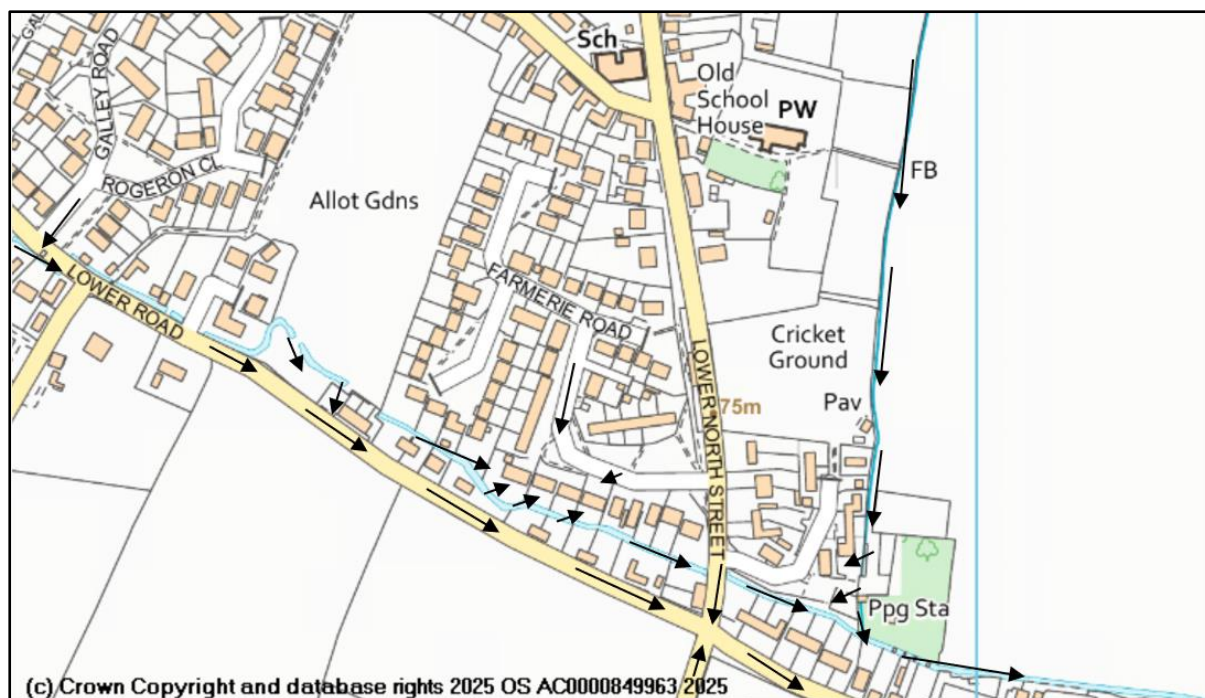
Figure 13. Approximate flood water flow routes on Lower North Street, Lower Road and Farmerie Road

On the morning of 20 October, intense rainfall caused vast amounts of floodwater to enter the watercourses above Hundon and flow towards the village. Large quantities of floodwater flowed in a southerly direction down the ditch to the east of Lower North Street and at the rear of the properties. Multiple properties and the car park in this area were flooded directly from the overwhelmed ditch as the flow of water exceeded the capacity of the ditch (see Figure 13).

Residents have reported that the flow of the floodwater in the ditch was hindered by overgrown vegetation in the channel and a potentially blocked culverted section of the watercourse. Figure 14 shows the yearly chance of surface water flooding on Lower North Street.

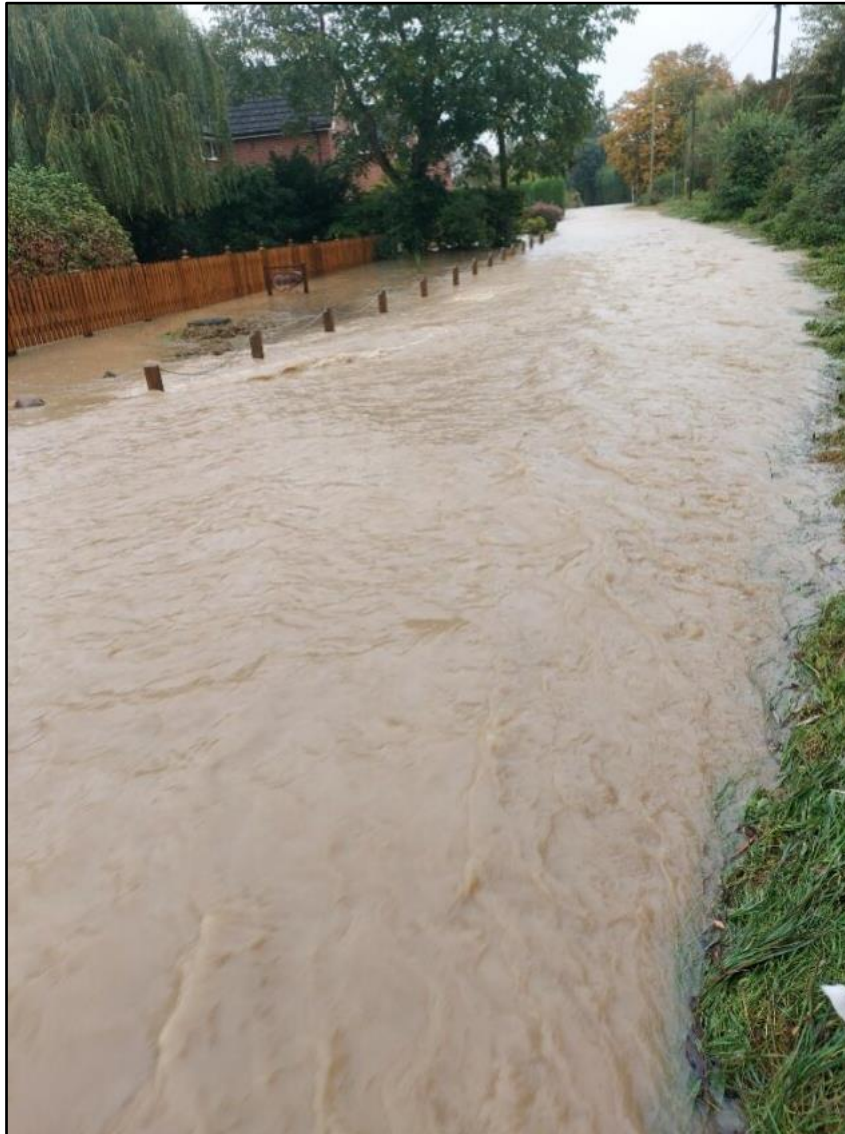
Image 1. Flooding on Valley Wash

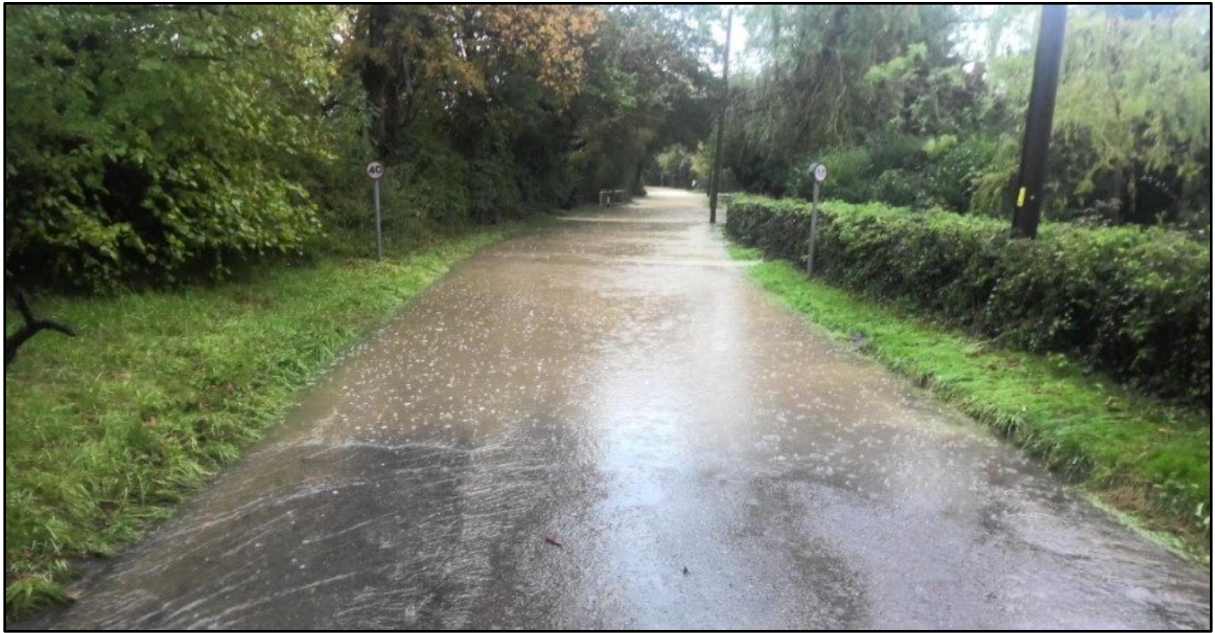
Image 2. Flooding on Valley Wash near Chilton Brook

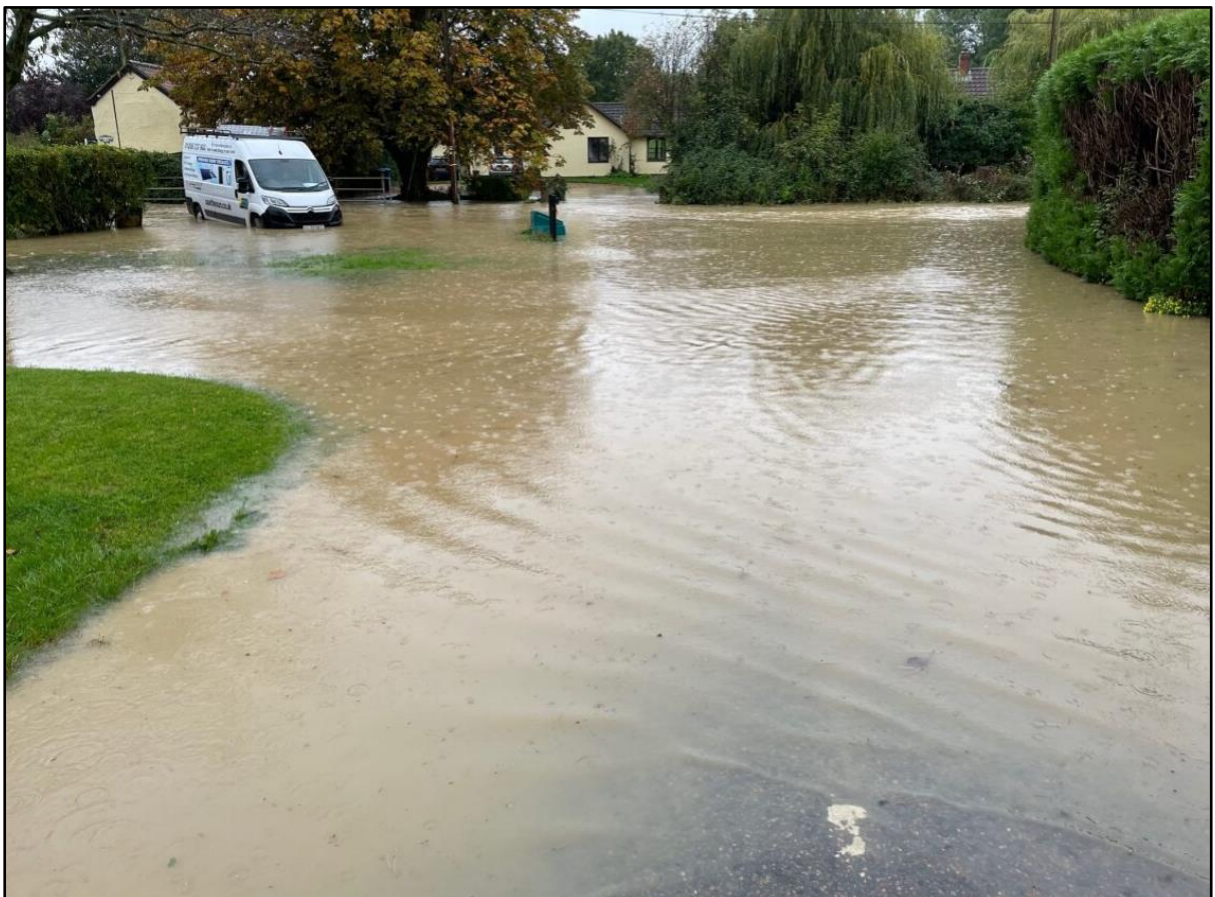
At the Galley Road junction with Lower Road, floodwater depths of up to 30cms were observed (see Image 3). At the junction of Lower Road and Lower North Street the flood water had a maximum depth of approximately 1m (see Image 5). There have been reports of a blocked and/or damaged pipe below the crossroads prior to and after Storm Babet. Floodwater has been observed flowing out of a kerb offset onto the highway whilst the ditches are full of water and not flowing away under the road junction as normal.

Image 3. View from Galley Road towards Lower Road

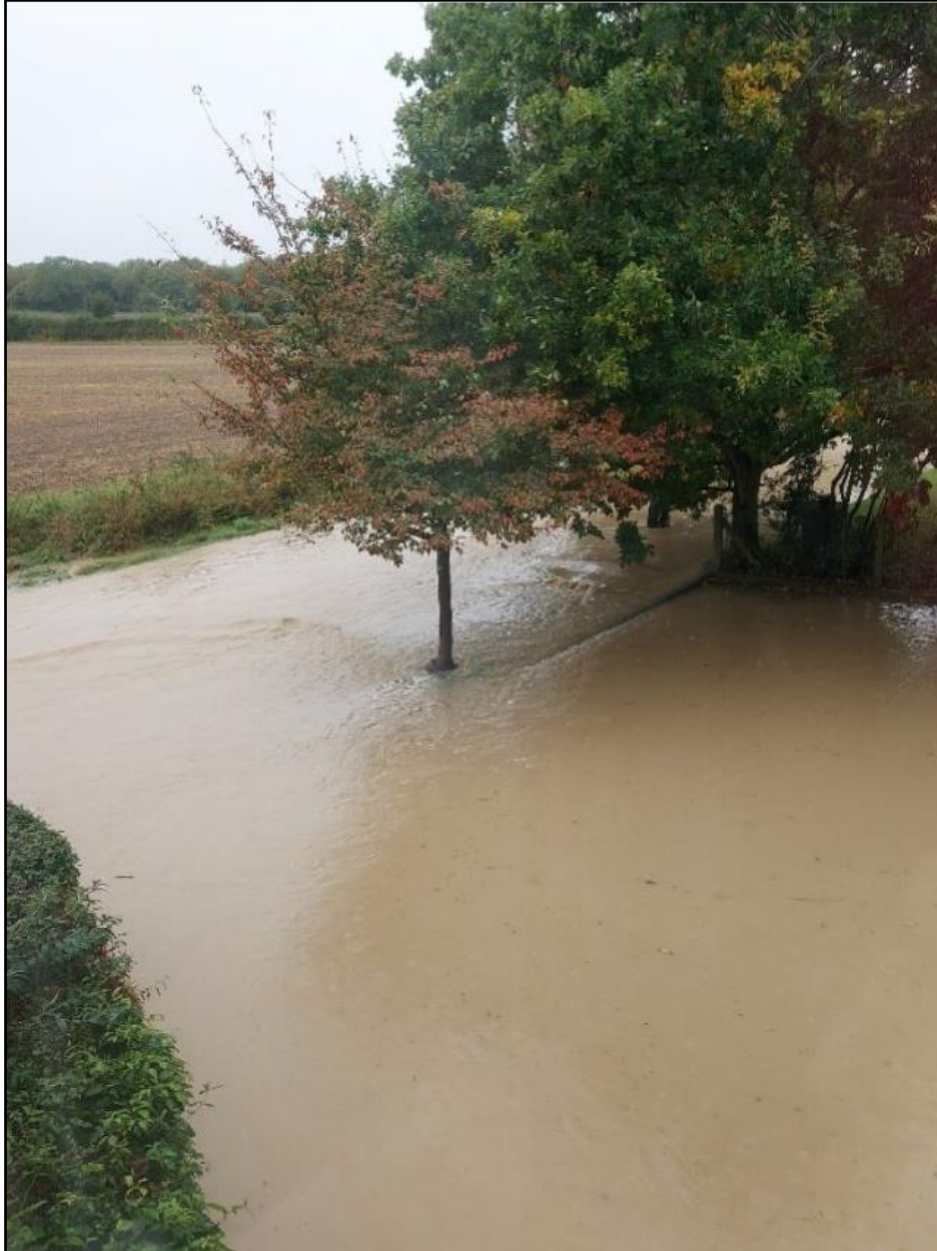
Wash and Lower Road were both flooded with fast flowing floodwater along almost their complete length (Image 4).

Image 4. Flooding on Lower Road

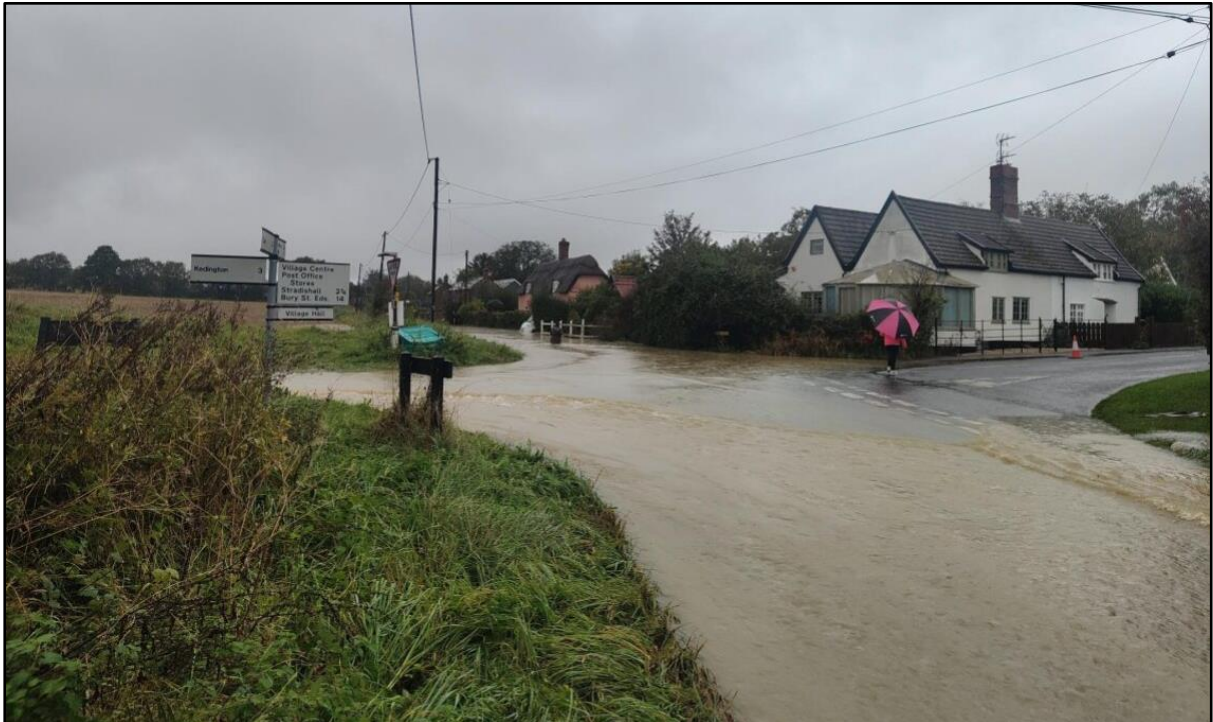
Image 5. Lower Road and Lower North Street Junction

- Suffolk Highways to investigate highway drainage assets at the crossroads of Lower North Street and Lower Road following reports of a blocked and/or damaged pipe below the road.

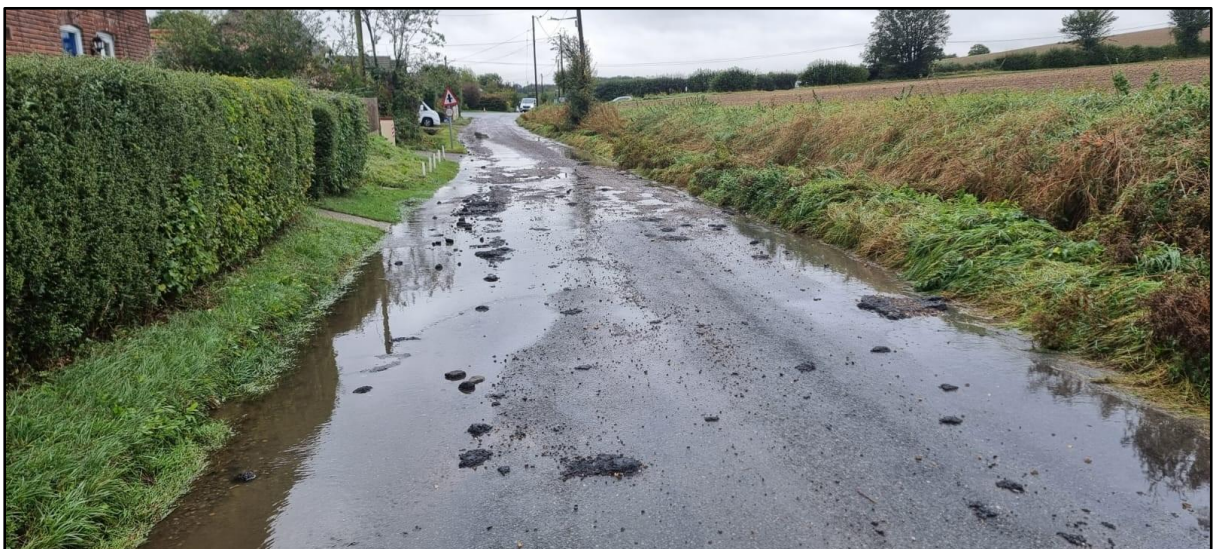
Image 6. Lower road after Storm Babet
