Section 19 Flood and Water Management Act 2010

Report Title: Garrison Lane, Felixstowe

CRNos. 325731, 326167

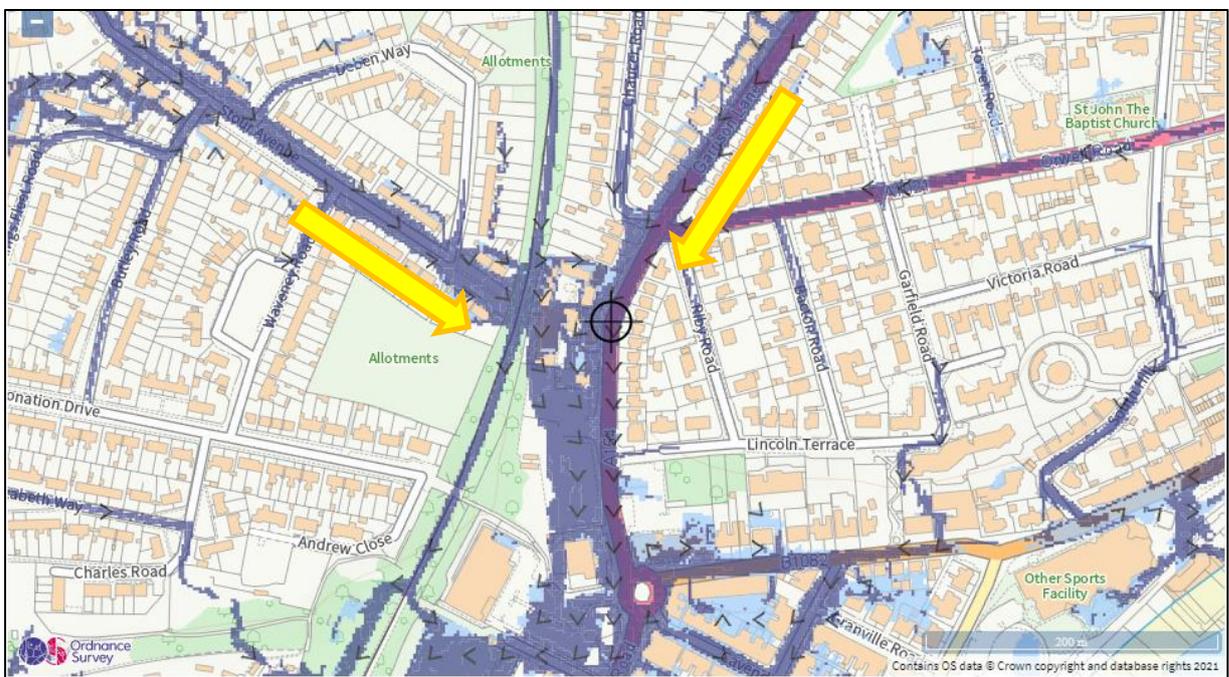
Figure 3 - Surface water flood risk: water velocity in low-risk scenario (main flow paths denoted by yellow arrows)

An extract of the pluvial flood mapping is shown below for reference. This demonstrates the direction and speed of flow during the worst-case scenario. Dark blue is flows over 0.25m/s with light blue denoting speeds of less than 0.25m/s. The small black arrows denote direction of flow. The cross hairs marker indicates the centre of the postcode area which was flooded.

The flow path down Stour Avenue and across the railway line, and the second flow path along Garrison Lane can clearly be seen in the above extract (yellow arrows). It is understood that these are the main contributing sources of surface water which inundated the properties.

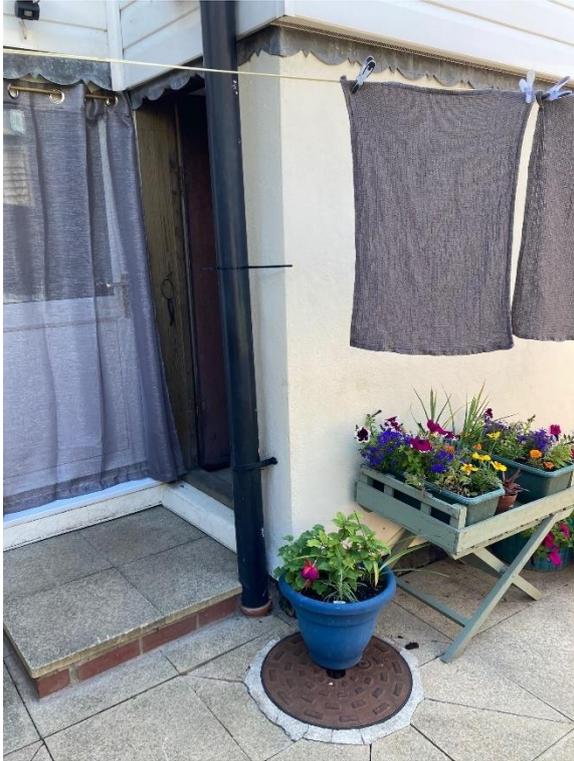
Flood depths within the basement areas reached 1.5m externally and over 0.6m internally. Bedrooms are located on upper floors and so safe refuge was available for the occupants temporarily until they could be rescued from the upper floors.

Depth of flooding externally adjacent semi-detached properties, marked by cable tie on downpipe

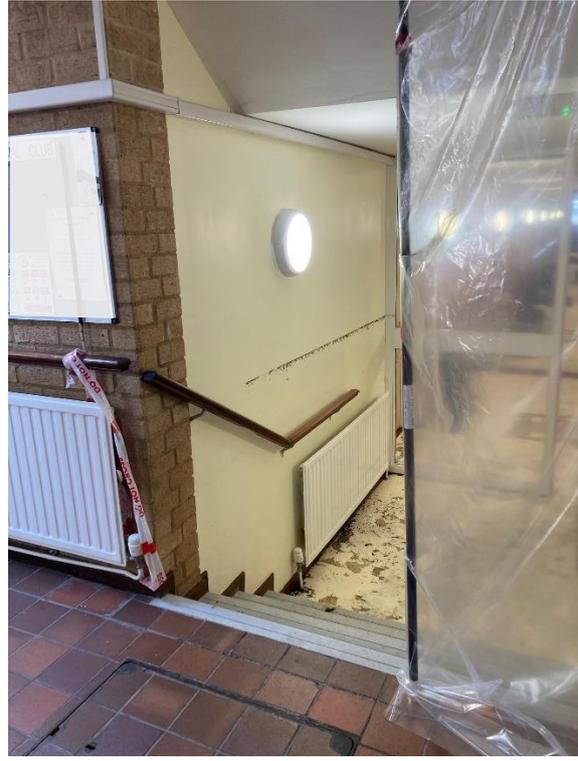
9 No. of the flats flooded internally. 8 No. of these are situated on a slope with ground levels to the rear higher than floor levels and thus experienced depths of flooding internally up to 1.2m within the access corridor and up to 0.6m in the flats. This resulted in deployment of the emergency services to pump out standing water and evacuate 12 No. residents. The 9th flat also experienced internal flooding but to a lesser extent due to its slightly elevated position.

Depth of flooding internally within the corridor serving the retirement flats, see watermark

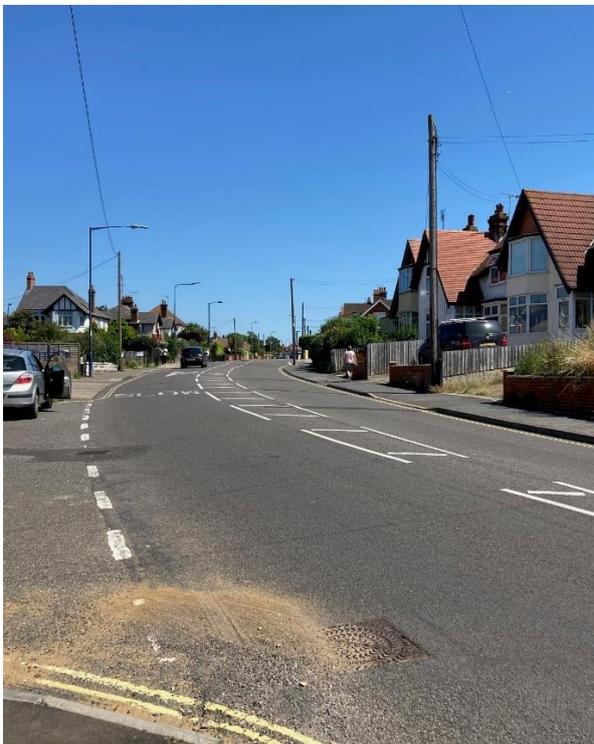
The intense nature of the rainfall resulted in a large volume of surface water flowing down Garrison Lane overwhelming the highway drainage infrastructure and heading southwards towards the properties. Surface water also flowed down Stour Avenue, across the railway line and down the embankment flooding the area from the north-west. Short power cuts were experienced locally.

Looking NE 'up' Garrison Road where surface water flows travelled, sediments/debris carried by floodwater

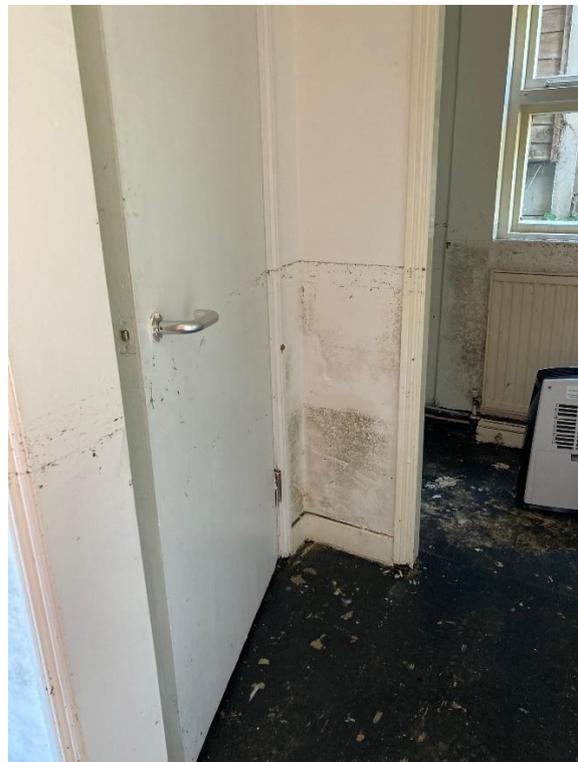
Depth of flooding internally within 'basement' floor of semidetached property, see watermark
