**Lead Local Flood Authority**  
**Section 19 (Flood and Water Management Act**  
**2010)**  
**Flood Investigation Report**

The Street,  
Icklingham

FW2020-0927	FW2016-1766
FW2016-1578

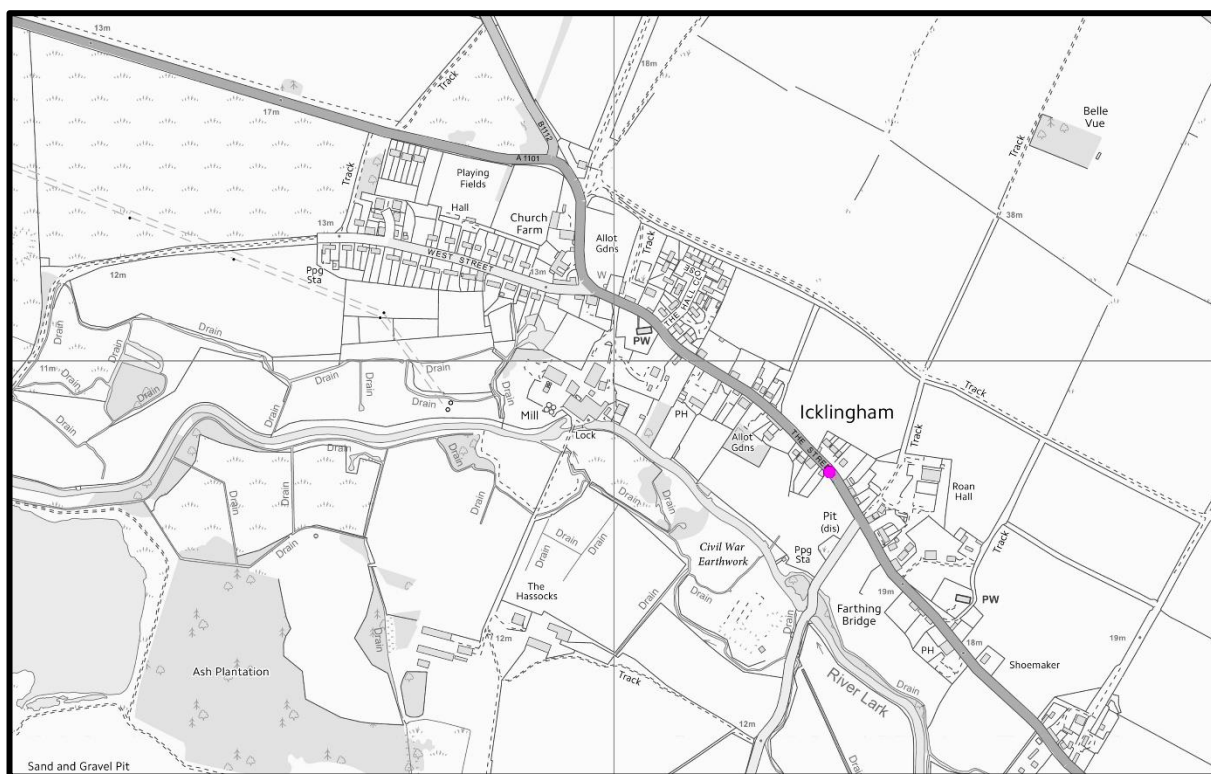
**2.6 OS Grid Reference:** TL 77357 72816

**2.7 Extent of flooding:** Surface water (<0.3m) within 1 property along the southern edge of The Street. Carriageway (A1101) opposite to these properties, also affected by deep surface water flooding.

**2.10 Flooding Source:** An intense, localised storm event on the 17th June and 16<sup>th</sup> August 2020 caused rapid runoff along The Street (A1101). The A1101 is steeply inclined and converges towards a central low point. This low point is then part of a natural overland flow path that runs in a south westerly direction towards the River Lark. Ultimately the property obstructs the natural flow path resulting in pooling of deep surface water in front of the property.
