Section 19 Flood and Water Management Act 2010

Marlesford Flood Investigation –

Storm Babet 2023

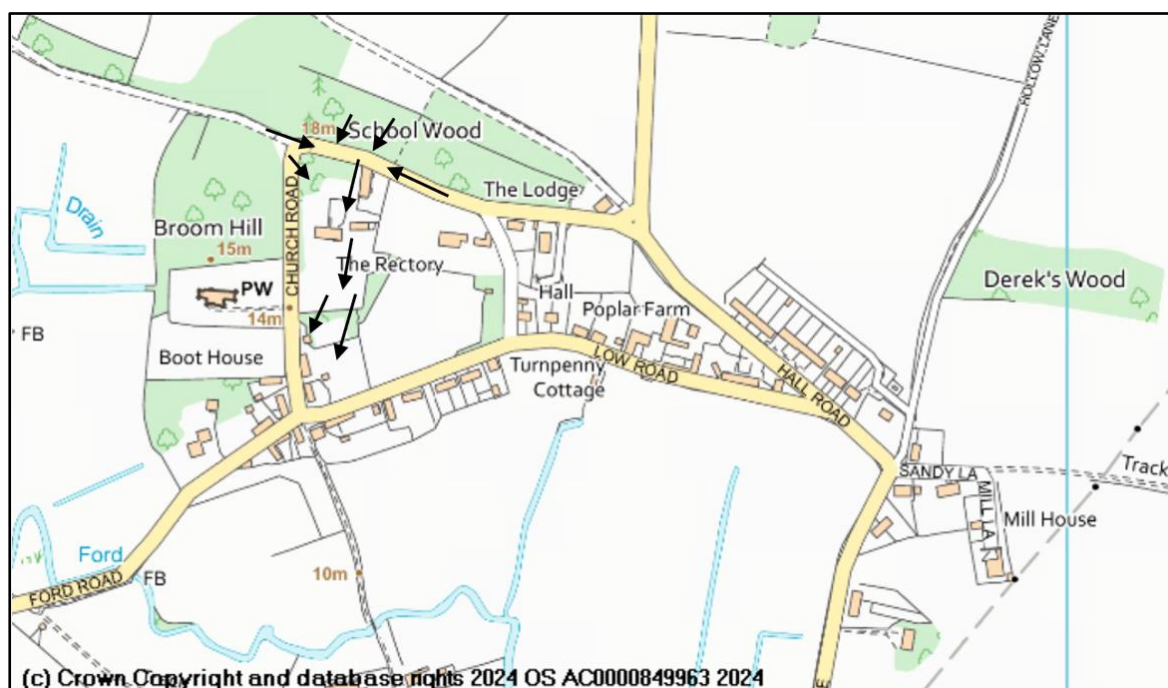
The floodwater flowed south impacting additional properties further south on Church Road (see Figure 10). Residents here described entire gardens submerged as water flooded properties from the front and rear.

Figure 10. Approximate flood water flow routes along Church Road

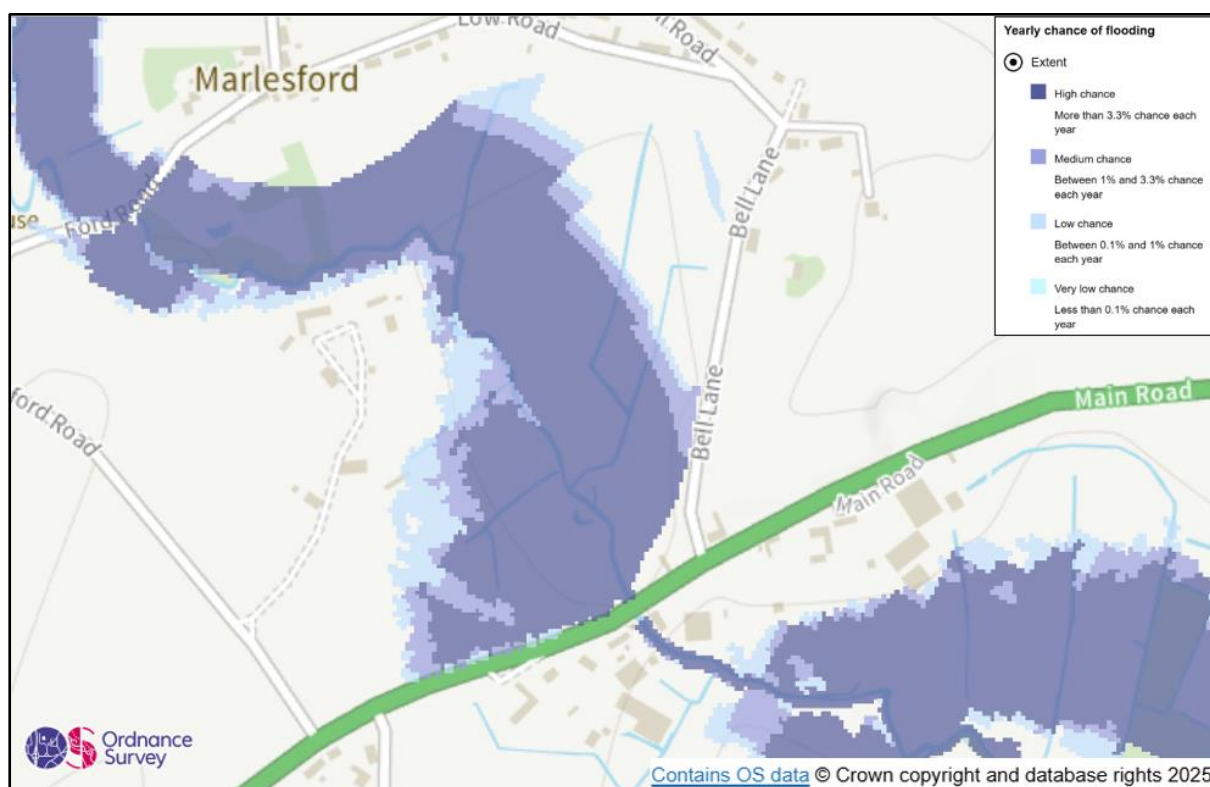
The flooded properties located immediately south of the A12 Main Road are shown to be outside of the fluvial flood risk area (see Figure 13). This may highlight the unique nature of the Storm Babet event in terms of its impact on the ground or possibly indicates an issue with the current flood model at this specific location. When the Environment Agency updates the model, they will look carefully at this location to ensure it is represented correctly.

Figure 13. Fluvial flood risk next to Main Road and Bell Lane

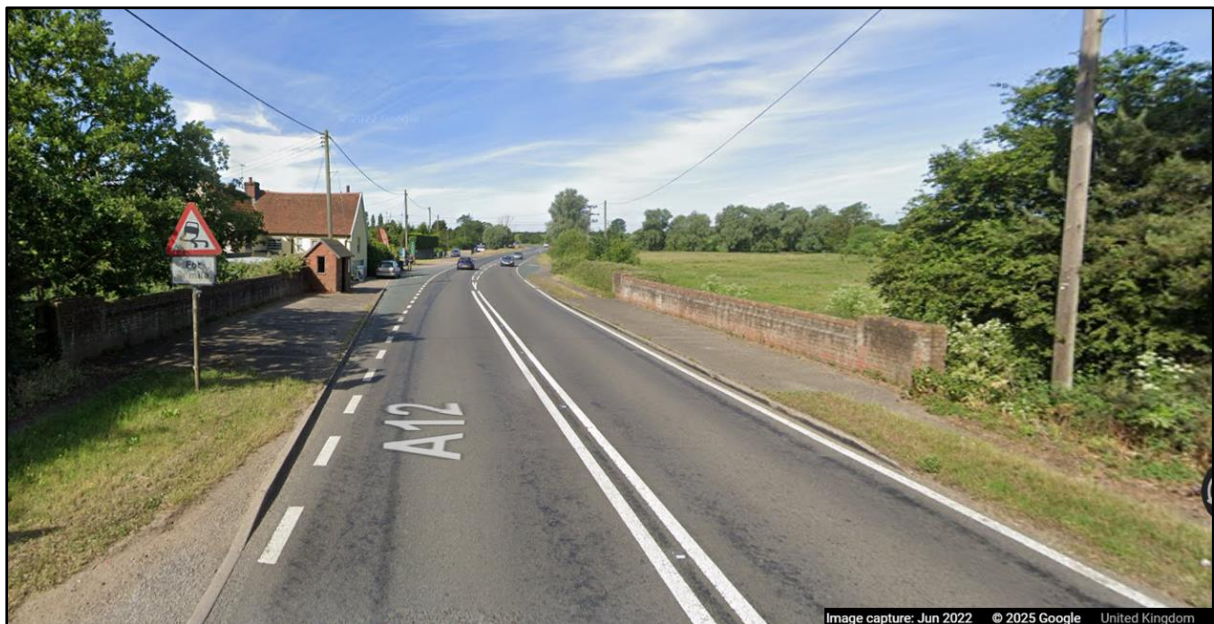
The section of the A12 next to the road bridge (see Image 2) over the river Ore was flooded. The floodwater is reported to have come off the Main Road towards adjacent properties. Floodwater also backed up and impacted nearby properties as the swollen river Ore also overtopped south of the Main Road (see Image 4) adding to the extent of the flooding.

The floodwater on the highway was slow to drain away, as the highway gullies were blocked up with mud and silt washed in with all the surface runoff during the storm. Prior to Storm Babet the highway drainage assets in this vicinity were cleaned and assessed to be operational in July 2023.

Image 2 - A12 road bridge over the river Ore

- Suffolk Highways to ensure the completion of highway drainage asset cyclic maintenance on Bell Lane and the A12 Main Road through Marlesford.
- Improved understanding of fluvial flood risk within the village through updates to the river Ore hydraulic modelling.

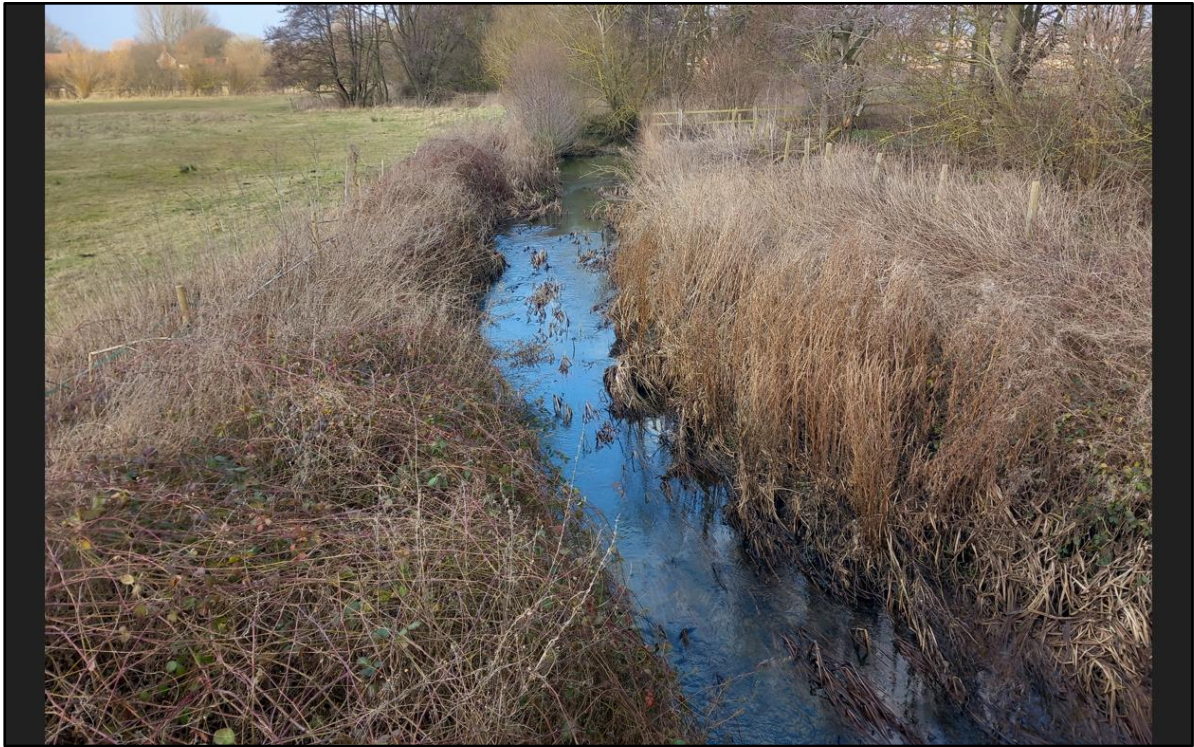
Following heavy rainfall on the morning of 20 October, extreme water levels flowed down the river Ore from the catchments upstream of Marlesford. From late morning onwards, the swollen river levels exceeded the capacity of the channel and floodwater flowed across the floodplain between the village centre and the A12 Main Road (see Figure 12). Some properties in this area were flooded directly from the overwhelmed river Ore with residents citing the sheer amount of rain and runoff from the surrounding fields.

Image 3 - River Ore looking upstream from A12 road bridge

- Residents to install Property Flood Resilience (PFR) via grant funded scheme.
- Explore potential NFM measures which aim to attenuate water and 'slow the flow' on overland flow paths in the upper catchments above Marlesford e.g. storage ponds, wetland areas, leaky dams, woody debris installation and restoration of watercourses.
- The EA to investigate if there is flood risk benefit to carrying out in-channel maintenance of the river Ore through Marlesford adjacent to the A12 road bridge. Where maintenance is undertaken it is to assist with conveyance in regular winter flows and there may be limited benefit in an event the size of Storm Babet.

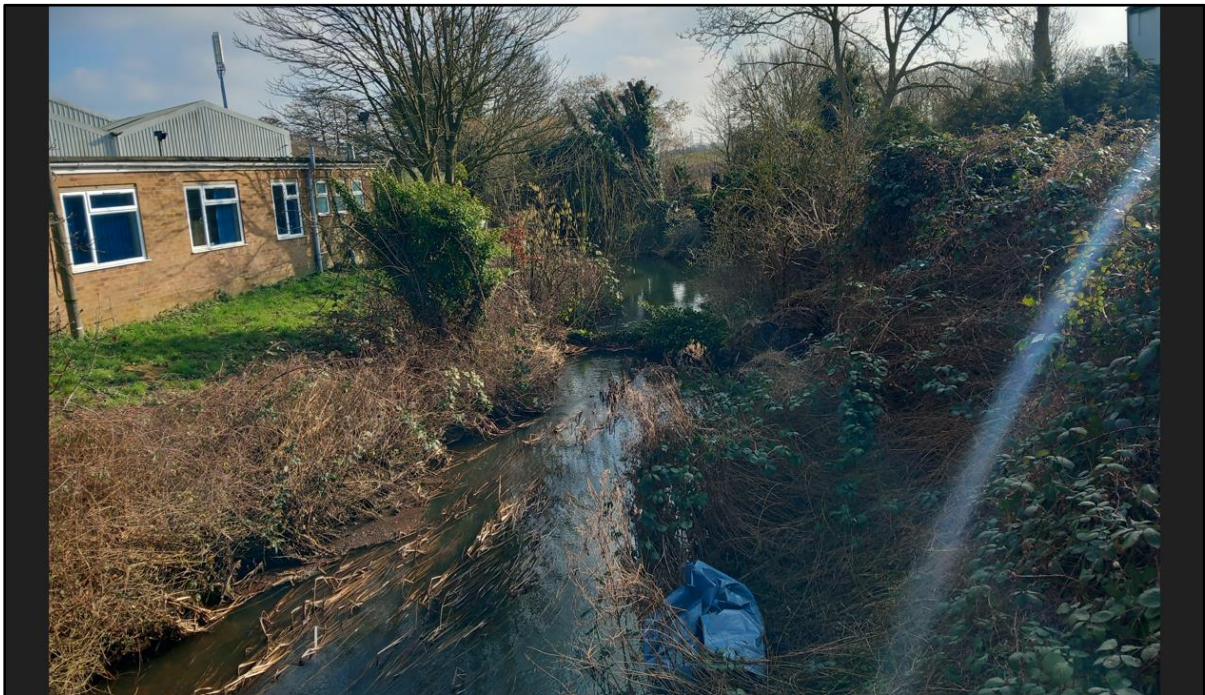
Image 4 - River Ore looking downstream from A12 road bridge
