Section 19 Flood and Water Management Act 2010

Needham Market Flood Investigation – Storm Babet 2023

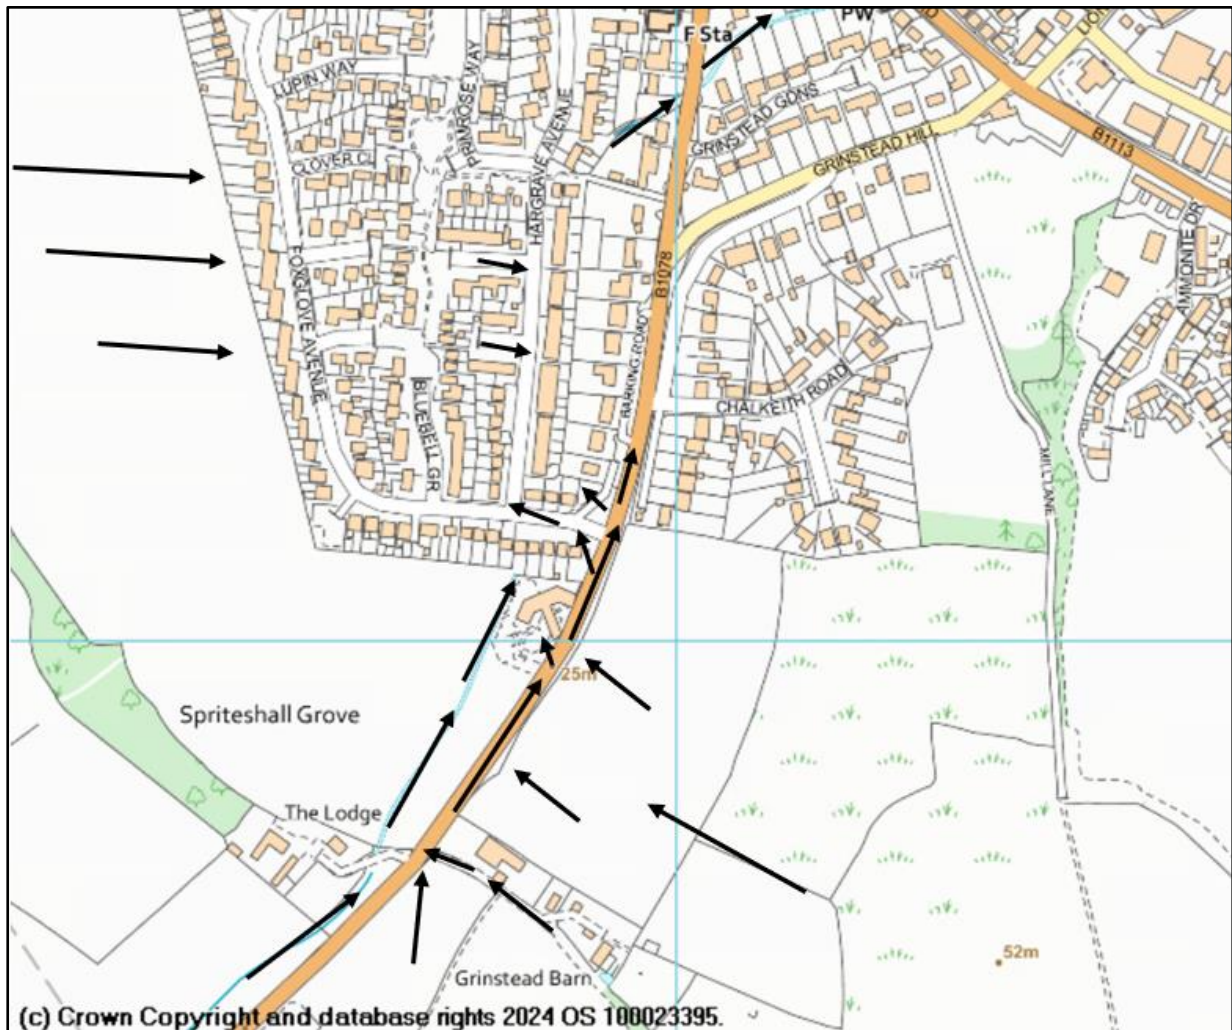
Figure 10 - Approximate floodwater flow routes on Barking Road, Foxglove Avenue, Hargrave Avenue and School Street

On the morning of 20 October 2023, a number of tributaries in the rural upper catchment directed water into the town. Floodwater flowed along Barking Road towards Foxglove Avenue originating from fields to the east around Grinstead Barn, before emerging onto the carriageway. There were additional overland (surface water run-off) flow paths merging onto Barking Road from fields to the south either side of Priestly Wood close to Barking. Outside the pharmacy entrance on Barking Road, water was starting to pool from 09:00am onwards and by 11:00am water was observed to be coming into the car park from the road (Image 1).

Water was also arising from a surcharging manhole at the entrance to the Grinstead Barn turnoff. Additionally, an inspection chamber in the field to the west of Barking Road was blocked and added to the floodwater flowing along the road. Since Storm Babet, there have been additional reports that water is still surcharging from the area near the entranceway to Grinstead Barn and flowing north-eastwards along the Barking Road and towards Foxglove Avenue. Suffolk Highways are aware of the issues at this location. Jetting and initial investigations have already happened, and further actions are planned to be carried out.

Properties near to the junction of Foxglove Avenue and Barking Road were impacted by water entering Foxglove Avenue from Barking Road later in the morning. A drop kerb immediately south of the junction created a low entry point from the road (Image 2). This low point allowed water to pass onto Foxglove Avenue at a quicker rate and bypass a raised traffic calming road bump on Foxglove Avenue close to the junction with Barking Road. Properties at this location were also flooded internally in early January 2024 during Storm Henk.

- Investigate potential NFM projects to 'slow the flow' and attenuate water on overland flow paths (leaky dams, restoration of watercourses, etc.) to the west and south of Needham Market.
- Explore options to reduce the field run off from the west of Foxglove Avenue. Possible use of a vegetation strip / break, bund or ditch between field and properties.
- Investigate the potential to raise the dropped kerb on Barking Road.
- Investigate the drainage problems below Barking Road near Grinstead Barn
- Ensure a maintenance regime is in place for the entrance to the Anglian Water culvert upstream Hargrave Avenue. A CCTV survey to be conducted.
- Investigate highway drainage infrastructure to ensure capacity and condition are sufficient.

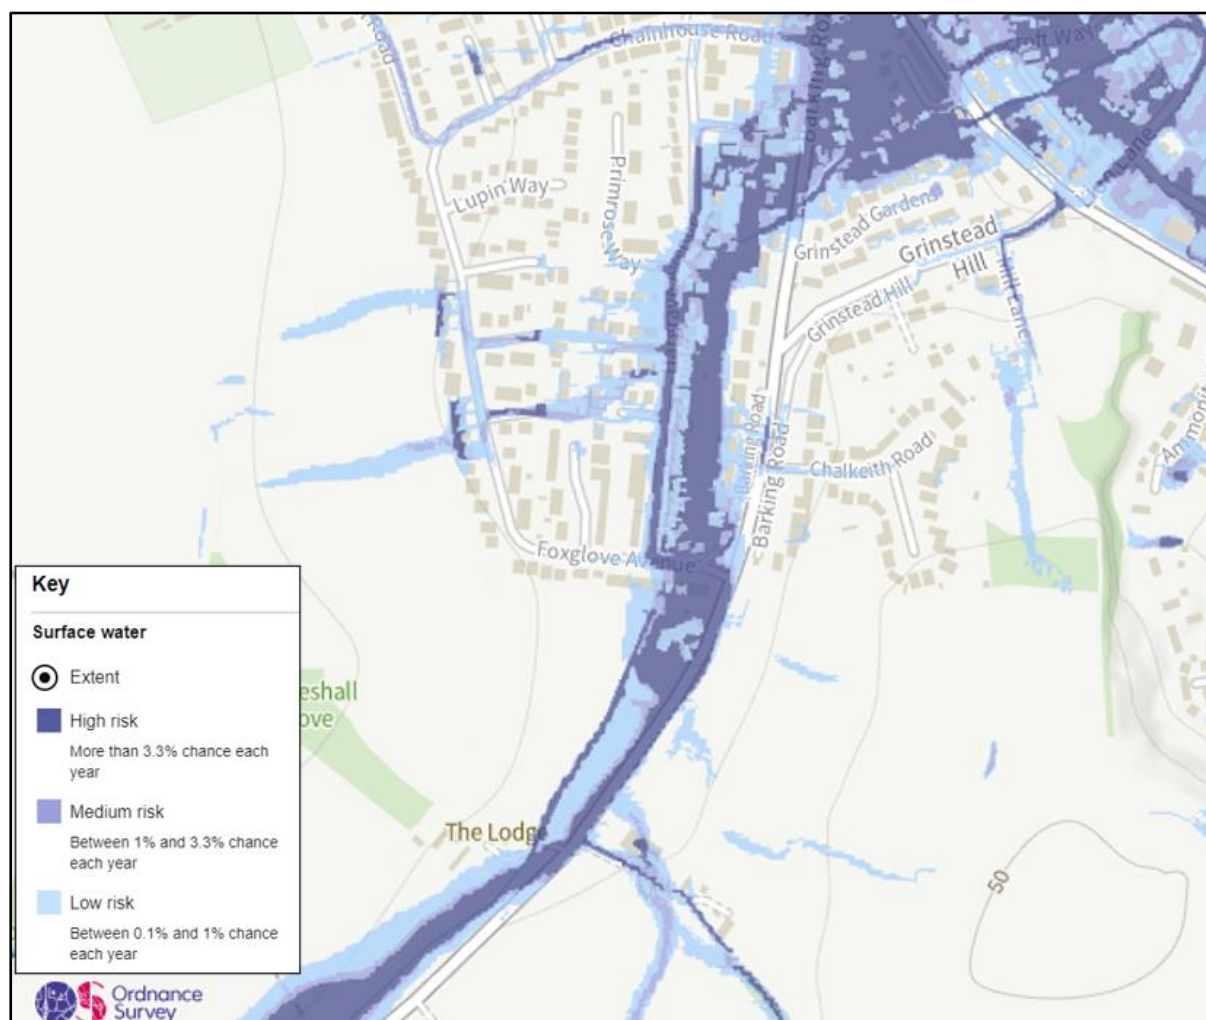
Figure 11 - Predicted Pluvial Flood Risk, Barking Road and Foxglove Avenue

Several properties along Foxglove Avenue were reported to have flooded from the fields to the west, at the rear of the properties. Local reports coupled with LIDAR imagery of the field, indicate the field slopes to the east funnel the surface water runoff towards the affected properties. This happened in the early hours of 20 October from around 03:00 am onwards. This closely matches the flow paths and extents shown in the predicted surface water flood risk mapping (Figure 11).

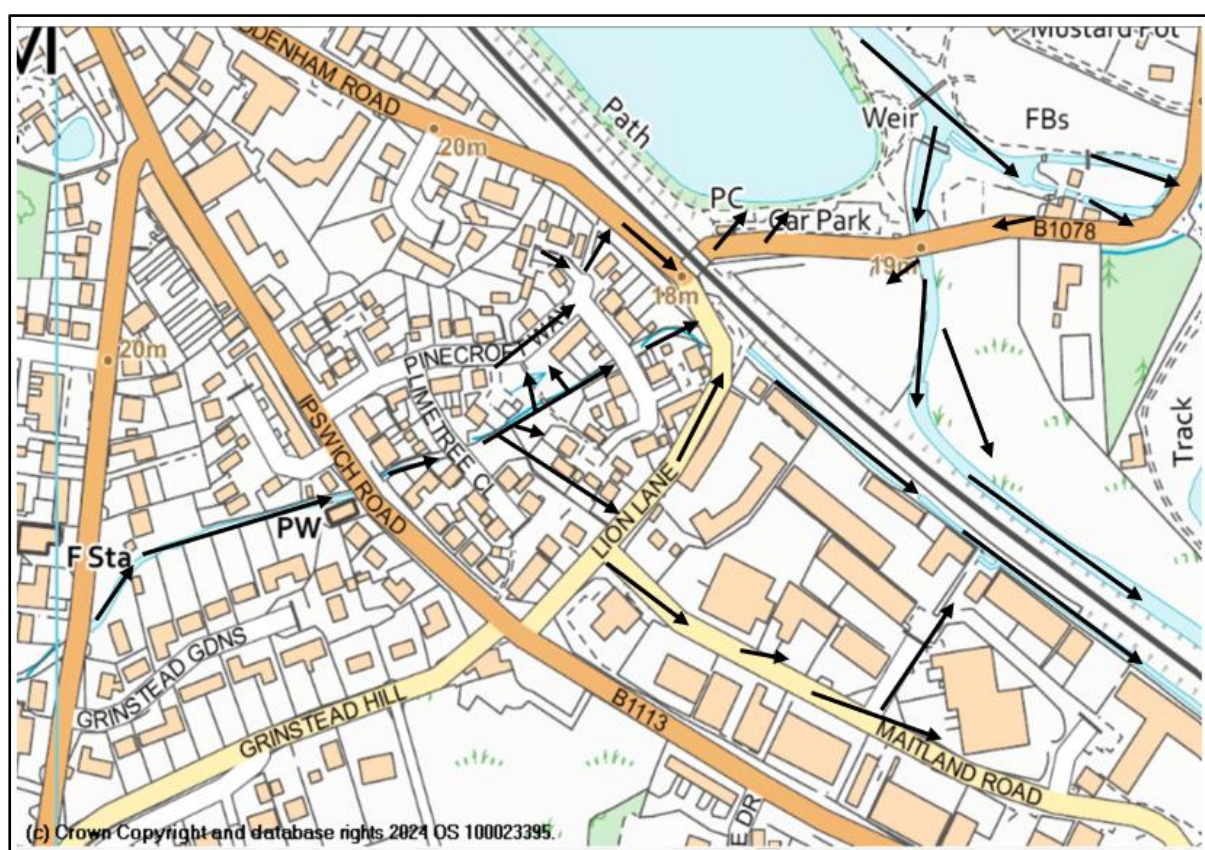
Figure 12 - Approximate floodwater flow routes on Pinecroft Way, Lime Tree Close, Lion Lane, Maitland Road and Coddendam Road

There were multiple flow pathways for the floodwater to travel across Pinecroft Way once water levels in the channel rose above the banks, resulting in water leaving the channel. Some of the floodwater flow paths followed the course of historic ditches and ponds that existed on the land prior to the housing estate. The channels and ponds have historically been infilled to aid the construction of the estate in the early 1980's. Historic maps that precede the development of Pinecroft Way show the alignment of a ditch and associated pond. It is this pathway that flooded properties on Lime Tree Close before flowing onto Lion Lane. Over time the ditch infill material has settled and created low spots in the landscape over which the floodwater could flow.

Floodwater overtopped the northern bank of the watercourse flooding properties on the northern side of Pinecroft Way and overtopped the southern bank flooding properties on the southern side of Pinecroft Way and Limetree Close (Images 4 & 5). It also backed up onto Lion Lane through another unflapped outfall, merging with floodwater on the corner with Coddensham Road from the railway bridge direction and then into Maitland Road, affecting buildings on the Lion Barn industrial estate (Image 6).

- Investigate potential NFM projects to 'slow the flow' and attenuate water on overland flow paths (leaky dams, restoration of watercourses, etc.) to the west and south of Needham Market.
- Fit non-return flaps on the outfalls along the Lion Barn drain through Pinecroft Way.
- Investigate capacity of the culvert under Lion Lane / Coddendam road corner. Carry out a de-silt / cleanse if required.
- Investigate options to enhance the flood risk benefit of the bund between Pinecroft and Coddendam way to allow drainage from the estate and defence from flooding from the main river Gipping.
- Investigate highway drainage infrastructure to ensure capacity and condition are sufficient.

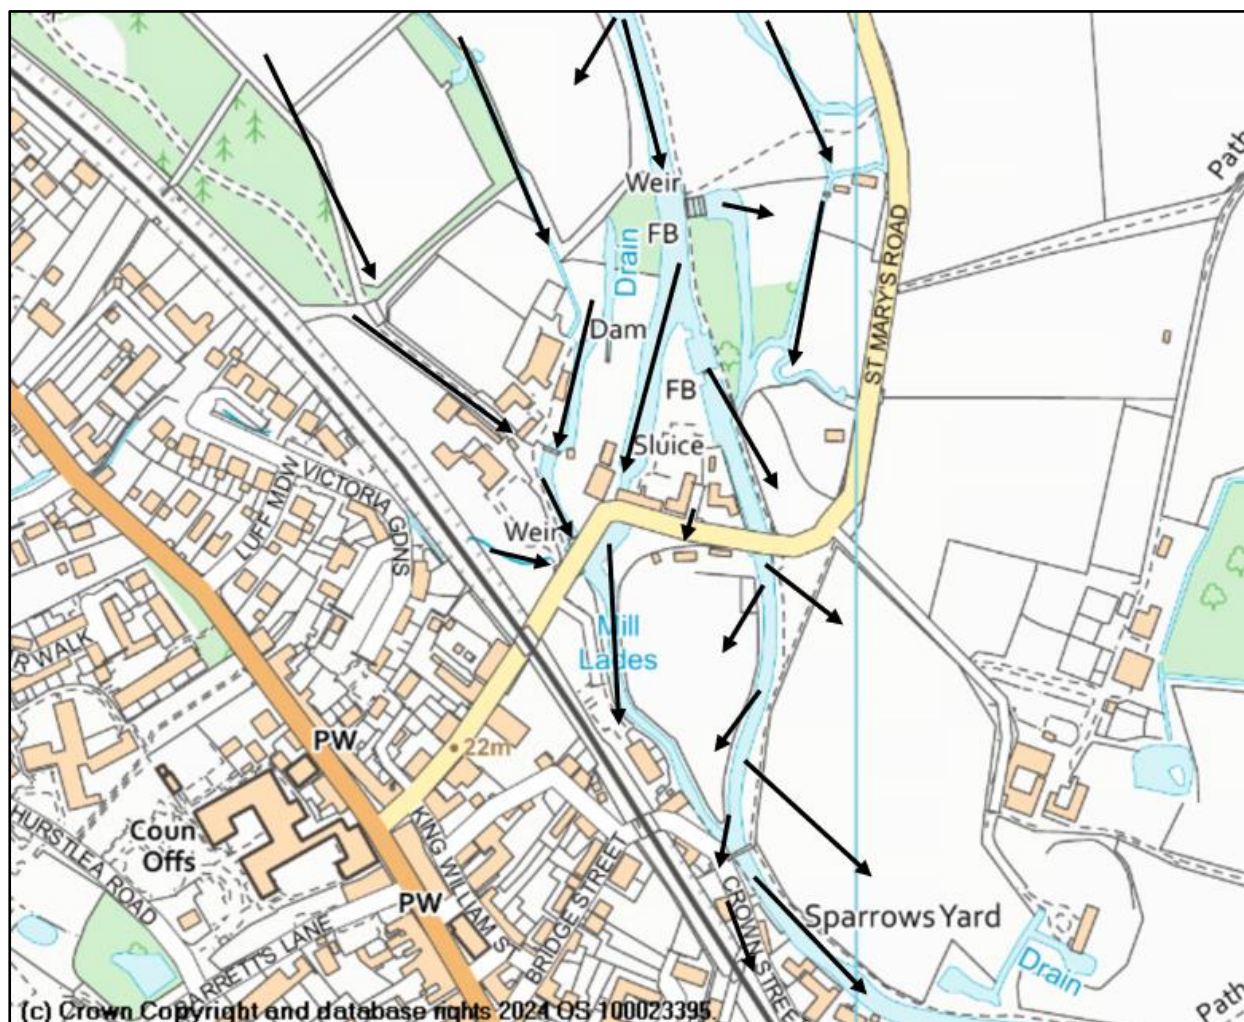
Figure 13 - Approximate floodwater flow routes on High Street, Hawks Mill Street, St Mary's Road and Crown Street

The primary source of flooding in the Hawks Mill and St Mary's Road area was fluvial flooding, with flood water from the river merging with overland flows already on the fields and roads. The banks of the River Gipping overtopped upstream of Hawks Mill and combined with surface water flows and river tributaries coming across the fields from the Northwest. This meant much of the River Gipping flood plain was inundated and remained in flood for a considerable period of time (Image 8). The sluice gate

The Orchard Gate watercourse travels from Victoria Gardens and discharges into the Hawks Mill millpond via a highways culvert. The culvert, feeding into Hawks Mill millpond (marked Mill Lades in Figure 14) was found to be blocked with building material and watercourse debris. This restricted the flow and backed up water towards the railway embankment and the bottom of Victoria Gardens. Witness reports highlighted significant flows coming through the culvert below the railway embankment

- Investigate potential NFM projects to 'slow the flow' and attenuate water on overland flow paths (leaky dams, restoration of watercourses, etc.) to the west and north of Needham Market.

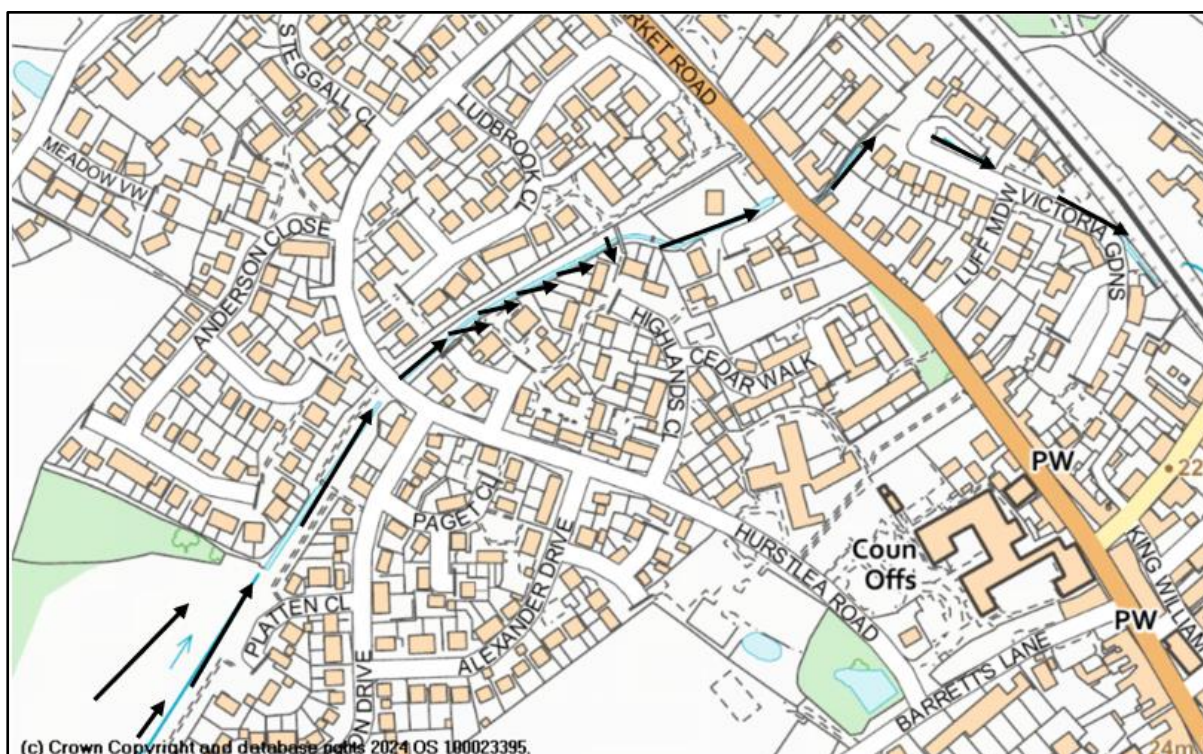
Figure 14 - Approximate floodwater flow routes on Highlands Close and John Swain Close

Flooding was likely caused by a combination of factors; a blockage in the culvert, the tall brick headwall of the footbridge blocking any flow downstream and the elevated height of the watercourse's northern bank. The observed floodwater extents and pathways from the watercourse match closely with the flood extents shown on the national surface water flood risk mapping (Figure 6).

- Investigate potential NFM projects to 'slow the flow' and attenuate water on overland flow paths (leaky dams, restoration of watercourses, etc.) to the west of Needham Market before entering the Orchard Gate watercourse.
- Ensure there is a channel maintenance regime in place for the upper section of the Orchard Gate watercourse (ordinary watercourse) in the urban areas.
- Ensure any observed blockages to bridges or culverts are reported to the relevant authority and removed.

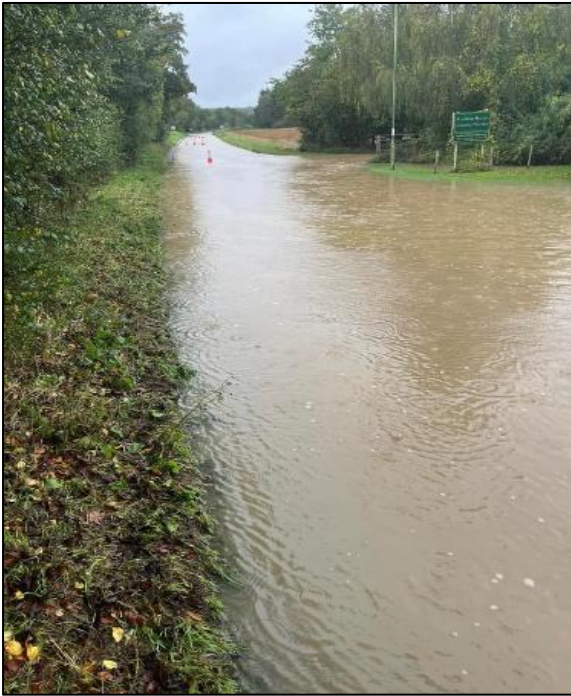
Image 1 - Flooding along Barking Road

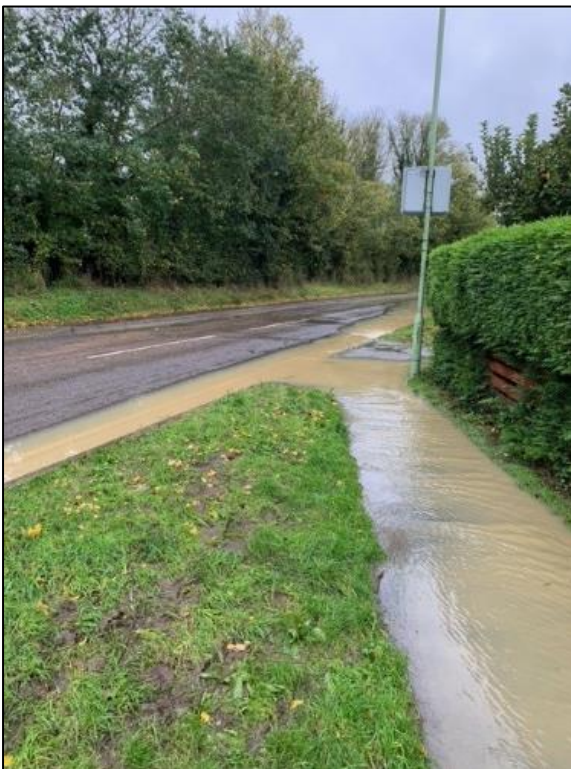
Image 2 - Barking Road floodwater showing flowpath over the dropped kerb

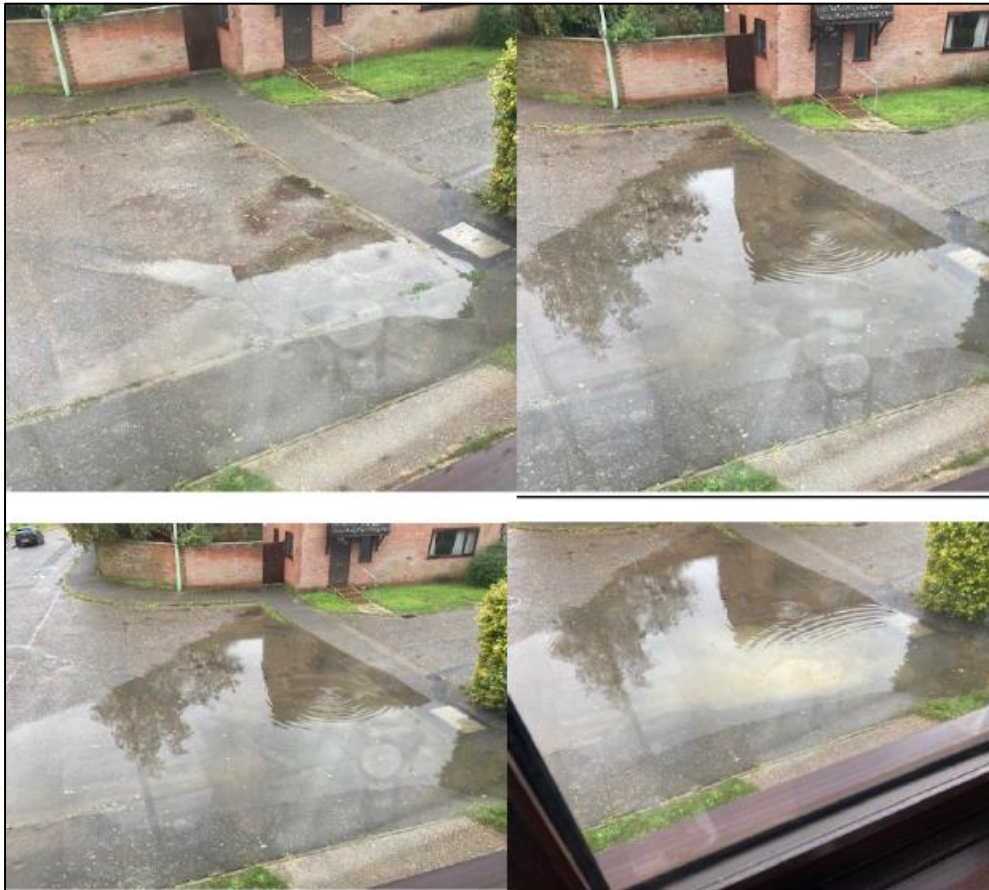
Image 3 - Sequence of flooding from a drainage gully on Pinecroft Way

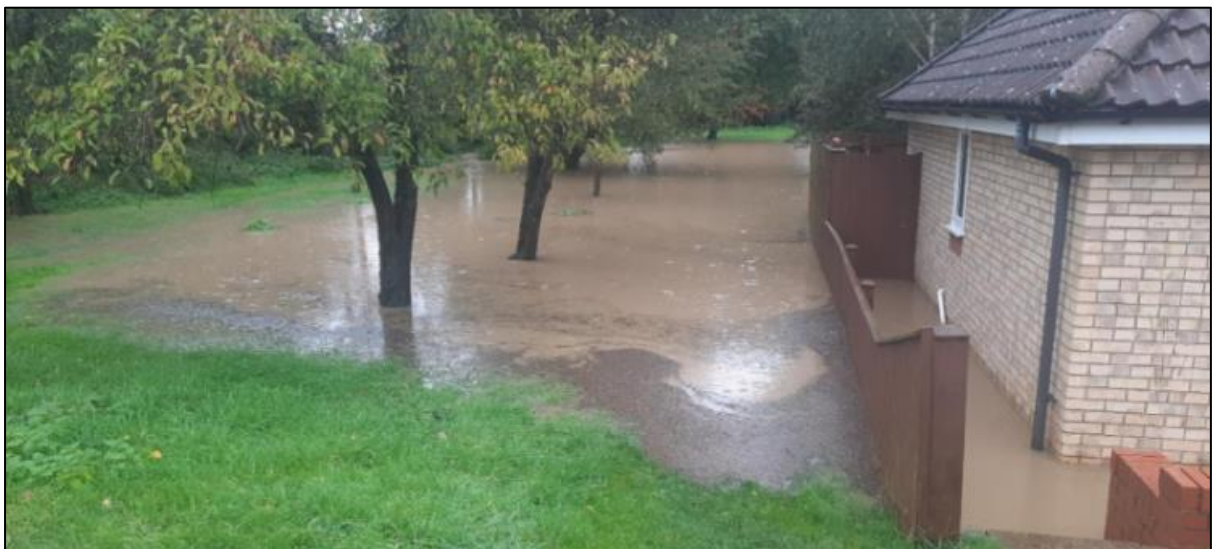
Image 4 - Flooding on Limetree Close next to the Lion Barn drain

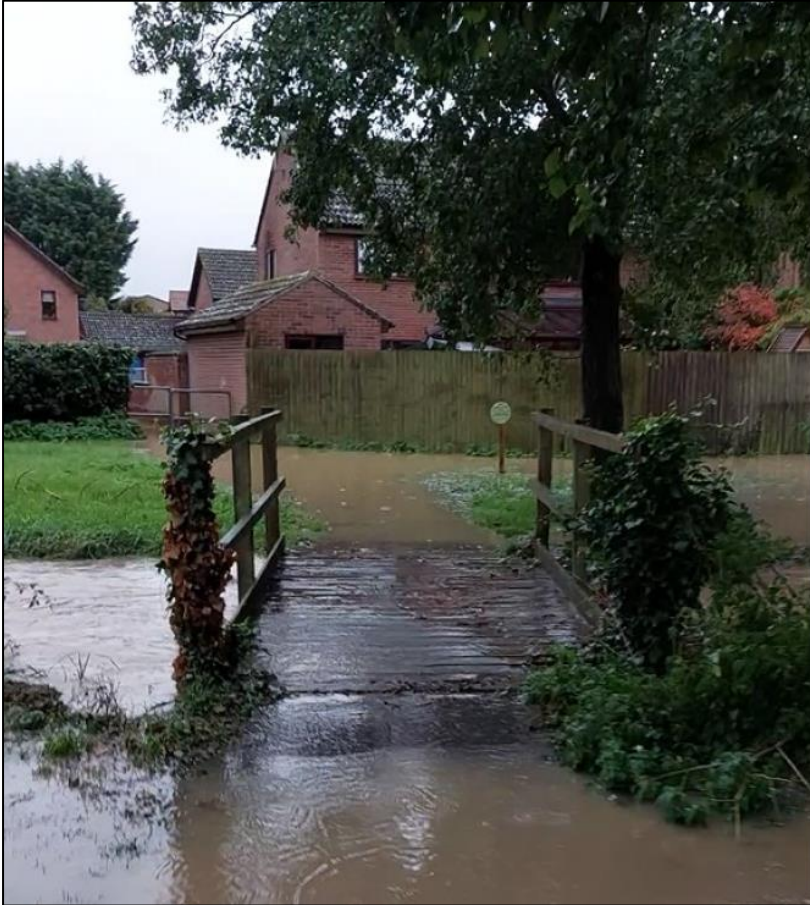
Image 5 - Flooding on Pinecroft Way from the Lion Barn drain

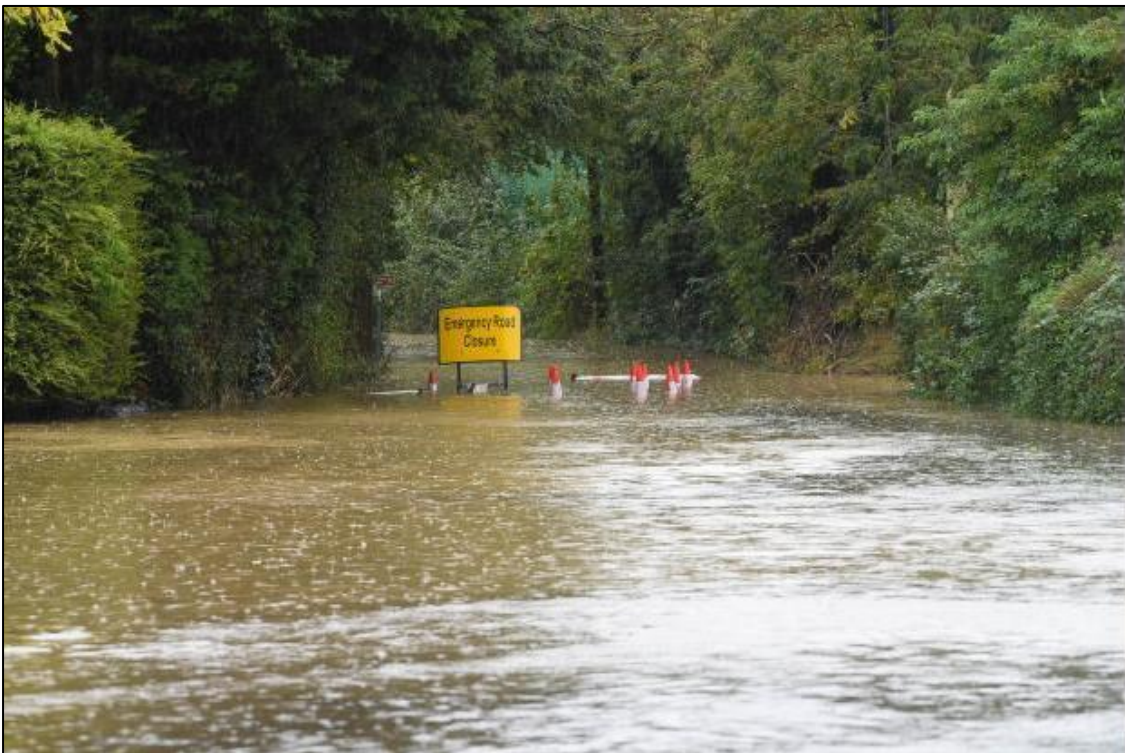
Image 6 - Flooding on Lion Lane

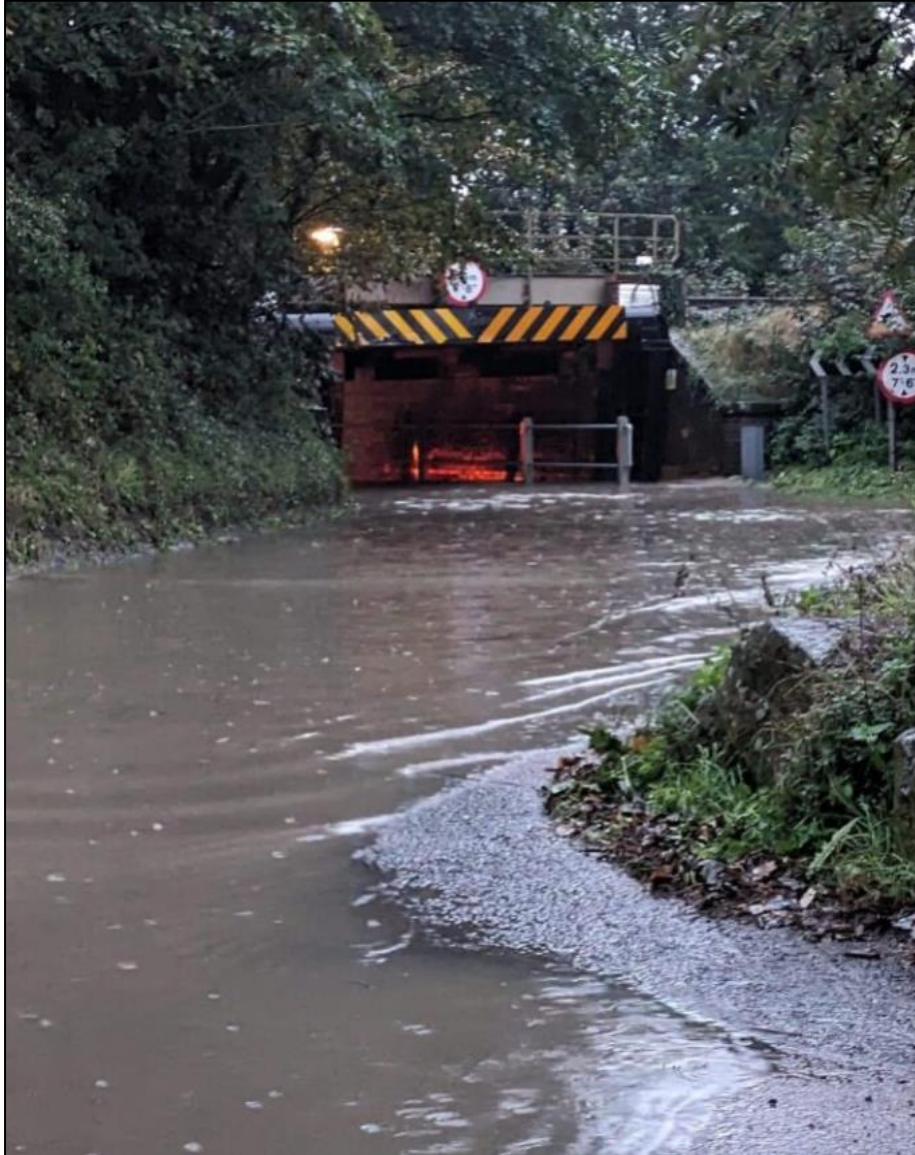
Image 7 - Flooding under Coddensham Road railway bridge

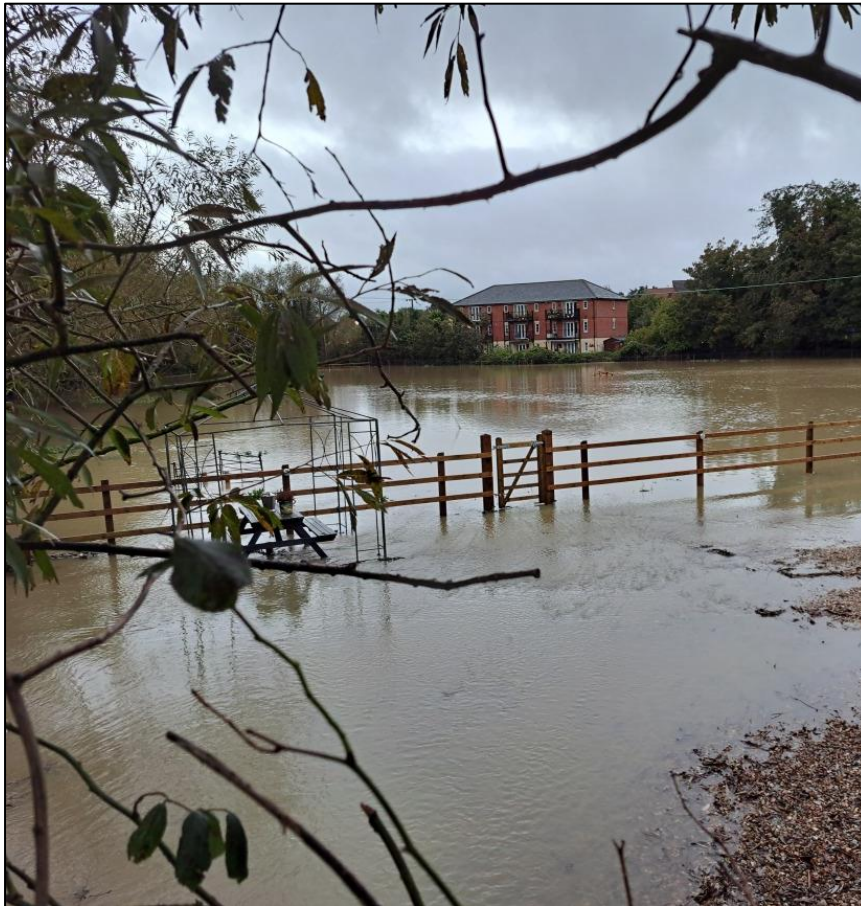
Image 8 - Flooding on Hawks Mill meadow

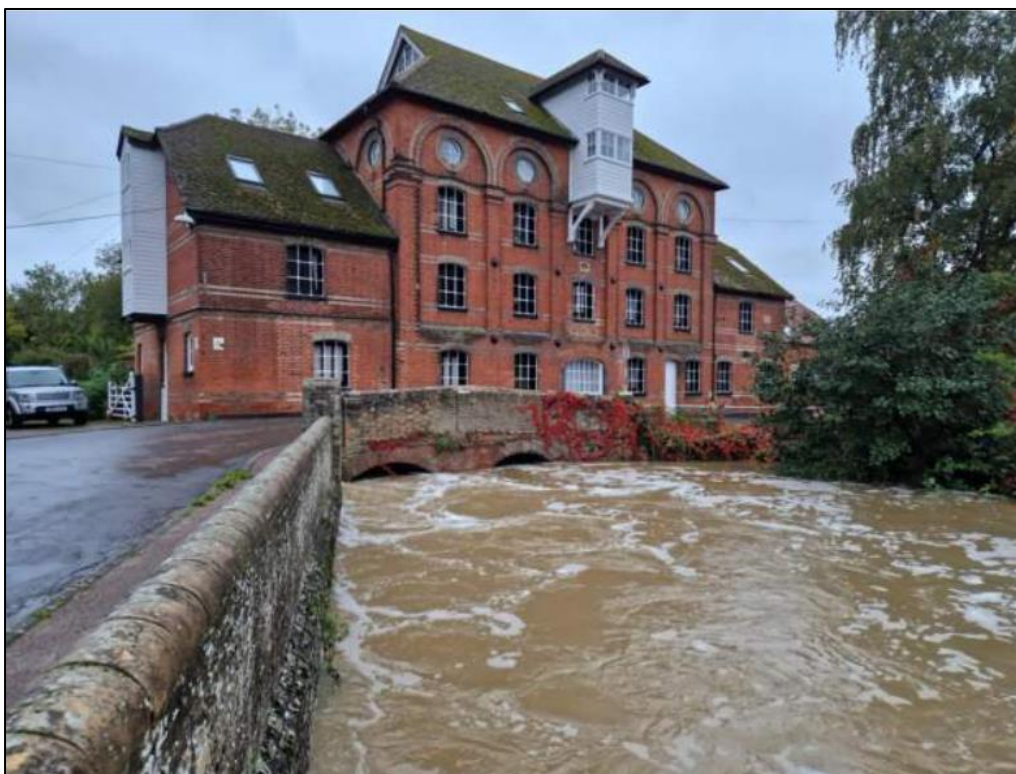
upstream of Hawks Mill which is operated and maintained by the Environment Agency was opened fully and functioned correctly throughout Storm Babet. The privately owned and operated gate below the mill was opened and operated at full capacity also (Image 9).

Image 9 - High river level in the Mill Pond on Hawks Mill Street

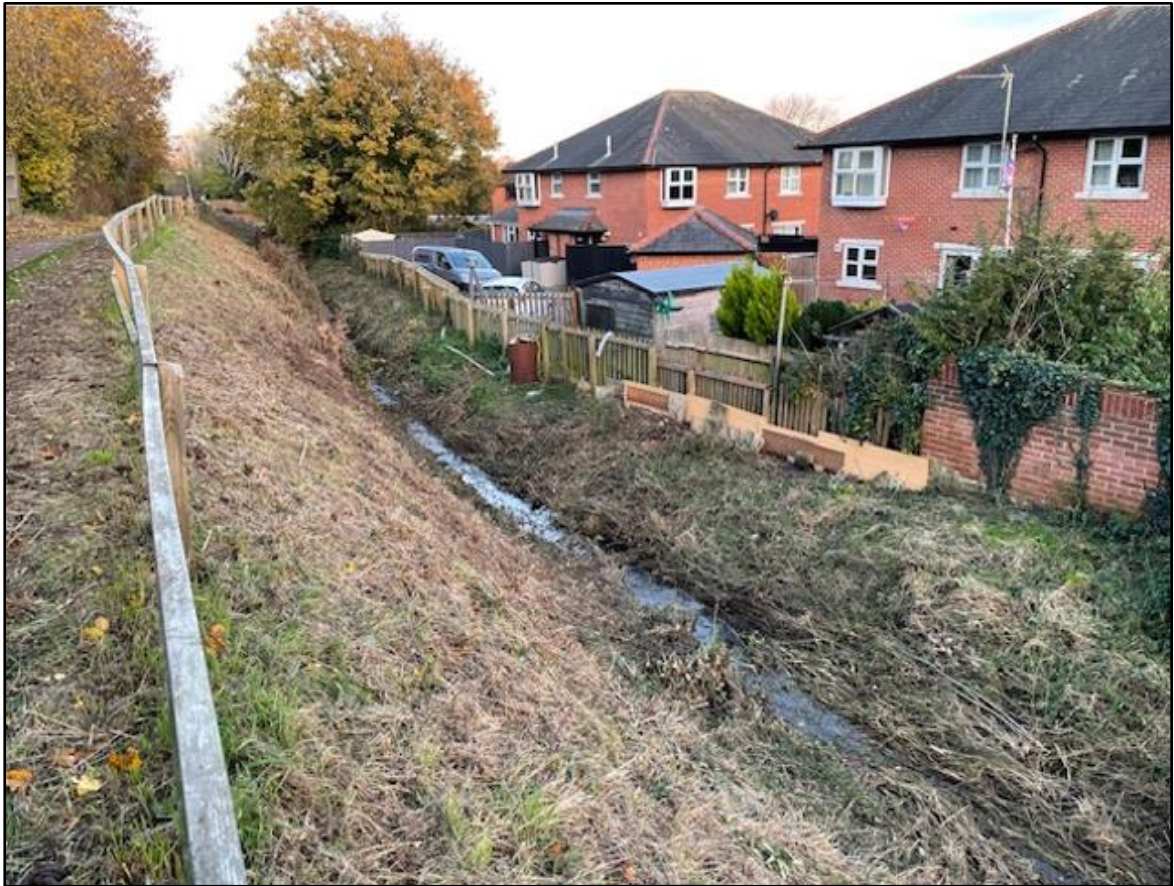
Upstream of the footbridge, the watercourse sits in a deep channel. The northern bank with the public footpath, is much higher than the southern bank. During site visits, Environment Agency officers noted an apparent low spot on the southern bank, potentially providing a flow pathway for the floodwater into the rear gardens on Highlands Close. There is also a low section of the southern bank to the rear of John Swain Close. At this location residents had created makeshift barriers to try to prevent water overtopping from the watercourse into their gardens post Storm Babet (Image 10).

Image 10 - Makeshift defences against floodwater overtopping from Orchard Gate watercourse
