Section 19 Flood and Water Management Act 2010

Bredfield Flood Investigation

Storm Babet 2023

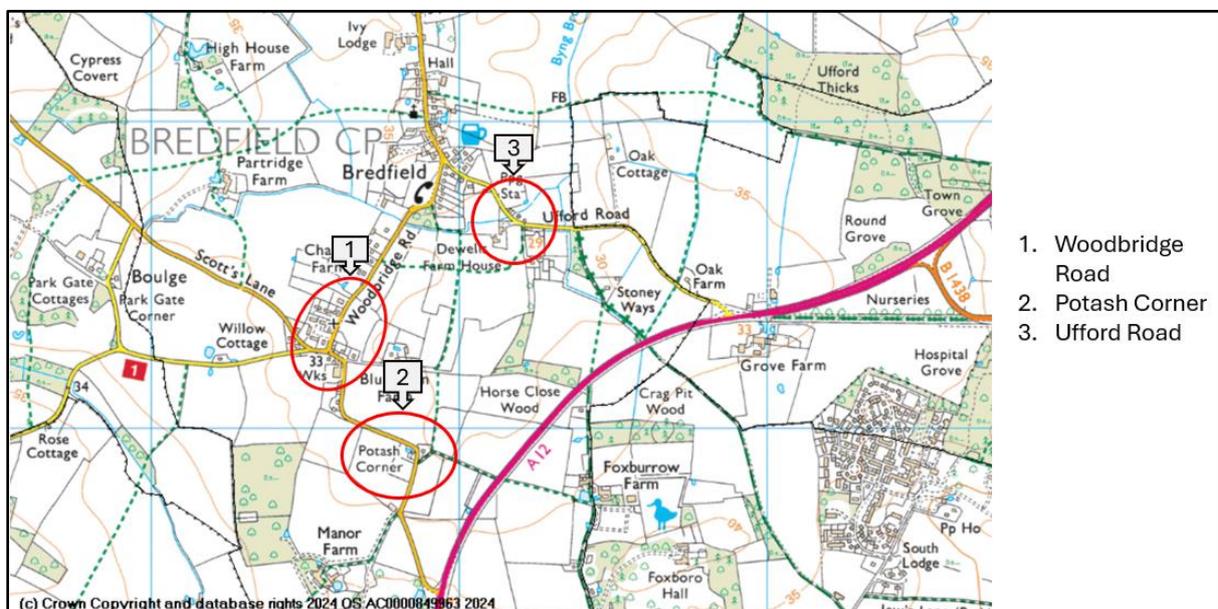
Fig. 5 Distinct flood zones where property was internally flooded

For the purposes of this investigation the various areas affected by flooding have been separated into three distinct zones:

1. Woodbridge Road
2. Potash Corner (road C309)
3. Ufford Road

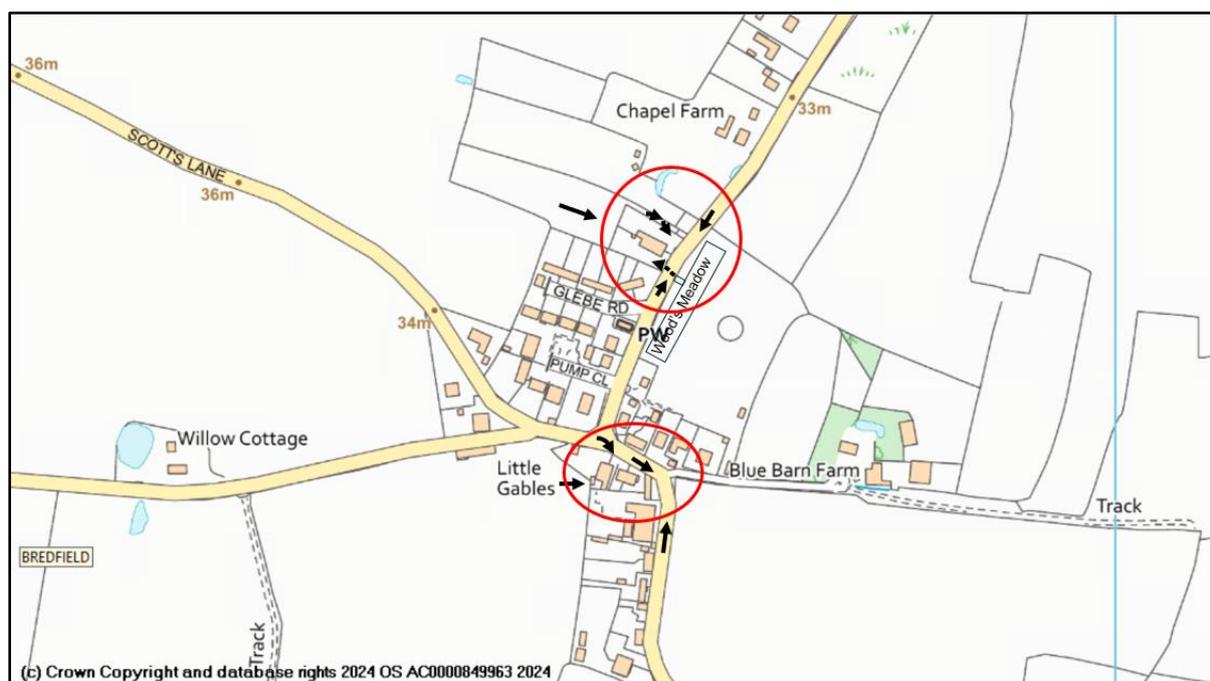
Fig. 10. Approximate floodwater flow paths, Woodbridge Road

Significant rainfall caused large quantities of surface water to flow from arable fields and field drainage ditches on the west side of Woodbridge Road. The pipe in a culverted watercourse, taking flow from a ditch on the south side of Jubilee Meadow towards Woodbridge Road was also reported to be broken, causing water to back up in the ditch and overtop close to Woodbridge Road. This ditch was reported to be silted up. (The broken pipe between Jubilee Meadow and Woodbridge Road has been repaired and the ditch adjacent to Jubilee Meadow has been cleared subsequent to Storm Babet. However, silt is reported to have then partly blocked the pipe under Woodbridge Road). A piped section of a watercourse on the east side of Woodbridge Road opposite this area was also reported to be blocked, causing water to back up and surcharge from a manhole in a garden on the west side of Woodbridge Road. (This blockage has been cleared since Storm Babet). Surface water also flowed west off Woodbridge Road into driveways that are situated lower than the highway. Flood water from fields to the west of Woodbridge Road, from the ditch on the south side of Jubilee Meadow and from the surcharging manhole merged together, causing internal flooding of property to a level of 6cm. Flooding of property in this location occurred

- Intense and prolonged rainfall exceeded the capacity of field ditches and surface water flowed across fields from the west of Woodbridge Road.
- A pipe in a culverted watercourse flowing from a ditch south of Jubilee Meadow towards Woodbridge Road was broken, blocking flow.

- This caused the water to back up, overtopping the ditch, which was silted up.
- Subsequent pipe repair between Jubilee Meadow and Woodbridge Road released silt which may have then blocked the pipe under Woodbridge Road.

- A piped section of watercourse on the east side of Woodbridge Road was blocked, causing water to back up and surcharge a manhole in a garden on the west side of Woodbridge Road. This blockage has been cleared subsequently.

- Flood water from fields west of Woodbridge Road, from the ditch on the south side of Jubilee Meadow and from the surcharging manhole merged together with floodwater flowing west off Woodbridge Road into lower level driveways to flood property internally.

- Floodwater from fields to the south of Woodbridge Road merged with surface water flowing down lower level driveways to flood property south of Woodbridge Road.

- Residents to install Property Flood Resilience (PFR) via grant funded scheme.
- SCC Highways to investigate potential blockage in piped watercourse under Woodbridge Road in the vicinity of Jubilee Meadow.

- Landowners to carry out watercourse maintenance to reduce flood risk as necessary in accordance with their riparian responsibilities.

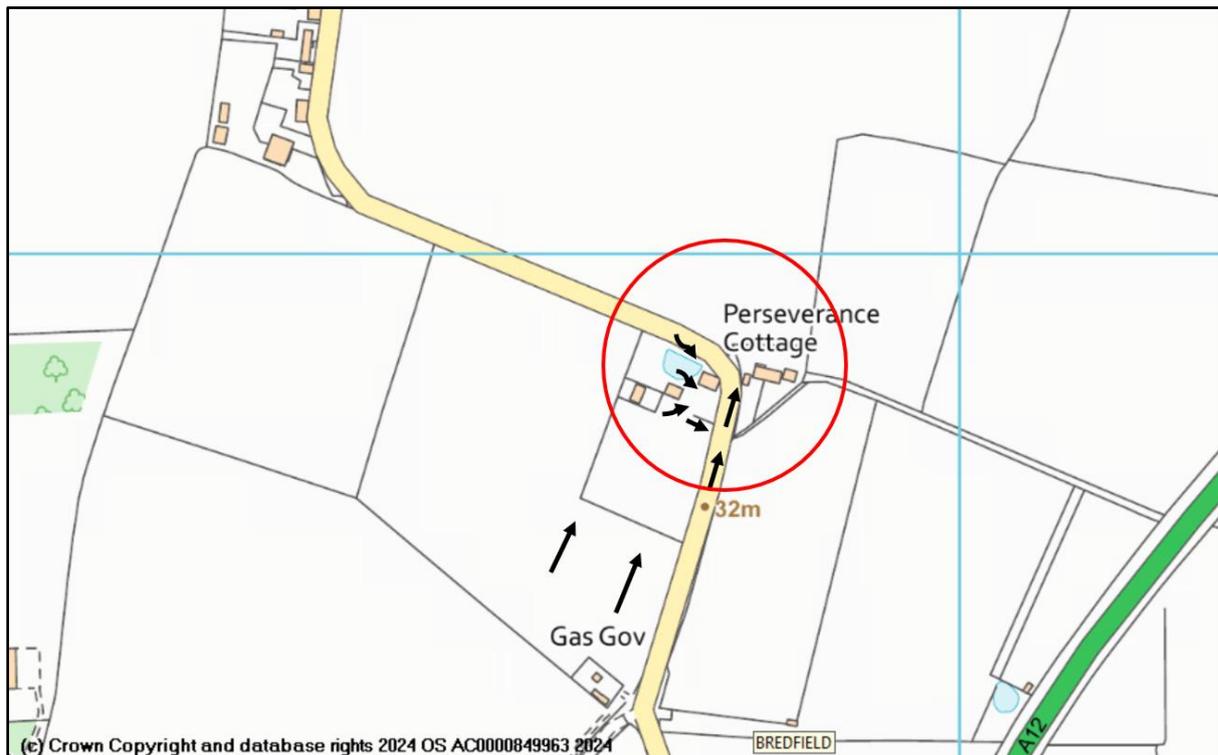
Fig. 11. Approximate floodwater flow paths in Potash Corner (C309)

A pond adjacent to property on the southwest side of the road C309 at Potash Corner receives surface water from highway gullies and fields to the south. Pipes for inflows to the pond are reported to be larger than the outflow. The pond overtopped due to a combination of extreme quantities of surface water runoff from fields and the highway causing the drainage system to exceed capacity. Surface water also flowed from the south down the highway to this low-lying area. Floodwater on the corner of the road C309 at Potash Corner reached approximately 15cm at 1.43pm on 20th October. All gullies in the vicinity were operational at the time, with the possible exception of one. However, grips were partly overgrown. Fully functional grips, particularly on the north side of the road where land adjacent to the road is at a significantly lower level, would have enabled some more water to flow away more rapidly from the highway. Floodwater from the overtopped pond combined with further surface water flowing

directly from the fields and the highway to flood property on the west side of the highway to an internal level of approximately 30cm.

Excess water from the pond flows into a ditch which continues eastwards through a small diameter piped culvert under the road and into another ditch flowing east at the rear of property on the eastern side of the road C309. Surface water also flowed east from the highway, around the north side of affected property. Surface water runoff from fields to the south of affected property contributed to floodwater in the vicinity. Some drainage ditches in the vicinity were reported not to have been kept clear prior to Storm Babet.

- Surface water from highway gullies and fields to the south drain into a pond on the southwest side of the road C309.
- Pipes for inflows to the pond are reported to be larger than the outflow.

- The pond overtopped due to a combination of extreme quantities of surface water runoff from fields and the highway causing the drainage system to exceed capacity.

- All of the gullies in the vicinity were operational at the time, with the possible exception of one.
- Excess water from the pond flows into a ditch which flows east through a small diameter pipe under the road C309 and past the rear of properties on the east side of the road.

- This ditch overtopped, adding to further surface water flowing directly from fields which had exceeded the capacity of field drainage systems and also surface water from the highway which both flowed from the south to this low-lying area.

- Some field drainage ditches in the vicinity were reported not to have been kept clear prior to Storm Babet.

- Residents to install Property Flood Resilience (PFR) via grant funded scheme.
- Landowners to carry out watercourse maintenance to reduce flood risk as necessary in accordance with their riparian responsibilities.
- SCC Highways to recut grips flowing to lower field
SCC Highways to investigate ditch ownership and action works to ditch levels accordingly.

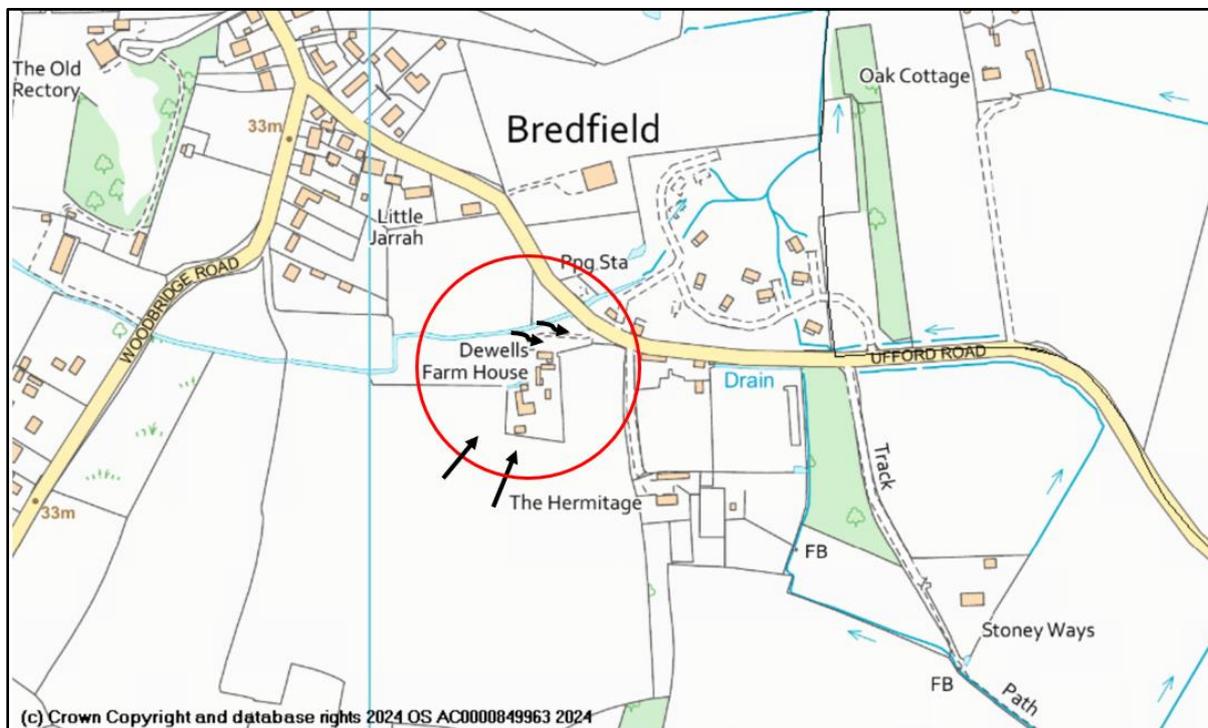
Fig. 12 Approximate floodwater flowpaths, Ufford Road

The northernmost area where property was affected by internal flooding was on the south side of Ufford Road, close to Byng Brook (Fig. 12). One property is known to have internally flooded. Affected property on Ufford Road is projected to be in a high

risk area for both surface water and fluvial flooding. Byng Brook is reported to have overtopped its banks and fluvial water flowed south, combining with surface water flowing from the southwest from fields. Flood water had entered property by 12.09 on the 20th October and reached a level of 30cm. It had receded by 5pm.

- Intense and prolonged rainfall caused Byng Brook to overtop its banks and fluvial water to flow south.
- This fluvial water combined with surface water flowing northeast from fields.

- Residents to install Property Flood Resilience (PFR) via grant funded scheme.
- Landowners to carry out watercourse maintenance to reduce flood risk as necessary in accordance with their riparian responsibilities.
