## Section 19 Flood and Water Management Act 2010

### Charsfield Flood Investigation – Storm Babet 2023

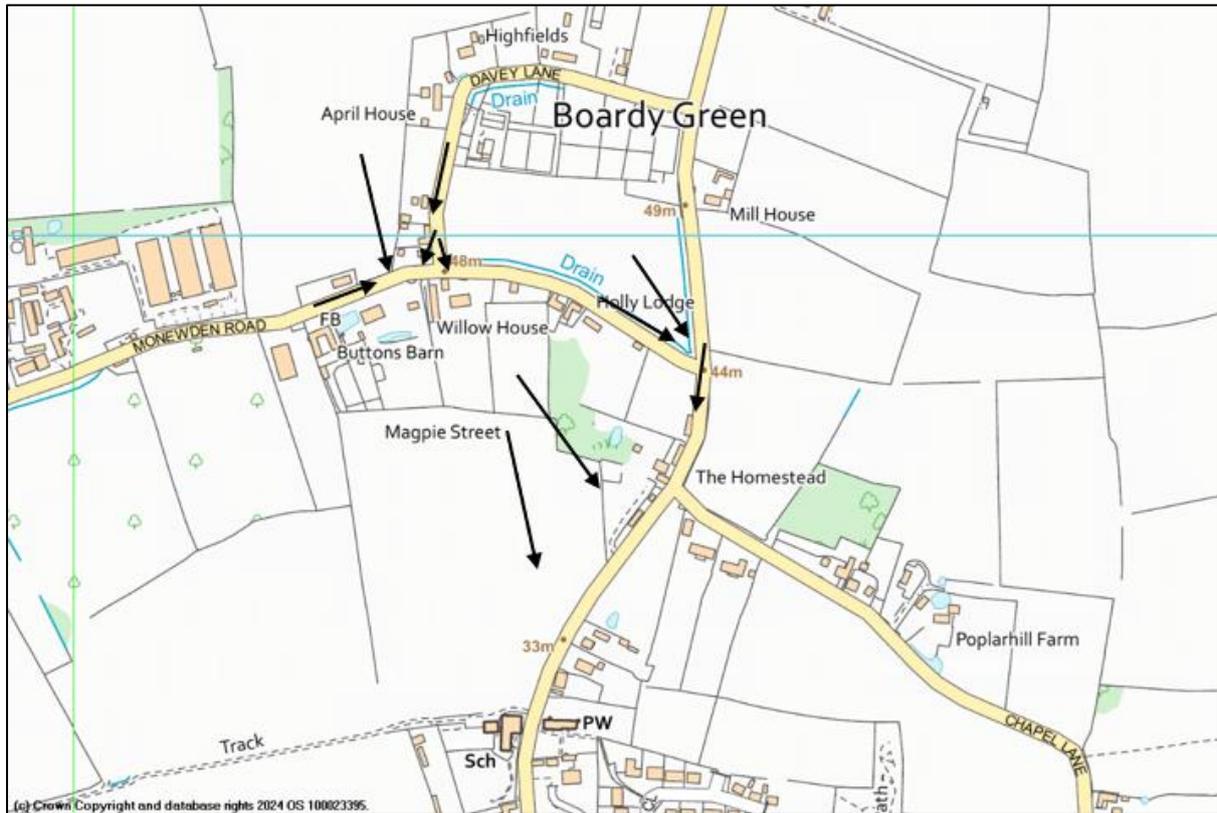
Figure 11 - Approximate flood water flow routes on Monewden Road

- High rainfall resulted in large amounts of surface water run-off coming from fields to the north on to Monewden Road.
- Surface water also flowed down Davey Lane onto Monewden Road impacting properties from the front.
- The limited number of drainage assets on the highway were temporarily overwhelmed.

- Landowner to undertake any required maintenance of the ditch on the north side of Monewden Road to reduce flood risk as per riparian landowner responsibilities.
- Ensure the completion of the existing highway drainage asset cyclic maintenance on Monewden Road.
- Investigate if the capacity and condition of the existing highway drainage assets on Monewden Road are sufficient.
- Maximise the take up of the £5k PFR Grant currently available to residents.

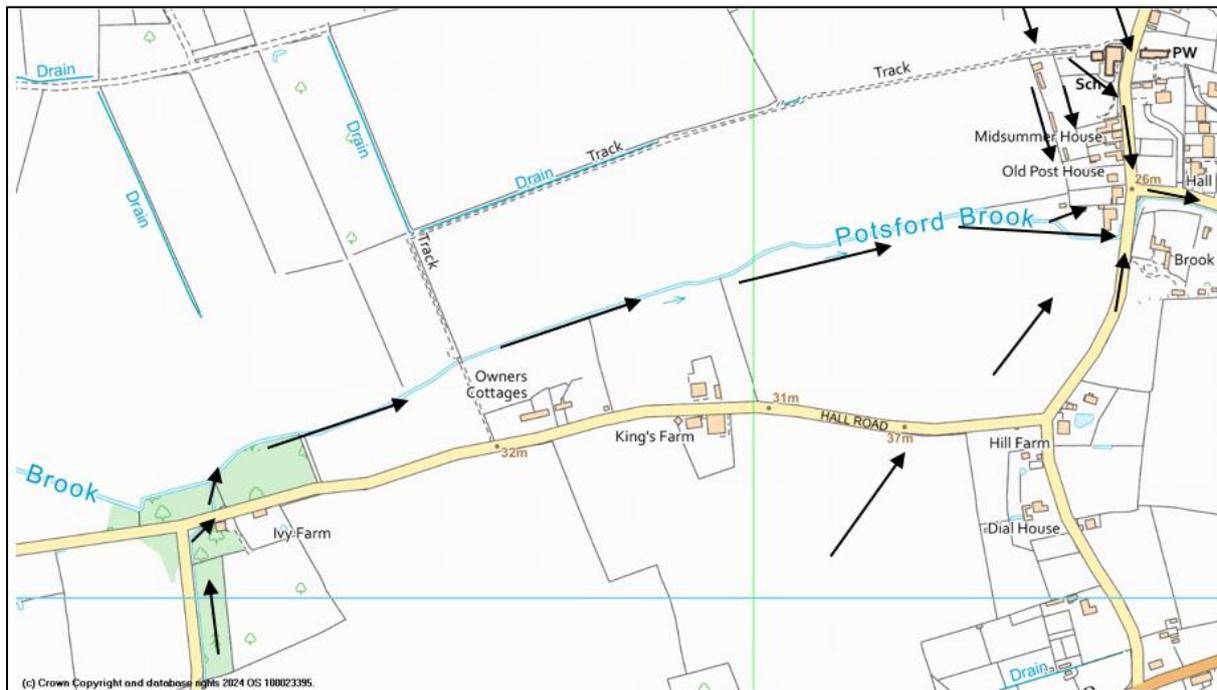
Figure 14 - Approximate flood water flow routes on Church Road and Hall Road

With the amount of water flowing into the Brook from fields north, south and the catchment further west, its capacity was completely overwhelmed and floodwater spilled onto Church Road. Properties were internally flooded from 10am onwards. Residents reported flood debris, including straw from the fields, building up and snagging at the road bridge under Church Road. The capacity under the bridge simply could not cope with the volume of water, which backed up, flooding the highway and nearby gardens (Image 4). Suffolk Highways are aware of a number of pre-existing issues at this location which may have reduced capacity at the road bridge.

At this point Church Road was acting as a secondary river channel, carrying floodwater downstream, which overflowed into The Street. The Street is amongst the lowest points in Charsfield and acted as the central basin into which the floodwater was accumulating. The roadside drainage assets were completely overwhelmed. Outfalls for highway drainage were quickly submerged as they fell below the peak water level in the Brook and were unable to discharge fully into the Brook causing the water to back up further.

On Hall Road, internal flooding occurred when surface water off the fields to the south merged with floodwater on the road at some of the lowest points on the road. The small streams and drainage ditches overflowed with the large volumes of water coming down the slope of the fields. The internal flooding occurred in the morning of 20 October, around 10am and by the next afternoon the floodwater was reported to have dispersed.

- High rainfall resulted in large amounts of surface water run-off coming from fields to the west of Church Road and along the highway from north and south.
- Pottsford Brook was completely overwhelmed, the fields upstream of the road bridge were inundated with floodwater.
- Floodwater overtopped from the Brook at the road bridge as the capacity underneath was exceeded. Accumulated debris and pre-existing damaged Highways drainage infrastructure may have contributed to the problem.
- Drainage assets on the highways were overwhelmed.

- Any observed blockages at the road bridge on Church Road to be reported to Suffolk Highways.
- Ensure the completion of existing highway drainage asset maintenance on Church Road and Hall Road.
- Investigate the known Highways drainage issues at the road bridge on Church Road.
- Maximise the take up of the £5k PFR Grant currently available to residents.

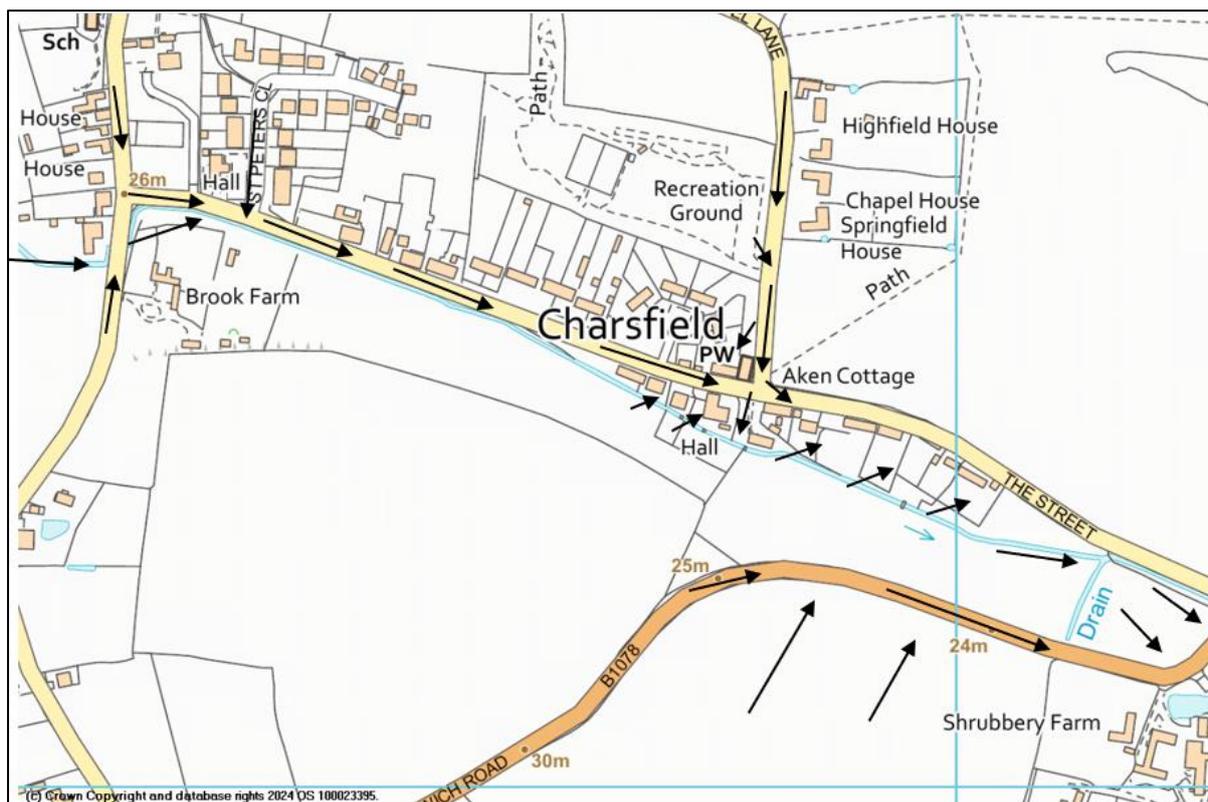
Figure 15 - Approximate flood water flow routes on The Street

There is a significant flow path identified along Chapel Lane, as outlined in Figure 13, with flood flows merging at the junction with The Street. There are a series of 'grips' to allow water to flow off the road and into the adjacent watercourse. These have become silted up and are last recorded to have been formally inspected in 2019. Whilst there is a minor watercourse running parallel to Chapel Lane, floodwater mainly flowed down the highway, which is relatively steep, collecting in large volumes at the southern end of Chapel Lane where it meets The Street (Image 3). At this point the watercourse is piped for a short section before out falling into Potsford Brook. However, as the pipe is relatively small (approx. 300mm in diameter) and most of the floodwater was within the highway rather than the upstream watercourse, this indicates the pipe could not accommodate the flow. The piped section has less capacity than the original open channel and has likely reduced the volume of water that could be safely conveyed from the bottom of Chapel Lane into Potsford Brook during a storm event.

Further along The Street, some residents suffered additional flooding to the rear of their properties as the water level in the Brook continued to rise and eventually overtop into gardens and houses from behind. There was a time lag between the initial onset of surface water to the front and water levels in Brook exceeding capacity. Fluvial floodwater rapidly filled the rear gardens. The properties were caught in the middle, surrounded by flood water from both sides. Consequently, as the drainage assets on the highway were overwhelmed, the flood water on the road could not discharge into the river, creating a large expanse of water around the properties.

Similar internal flooding had occurred previously at this location in May 2023. During that event, the floodwaters flowed down Chapel Lane and accumulated on The Street to a depth where it breached property thresholds. The majority of the properties located near the junction of Chapel Lane and The Street experienced water ingress into the ground floors.

Suffolk Highways are aware of pre-existing drainage issues at the junction of Chapel Lane and The Street. Highways records show instances of water surcharging from inspection chambers and water frequently pooling on the road surface. Further investigation is needed to fully understand the causes and likely solution to the problems.

- Investigate potential NFM projects and funding opportunities which aim to attenuate water and 'slow the flow' in the catchments to the west and north of Charsfield, targeting the flowpaths that feed into Potsford Brook.
- Any observed blockages within the main river section of Potsford Brook to be reported to the EA.
- Ensure the completion of existing highway drainage asset maintenance on Chapel Lane and The Street.
- Re-cut the grips on Chapel Lane
- Investigate the known Highways drainage issues at the junction of Chapel Lane and The Street.
- Maximise the take up of the £5k PFR Grant currently available to residents.

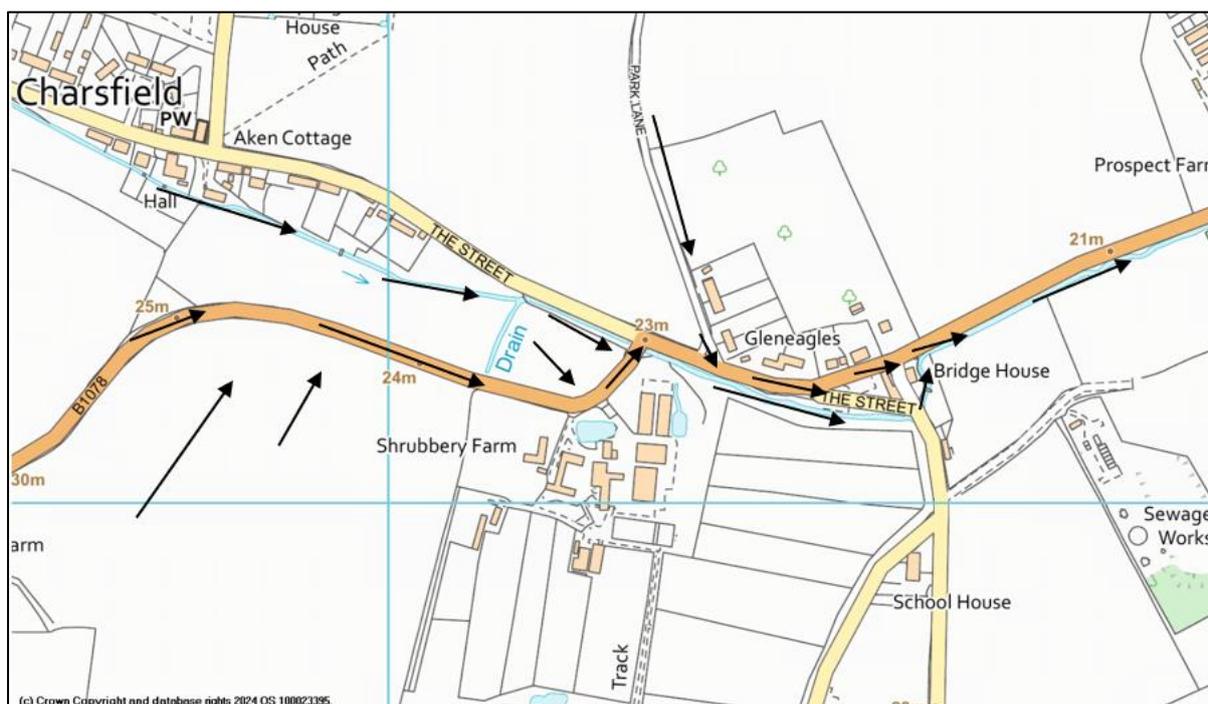
Figure 16 - Approximate flood water flow routes on Wickham Market Road

On the east side of Charsfield, a number of properties on the Wickham Market road were impacted by internal flooding. Large amounts of floodwater were reported to be flowing along the road surface from the junction of the B1078 and The Street (Image 8). The floodwater on the B1078 originated as run-off from the fields to the south. There was also fluvial flooding from the Potsford Brook as the water levels rose out of bank, water in the channel backed up at the road bridge as it was partially blocked and silted up on the upstream side. It then merged with the expanse of floodwater on the road with additional flows coming from the fields to the north down Park Lane.

The properties were flooded to the front from the road. The flooding in this area is reported to have occurred between 11am and 1pm, slightly later than other parts of the village presumably indicating the time taken for the peak flow to travel through the village from the west.

- Investigate potential NFM projects and funding opportunities which aim to attenuate water and 'slow the flow' in the fields south of the B1078, and north of Park Lane.
- Any observed blockages within the main river section of Potsford Brook to be reported to the EA.
- Any observed blockages at the B1078 road bridge to be reported to Suffolk Highways.
- Ensure the completion of highway drainage asset maintenance on along the B1078 and The Street.
- Maximise the take up of the £5k PFR Grant currently available to residents.

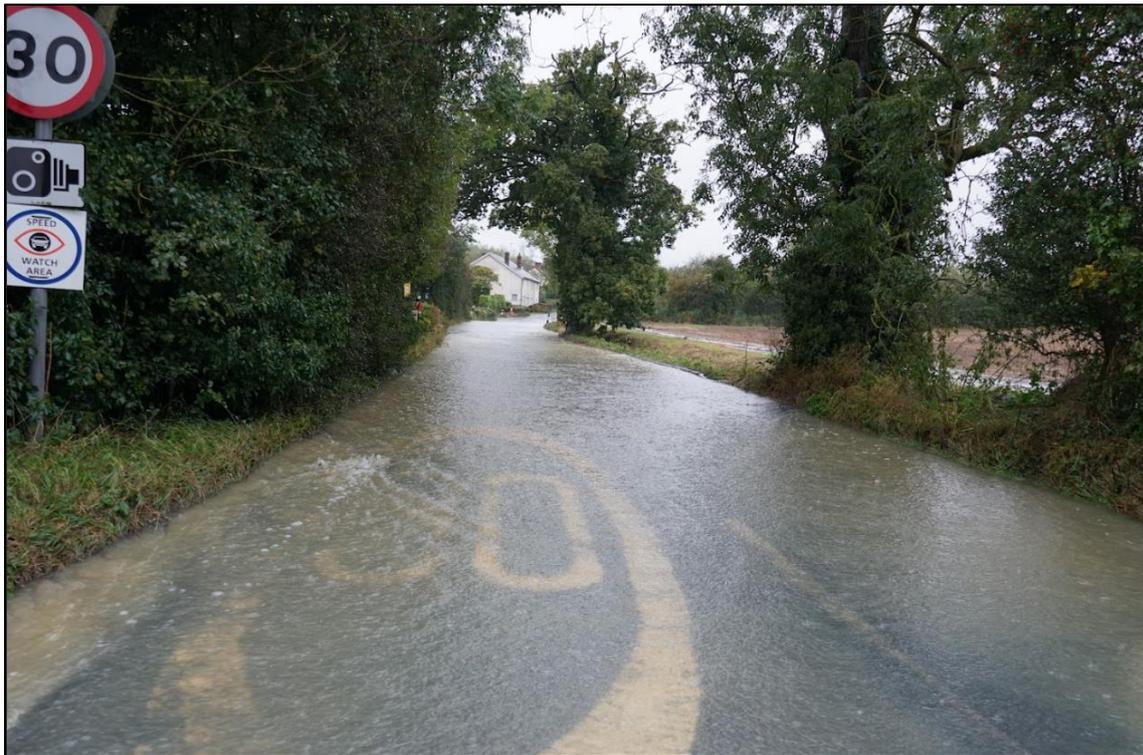
*Image 1 - Church Road junction looking toward The Street*

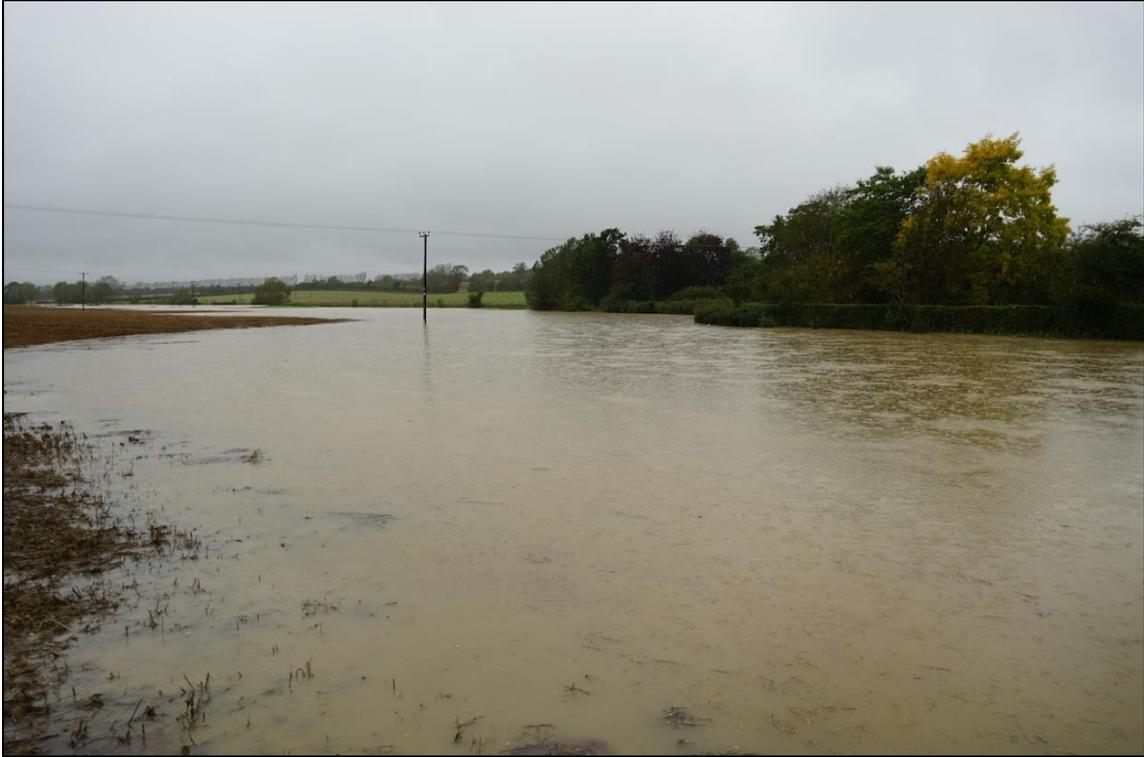
*Image 2 - Looking upstream of Church Road bridge*

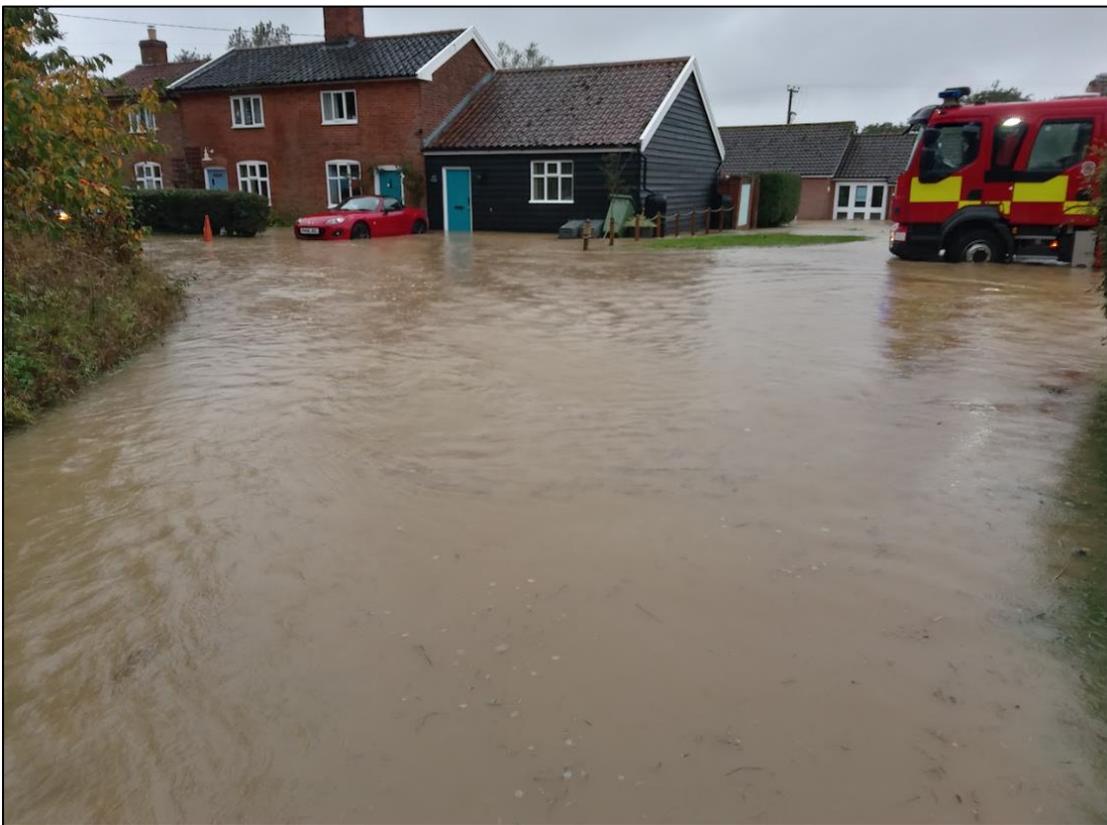
*Image 3 - View from Chapel Lane toward The Street*

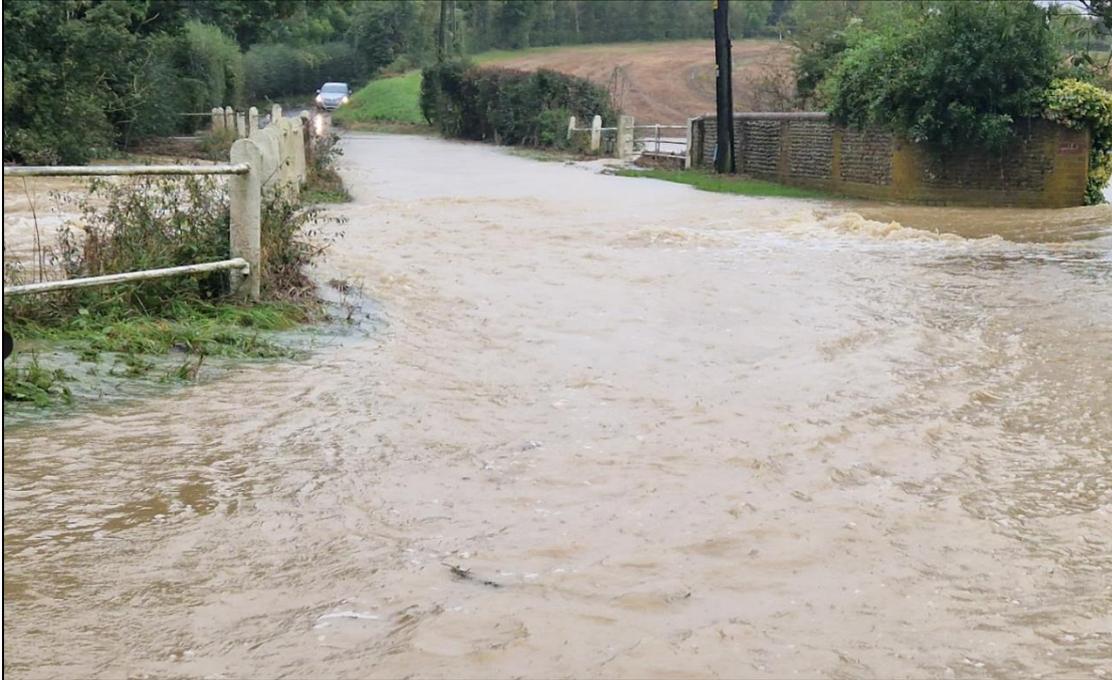
*Image 4 - Flooding on Church Road bridge*

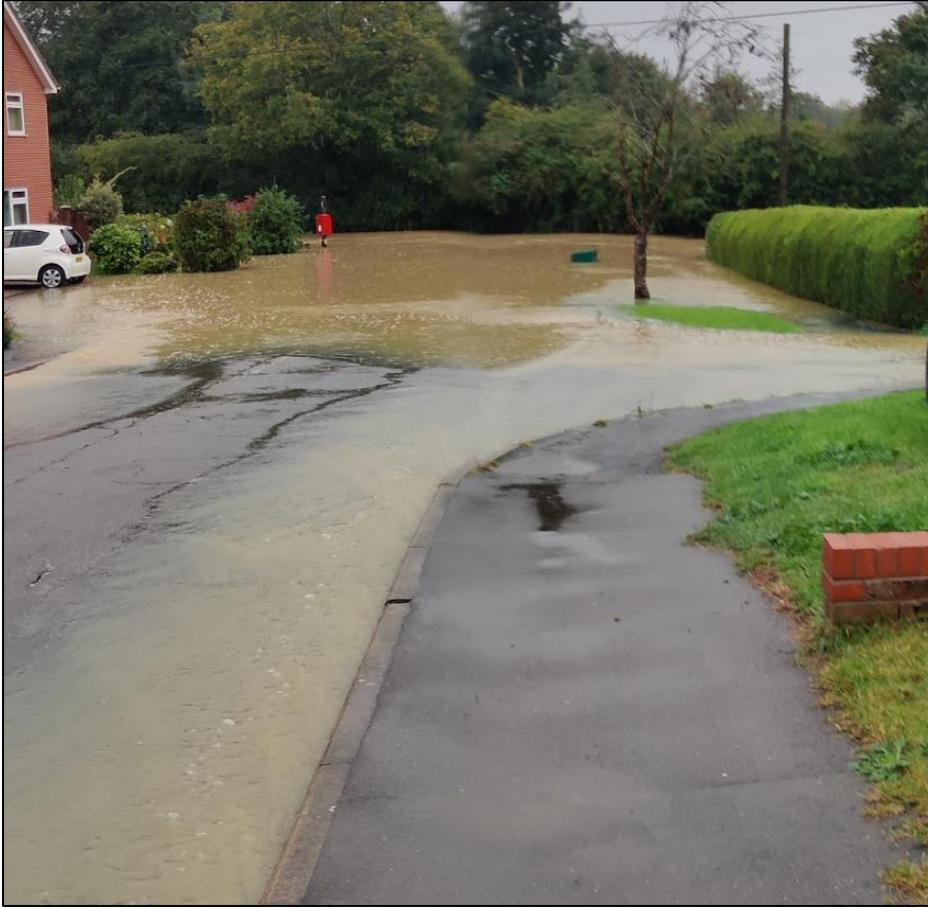
Floodwater was accumulating at the bottom of St Peters Close from 7:00am onwards, making it one of the earliest sites of flooding in the village (Image 5). Internal flooding on St Peters Close was reported from 8:00am onwards with no sign of lessening until late afternoon. The observed floodwater flow path seen on Chapel Lane and St Peters Close is consistent with the predicted surface water flood risk which is defined as Medium to High in this location (see Figure 13).

*Image 5 - Looking south on St Peters Close toward The Street*

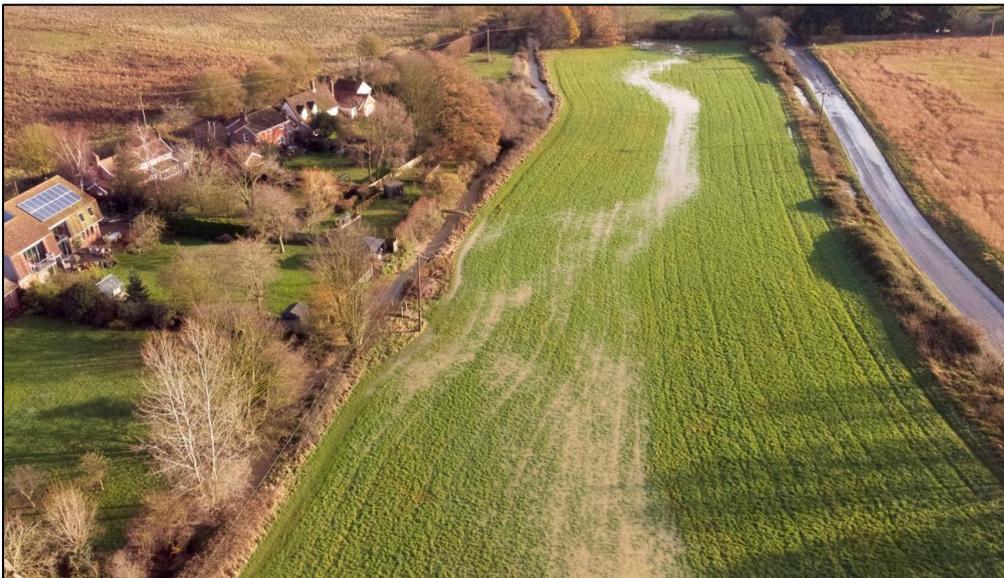
*Image 6 - View over Longmeadow showing Potsford Brook and possible former river channel*

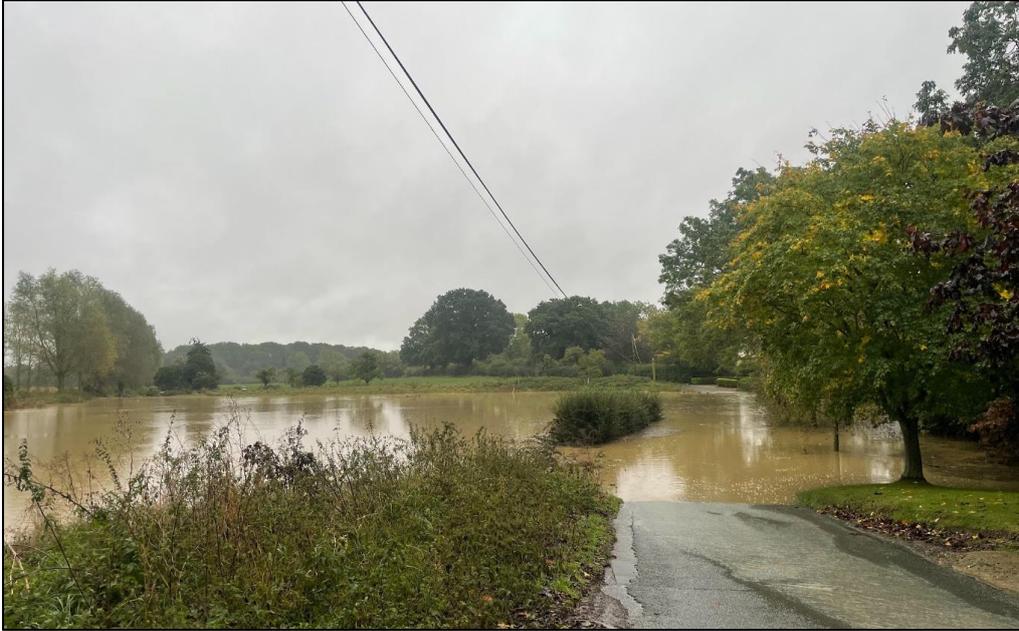
*Image 7 - Flooding on Hall Road*

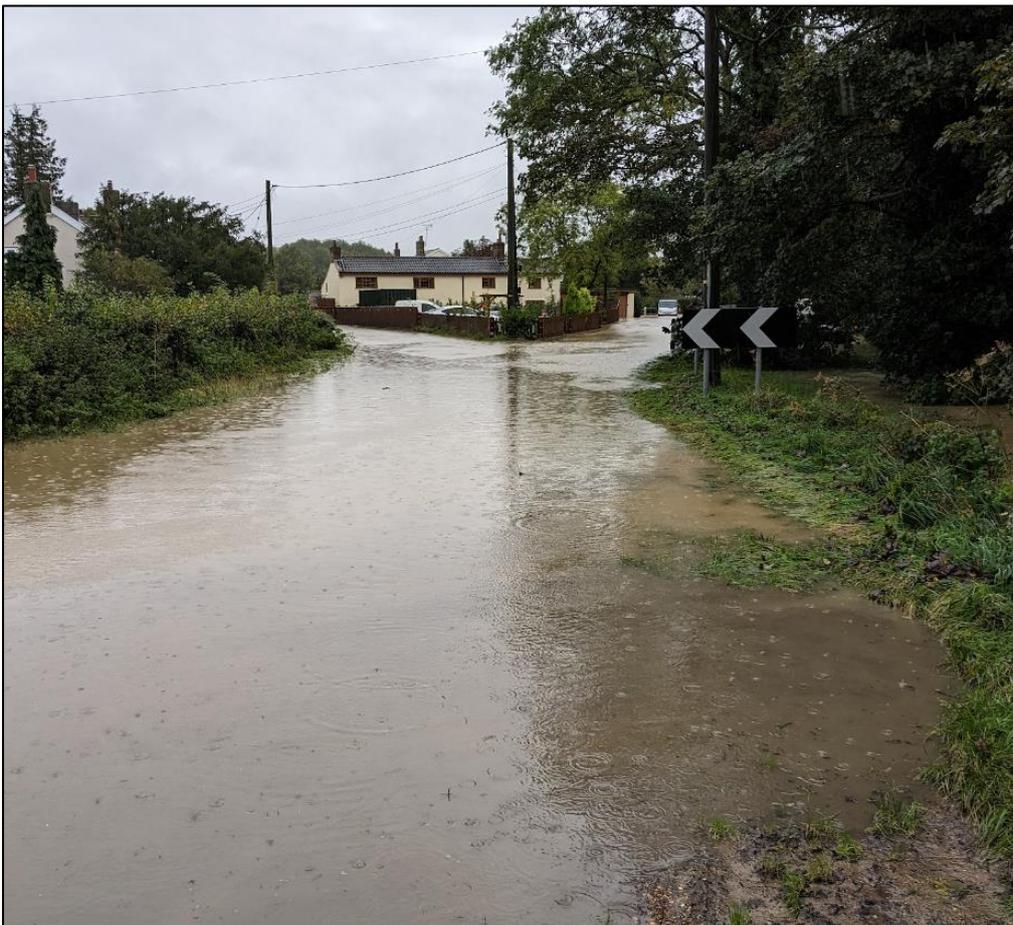
*Image 8 - View from The Street looking towards Wickham Market Road*

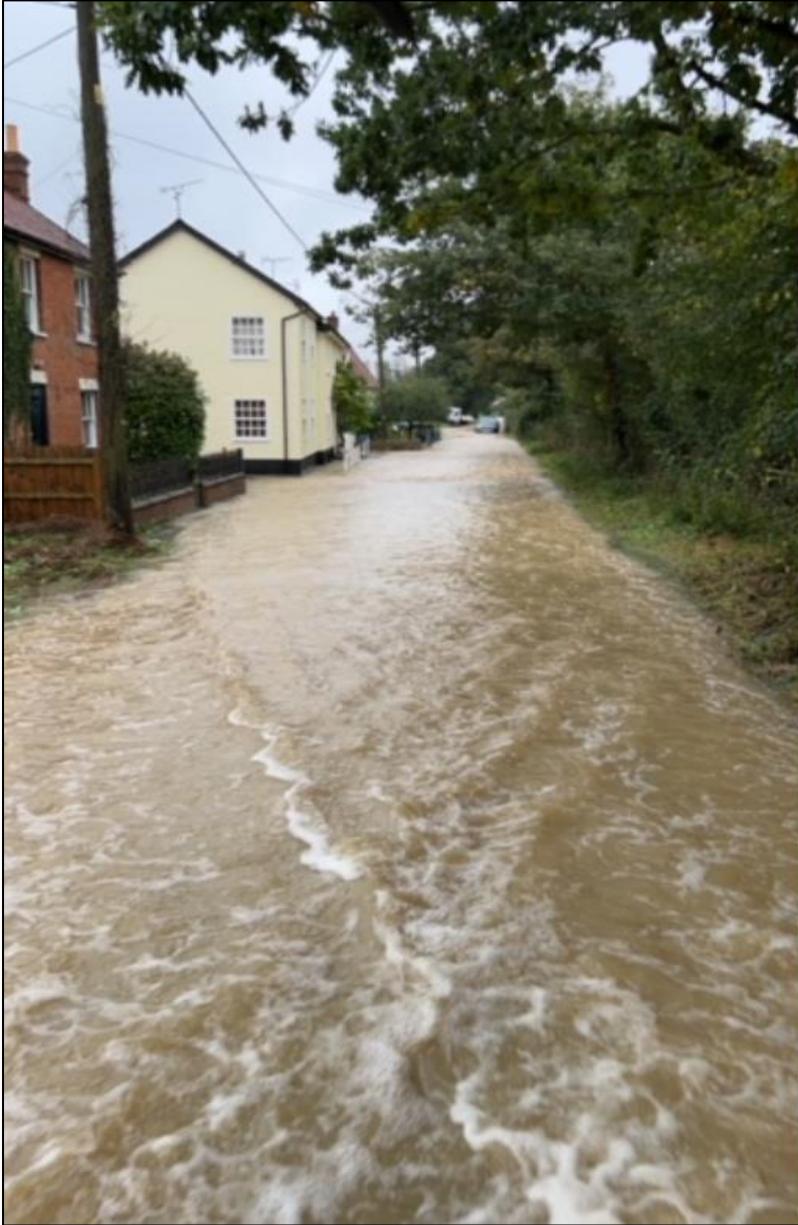
*Image 9 - Flooding on The Street*
