Section 19 Flood and Water Management Act 2010

Cretingham Flood Investigation

Storm Babet 2023

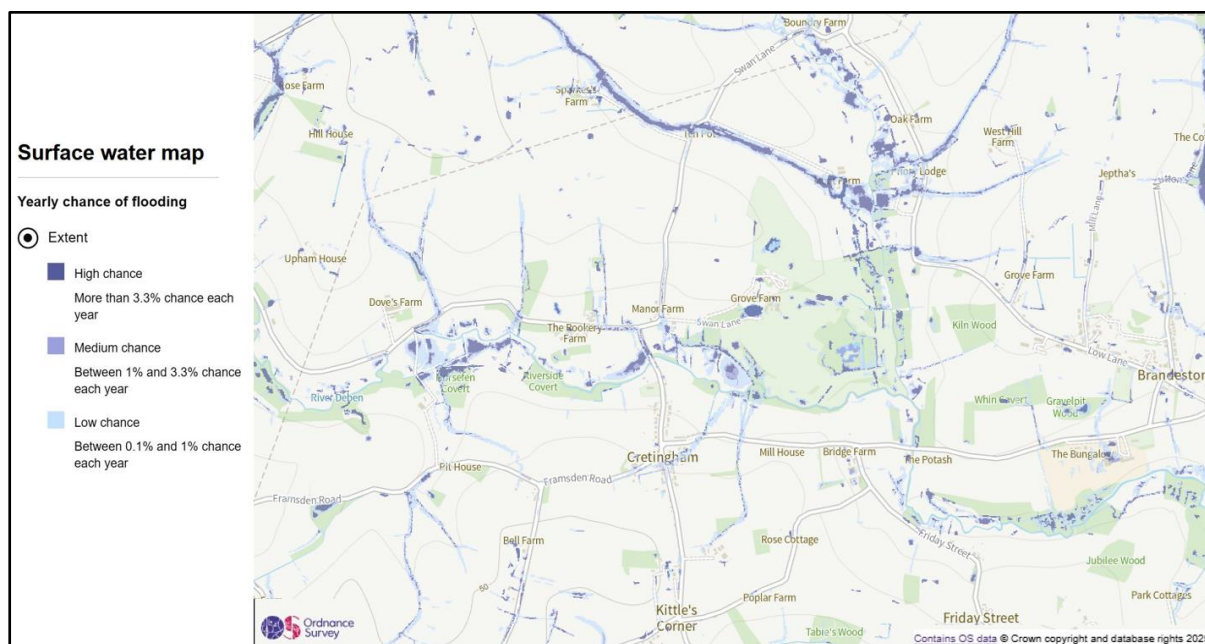
Fig. 6. Predicted flood risk from surface water (Environment Agency)

The parish of Cretingham is at significant risk of pluvial flooding (Fig. 5). Surface water flood risk ranging from low to high chance of flooding is associated with all the affected property in Cretingham, except for affected property in Cretingham Lane which was projected to be at no surface water flood risk. It should be noted that low chance of flooding indicates a flood risk during extreme events, such as Storm Babet.

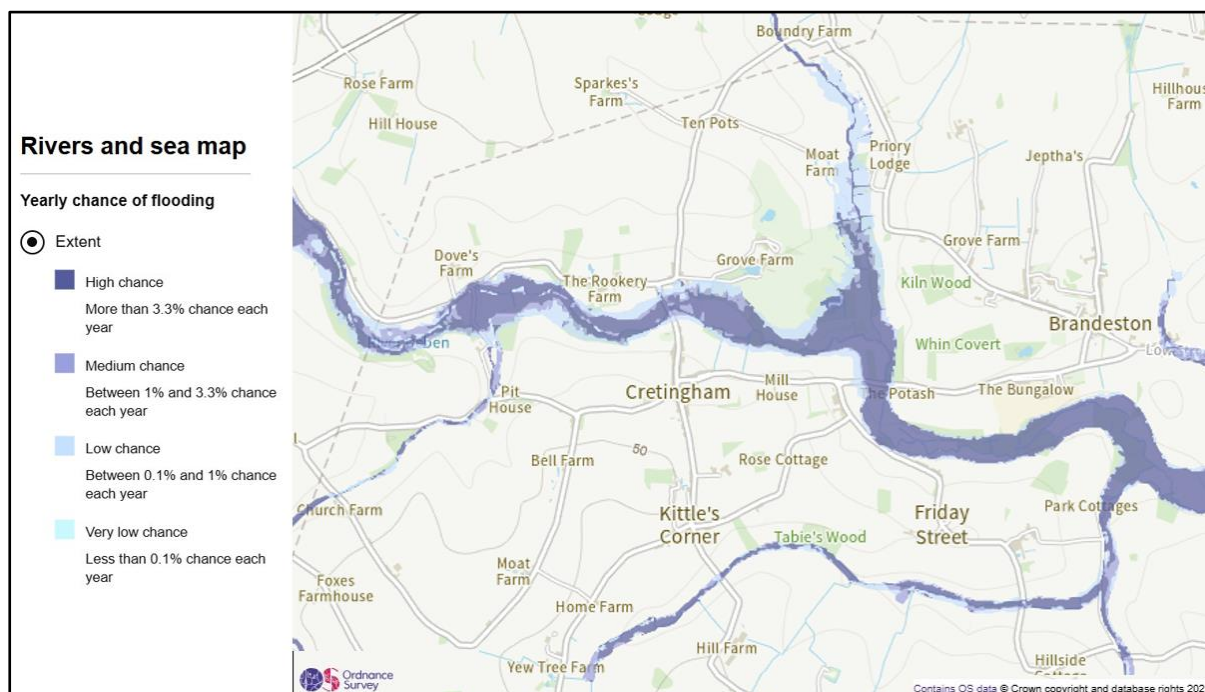
Fig. 7. Predicted flood risk from rivers (Environment Agency)

Fluvial flood risk for property in Cretingham parish is associated primarily with the River Deben, which flows eastwards across the parish. Affected property in the southern part of Swan Lane, close to the junction with The Street, is projected to be at low fluvial flood risk and adjacent to an area of high risk. All other affected property is not projected to be at fluvial flood risk.

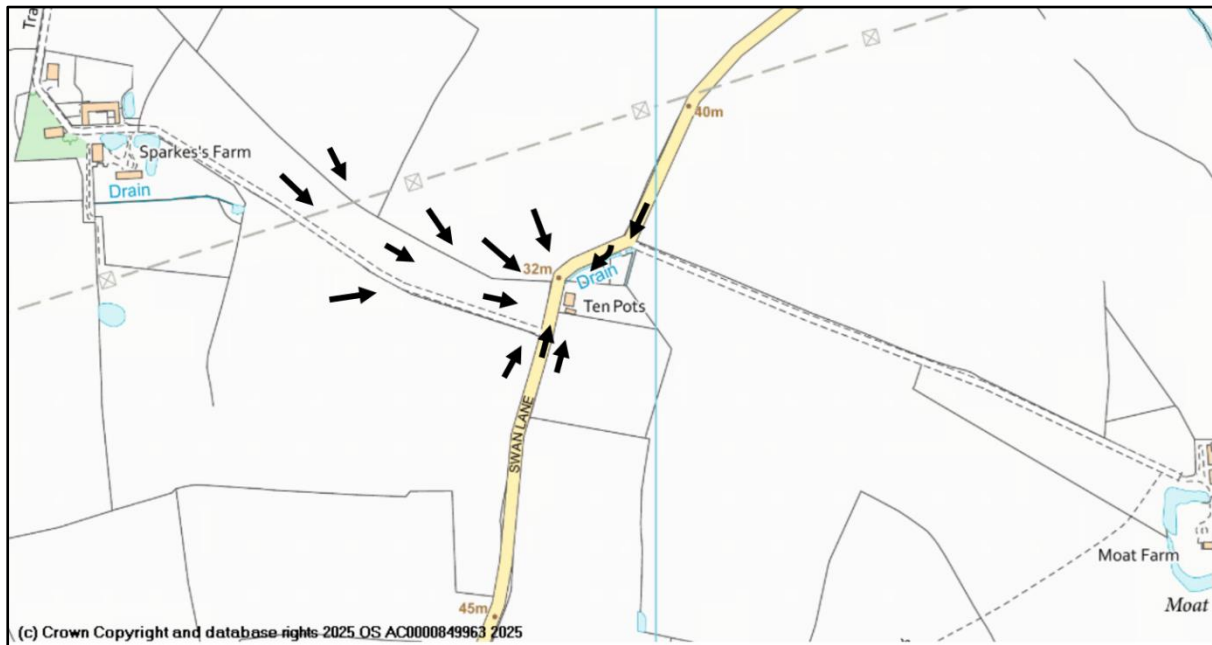
Fig. 11. Approximate floodwater flow paths, Swan Lane (north)

The northernmost area where property was affected by internal flooding was on the east side of Swan Lane (north). Affected property was at high risk of surface water flooding and no risk of fluvial (river water) flooding.

Significant rainfall on a relatively large catchment caused considerable quantities of surface water to flow from arable fields and field drainage ditches primarily from the west side of Swan Lane, although surface water also flowed north towards affected property on the east side of Swan Lane. Local ditches were reported not to have been maintained. Surface water also flowed down Swan Lane towards affected property from the north and south. Two of the gullies in the vicinity may not have been fully functioning at the time as they were reported not to be operational in subsequent cyclical maintenance visits. However, due to the extreme rainfall conditions, the capacity of the wider drainage system, even if fully functioning, would have been exceeded.

- Large quantities of surface water from a large catchment flowed across fields and from overtopping ditches towards affected property.
- Ditches in the vicinity were reported not to have been maintained.
- Surface water also flowed down Swan Lane from the north and south towards affected property.
- Two gullies may not have been fully functioning.

- Residents to install Property Flood Resilience (PFR) measures.
- Explore potential natural flood management measures (eg. ploughing across flow paths, buffer strips, field bunds, leaky dams, and attenuation ponds) to “slow the flow” and attenuate water in the upper catchment on the surface water flow paths and ditches.
- Landowners to carry out watercourse maintenance to reduce flood risk as necessary in accordance with their riparian responsibilities.
- SCC Highways to investigate potential blockages of gullies on Swan Lane in the vicinity of affected property.
- SCC Highways to ensure completion of highway drainage asset cyclic maintenance.

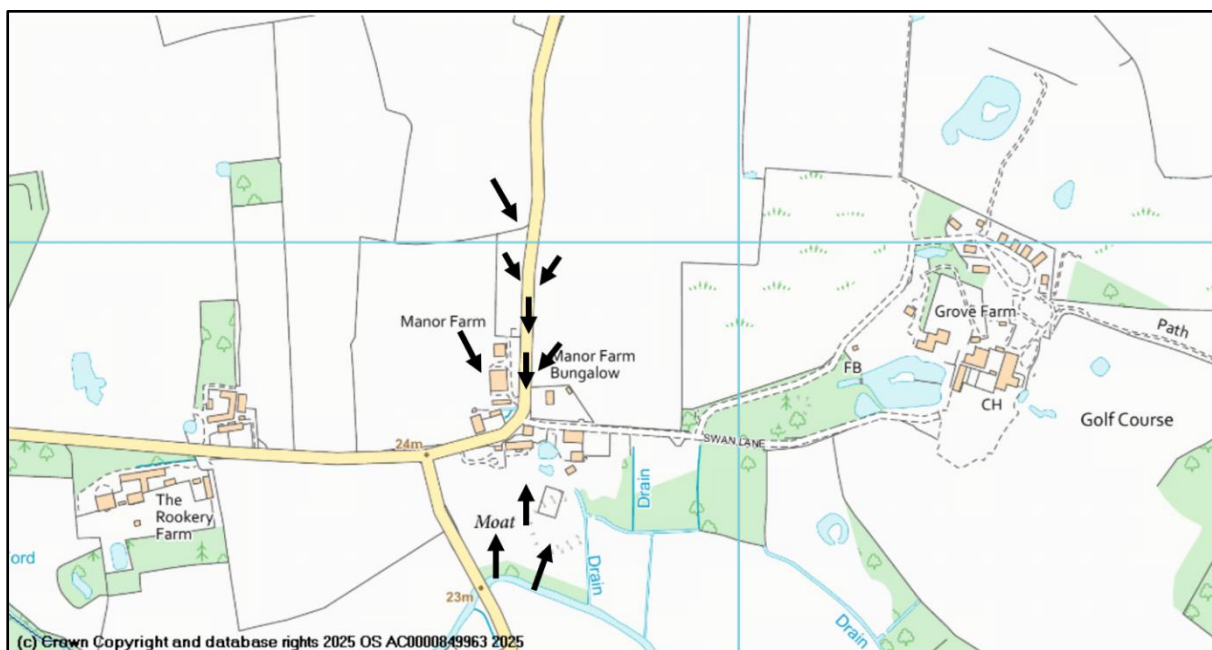
Fig. 12. Approximate floodwater flow paths in Swan Lane (south)

Affected property in the southern part of Swan Lane, close to the junction with The Street, is projected to be at low fluvial and surface water flood risk and adjacent to an area of high fluvial and surface water flood risk.

Property on the south side of Swan Lane reported flooding on the morning of the 20th October due to water flowing down Swan Lane from the north. 2-3 inches of water was reported to be flowing down Swan Lane, overwhelming the drainage system, with drains reported to be blocked. Surface water runoff was also flowing south across fields towards affected property and from fields onto the highway. Affected property flooded again later on the 20th October due to the River Deben water level rising and

overtopping south of affected property. After Storm Babet, ditches to the north of affected property on the west and east side of Swan Lane and highways drainage were inspected by SCC LLFA. Gullies were found to be blocked with silt. Ditches were found to be blocked due to dense vegetation, silt and debris. Both headwalls on the east side were also showing signs of damage. Riparian owners were advised of their responsibilities for maintaining watercourses. In 2024 and in March 2025, SCC Highways cleared and jetted gullies and culverts in the vicinity of affected property.

- Affected property was initially flooded from the north, from Swan Lane and surface water runoff from fields.
- Affected property was later flooded from the south, from the overtopping River Deben.
- The drainage system was overwhelmed.
- Ditches in the vicinity were found to be blocked and in poor condition during inspection after Storm Babet.
- Gullies in the vicinity were also found to be blocked with silt.
- Riparian owners were advised of their responsibilities for maintaining watercourses.
- SCC Highways cleared and jetted gullies and culverts in the vicinity of affected property after Storm Babet.

- Residents to install Property Flood Resilience (PFR) measures.
- Explore potential natural flood management measures (eg. ploughing across flowpaths, buffer strips, field bunds, leaky dams, and attenuation ponds) to “slow the flow” and attenuate water in the fields to the north of affected property on the surface water flow paths and ditches if further flooding is observed from the north.
- Explore potential natural flood management measures (eg. ploughing across flowpaths, buffer strips, field bunds, leaky dams, attenuation ponds and floodplain reconnection) to “slow the flow” and attenuate water in the upper catchment of the River Deben.
- Landowners to continue to carry out watercourse maintenance to reduce flood risk as necessary in accordance with their riparian responsibilities.
- SCC Highways to ensure completion of highway drainage asset cyclic maintenance.

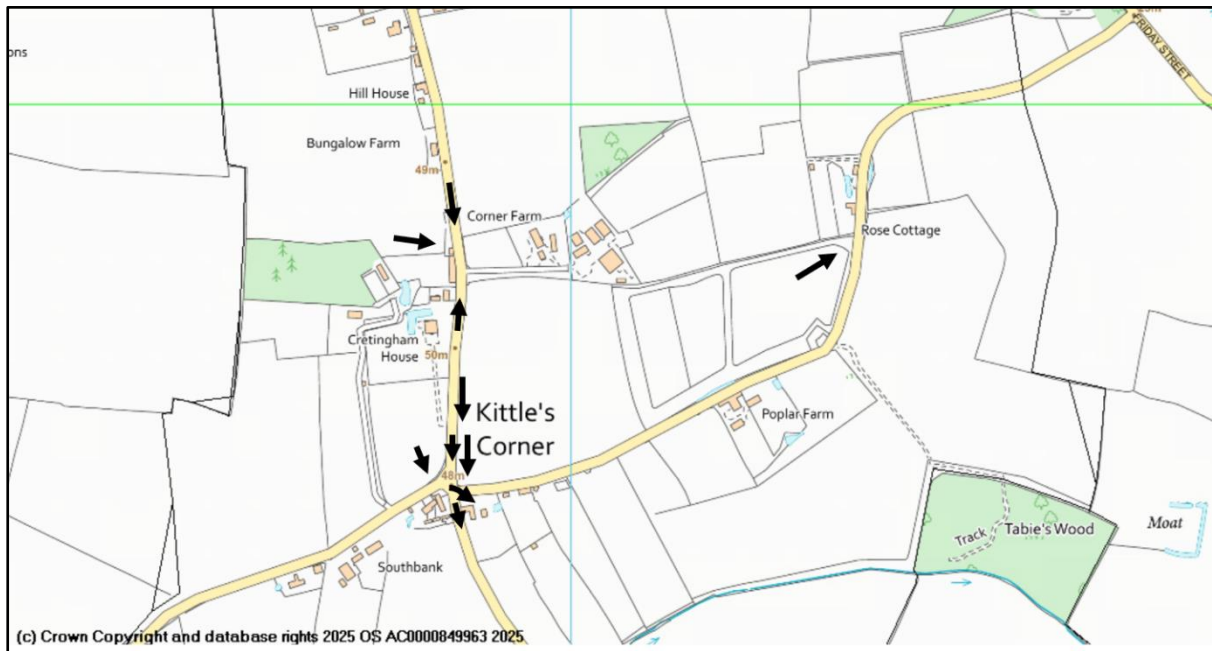
Fig. 13 Approximate floodwater flowpaths in The Street, Cretingham Lane and Ipswich Road

Property on the west side of The Street, to the north of Kittle's Corner, is reported to have flooded. Property in this area is projected to be at low surface water flood risk and no fluvial flood risk.

Surface water flowed from fields west of affected property, overwhelming a small drainage channel on the edge of the field to the rear of the property. This floodwater was supplemented by surface water flowing from the north and south along The Street towards an area of low-lying road, adjacent to affected property. Internal property flood water levels reached approximately 10cm.

- Surface water flowed across fields and overwhelmed a ditch at the rear of affected property.
- Surface water also flowed down The Street from the north and south towards affected property.
- Sections of ditch were cleared to the rear of affected property after Storm Babet and reconnected to the existing drainage system.

Property on the east side of Cretingham Lane, close to Kittle’s Corner, is reported to have flooded. This property was reported to have flooded again in Storm Henk. Property in this area is projected to be at no fluvial and surface water flood risk.

Surface water is reported to have flowed from fields located to the north of affected property and then on to Cretingham Lane and Ipswich Road and into affected property (Fig. 13). Field ditches in the vicinity were overwhelmed. Field ditches to the north of affected property were reported subsequently to be in poor condition.

- Surface water flowed south from fields on to Cretingham Lane and Ipswich Road towards impacted property.
- Field ditches in the vicinity overtopped.
- Ditches to the north of affected property were subsequently found to be in poor condition during an inspection by SCC LLFA.

Property on the west side of Ipswich Road is reported to have flooded. Property in this area is projected to be at high surface water flood risk. (Low fluvial flood risk is shown aligned with the onsite pond).

Surface water flowed from fields located west and south of affected property towards it and towards a farm ditch adjacent to it (Fig. 13). This farm ditch is reported to have overtopped. Farm ditches in the vicinity were reported to be in need of maintenance. A culvert under Ipswich Road which would have enabled floodwater to flow east, away from affected property, was reported to be blocked.

- Surface water flowed northeast across fields towards affected property.
- A farm ditch adjacent to affected property overtopped.
- Farm ditches in the vicinity were reported to be in need of maintenance.
- A culvert under Ipswich Road was reported to be blocked.

Following Storm Babet, adjacent landowners and a farmer deepened the drainage channel to the rear of affected property (which had filled with silt over time) and reconnected it to the cleared section of ditch adjacent to affected property, to connect it with a ditch on the east side of the highway.

- Residents to install Property Flood Resilience (PFR) measures.
- Explore potential natural flood management measures (eg. ploughing across flow paths, buffer strips, field bunds, and attenuation ponds) to “slow the flow” and attenuate water on the surface water flow paths and ditches if further flooding occurs.
- Landowners to continue to carry out watercourse maintenance to reduce flood risk as necessary in accordance with their riparian responsibilities.
- SCC Highways to ensure completion of highway drainage asset cyclic maintenance.

- Residents to install Property Flood Resilience (PFR) measures.
- Explore potential natural flood management measures (eg. ploughing across flow paths, buffer strips, field bunds, and attenuation ponds) to “slow the flow” and attenuate water on the surface water flow paths in the fields to the north of affected property.
- Landowners to carry out watercourse maintenance to reduce flood risk as necessary in accordance with their riparian responsibilities.

- Residents to install Property Flood Resilience (PFR) measures.
- Explore potential natural flood management measures (eg. ploughing across flow paths, buffer strips, field bunds, and attenuation ponds) to “slow the flow” and attenuate water on the surface water flow paths.
- Landowners to carry out watercourse maintenance to reduce flood risk as necessary in accordance with their riparian responsibilities.
- SCC Highways to investigate and clear potential blockages in the culvert under Ipswich Road.
- SCC Highways to ensure completion of highway drainage asset cyclic maintenance.
