## **Section 19 Flood and Water Management Act 2010**

### **Crowfield Flood Investigation –**

### **Storm Babet 2023**

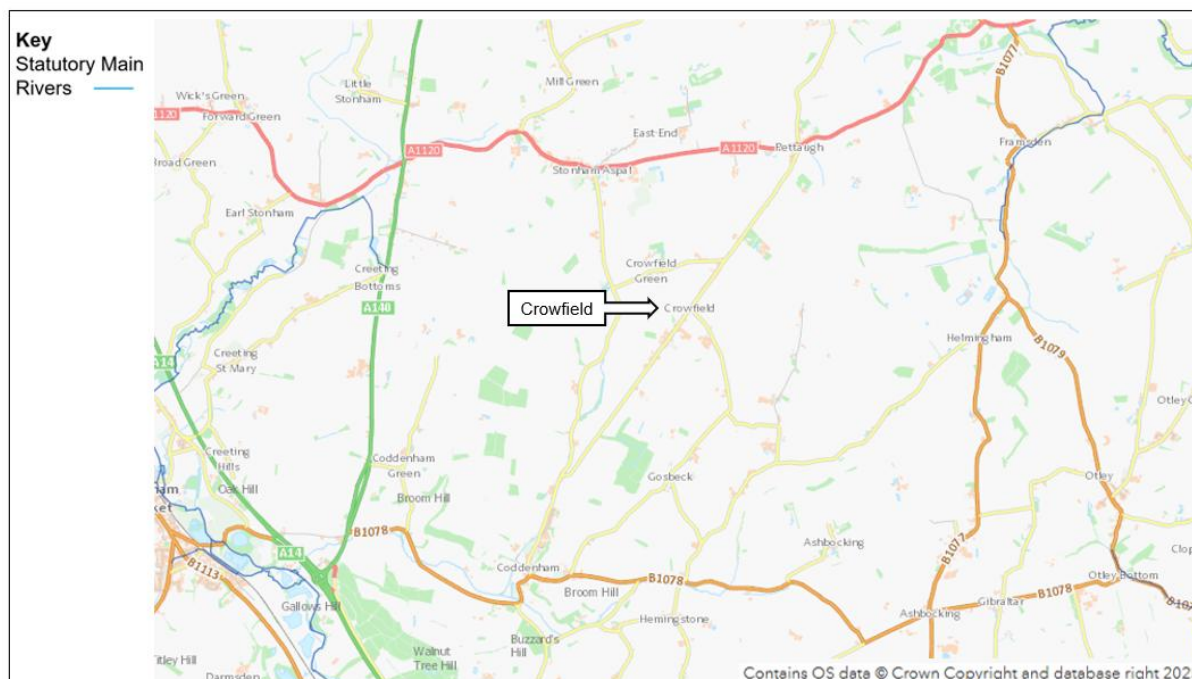
*Figure 3. Location of statutory main river and ordinary watercourses*

Fig. 3 shows the location of the nearest statutory main rivers near Crowfield. However, in this case, main rivers did not contribute to flooding experienced in Crowfield, during Storm Babet.

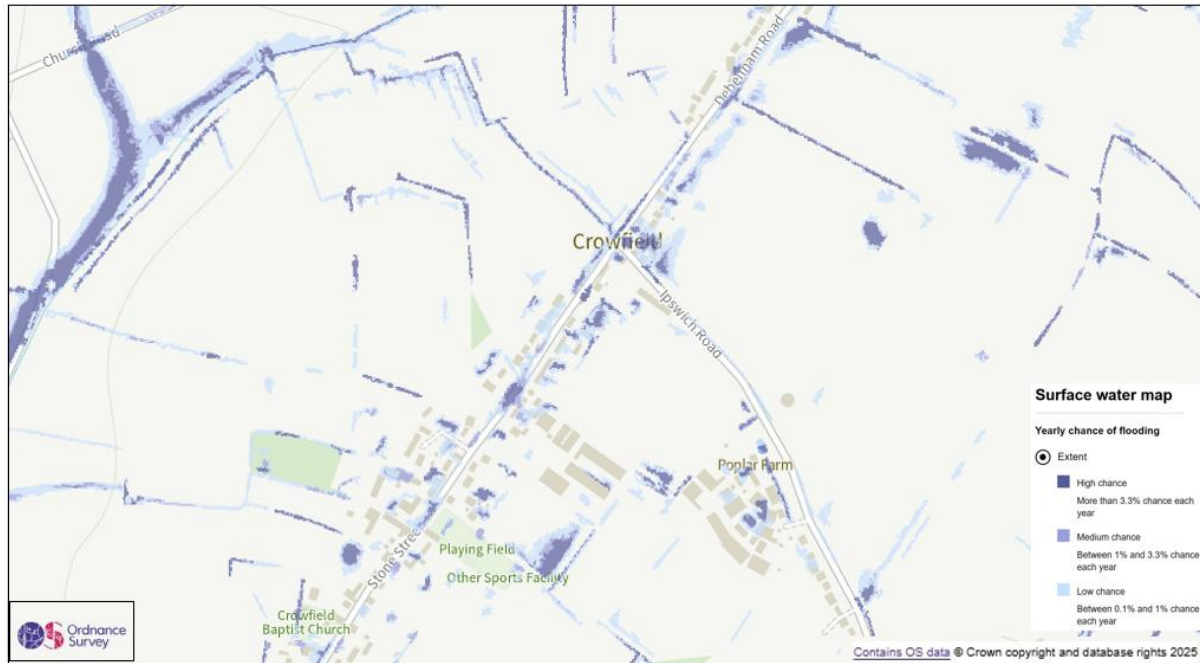
*Figure 5. Surface water flood risk*

Figure 5 highlights the predicted pluvial (surface water run-off from surrounding land) flood risk in Crowfield, with several isolated locations predicted to be at risk.

Pluvial flood risk varies across this location, ranging from low to high risk. Impacted locations including Debenham Road, Gosbeck Road and Stone Street, closely align with predicted flood risk for this area.

The floodwater flow paths observed on Debenham Road, Gosbeck Road and Stone Street during Storm Babet closely align the national pluvial flood risk mapping (see Figure 5). Pluvial flood risk varies across this location, ranging from low to high risk. Impacted locations including Debenham Road, Gosbeck Road and Stone Street, closely align with predicted flood risk for this area.

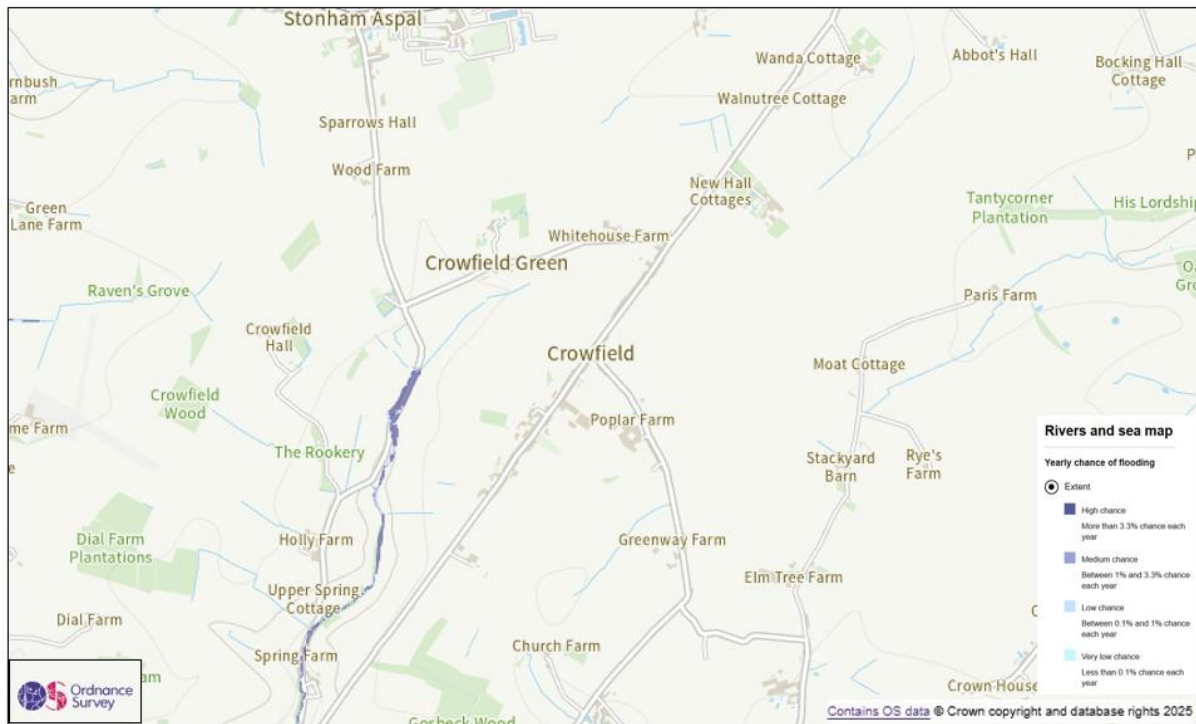
Figure 6. Flood risk from rivers and sea

Figure 6 shows the predicted fluvial (from designated main river and ordinary watercourses) flood risk in Crowfield. There is a minor watercourse that runs adjacent to Spring Lane to the west, and no further designated main river or significant watercourses within Crowfield. Fluvial flood risk is therefore low in this location.

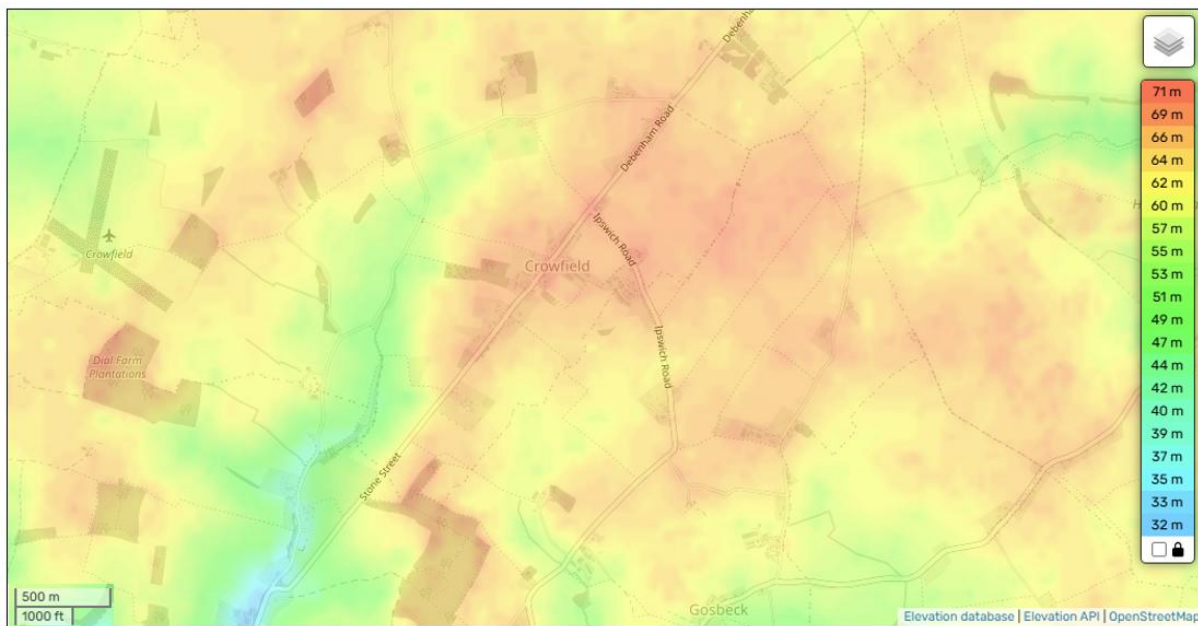
*Figure 7. Crowfield and surrounding topography (TessaDEM as cited in [topographic-map.com](http://topographic-map.com))*

Figure 7 shows the topography surrounding Crowfield, with gradient changes across the wider region. The village of Crowfield is situated on higher ground, with a gradual gradient change to the southwest of the village. The village centre is predominantly flat. (see Figure 7).

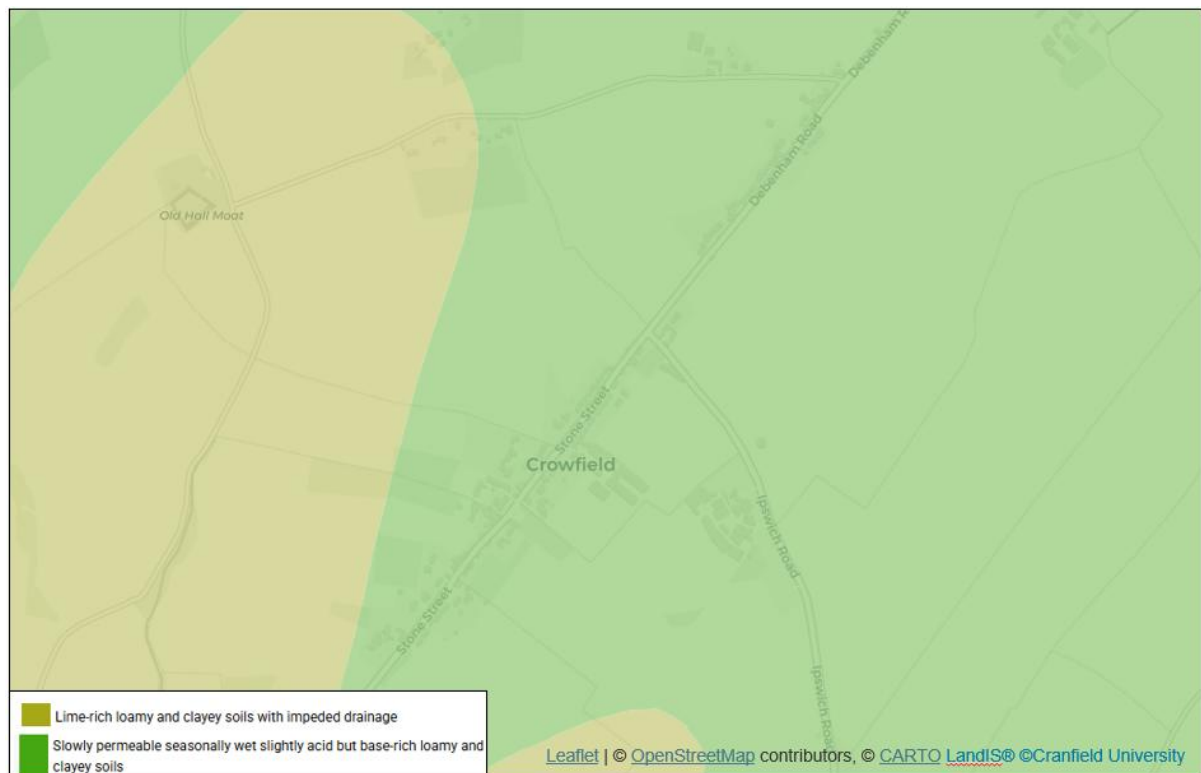
Figure 8. Soil map (LandIS Soils)

The soils in and around Crowfield are loamy and clayey with impeded drainage, meaning that water permeates more slowly and surface water runoff is greater.

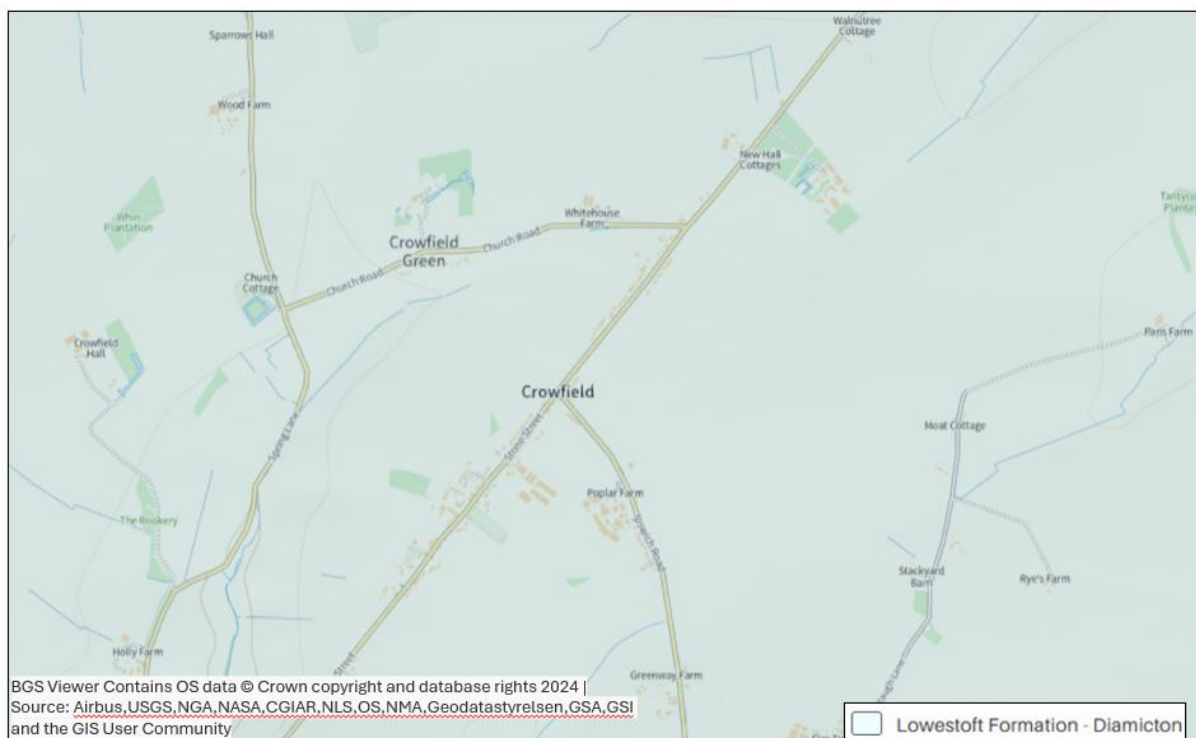
Figure 9. Superficial Geology (BGS Viewer)

Lowestoft Formation 'Diamicton' surrounds Crowfield which is described by the British geological survey as a diverse mixture of clay, sand, gravel, and boulders varying widely in size and shape. This generally has a low permeability, meaning water will tend to flow off it before it can be infiltrated. Saturated ground and high rainfall, like that of Storm Babet, will further emphasise the vulnerability of the parish and localised flooding could be experienced.

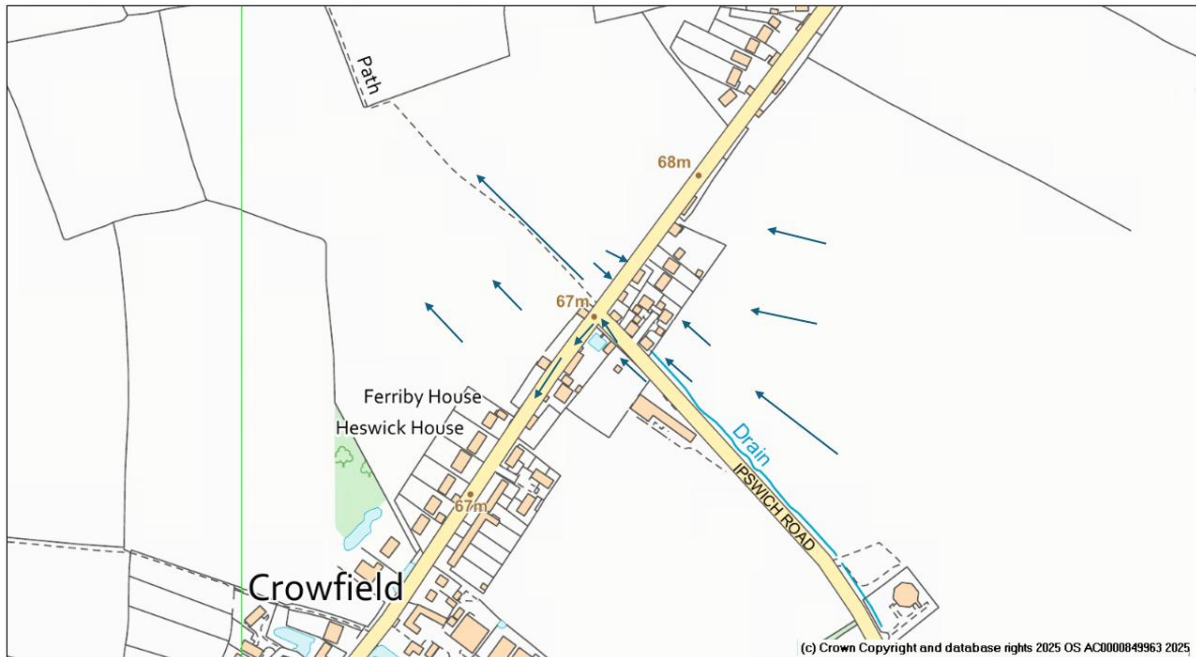
Figure 10. Approximate flood water flow routes along Debenham Road, Gosbeck Road and Stone Street

On the morning of 20 October, following a period of heavy rainfall, it was reported that surface water began to accumulate on fields (approximately 9am) close to the junction. Property was impacted by a combination of surface water runoff from neighbouring fields, highway as well as overtopping of watercourses.

Flood water began to pool on fields located to the east of the junction at the rear of properties and opposite, across the road. The flood water flowed overland into the adjacent watercourse, however due to the volume of water and reports of unmaintained channels (both open and piped) the feature quickly exceeded capacity. Flood water flowed across rear gardens, before breaching thresholds and entering

properties. Water also overtopped directly onto the highway and consequently flooding into properties.

A further source of flooding was reported from a small watercourse slightly south of the junction. It has been reported to have been unmaintained, causing water to discharge directly onto the highway. The over-topping of watercourses within this area caused flood water to merge at the junction of Debenham Road, Gosbeck Road and Stone Street. Additional flows were seen coming off fields north of the road junction. Water flowed across a public right of way directly onto the highway as well as overtopping the watercourse. This surface water further contributed to the flooding.

By approximately midday, the accumulation of surface water had resulted in internal flooding to multiple properties along Debenham Road and Stone Street. One resident reported flood water levels reaching 8 inches within their affected property.

Residents reported that the local drainage system was unable to cope with the volume of water during the storm. They also noted that several highway gullies were blocked at the time. Both surface water and foul water were observed surcharging from drains and manholes. Reports indicated that ditches were overflowing and unmaintained, which restricted flows and contributed to overtopping. Residents have since made efforts to reduce the impacts of flooding, including the removal of blockages from ditches where possible.

- Following heavy rainfall, high water levels flowed across fields. Flood water exceeded the capacity of watercourses in multiple locations, causing water to flow across land and onto the highway.
- Unmaintained and/or culverted watercourses restricted the flow of water and caused flood water to travel overland.
- Surface water from the highway added to the extent of the flooding as highway drainage was overwhelmed by the amount of floodwater. There were reports of some assets being blocked.
- Property was impacted by a combination of surface water runoff from neighbouring fields, highway as well as overtopping of watercourses.

LLFA recommended action(s):

- Residents to install Property Flood Resilience (PFR).
- Riparian landowners to carry out appropriate watercourse maintenance (both open and piped) to reduce flood risk as necessary as per their riparian responsibilities.

- Explore potential NFM projects to 'slow the flow' and attenuate water on overland flow paths east of Debenham Road, e.g. storage ponds, wetland areas, field bunds.
- Suffolk Highways to investigate potential blocked assets in the affected areas of Debenham Road, Gosbeck Road and Stone Street
- Suffolk Highways to ensure the completion of highway drainage asset cyclic maintenance (with the inclusion of grips) on Debenham Road, Gosbeck Road and Stone Street.
- Landowner to ensure that the piped ditch is installed and maintained in accordance with the required consents from the LLFA and SCC Rights of Way.

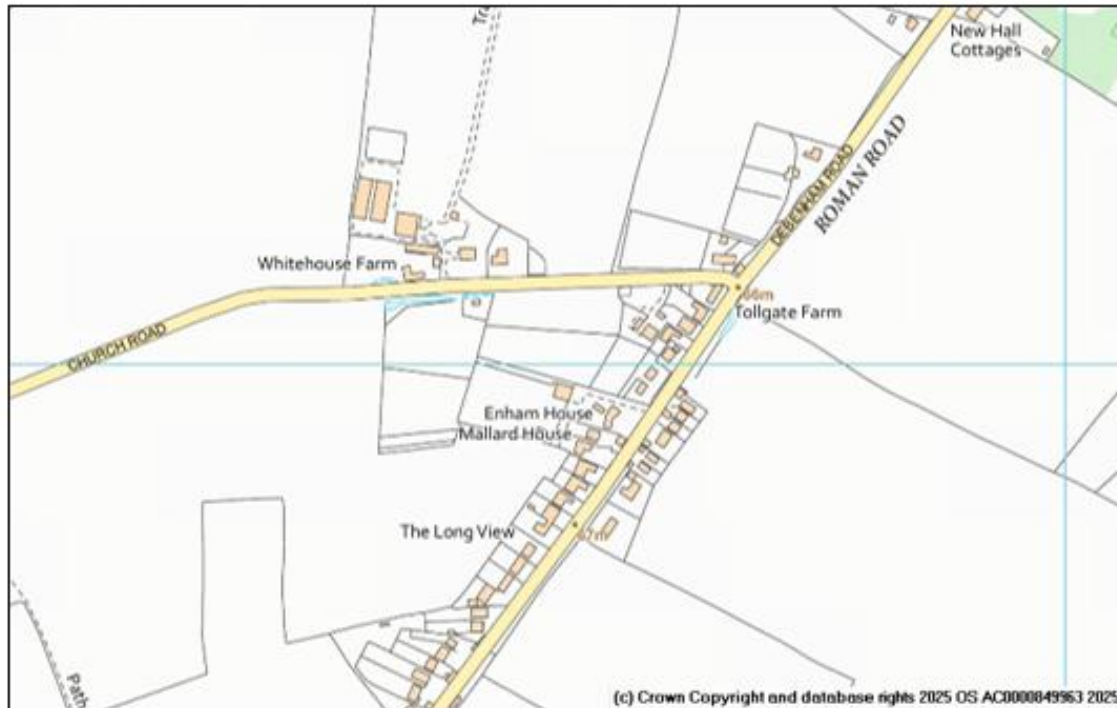
On 20 October, following a period of intense rainfall, the capacity of both the highway drainage system and Anglian Water infrastructure was exceeded. Hydraulic overload of these assets resulted in the highway flooding, loss of serviceability of utilities within adjacent properties, and surcharging of local drainage networks caused discharge into residential gardens.

This condition has recurred in this locality since 2021 during moderate to heavy rainfall events. Initial investigations by Anglian Water suggested that probable cause of flooding at this location is misconnections into the sewer system. Further investigation is required to determine the root cause of the flooding at this location.

- Heavy rainfall overwhelmed highway and drainage assets causing utilities to back up in a property.

*Figure 12 Church Road which was affected by surface water flooding*

### **LLFA recommended action(s):**

- Suffolk Highways to ensure the completion of highway drainage asset cyclic maintenance (with the inclusion of grips) on Church Road.
- Suffolk Highways to investigate the surface water drainage infrastructure at Church Road to outfall.
- Anglian Water to investigate the sewer system at Church Road.
- Following investigations Suffolk Highways and Anglian Water to coordinate efforts to resolve flooding at this location.
