Section 19 Flood and Water Management Act 2010

Debenham Flood Investigation - Storm Babet October 2023

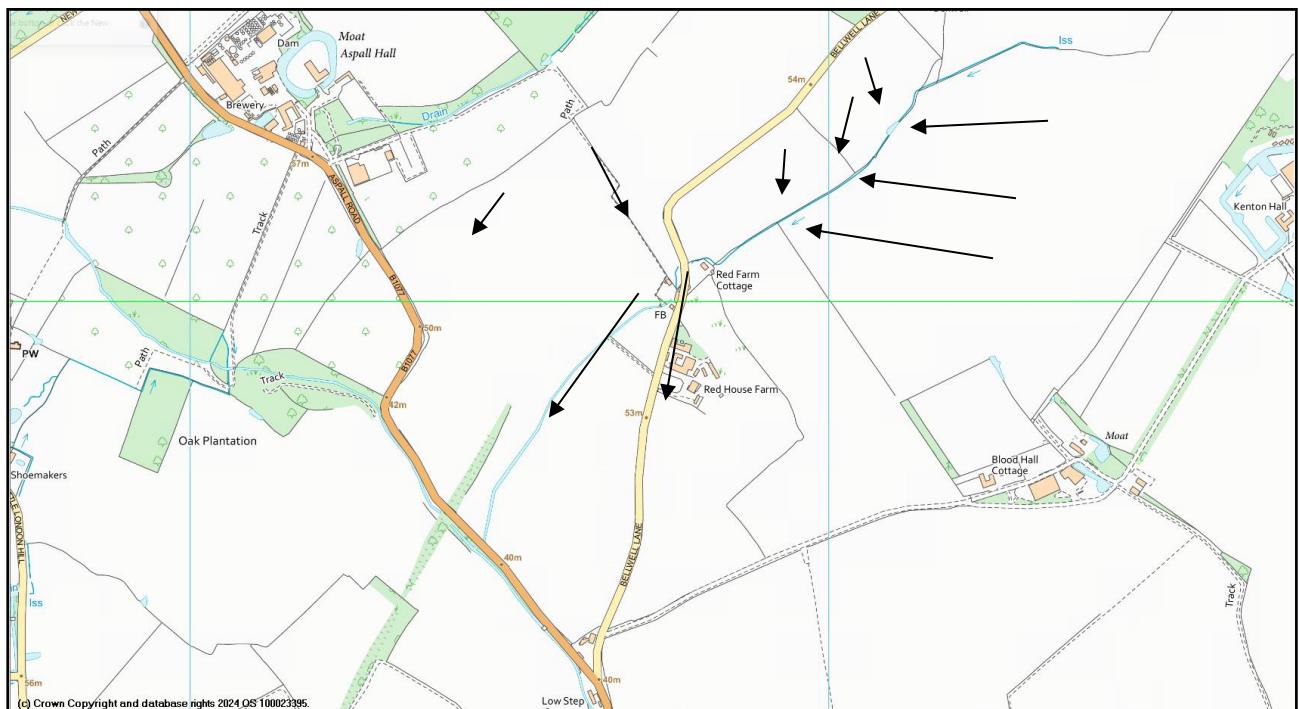
Figure 10 – Flow paths in northern Debenham

Located north of the village, Bellwell Lane runs adjacent to an ordinary watercourse which travels under the road, through a culvert located approximately 2 kms north of the village centre. According to reports, the culvert in this area was overwhelmed early in the day due to the volume of water coming off the surrounding field network.

A small ordinary water course inflows from the east taking water from a large surrounding area. A site visit confirmed there to be three interconnecting watercourses in this area which appear to flow through a large box culvert under the highway. There appeared to be a significant level of silt in the culvert which may have influenced its functioning capacity during the event. Additionally, there is a headwall in the northern watercourse which does not appear to contain a pipe to continue the flow, either the pipe is buried under significant debris or there is not a pipe to convey the water. This headwall then effectively forces the water onto the highway at this point preventing its movement downstream in the watercourse.

Reports suggest that a small number of properties on Bellwell Lane were flooded, which flooded previously in May 2023 potentially due to a blockage of the culvert under the highway.

- Drainage assets were overwhelmed beyond their capacity.
- Culvert under the road may have been blocked or not working correctly, resulting in impedance of flood water.
- Watercourse in area may have been blocked or not flowing at full capacity, resulting in impedance of flood water.

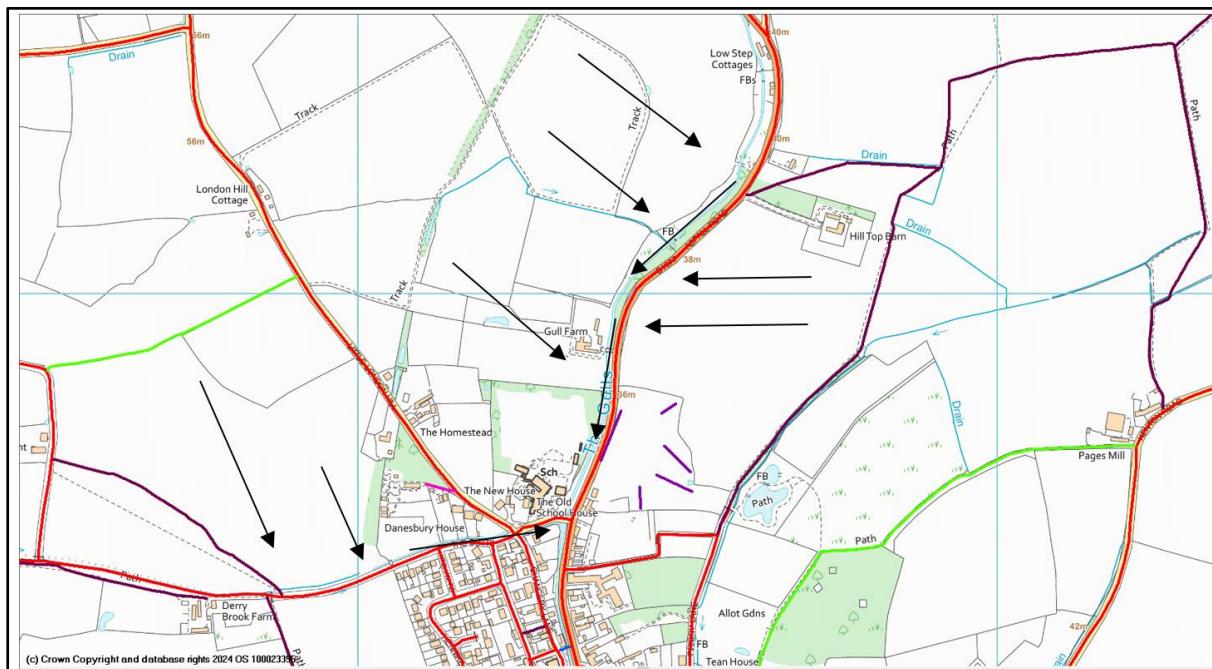
Figure 12 – Flow paths in northern Debenham

Reports from the southern end of Chancery Lane and Aspall road suggest sewage and oil were present in the flood water suggesting the sewerage system had become overwhelmed, and reports from the community suggest a home oil storage tank had slipped into the watercourse, possibly causing an additional blockage and leaking oil into the river.

The flow from the north, down Aspall Road and the adjacent watercourse, meets the main river Deben beside the road junction with the Butts, just south of the primary school. There is additional flow from Little London Hill and The Butts which travels in from the west. As a result of the overtopped river Deben, water flowed south down Chancery Lane and Aspall Road where it affected 25 properties across the two roads. Reports suggest internal water depths ranging from 5cm to 45cm, resulting in damaged properties, cars and the need to evacuate homes.

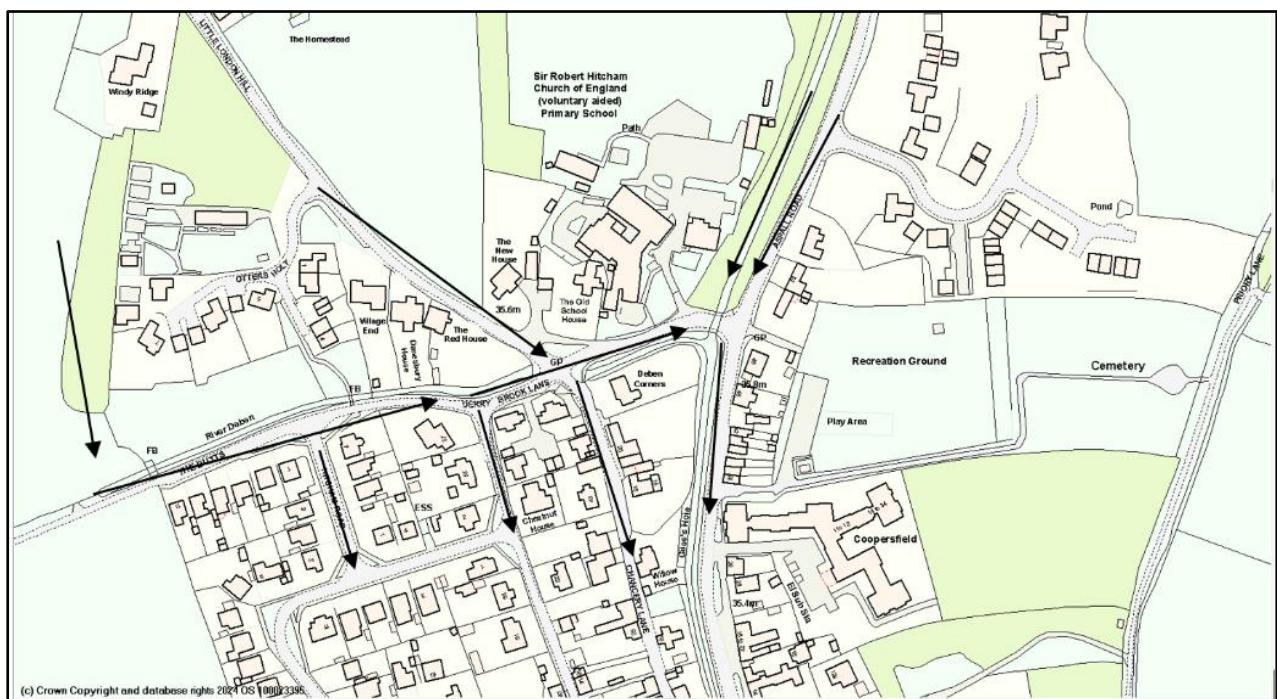
Figure 11 – Flow paths in northern Debenham

Chancery Lane and Aspall Road are in the northern part of Debenham, with Aspall Road being one of the main routes into the village from the north and Chancery Lane running south of the primary school. Reports from the area suggest that water flowed off fields surrounding Aspall Road, causing damage to the watercourse and road surface. This contributed to the flooding as a damaged bank of the watercourse allowed water to flow directly onto the road and into properties. Some reports indicated that the watercourse has not received regular maintenance which may have resulted in a reduction in the watercourse capacity. Following discussions with the Environment Agency it has been confirmed that a cut and clear vegetation clearance is carried out in this area once a year, normally in the autumn, in 2023, this was carried out in November.

- Large volume of water runoff from surrounding fields possibly caused damage to watercourses and allowed water to flow down the road.
- Concerns that the attenuation features on the new housing developments were not working correctly.
- Watercourses overtopping into the highway possibly exacerbated by high levels of vegetation in the area.
- Possible changes in cultivation direction could have funnelled water towards the highway and watercourses faster.

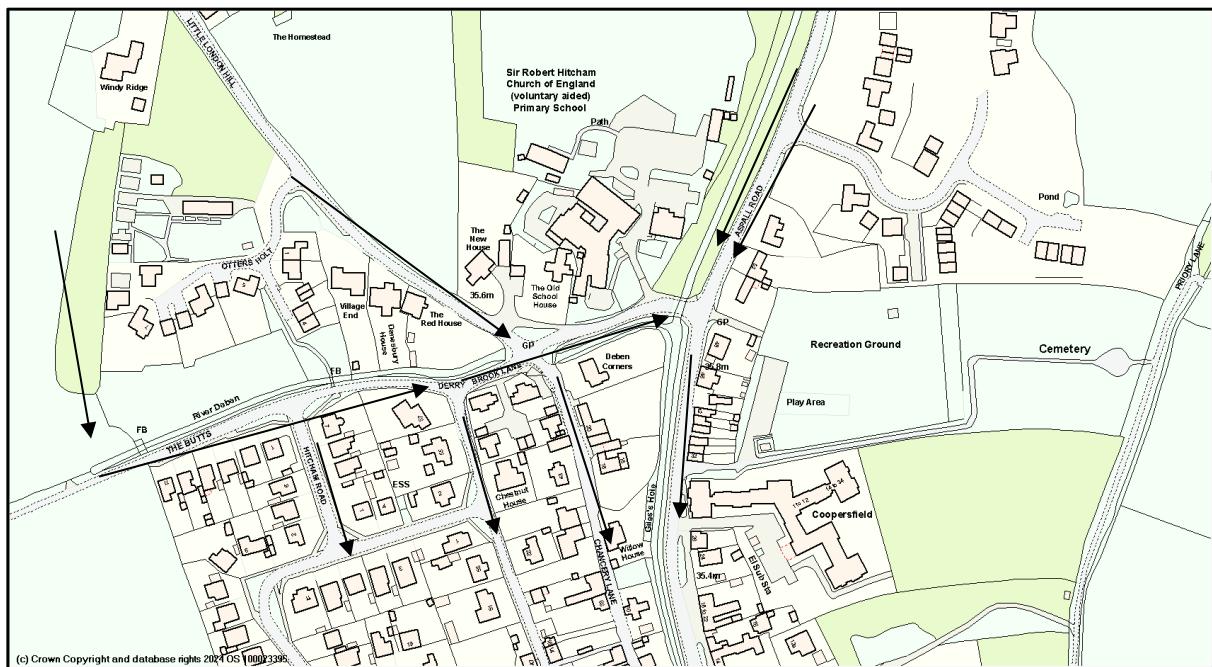
Figure 13 – Flow paths in northern Debenham

The flow path for the water in this area is from the west and north, heading east and south into the central village catchment. The overtopping of the Derry Brook in this area causing the road to act as a secondary flow path, contributing to the flooding experienced here and on the surrounding and adjoining streets such as Aspall Road and Chancery Lane.

Reports have said that internal flooding was experienced by at least 5 properties across the four roads with internal depths of water reaching 35cm and external depths deep enough to fully submerge cars.

- Overwhelmed watercourses caused spill of flood water onto the highway which then entered properties from the highway.
- Concerns about recent housing developments and the management of surface water from the site.
- Saturated and low permeable ground could have exacerbated the flooding on this occasion.

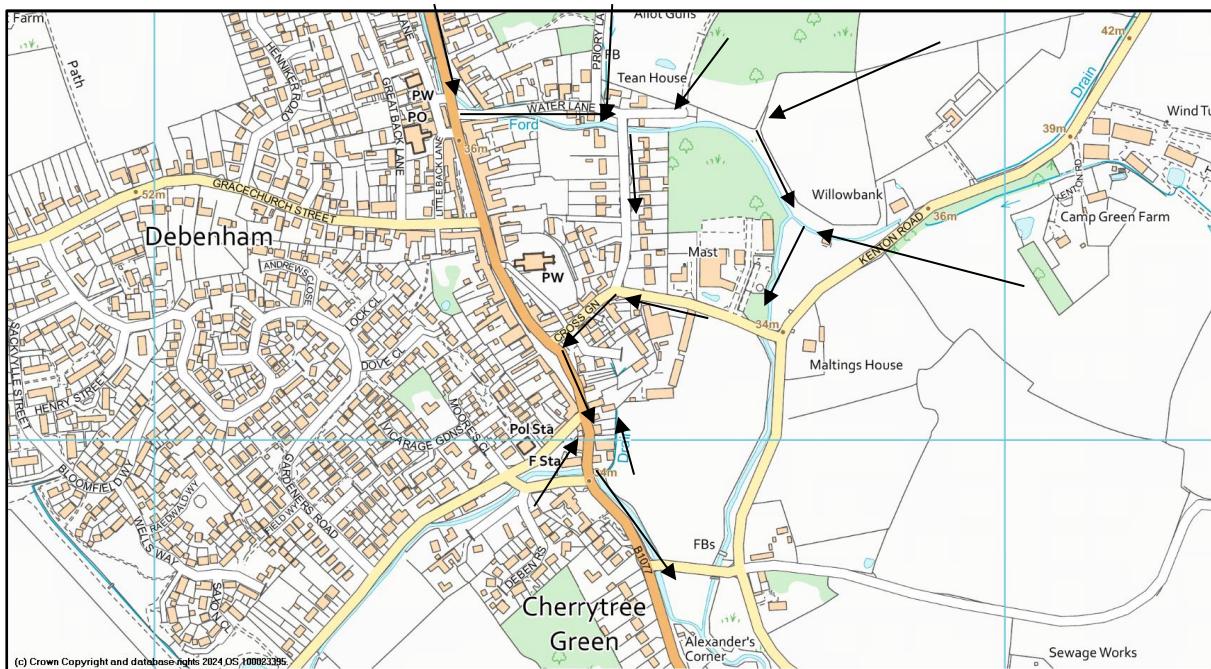
Figure 14 – Flow paths in central Debenham

The flow in this area comes primarily from the over topped River Deben, with water traveling south along Aspall Road and Chancery Lane, before flowing along Water Lane and down Priory Lane. Flow paths from northern Priory Lane and Kenton Road to the east, added to the flows, and resulted in the flooding of Cross Green and the Meadow Works business park.

There is some concern that the watercourse on the northern arm of Priory Lane and the culvert under the road on water lane were not operating to full capacity due to overgrowth and silting up of the features. This may have contributed to the severity of the flooding within this location. Currently the riparian ownership responsibilities of the section of watercourse in northern Priory Lane is under discussion. It should however be acknowledged that the volume of rainfall experienced, is likely to have exceeded the design capacity of drainage assets and led to the overwhelming of infrastructure in spite of vegetation levels.

There were 24 reports of affected properties in this area with internal flooding depths ranging from 20cm to over 90cm and external flood water being over 150cm deep.

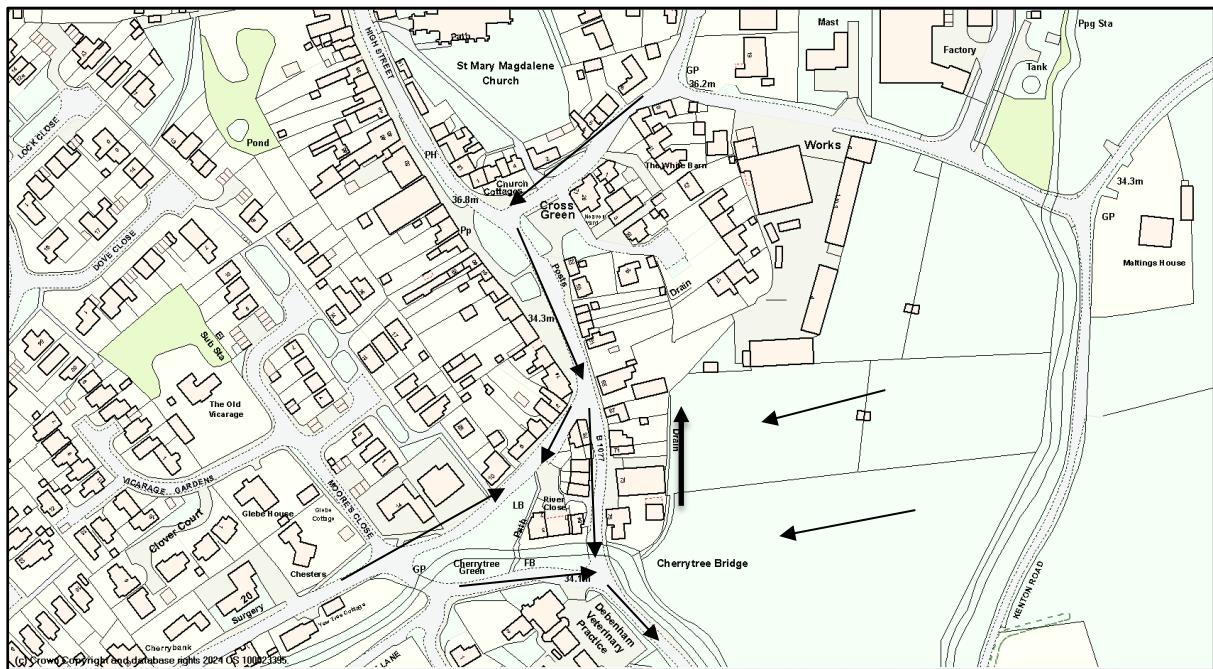
Figure 15 – Flow paths in central Debenham

Due to the significant amount of rainfall, once the Cherry Tree Brook and River Deben had been overwhelmed reports suggest that water was being forced north (against the natural flow) along an ordinary water course which borders the easterly edge of the back gardens of properties on the High Street, as a result of this the watercourse was very quickly overwhelmed and spilled out affecting properties from the back in addition to the water already coming from the highway to their front.

The land to the east of the High Street behind the properties is known to be one of the worst affected spots and is at very high risk of flooding from both fluvial and pluvial sources.

24 Properties are known to have been affected in this area with reports ranging from 15cm to over 60cm of internal flooding.

- Flood water from Cherry Tree Brook, Cross Green, and green space to the east of high street congregated in this area.
- Overland flows resulted in the cherry tree brook and River Deben to reach capacity.
- Continued vehicle movement through flood water caused worsening of flood water ingress to properties.
- Drainage assets on the highway were overwhelmed.

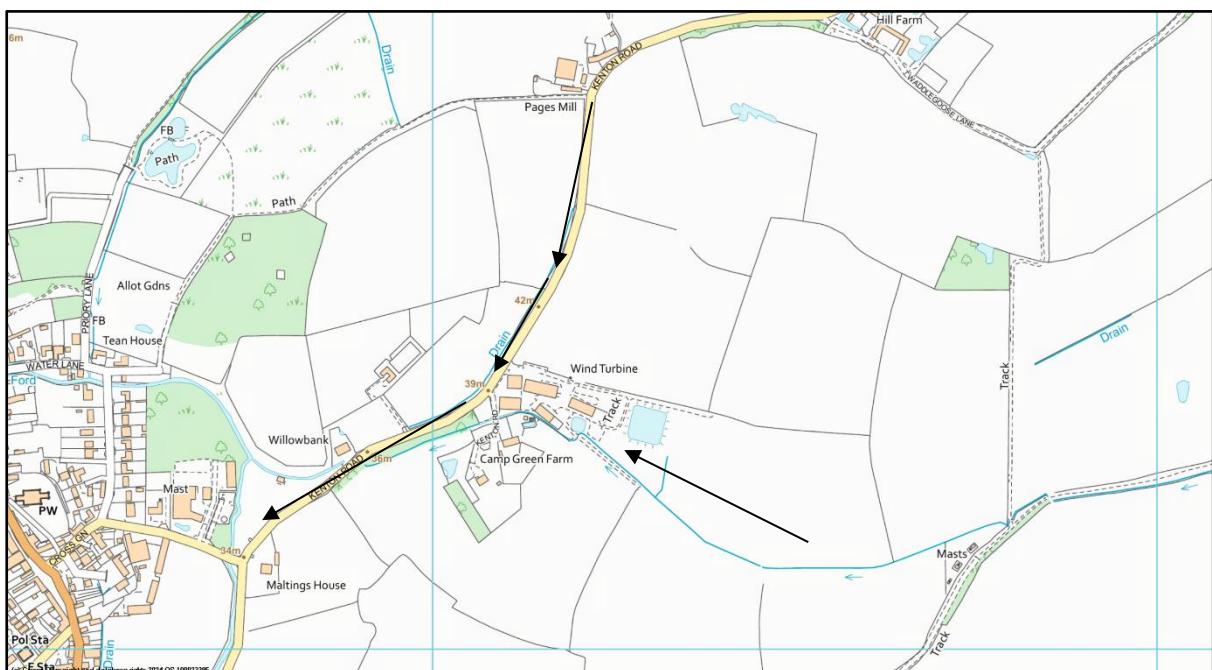
Figure 16 – Flow paths in eastern Debenham

Located to the east of the village centre, Kenton Road was an isolated case from the rest of the village. Reports suggest a combination of fast flowing surface water and overwhelmed watercourses in the area, contributed to the flooding, the water simply flowed to the lowest point once watercourses were overwhelmed.

Kenton Road is a main flow path on the predicted risk of surface water flooding maps. There are several ordinary watercourses in the area which flow adjacent to the road on both sides. Additionally, there are a number of watercourses that are piped, which may have caused a constriction if blocked or have insufficient capacity during Storm Babet. This may have resulted in the overwhelming of watercourses and contributed to flooding experienced in this location.

Flooding was recorded as being approximately 45cm deep affecting offices, farm buildings and workshops.

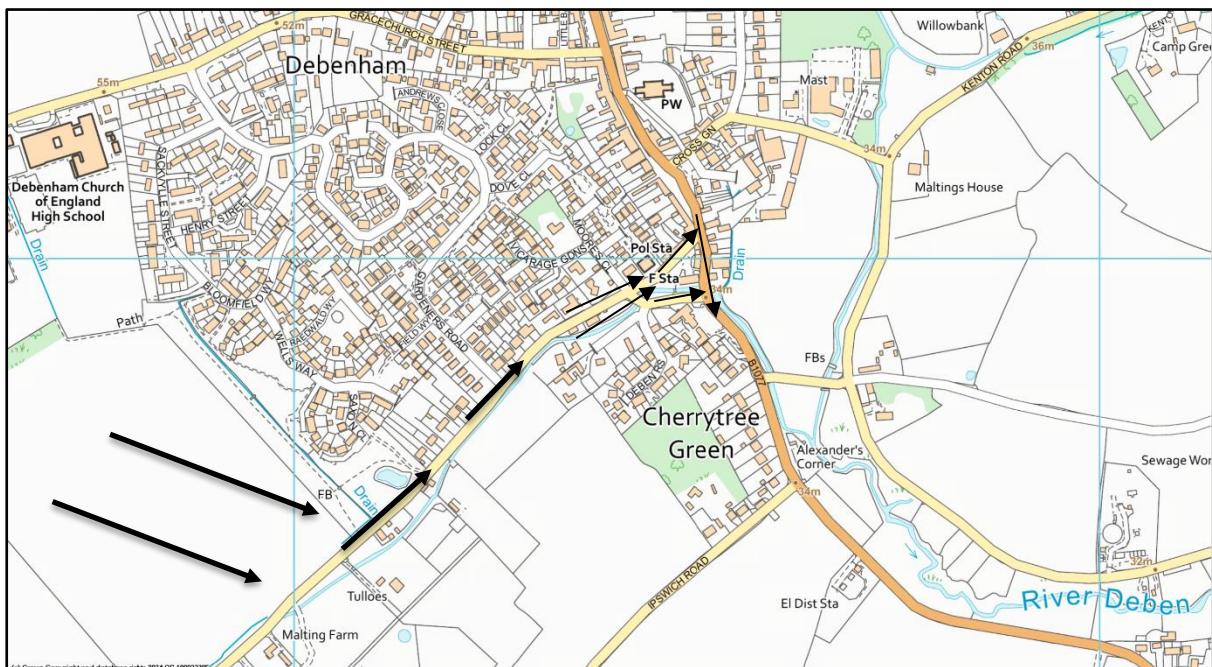
Figure 17 – Flow paths in southern Debenham

Many properties in the area reported being affected from both the road at the front of the property and the Brook at the back of the property. Properties were surrounded by flood water and in some cases flood water was coming up through the floor due to rising groundwater levels.

The flow path experienced is in line with the predicted flood risk map, coming along the line of the Cherry Tree Brook and spilling on Low Road and Cherry Tree Lane. As the water passes along Low Road, it meets the High Street, accumulating here before flowing south out of the catchment.

centres. 23 properties are known to have been affected with reports suggesting internal flooding levels of between 15cm and 90cm being recorded and external depths of over 90cm being observed.

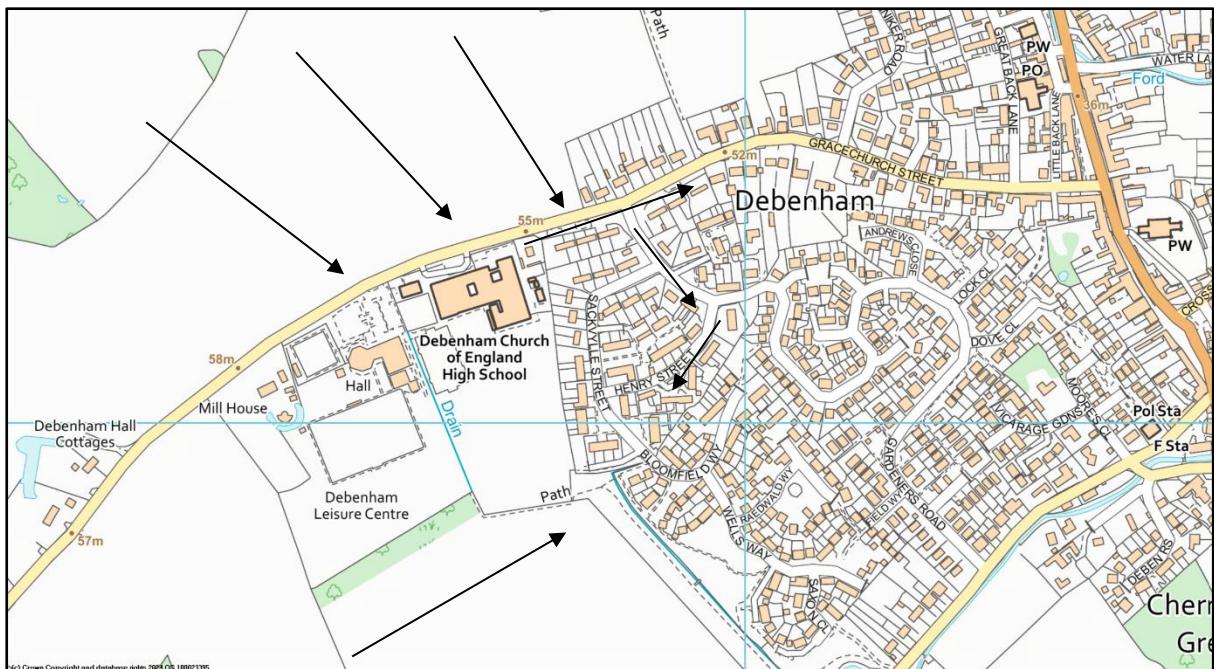
Figure 18 – Flow paths in western Debenham

It is therefore likely that volume of water and potential blockages within highways networks were contributing factors.

Gracechurch Street shows as an area of very low risk to surface water flooding on the predicted flood maps. However, reports in the area suggest that a blocked sewer or highways drainage gully could have been a contributing factor. Given only a small number of properties were affected, a localised blockage could have contributed to the flooding.

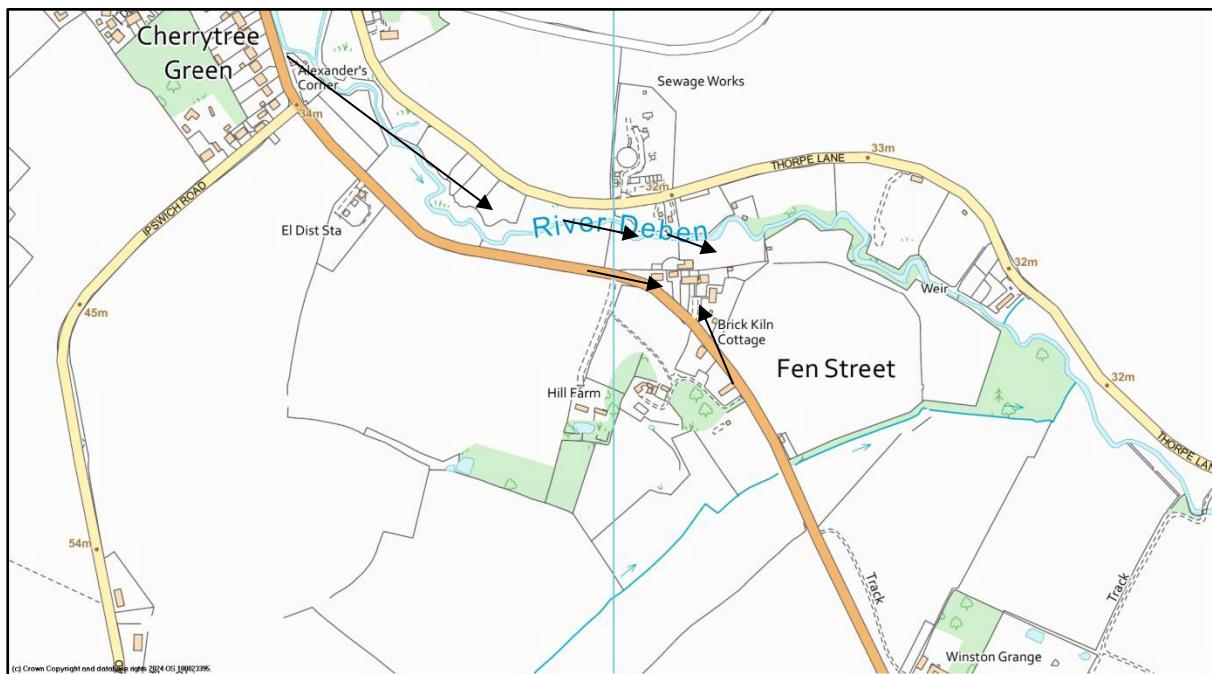
Figure 19 – Flow paths in southern Debenham

Fen Street, situated in the parish of Winston is half a kilometre southeast of Debenham village. A small number of properties were reported to have flooded during Storm Babet and are situated parallel to the River Deben. Residents reported that the River Deben quickly exceed capacity and overtopped onto the flood plain before flooding properties from the rear. Flood water also travelled from the road descending north towards the properties resulting in properties being surrounded by flood water. Impacted properties are situated lower than the road.

- No action suggested beyond those made to all affected residents in the recommendations section of this report.

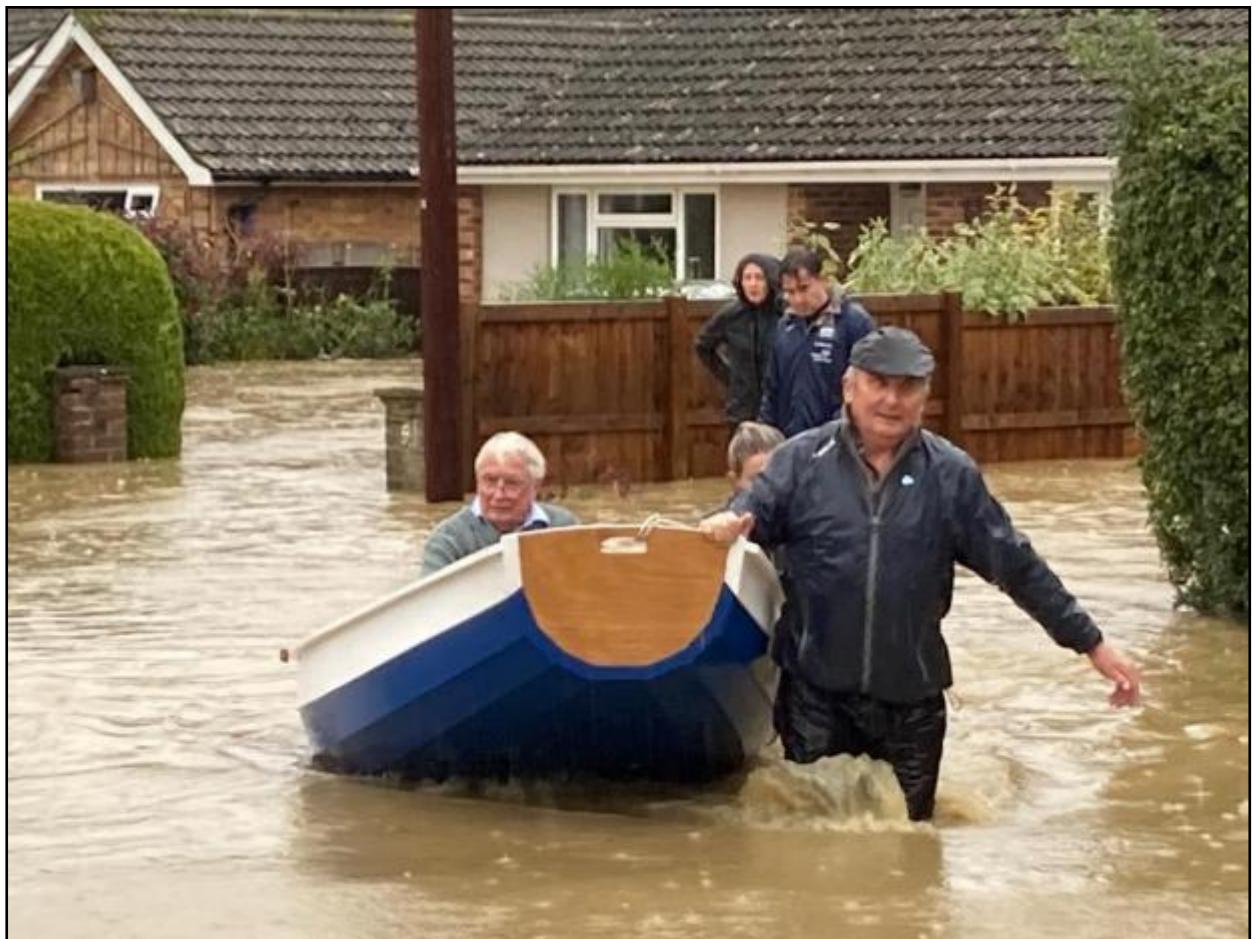
Central Debenham, residents having to be rescued by boat

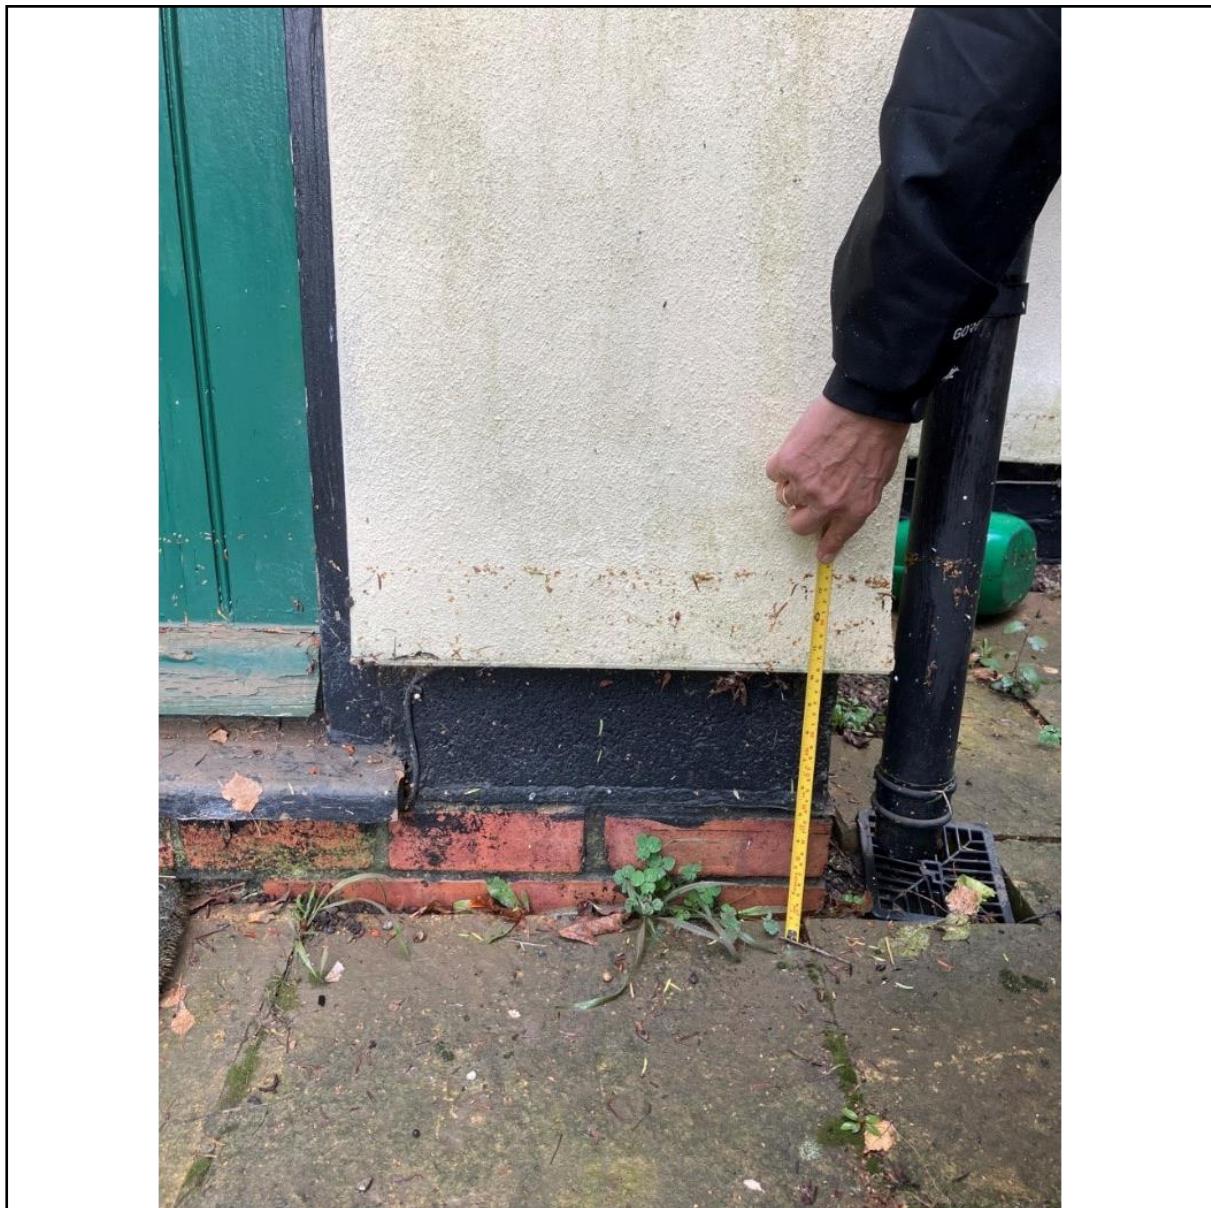
Post event wrack marks measured by EA CIOs

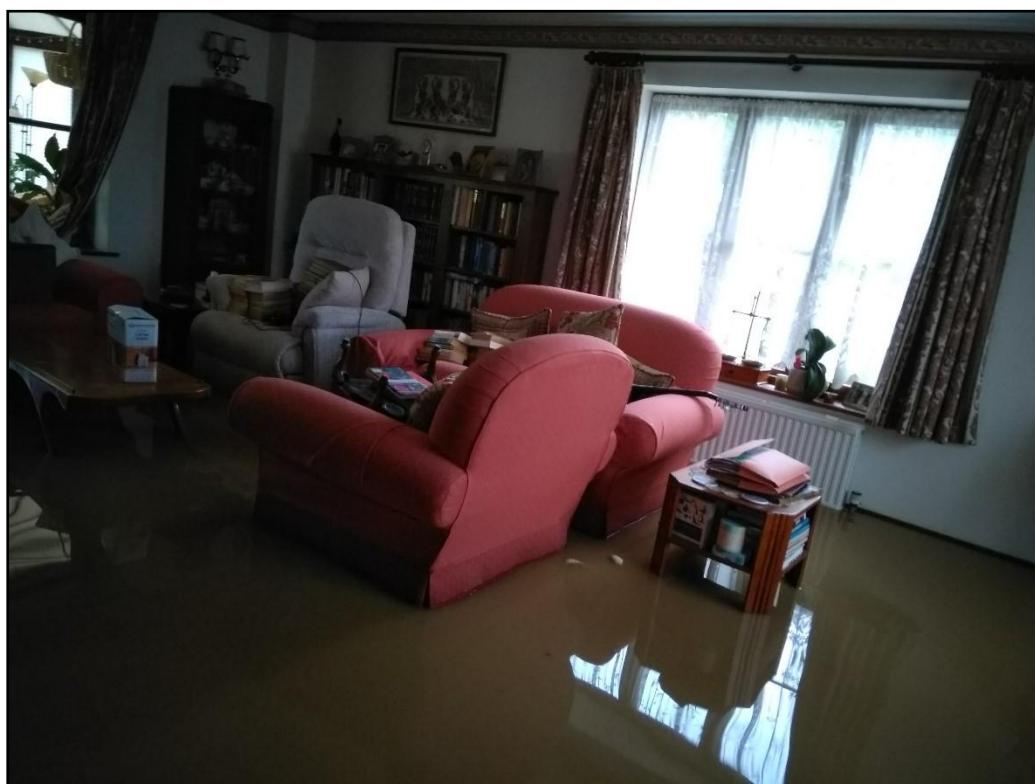
Internal Flooding extents

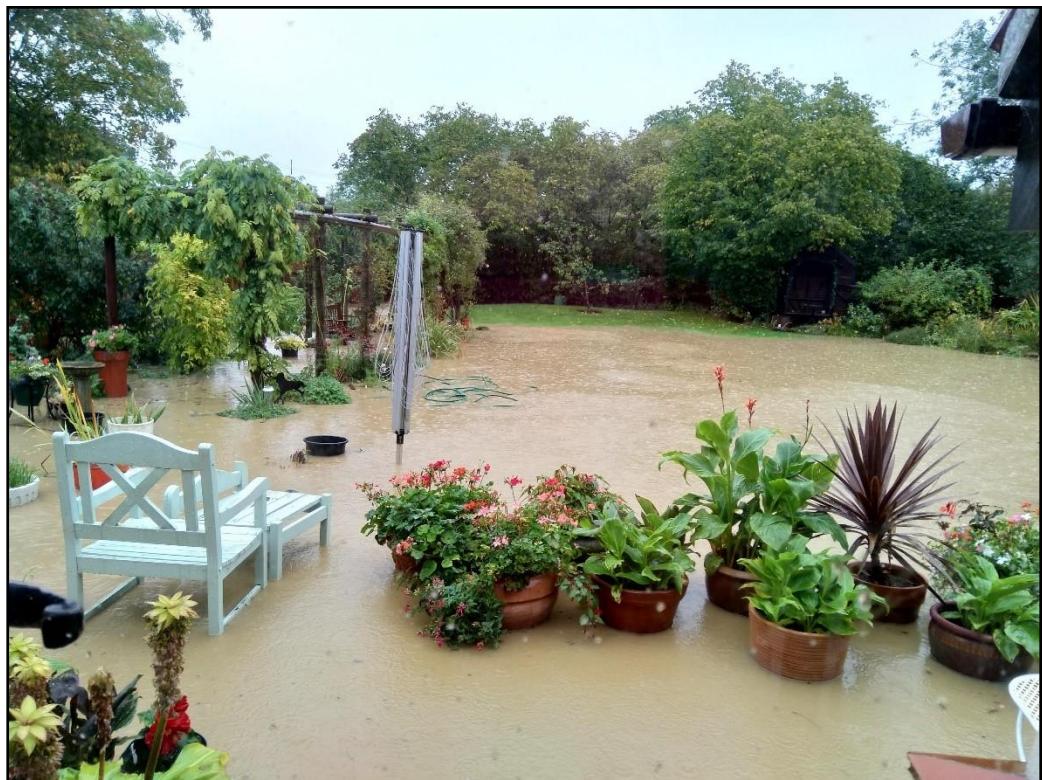
External flooding extents
