Section 19 Flood and Water Management Act 2010

Easton Flood Investigation –

Storm Babet 2023

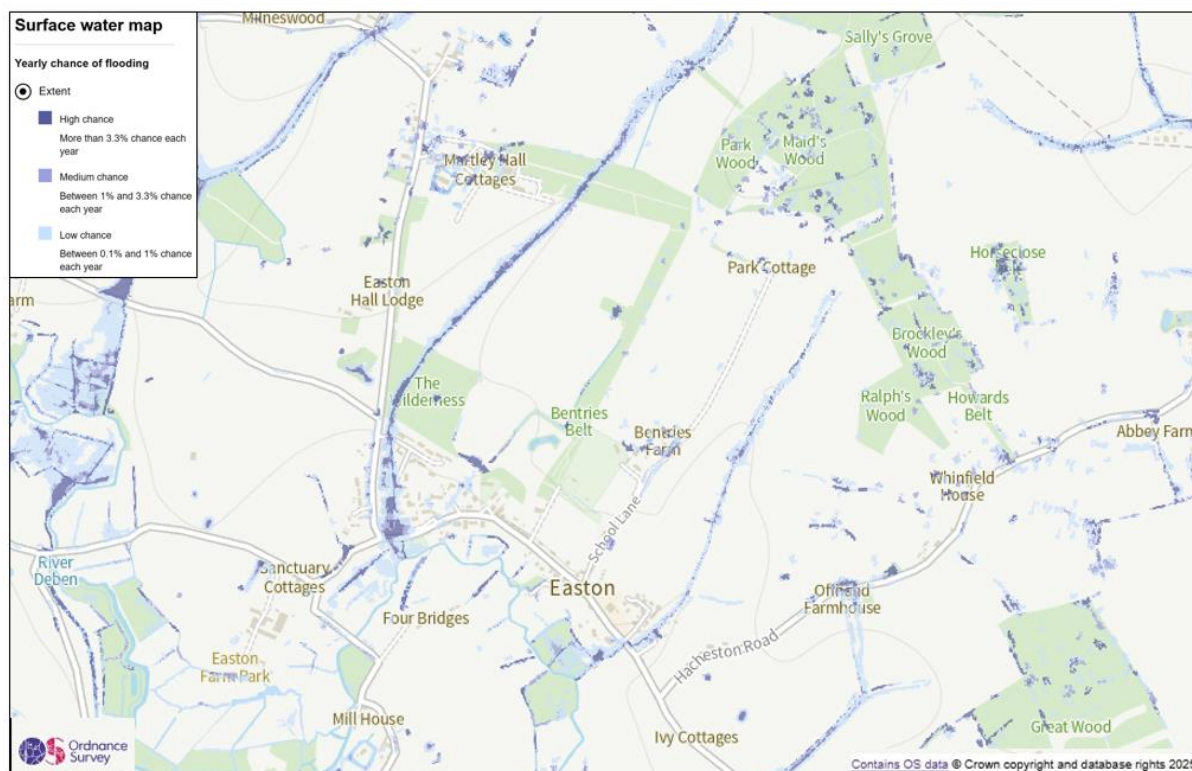
Figure 6. Surface water flood risk

Figure 6 highlights the predicted pluvial (surface water runoff from surrounding land and highways) flood risk in Easton. There are several flow paths that run through the village from the north, joining the river Deben to the South. There are also areas of isolated surface water flood risk.

There is a high chance of surface water flooding on Harriers Walk, Hacheston Road and sections of The Street. These areas were all affected by flooding during Storm Babet.

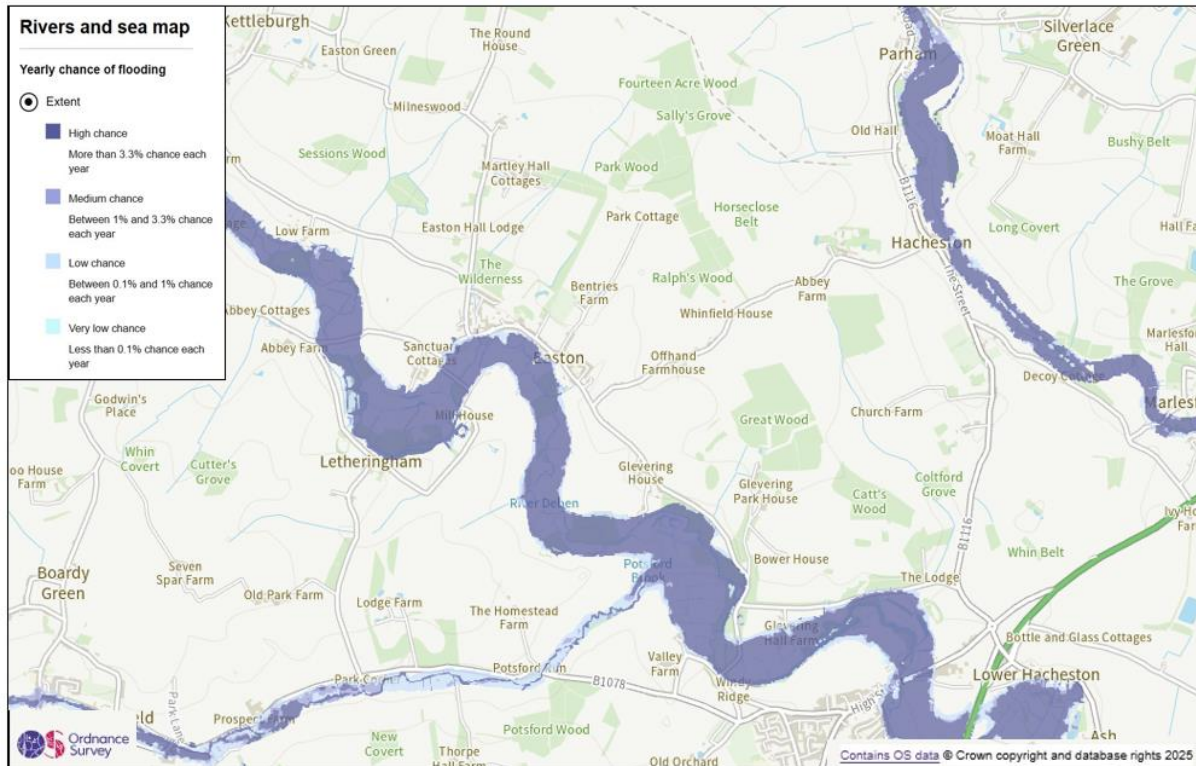
Figure 7. Flood risk from rivers and sea

Figure 7 shows the predicted fluvial (from designated main river and ordinary watercourses) flood risk in Easton. The fluvial flood risk in Easton is predominantly associated with the river Deben which flows from the northwest of the catchment, then adjacent to the village, and onwards southeast towards Wickham Market.

There is a low chance of fluvial flooding to some properties on The Street.

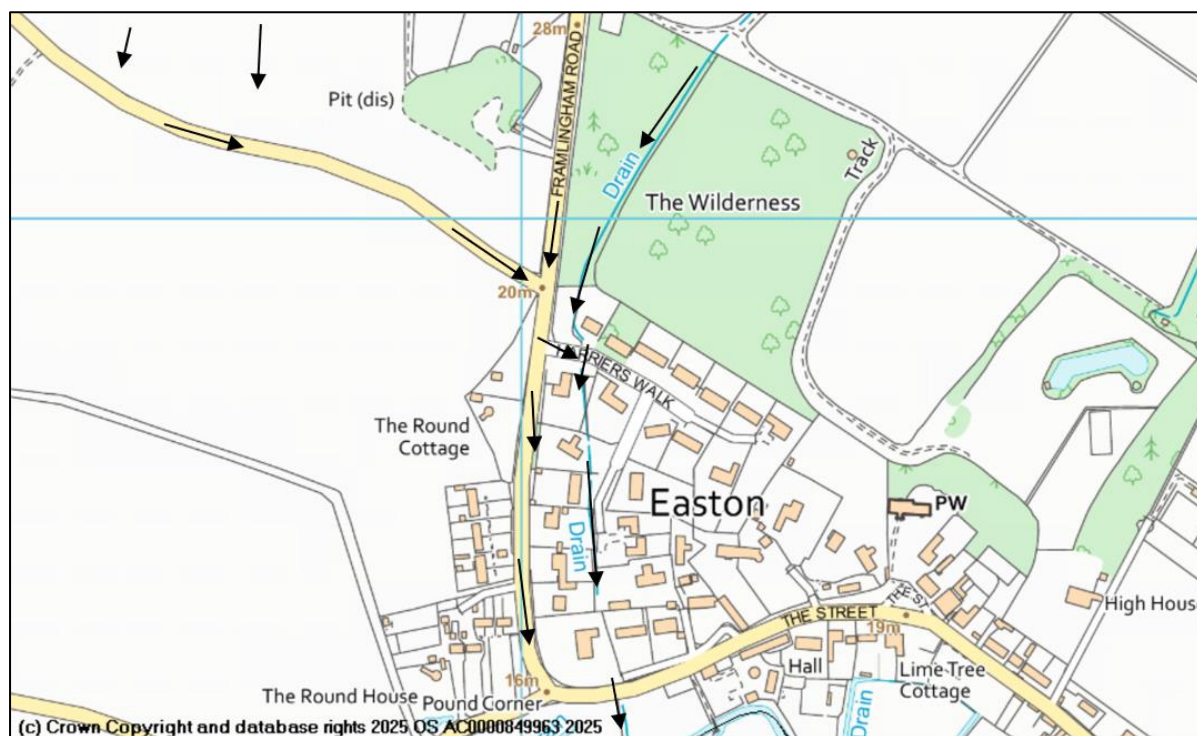
Figure 12. Approximate flood water flow routes on Harriers Walk

The primary cause of flooding on Harriers Walk was pluvial flooding. On 20 October 2023, intense rainfall caused huge amounts of surface water to flow north to south, from the farmland above Easton towards the village. Much of the water arrived along the watercourse identified as the main flow path on the flood map, but some of the internal flooding on Harriers Walk was caused by surface water runoff from fields draining onto the Kettleburgh Road, flowing onto Framlingham Road and then into

properties. Residents described this fast-flowing floodwater on the highway as sweeping into Harriers Walk and also into property adjacent to Framlingham Road, submerging gardens, garages and flowing down driveways and surrounding houses (see Figure 12). The existing highway drainage along Framlingham Road and on Harriers Walk was overwhelmed by the sheer volume and force of floodwater during the storm event.

One property was flooded directly from the watercourse that runs through Harriers Walk north to south towards the Deben. The capacity of this watercourse was clearly exceeded by the amount of floodwater flowing into it from the catchments above. There are culverted sections of this channel in the built up area of the village, for road crossings and within private property. This will have reduced conveyance in the watercourse and increased the risk of water backing up behind the culverts as well as being a site for potential blockages, although this was not reported during the storm. Two sections of culverting on private property were identified as unconsented works, these were assessed by SCC LLFA engineers and one section was removed due to the potential for increased flood risk.

The primary cause of flooding in this location was the amount of water falling on a large arable catchment which flows unrestricted onto roads and via a watercourse directly adjacent to properties in the built up area of the village. The floodwater flowpaths observed on Harriers Walk during Storm Babet closely match the national surface water flood risk mapping (see Figure 13), which show a high likelihood of surface water flooding.

- The primary cause of the flooding on Harriers Walk was pluvial flooding.
- Intense rainfall caused huge amounts of surface water runoff from the fields north and northwest of Easton to drain onto watercourses and onto the highway.
- Kettleburgh Road and Framlingham Road acted as pathways for the floodwater to flow into Harriers Walk.
- The watercourse running through Harriers Walk overtopped as its capacity was exceeded by the amount of surface water flowing from the catchments to the north.
- Floodwater flowed down driveways, surrounding properties and submerging gardens.

- Residents to consider installing Property Flood Resilience (PFR) measures.
- Riparian landowners to carry out appropriate open and piped watercourse maintenance to reduce flood risk as necessary as per their riparian responsibilities.
- Explore potential NFM projects to 'slow the flow' and attenuate water on overland flow paths north and northwest of Kettleburgh Road and Harriers Walk, E.g. leaky dams, woody debris installation, restoration of watercourses, storage ponds, wetland areas.
- Suffolk Highways to investigate options for improving highway drainage on Kettleburgh Road and Framlingham Road to manage surface water flows.
- Suffolk Highways to ensure the completion of highway drainage asset cyclic maintenance on Framlingham Road and Harriers Walk.

- Riparian landowners and members of the public to report any observed blockages in the culverts below the highway on the Suffolk Highways online reporting tool.

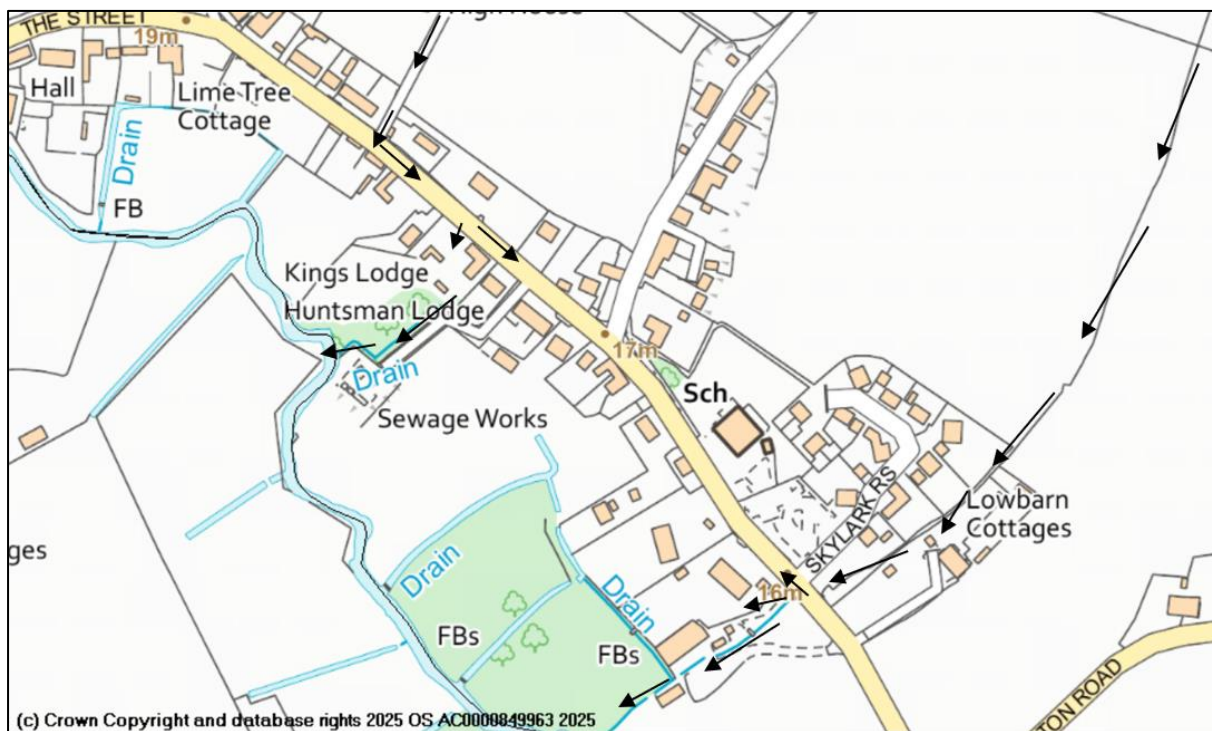
Figure 14. Approximate flood water flow routes on The Street

On the morning of 20 October 2023, intense rainfall caused large amounts of surface water to flow down Cemetery Lane on to The Street. Large sections of The Street were submerged, with the sewers backing up and foul water merging with the increasing extent of floodwater. Residents have described the highway drainage system on The Street as ineffective, with the problem of blocked drains being highlighted on numerous occasions prior to Storm Babet.

One property was flooded directly from the surface water pooling on the highway as the water overtopped from a gully and flowed down the driveway. The gully drains via a pipe to a ditch and then on to the river Deben. The outfall at the ditch and possibly the pipe itself was blocked. Floodwater was also observed emerging via the tarmac drive, leaking through the pipe surround indicating the possibility of a blockage. The property was internally flooded to a depth of approximately 180mm.

During Storm Babet large amounts of floodwater flowed down the open watercourse adjacent to the Skylark Rise development from the catchments upstream of Easton. Two properties were flooded directly from the overwhelmed watercourse as the extreme water levels exceeded the capacity of channel in multiple locations (see Figure 14). Reports from the residents indicate the culvert below the highway was blocked with silt and vegetation and the watercourse itself was overgrown with vegetation along its length due to a lack of maintenance prior to the storm. The floodwater backed up at the culvert and discharged over the road at this location.

- Intense rainfall caused large amounts of surface water to flow down Cemetery Lane and the open watercourse adjacent to the Skylark Rise development towards The Street.
- Parts of The Street were completely submerged in floodwater as the highway drainage assets were overwhelmed and the capacity of the watercourse next to Skylark Rise was exceeded.
- Some of the gullies, associated pipework and ditches may have been partially blocked, inhibiting drainage from the highway. Residents had reported drainage issues on The Street prior to Storm Babet.
- The watercourse next to Skylark Rise was undermaintained with overgrown vegetation and the downstream culvert was partly blocked with silt.
- One property was flooded directly from floodwater on the highway. Two properties were flooded from the overtopped watercourse.

- Residents to consider installing Property Flood Resilience (PFR) measures.
- Riparian landowners to carry out appropriate open and piped watercourse maintenance to reduce flood risk as necessary as per their riparian responsibilities.

- Explore potential NFM projects to 'slow the flow' and attenuate water on overland flow paths north and northeast of The Street and Skylark Rise, E.g. leaky dams, woody debris installation, restoration of watercourses, storage ponds, wetland areas.

- Suffolk Highways to ensure the completion of highway drainage asset cyclic maintenance on The Street.
- Suffolk Highways to investigate the condition of the existing highway drainage assets on The Street.

- East Suffolk District Council (ESDC) and Suffolk County Council, as Lead Local Flood Authority (LLFA), continue to explore what, if any, impact the Skylark Rise development may have had on the overall local flood risk.

- Riparian landowners and members of the public to report any observed blockages in the culverts below the highway on the Suffolk Highways online reporting tool.

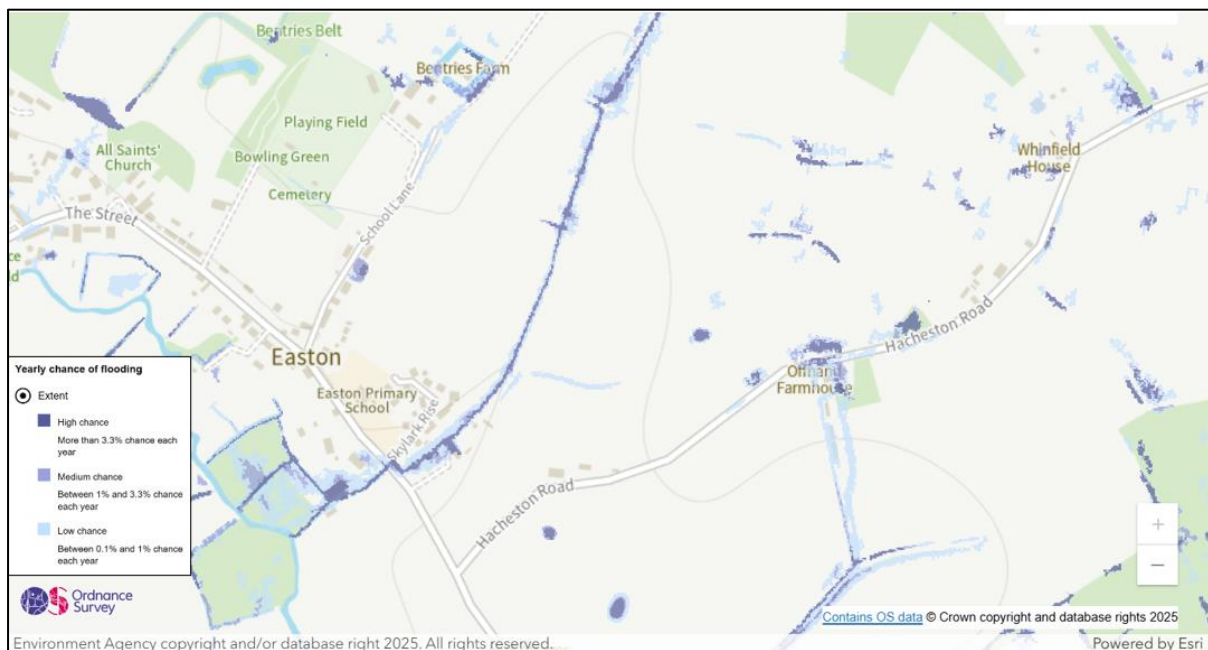
Figure 15. Surface water flood risk on The Street and Hacheston Road

The floodwater flowpaths observed on The Street during Storm Babet align closely with the national surface water flood risk mapping (see Figure 15). In some locations the flooding experienced was more extensive than the mapped risk. The majority of the internally flooded properties are located in areas characterised as having a high chance of surface water flooding.

Resident reports suggest the floodwater accumulated in the roadside ditch before overtopping and merging with surface water on the highway before flowing across the driveway and impacting the property and outbuildings. The existing highway drainage assets on Hacheston Road were overwhelmed by the volume of water on the road. Parts of Hacheston Road are characterised as being at high risk of surface water flooding on the national surface water flood risk mapping (see Figure 15).

- Residents to consider installing Property Flood Resilience (PFR) measures.
- Riparian landowners to carry out appropriate open and piped watercourse maintenance to reduce flood risk as necessary as per their riparian responsibilities.
- Explore potential NFM projects to 'slow the flow' and attenuate water on overland flow paths north of Hacheston Road, E.g. leaky dams, woody debris installation, restoration of watercourses, storage ponds, wetland areas.
- Suffolk Highways to ensure the completion of highway drainage asset cyclic maintenance on Hacheston Road.
