Section 19 Flood and Water Management Act 2010

Framlingham Flood Investigation – Storm Babet 2023

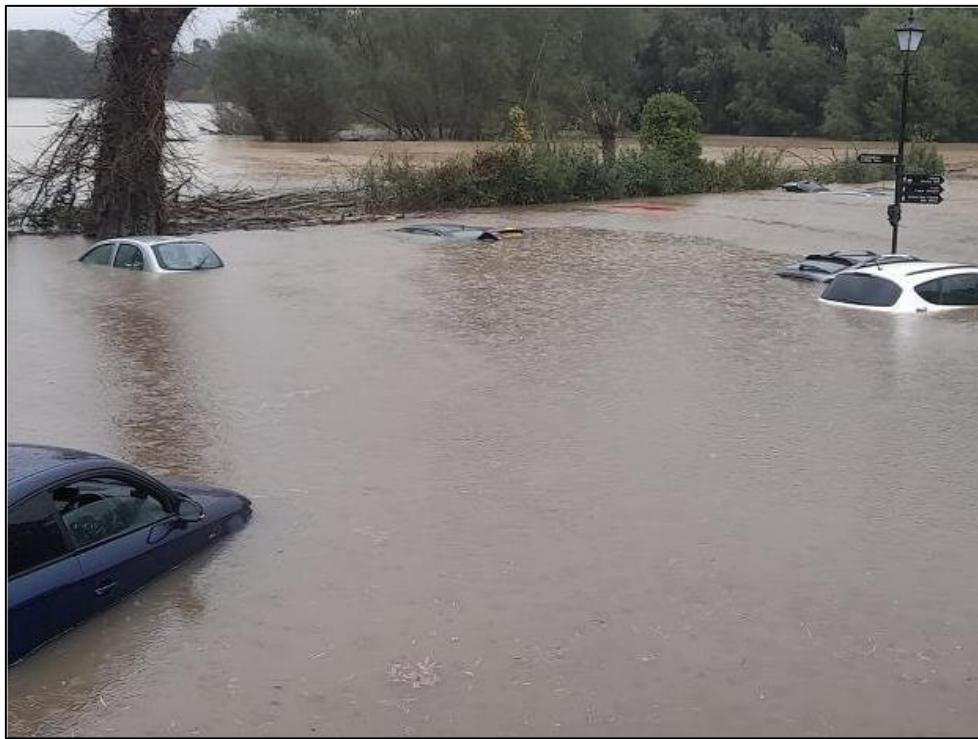
Image 1 - Flooding of The Elms car park and The Mere

The primary source of flooding in the north of Framlingham was fluvial flooding, from the overtopping of the River Ore and the Mere through which the Ore flows. There are five overland flow paths that feed into the Mere from the Upper Catchment above Framlingham. Residents reported that the water flows in both the River Ore and Mere rapidly expanded on the morning of Friday 20th. After overtopping the banks, overland fluvial flows quickly moved towards The Elms car park where depths reached approximately 150cm (Image 1). The depths in the car park increased and the area of flooding was enhanced by pluvial flows coming from New Road.

Flood water continued through the car park to flood the Elms residential area from the rear, inundating the entire area. This was increased by the surface water run-off flowing eastwards off New Road towards the residential area and the car park from the west and northwards from Bridge Street. Residential housing was flooded internally to a depth of approximately 80cm. All ground floor premises are thought to have been flooded (approx. 10). Residential, commercial properties and the road on Bridge Street were also flooded as the river overtopped between the road bridge and the Mere. Reports from residents suggest that there were blockages, most likely woody debris from the Mere, under the bridges over the Ore in this area which may have contributed to overtopping of the river channel. The combined fluvial and pluvial flood water flowed South and West towards Riverside and Well Close Square respectively but was limited in the direction of Market Hill by the natural raising incline to the East (Image 2).

- Investigate potential NFM projects and funding opportunities which aim to attenuate water and 'slow the flow' in upper catchment north of Framlingham.
- Framlingham College and Suffolk Wildlife Trust to review their maintenance/management of the Mere.
- Investigate potential new/additional highway drainage assets on New Road.
- Improve drainage system on The Elms carpark
- Remove any observed blockages within main river and ordinary watercourses where flood risk is increased.
- Ensure the completion of highway drainage asset maintenance and investigate if capacity and condition are sufficient.
- Investigate any capital interventions that can improve the flood resilience of the town.

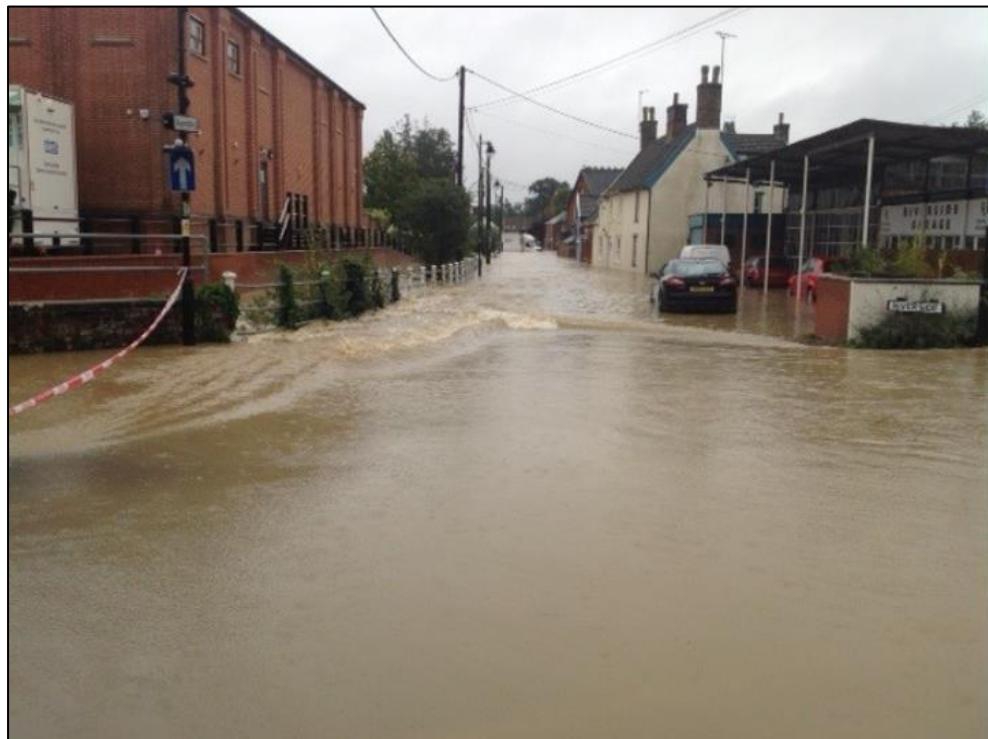
Image 2 -

Flooding on Bridge Street looking towards Riverside

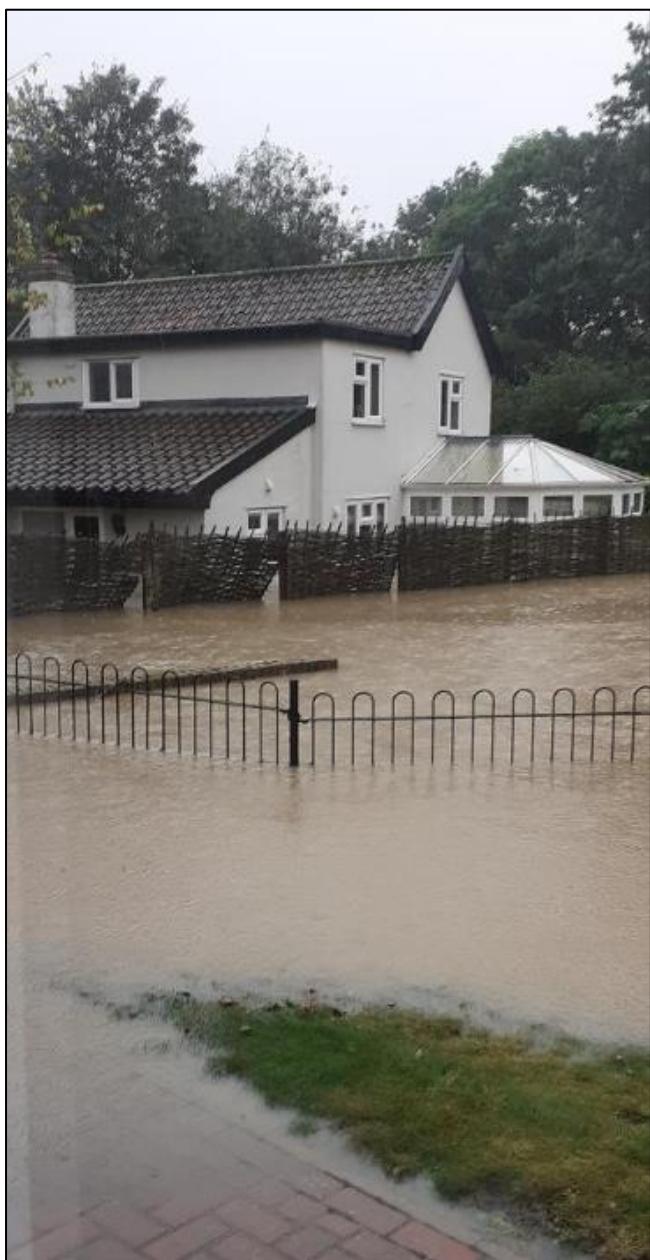
Image 3 - Flooding on Brook Lane

The Cherry Brook watercourse breached its banks early on 20th October and caused flooding of the adjacent Brook Lane (Image 3). The overtopping of the watercourse effectively creating a second flow path along the road, following the natural gradient towards Station Road (Image 9). This substantial amount of flood water is likely to have been greater than the design capacity of the highway gullies. This correlates closely with the predicted flood risk maps, with fluvial risk being categorised as Medium to High and the pluvial flood risk categorised as high along the length of Brook Lane.

- Investigate potential NFM projects and funding opportunities which aim to attenuate water and 'slow the flow' in the catchments West of Framlingham.
- Remove any observed blockages within main river and ordinary watercourses where flood risk is increased.
- Ensure the completion of highway drainage asset maintenance and investigate if capacity and condition are sufficient.
- Investigate options to connect surface water flowing on Brook Lane back into the river.
- Investigate options to improve the capacity of the culvert below The Mills on Brook Lane.

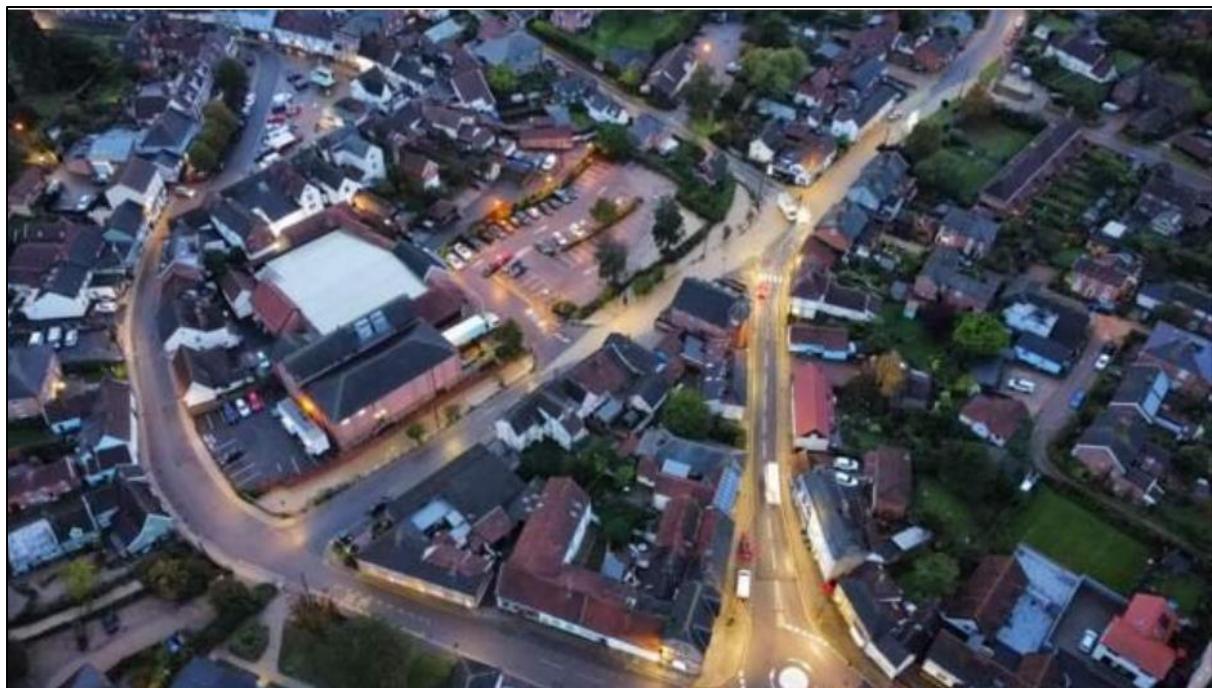
Image 4 - River overtopping at Riverside / Albert Place corner, early on the morning of 20th Oct

The River Ore burst its western bank initially at the junction of Albert Place and Fore Street and then south of the Bridge Street and Riverside junction (Image 4). This flood water flowed along Riverside, with the road acting as a secondary river channel, carrying floodwater downstream, inundating Albert place (Image 5). Residential and commercial properties on Riverside were flooded internally to approximately 33cm. The flood waters were added to by surface water from Bridge Street and New Road, flowing into Well Close Square and toward Albert Place. Central Framlingham and Albert Place in particular, being amongst the lowest points in Framlingham, acted as the central basin into which a combination of pluvial and fluvial floodwater accumulated. The roadside drainage assets were completely overwhelmed. Outfalls for highway drainage were quickly submerged as they fell below the peak river level, were unable to discharge fully into the river and caused water to back up.

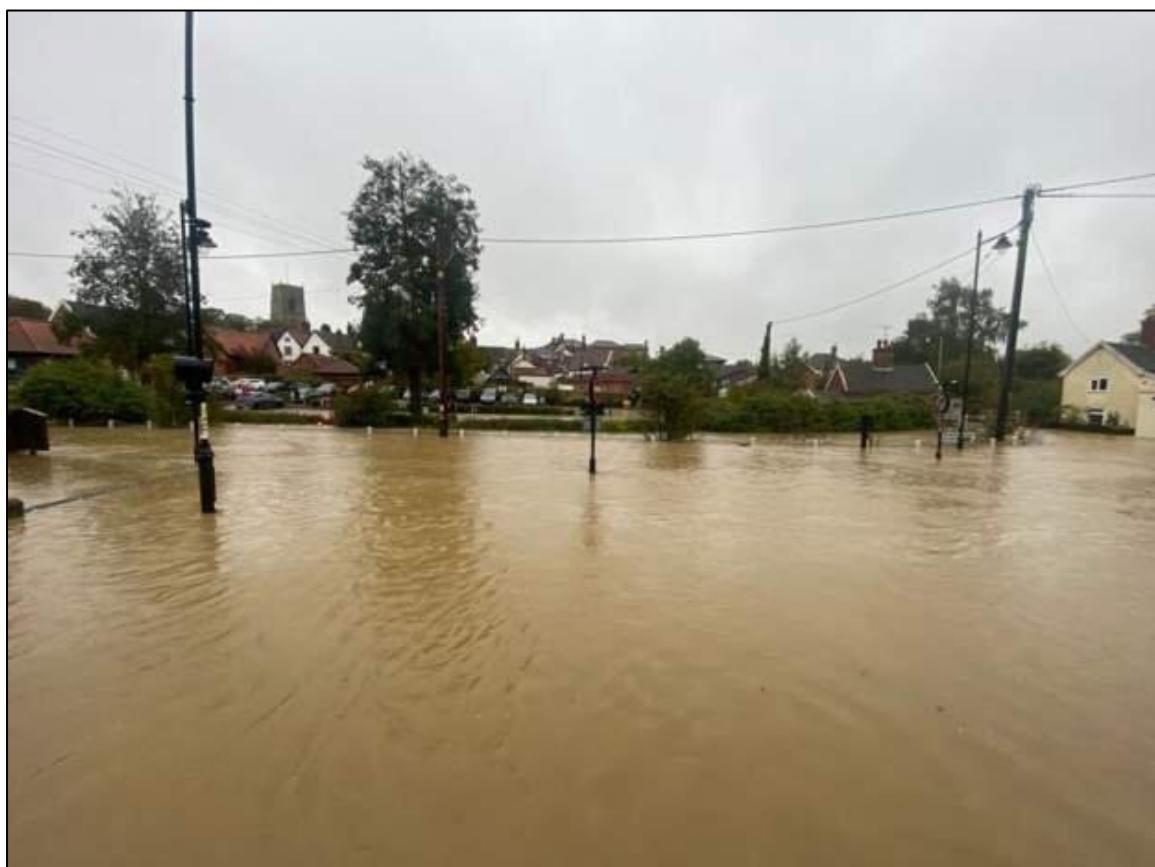
Image 5 - Extensive flooding on Albert Place

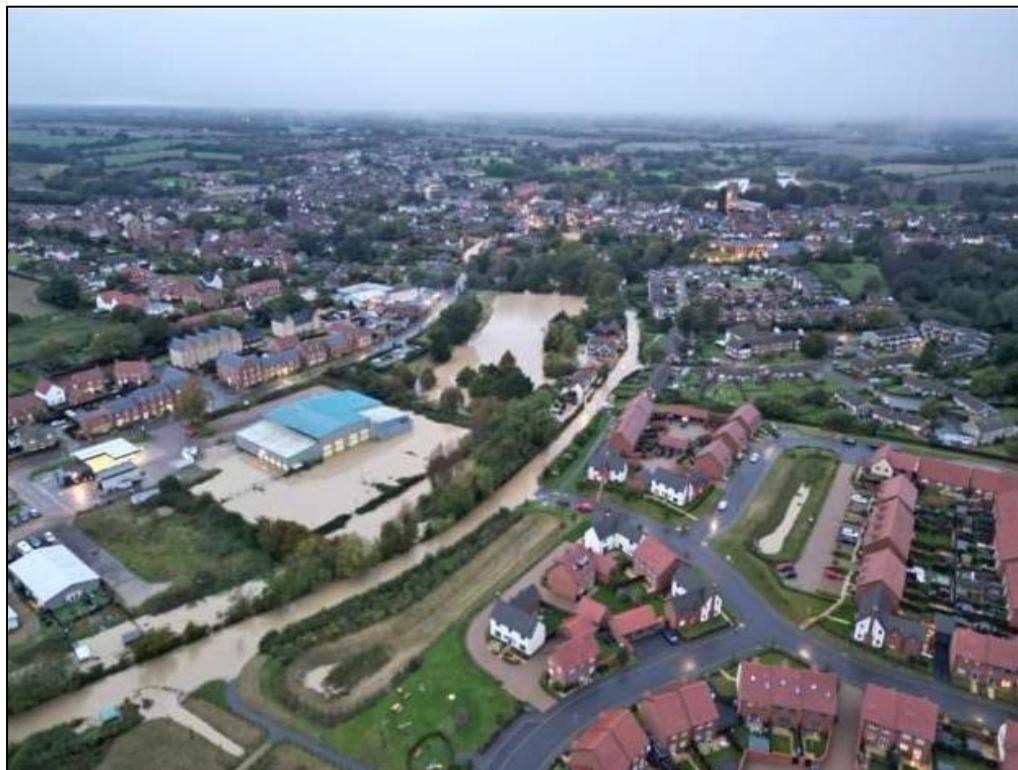
Image 6 - Flooding along Fairfield Road

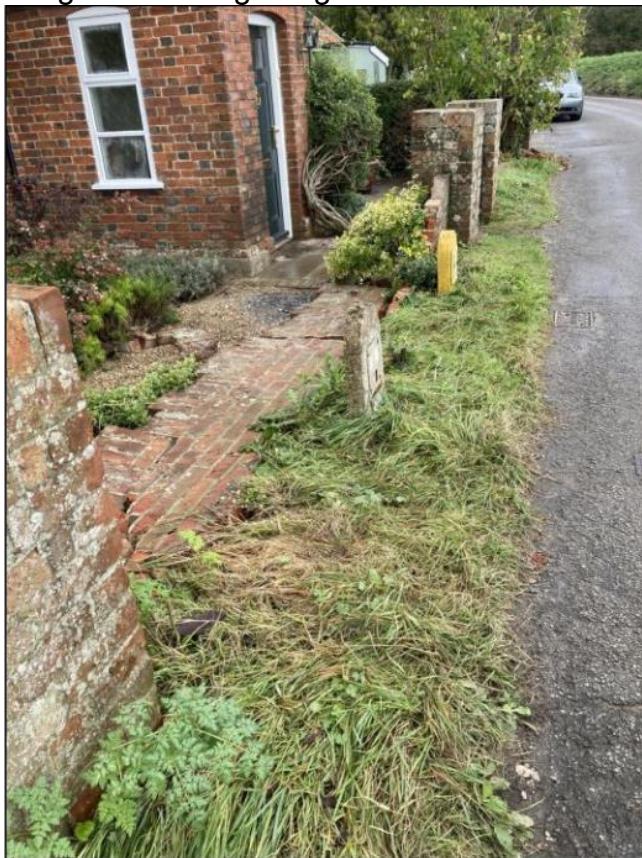
Flood water continued to flow along Fairfield Road and further impact residential properties from the front. The velocity of the water damaged fencing at the front of one property. Again, this was in addition to fluvial flooding to the rear from the Ore which had overtopped its Eastern bank, leading to combined source flooding.

Image 7 - Damage to garden wall on Fairfield Road

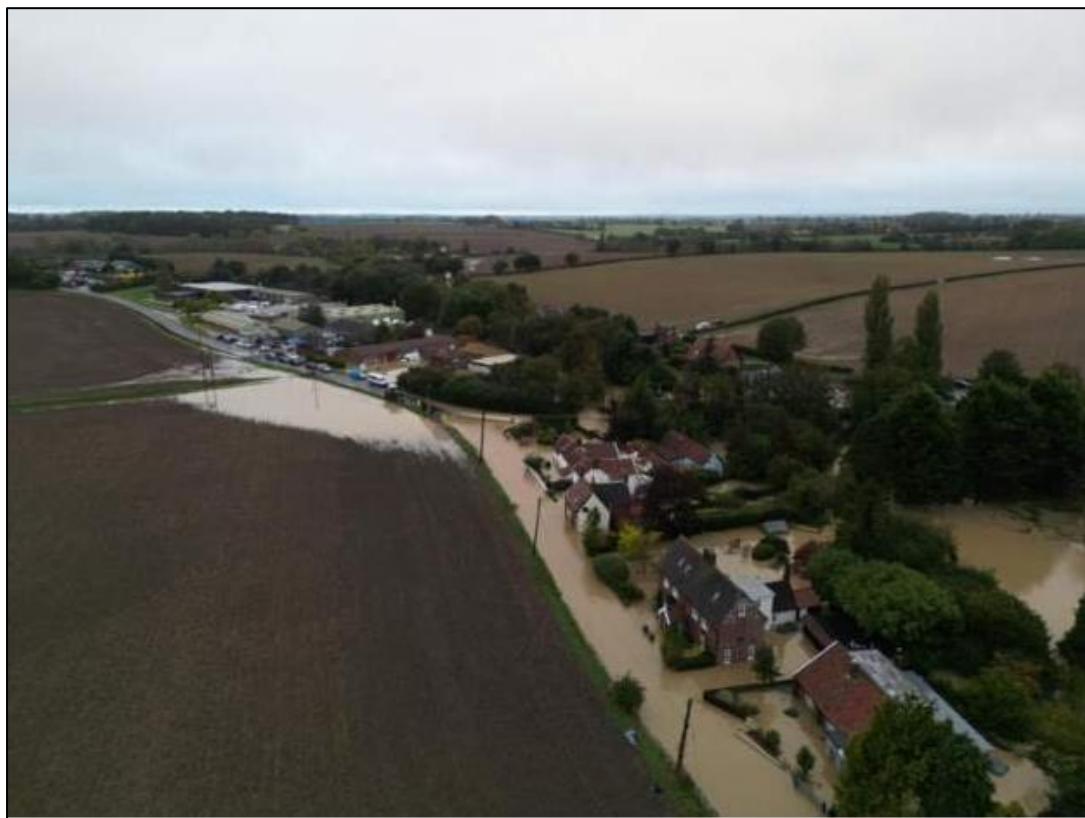
Image 8 - Flooding on Fairfield Road looking towards Woodbridge Road

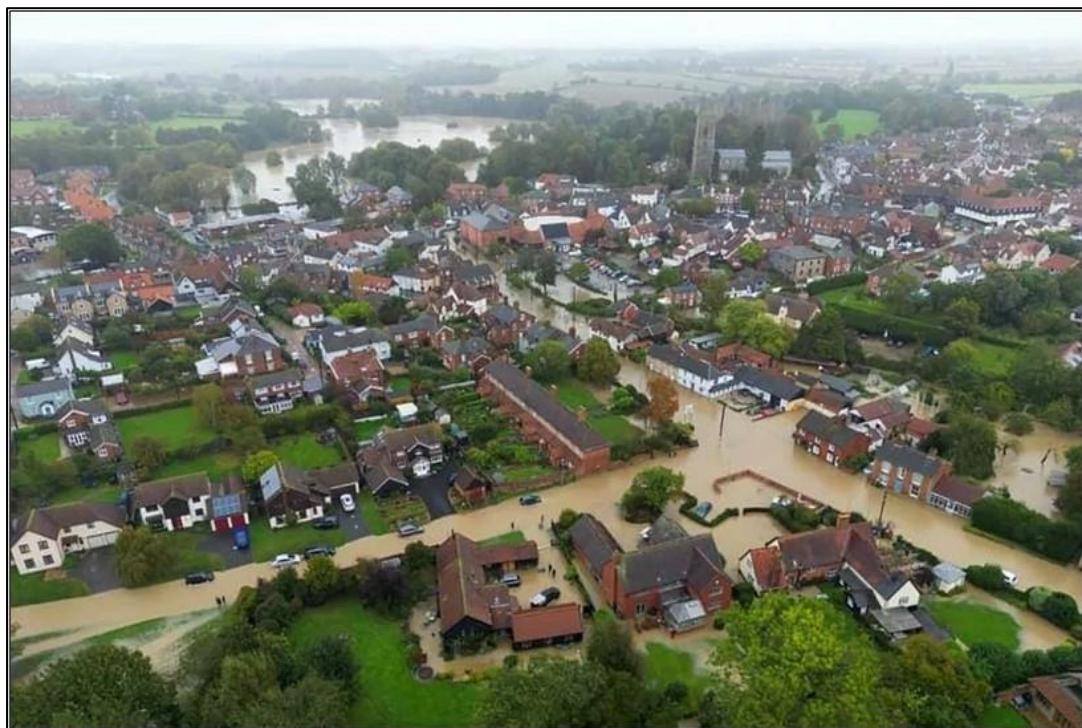
Image 9 - Flooding on Brook Lane and Station Road
