Section 19 Flood and Water Management Act 2010

Framsden Flood Investigation – Storm Babet 2023

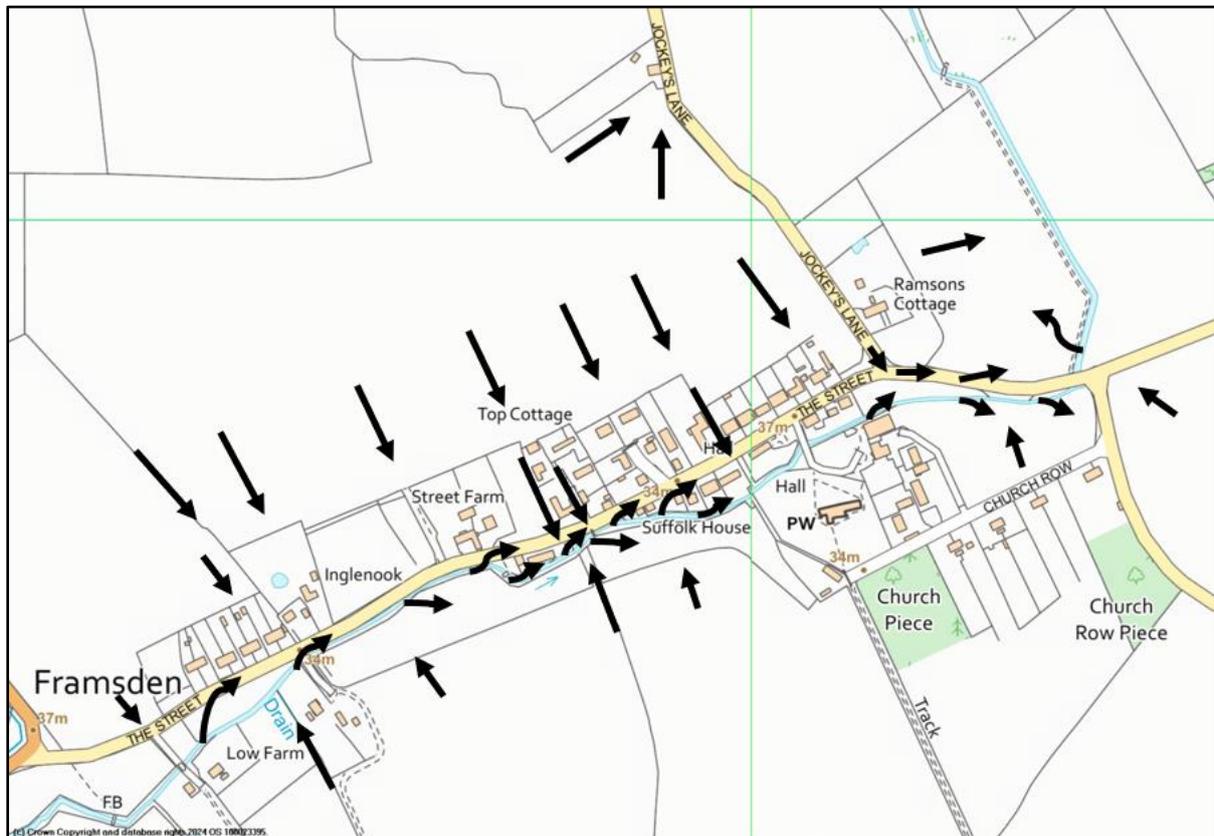
Figure 10. Approximate floodwater flow paths, The Street and Jockey's Lane

Incidents of property flooding were first reported when significant rainfall caused large quantities of surface water to flow from the fields, impacting the rear of properties on the north side of the eastern end of The Street. Reports describe this as not having

been observed for 34 years. Floodwater also flowed between some of the properties and began to collect on The Street, subsequently entering properties on the north and south side from the front, particularly those with driveways and properties at lower levels than the highway (Image 1). The road was reported as flooding by 10.15am on the 20th October.

There are no ditches currently within the fields to the rear of the properties on the north side of The Street, having been reported to have been removed when field drainage was installed 70 years ago. Mole drains had been redone 2 years prior to Storm Babet but the drains were described as having been overwhelmed by the volume of water. Fields were ploughed across slopes (horizontally), rather than down slopes (vertically) which is beneficial in slowing surface water flow but would have had a relatively small effect in the intense rainfall of Storm Babet. There is currently no means of attenuating the flow of surface water from these fields if the drainage network exceeds capacity.

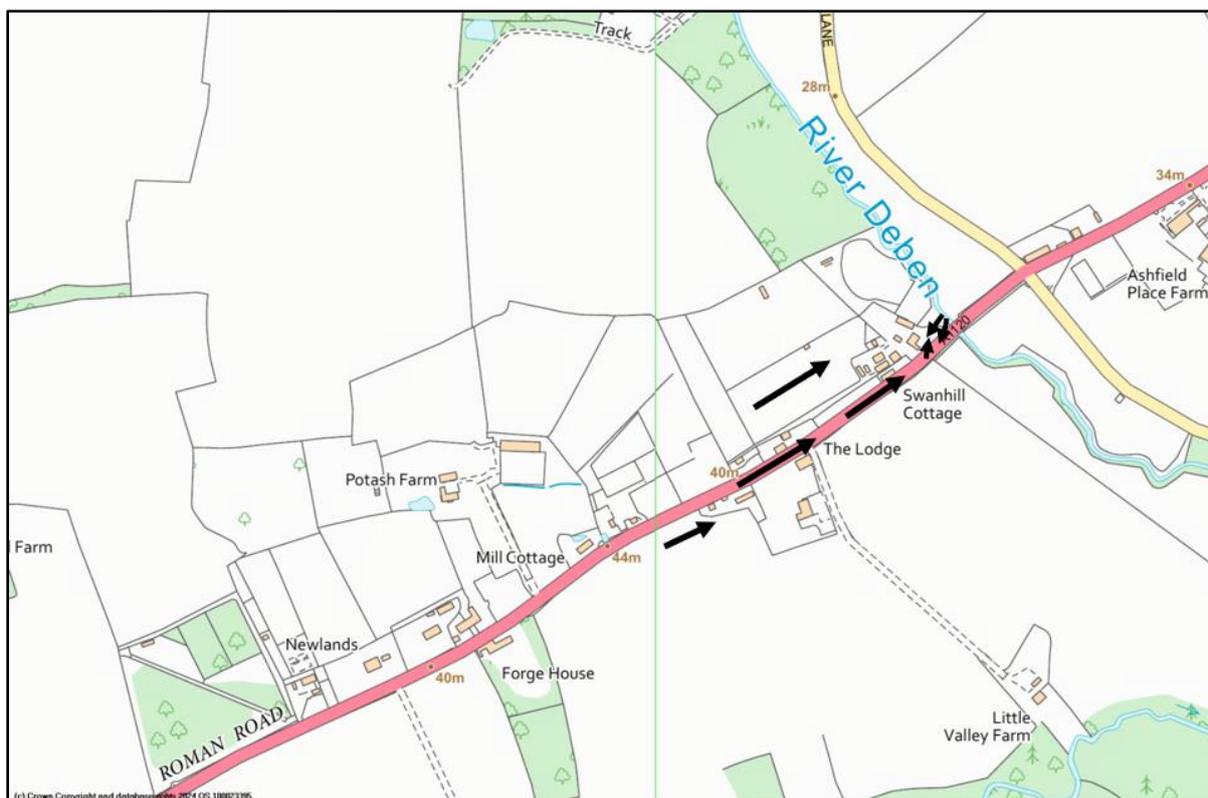
Figure 11. Approximate floodwater flow paths Swan Hill, A1120

Impacted properties in this area were located near the top and bottom of Swan Hill, A1120, to the west of the River Deben. Flooding near the top of the hill was attributed to surface water and groundwater flooding. At the bottom of the hill, property was affected by surface water and fluvial flooding.

- Surface water and groundwater caused internal flooding to properties close to the top of Swan Hill on the south side.
- Surface water on the A1120 flowed east down the highway on Swan Hill towards the River Deben, entering properties via driveways at the bottom of the hill. This was supplemented by surface water from fields.
- Storm drains on Swan Hill on the A1120 were unable to cope with the volume of surface water on the highway.
- The capacity of the bridge over the River Deben on the A1120 was exceeded, contributing to water overtopping the banks on the north side of the bridge which merged with surface water and flooded adjacent properties.

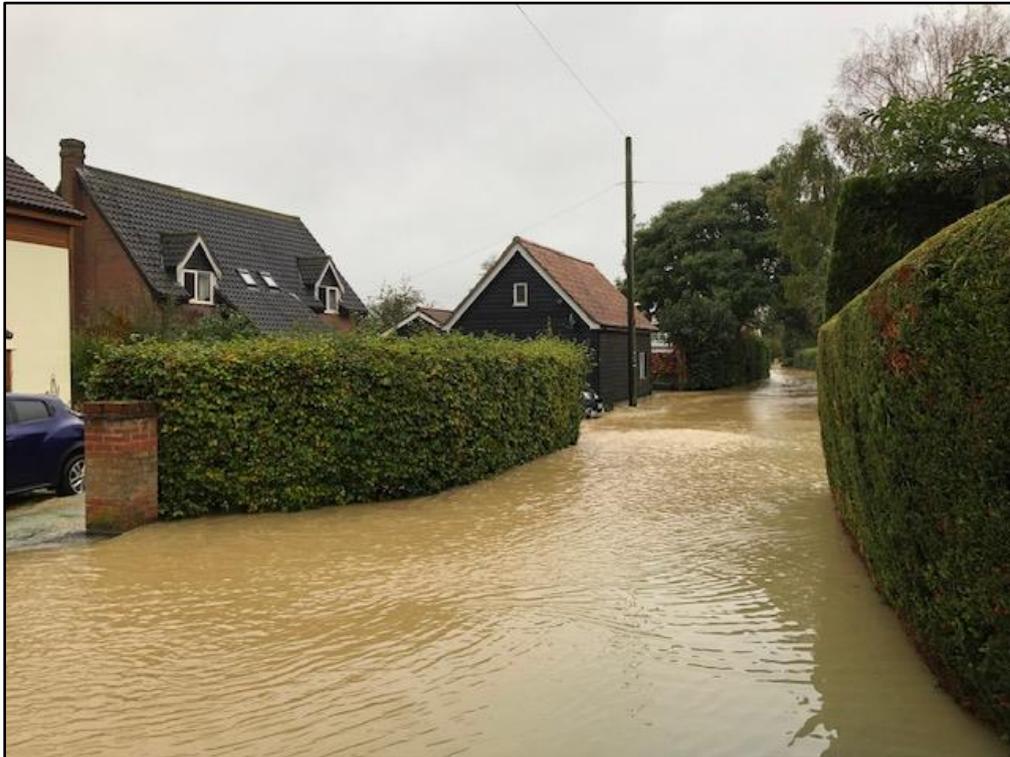
Witnesses describe that after properties on the north side of The Street were flooded by surface water from fields, reported to have happened by 10.15am on the 20th October, Framsdan watercourse overtopped its banks and began to impact the rear of properties on the south side of The Street (Image 2). The fluvial flood water merged with surface water, already present on the highway and further exacerbated the flooding of properties on the north side of The Street. Internal flooding of property on the north side of The Street was reported to have reached approximately 23cm.

Floodwater had entered properties on the south side of The Street by 2pm on 20th October. Water levels on the road were reported as reaching approximately 1 metre in depth. British Telecom's cabinet was submerged, causing properties to be disconnected from telephone and broadband services until water levels subsided and services were restored.

Image 1. View west along The Street during Storm Babet

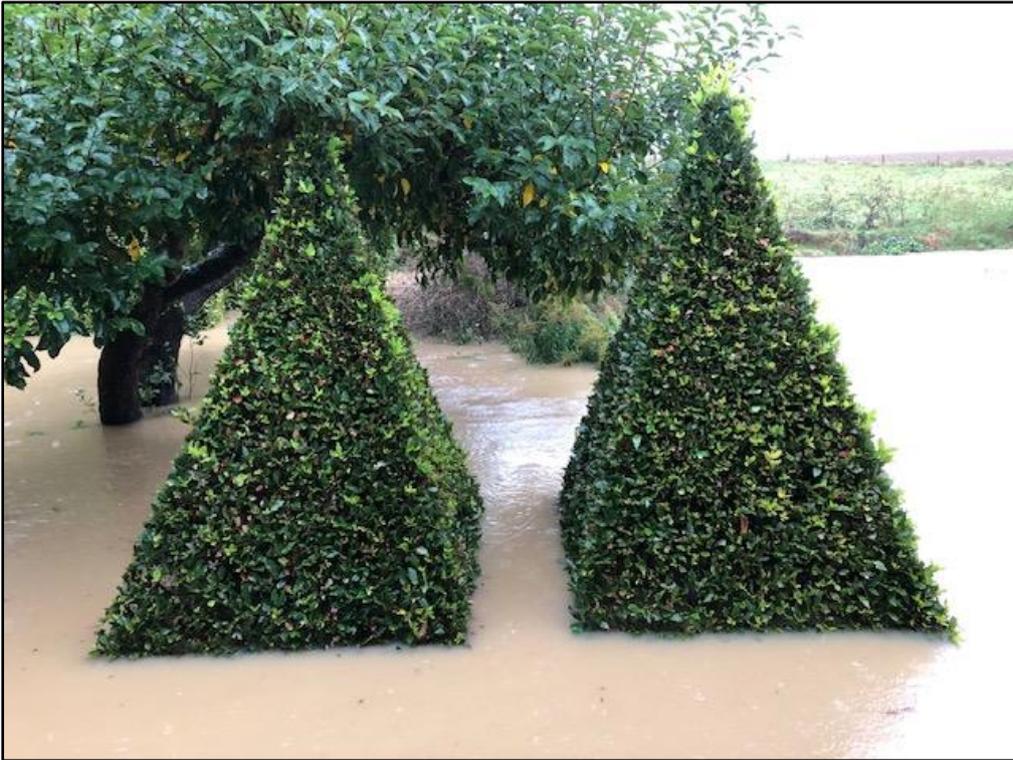
Silt and vegetation were reported as having accumulated in Framsdén watercourse due to a lack of maintenance which could have hindered the flow of floodwater away from the village. The bridge behind the village hall garden was reported after Storm Babet as accumulating a lot of detritus which has been partially cleared by residents. The Environment Agency undertakes annual maintenance of in-channel vegetation in the Framsdén watercourse which is scheduled to be carried out each November.

Image 2. View looking south across gardens and Framsdan watercourse to the far bank of the watercourse from property on the south side of The Street during Storm Babet

- Report observed blockages, such as fallen trees, in Framsdén watercourse to the Environment Agency
- Report observed blockages of debris under highways bridges to Suffolk Highways authority.
- Residents to install Property Flood Resilience (PFR) via grant funded scheme.
- Explore potential natural flood management measures (eg. leaky dams and attenuation ponds) to “slow the flow” and attenuate water on surface water flow paths and ditches on fields south of Framsdén watercourse.
- Explore potential natural flood management (NFM) measures (eg. rough buffer strips, bunds, and/or ponds) for attenuating excess surface water flows from the fields on the north side of the eastern section of The Street.
- Explore potential NFM measures which aim to attenuate surface water in the upper catchment of Framsdén watercourse (eg. storage ponds and wetland areas).

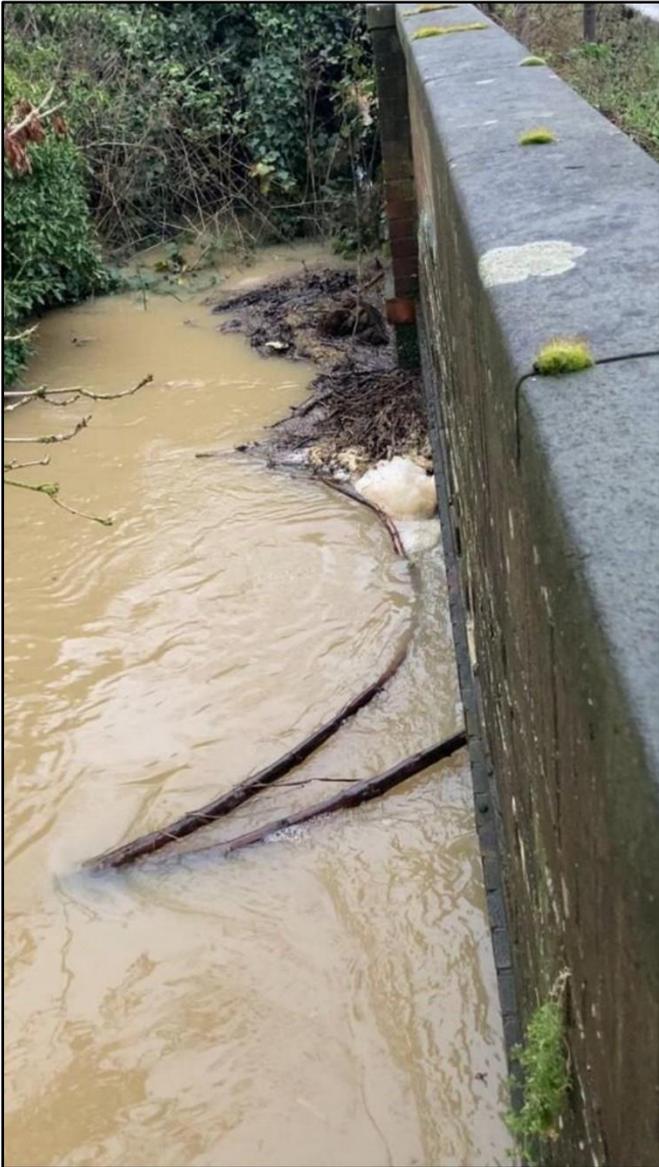
At 12.30pm water continued to rise in the River Deben and at 2.30pm property close to the River Deben was flooded, reported to be primarily from fluvial water from the River Deben overtopping its banks. The bridge on the A1120 over the River Deben was unable to accommodate all the river flow and was reported to have exceeded capacity. This caused water to back up on the north side of the bridge, with the river level close to the top of the wall. This contributed to flooding of property in the vicinity of the bridge whilst the flood plains to the south of the bridge remained relatively clear (see Image 3).

Image 3. North side of River Deben bridge at the bottom of Swan Hill, A1120, during normal winter river flow

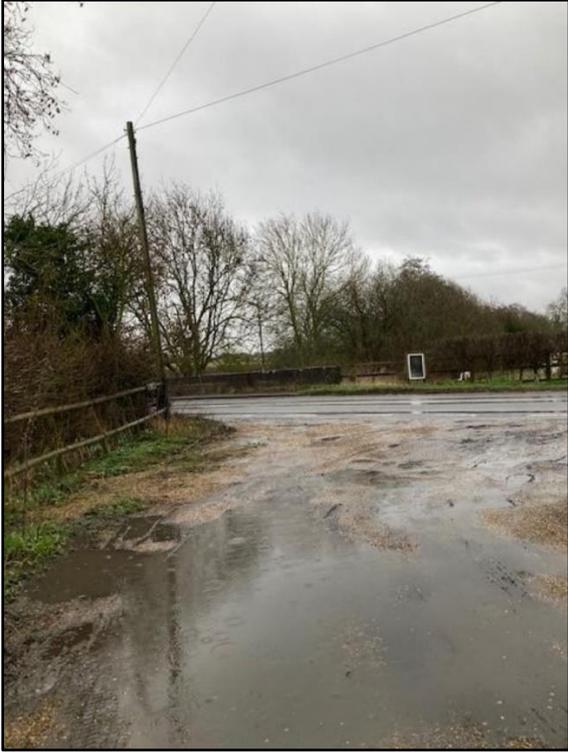
Property on the A1120, further west up the slope (Swan Hill) from the River Deben reported to have experienced internal flooding at approximately 9:30am, with flood water depths up to 15cm. Property in this location has since flooded again on 24th May 2024. The highway is elevated at this location and therefore surface water flowed from the highway towards the River Deben, entering property driveways which are at a lower elevation than the A1120 (Images 4 and 5).

Image 4. Flooding from the highway entering a driveway at the bottom of Swan Hill, A1120 on 21st February 2023, after a couple of hours of light rain

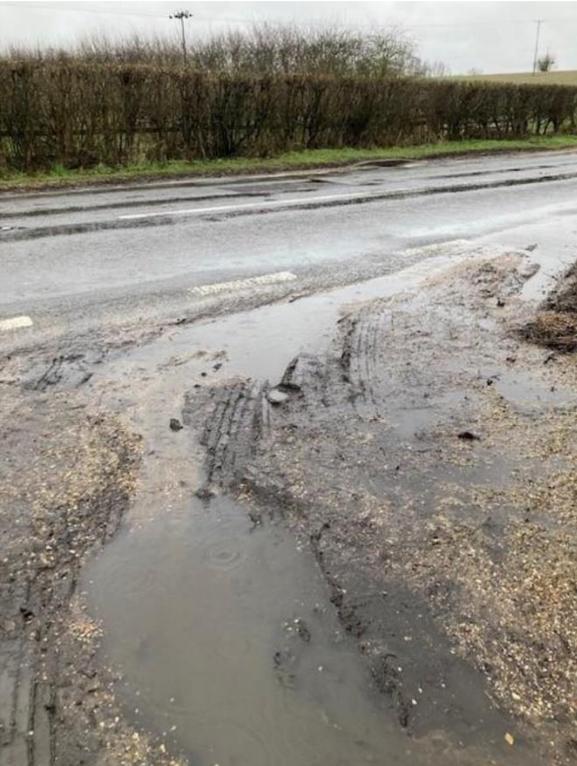
Image 5. Surface water pathway from the A1120 on to property at the bottom of Swan Hill

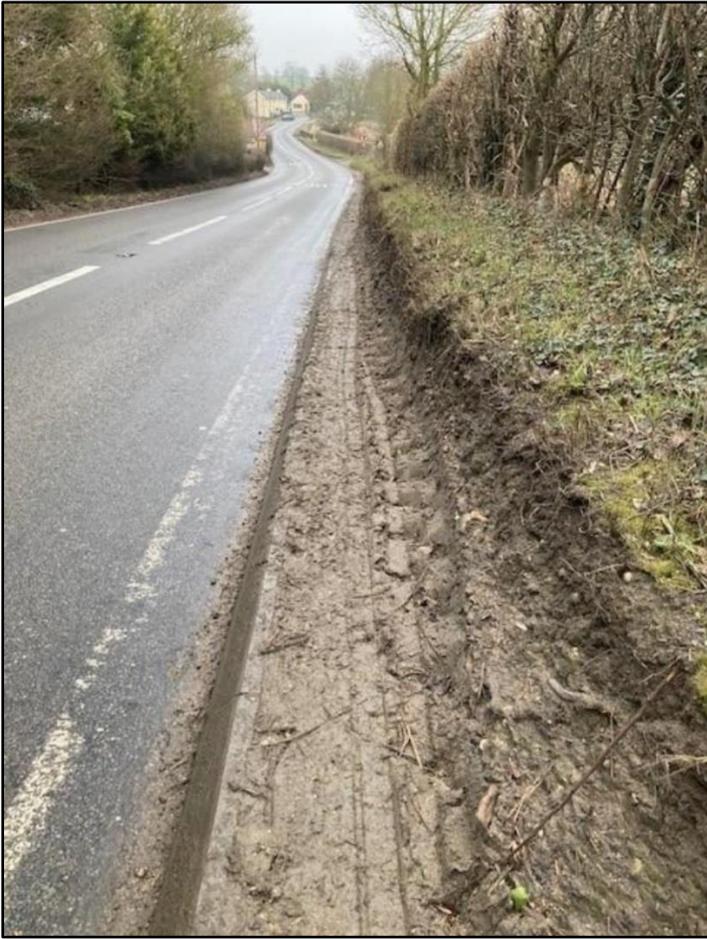
Image 6. View down Swan Hill, A1120, showing erosion of verge

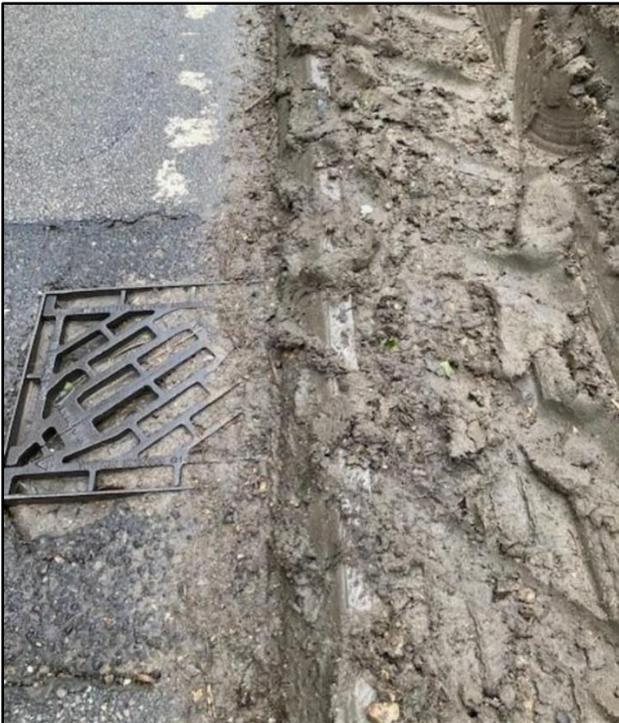
Fluvial floodwater was supplemented by surface water from the highway. Drainage assets were overwhelmed. Concerns have been raised by residents that gullies on this stretch of the A1120 are frequently blocked from mud deriving from heavy vehicles eroding the highway verges (Images 6 and 7). SCC Highways are aware of gullies on Swan Hill that are not fully functional and anticipate investigating and resolving this.

Image 7. Gully on Swan Hill, A1120, blocked by erosion of verge

- Increase frequency and ensure completion of maintenance cycle for gullies on Swan Hill.
- Investigate/resolve non-operational gullies to west of river on Swan Hill.
- Report observed blockages of debris under the River Deben bridge to Suffolk Highways authority.
- Residents to install Property Flood Resilience (PFR) via grant funded scheme.
- Explore the potential for NFM measures to reconnect the River Deben with the floodplain between Debenham and the A1120 to allow for greater water attenuation on the floodplain.

<p>Investigate and resolve non-operational gullies on Swan Hill, A1120</p>	<p>SCC Highways Authority</p>	<p>6 months</p>	<p>Ongoing</p> <p>Update from SCC Highways Authority - Jetting works on Ashfield Road, Framsdén, completed on 2nd–3rd May 2025, cleared the entire network pipe with 75–100% debris blockage, restoring functionality to most inlets. However, the piped ditch section north of Greggale Cottage has buried</p>
