## Section 19 Flood and Water Management Act 2010

### Hepworth Flood Investigation – Storm Babet 2023

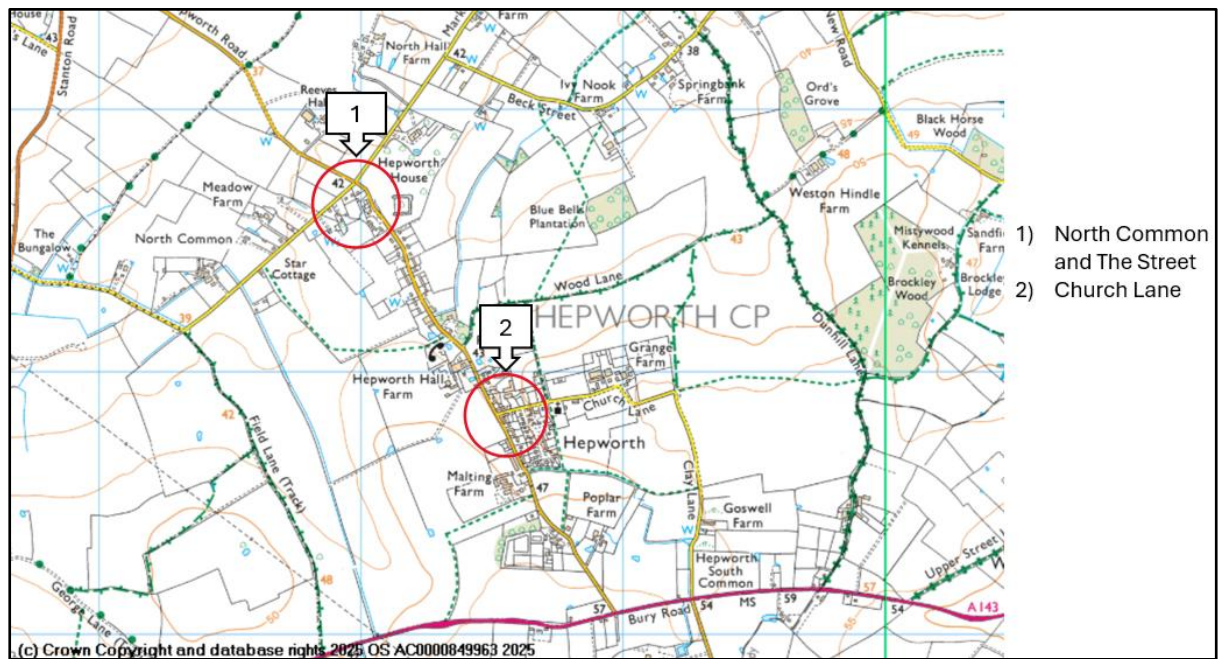
**Figure 4. Distinct flood zones**

For the purposes of this investigation the various areas affected by flooding have been separated into two distinct zones (Figure 4):

1. The Street and North Common
2. Church Lane

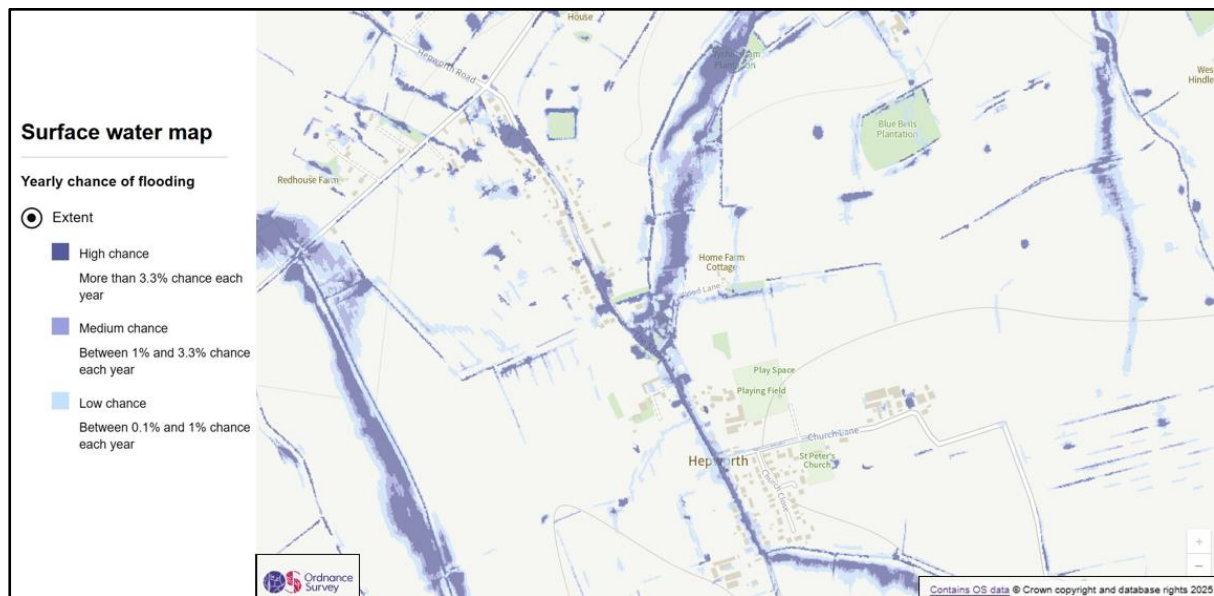
**Figure 5. Projected flood risk from surface water (Environment Agency)**

Areas of Hepworth are at significant surface water (pluvial) flood risk. High surface water flood risk is projected for all the affected property in The Street and North Common and low surface water flood risk is projected for affected property in Church Lane. It should be noted that low chance of flooding indicates a flood risk during extreme events, such as Storm Babet.

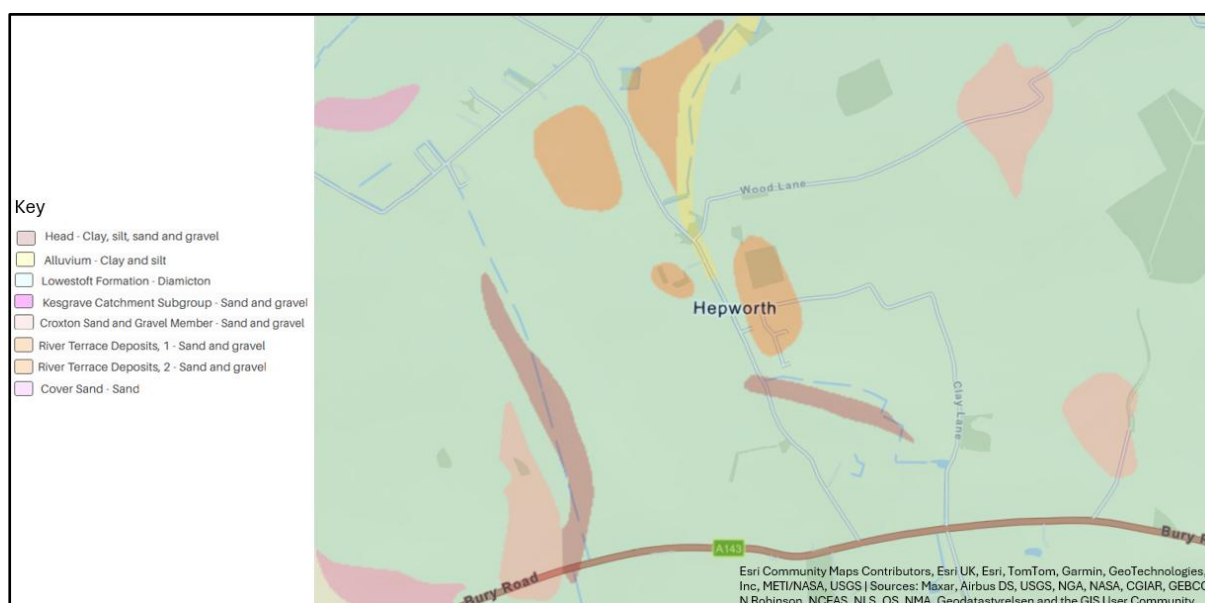
**Figure 8. Superficial geology (BGS Viewer)**

Figure 8 shows that much of the superficial geology surrounding Hepworth is made up of 'Lowestoft Formation – Diamicton' which is described by the British Geological Survey as a diverse mixture of clay, sand, gravel, and boulders varying widely in size and shape. This is sometimes known as boulder clay. Generally, this has a low permeability, meaning water will tend to flow off it before it can infiltrate in short term events, which also reflects the reports collected during Storm Babet. However, there are also some more permeable isolated areas of sand and gravel, including under part of Church Lane.

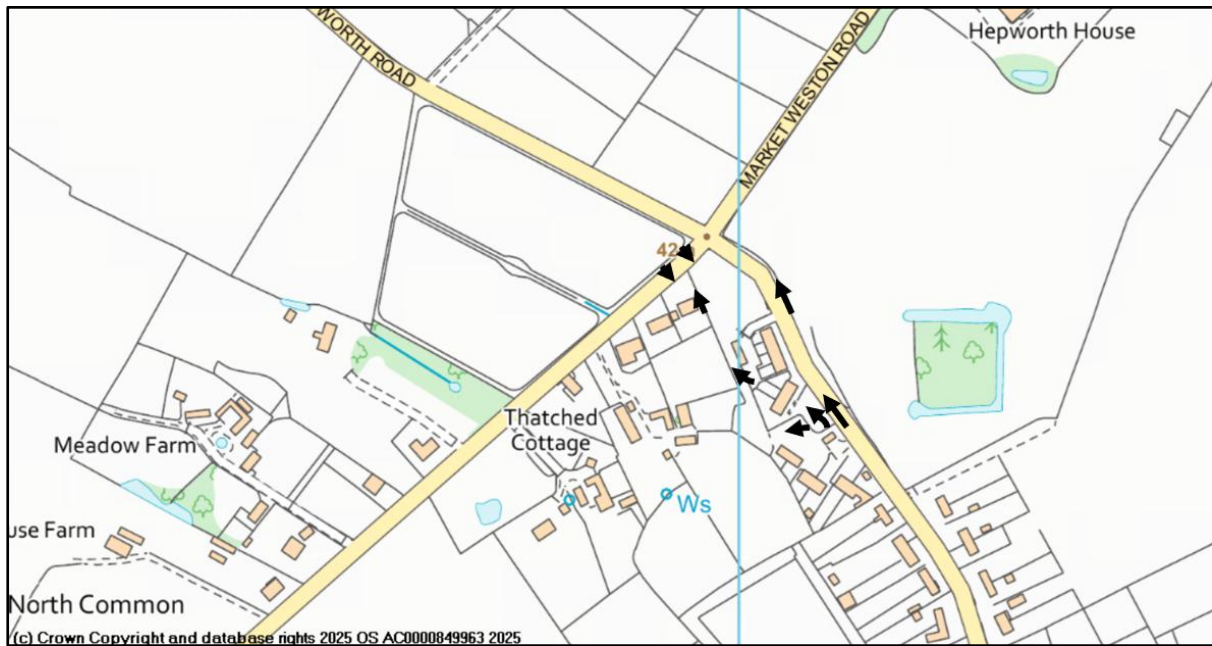
**Figure 9. Approximate floodwater flow paths, North Common and The Street**

This was the northernmost area of Hepworth where property was affected by internal flooding. One property in North Common and three properties nearby in The Street were reported to have flooded. Affected property was projected to be at high surface water flood risk and no fluvial flood risk.

Due to the extreme rainfall, water levels rose in a watercourse to the south of affected property on The Street, causing the watercourse to overtop and merge with surface water collecting at a low point on The Street and flood three properties. The watercourse was reported to have been in need of maintenance. This floodwater flowed north, combining with further surface water and exceeding the capacity of private property surface water drainage systems. On reaching North Common (road) and combining with more surface water, the capacity of the piped culvert under the road was exceeded, causing floodwater to accumulate on the south side of the highway. The ditch on the north side of North Common (road) was reported to be obstructed by tree roots and also overtopped, flowing south across the highway and into lower-level driveways and gardens and contributing further to the flooding of property. Due to the extreme rainfall conditions, the capacity of the wider drainage system, even if fully functioning, would have been exceeded by the amount of water present.

Sewage was also reported to have backed up in property on The Street. Anglian Water confirmed external sewer flooding further south on The Street due to a defect in a sewer pipe combined with hydraulic overload of system due to extreme rainfall.

Internal property flood water levels were reported to have reached in excess of 30cm.

- Intense and prolonged rainfall exceeded the capacity of field drainage systems.
- Highways drainage in The Street was overwhelmed.
- A watercourse to the south of affected property overtopped.

- The watercourse was reported to have been in need of maintenance.
- Floodwater from the watercourse and surface water merged.
- The floodwater flowed north, exceeding the capacity of private surface water drainage systems.

- Sewage was reported to have backed up in property on The Street.
- External sewer flooding further south on The Street occurred due to a defect in a sewer pipe combined with hydraulic overload of system.

- Culverts under North Common (road) were reported to have exceeded capacity.
- A ditch on the north side of North Common (road) was reported to have been obstructed by vegetation and overtopped, flowing south across the highway.

- Due to the extreme rainfall conditions, the capacity of the wider drainage system, even if fully functioning, would have been exceeded.

- Residents to install Property Flood Resilience (PFR) measures.
- Suffolk Highways to investigate the functioning and capacity of the piped culvert under North Common (road).

- Suffolk Highways to ensure completion of highway drainage asset cyclic maintenance.
- Anglian Water to investigate and repair defects in sewer pipe on The Street.
- Explore potential natural flood management measures on surface water flow paths in the upstream catchment (eg. leaky dams, buffer strips, tree planting and attenuation ponds and floodplain reconnection) to “slow the flow” and attenuate water.
- Landowners to carry out watercourse maintenance, to reduce flood risk as necessary in accordance with their riparian responsibilities.

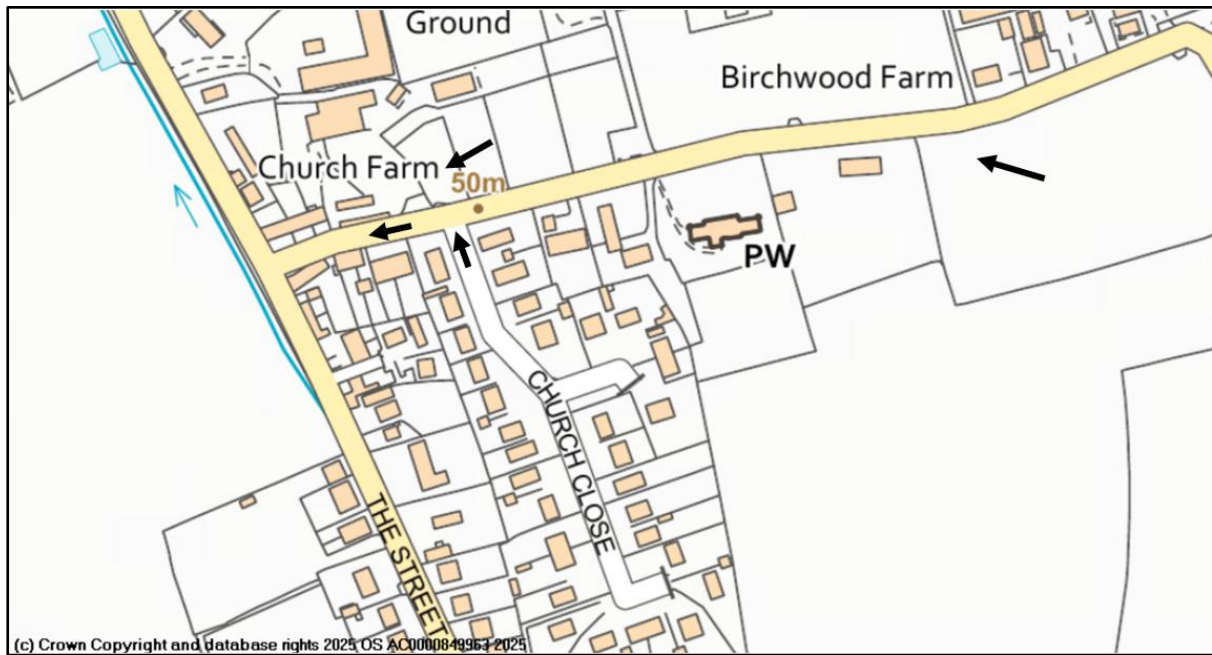
**Figure 10 Approximate flood water flow paths in Church Lane**

Affected property was projected to be at no fluvial flood risk and on the edge of an area of low surface water flood risk. At least one property was reported to have flooded at this location. Surface water runoff from fields was reported to have combined with surface water on Church Lane and flowed down Church Lane, contributing to flooding of the junction with The Street. Gullies in the vicinity of affected property on Church Lane were reported to be blocked. They may not have been fully functioning during Storm Babet as they were reported not to be fully functional during subsequent routine maintenance visits. It was noted in addition that at least one gully was partially obstructed by wooden sleepers. Groundwater may also have infiltrated the drainage system. The condition of the gullies merits further investigation.

Affected property (which is at a slightly higher level than the junction between Church Lane and The Street) was reported to have flooded from water levels rising through the floor. Impacted property has flooded on previous occasions. There is a small isolated area of sand and gravel in the superficial geology underneath and surrounding affected property on Church Lane which allows the groundwater more easily to rise to ground level compared with the wider area, where the superficial geology is clay-based.

- Affected property was flooded from groundwater, exacerbated by local superficial geology.
- Intense and prolonged rainfall exceeded the capacity of local field drainage systems and surface water flowed across fields and down Church Lane.
- Gullies in Church Lane were reported to be blocked.

- Residents to install Property Flood Resilience (PFR) measures.
- SCC Highways to investigate the functioning of gullies in the vicinity of affected property on Church Lane.
- Suffolk Highways to ensure completion of highway drainage asset cyclic maintenance.
