Section 19 Flood and Water Management Act 2010

Hundon Flood Investigation –

Storm Babet 2023

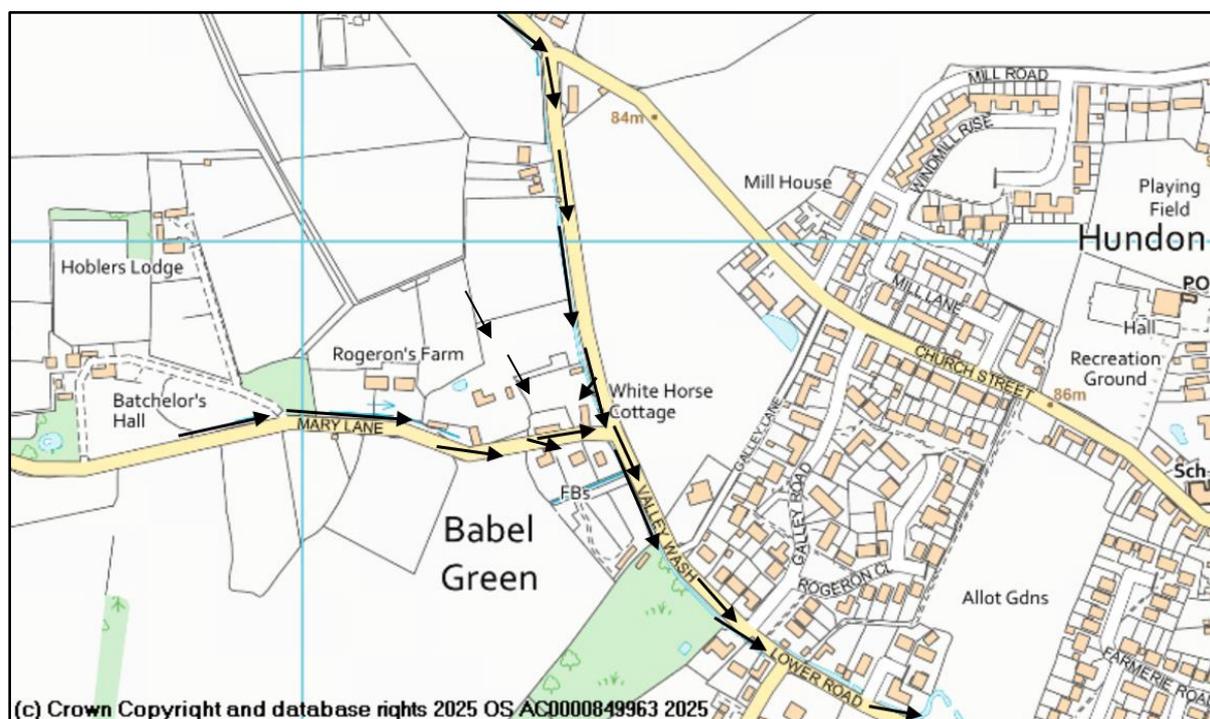
A torrent of water flowed down Valley Wash (see Image 1) towards the junction with Mary Lane. Some properties in this area were flooded directly from the overwhelmed Chilton Brook. The situation was compounded by additional surface water flows coming in an easterly direction on Mary Lane and from the adjacent ditch (see Figure

10). Sections of this ditch have been filled in and built over historically, meaning the majority of the floodwater flowed along the highway towards the Valley Wash junction.

Figure 10. Approximate flood water flow routes along Mary Lane and Valley Wash

A culverted section of the watercourse and the road bridge at this location may also have held up some floodwater as their capacity was exceeded. Additionally, there was a section of coir matting on the roadside bank displaced into the channel of the Brook on Valley Wash and there may have been some subsequent bank erosion, reducing its capacity and ability to convey the floodwater.

- Residents to install Property Flood Resilience (PFR).
- Increase awareness of riparian landowner responsibilities with regard to watercourse management across Hundon.
- Riparian landowners to carry out appropriate watercourse maintenance to reduce flood risk as necessary as per their riparian responsibilities.
- Identify where works could be considered to improve flow through the village to reduce risk within this location, in particular on Valley Wash and Mary Lane.
- Explore potential NFM projects to 'slow the flow' and attenuate water on overland flow paths west of Mary Lane and north and west of Valley Wash, E.g. leaky dams, woody debris installation, restoration of watercourses, storage ponds, wetland areas.
- Suffolk Highways to ensure the completion of highway drainage asset cyclic maintenance on Valley Wash and Mary Lane.

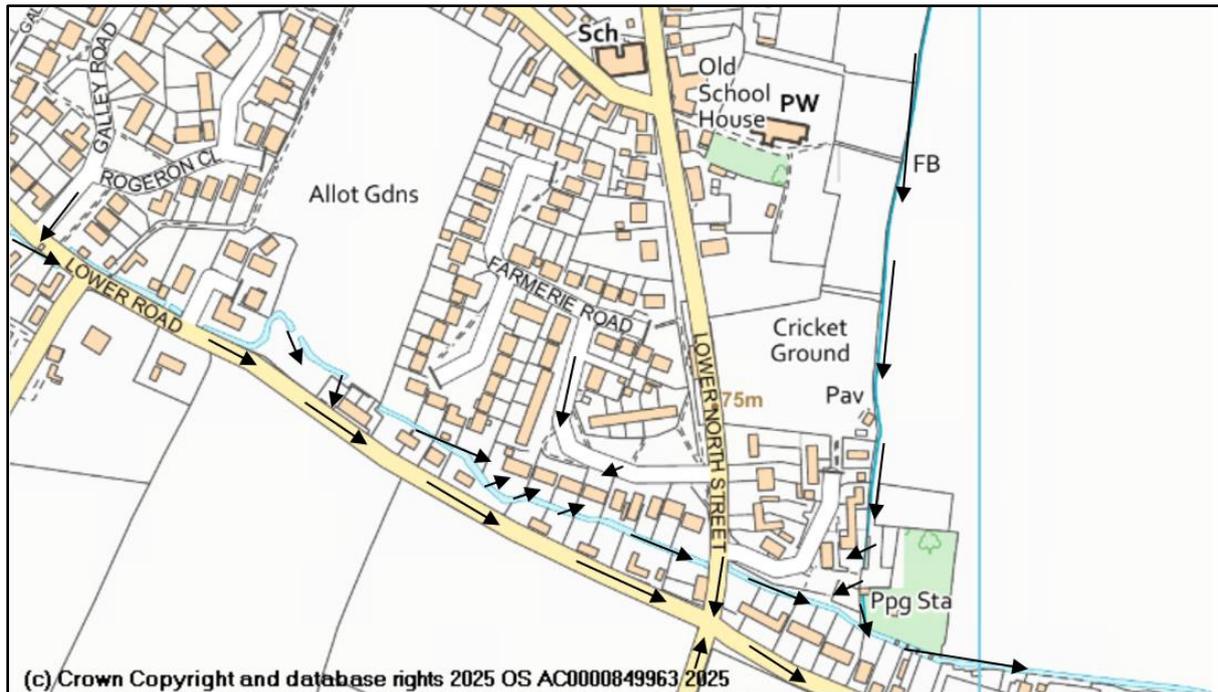
On the morning of 20 October, intense rainfall caused vast amounts of floodwater to enter the watercourses above Hundon and flow towards the village. Large quantities of floodwater flowed in a southerly direction down the ditch to the east of Lower North Street and at the rear of the properties. Multiple properties and the car park in this area were flooded directly from the overwhelmed ditch as the flow of water exceeded the capacity of the ditch (see Figure 13).

Residents have reported that the flow of the floodwater in the ditch was hindered by overgrown vegetation in the channel and a potentially blocked culverted section of the watercourse. Figure 14 shows the yearly chance of surface water flooding on Lower North Street.

Figure 13. Approximate flood water flow routes on Lower North Street, Lower Road and Farmerie Road

- Residents to install Property Flood Resilience (PFR).
- Increase awareness of riparian landowner responsibilities with regard to watercourse management across Hundon.

- Riparian landowners to carry out appropriate watercourse maintenance to reduce flood risk as necessary as per their riparian responsibilities.
- Parish Council to investigate utilising the Community Self Help scheme to undertake minor maintenance activities.

- Identify where works could be considered to improve flow through the village to reduce risk, in particular on Lower Road, North Street and Clare Road.

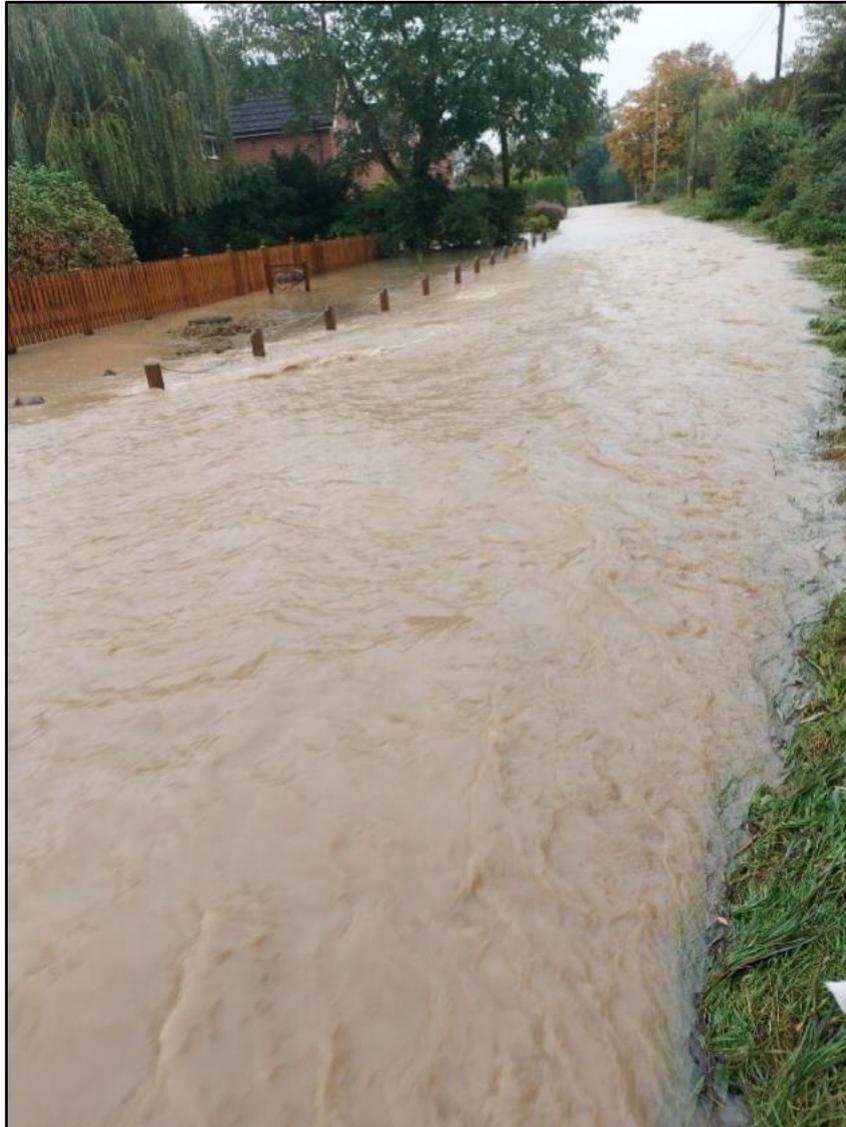
Image 1. Flooding on Valley Wash

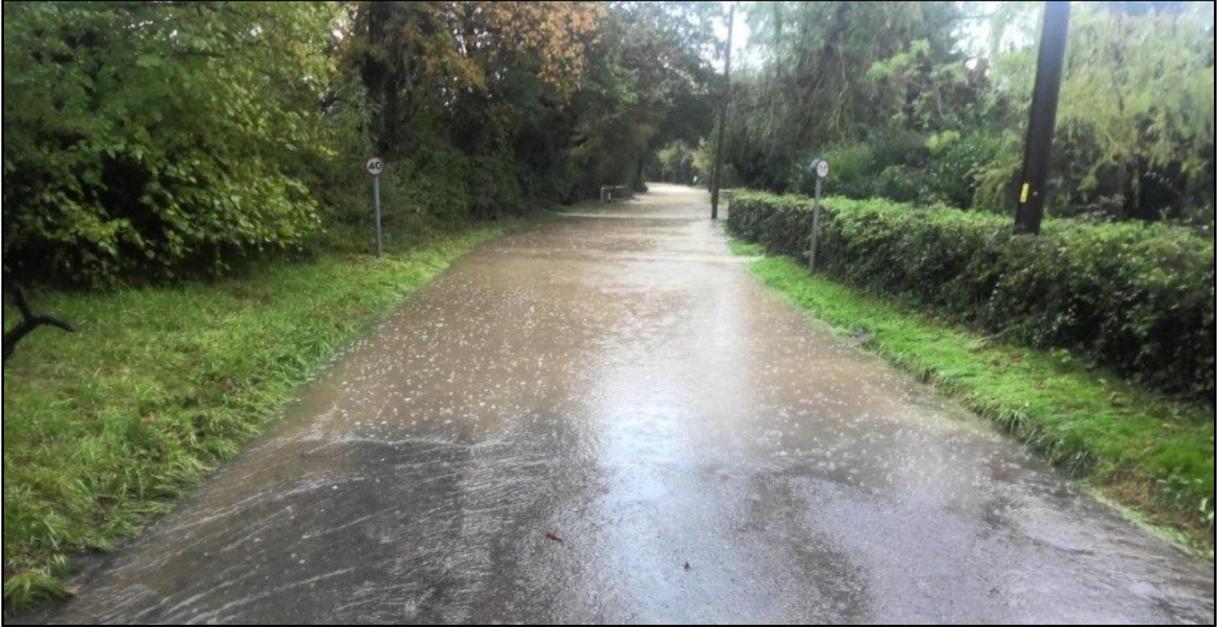
Image 2. Flooding on Valley Wash near Chilton Brook

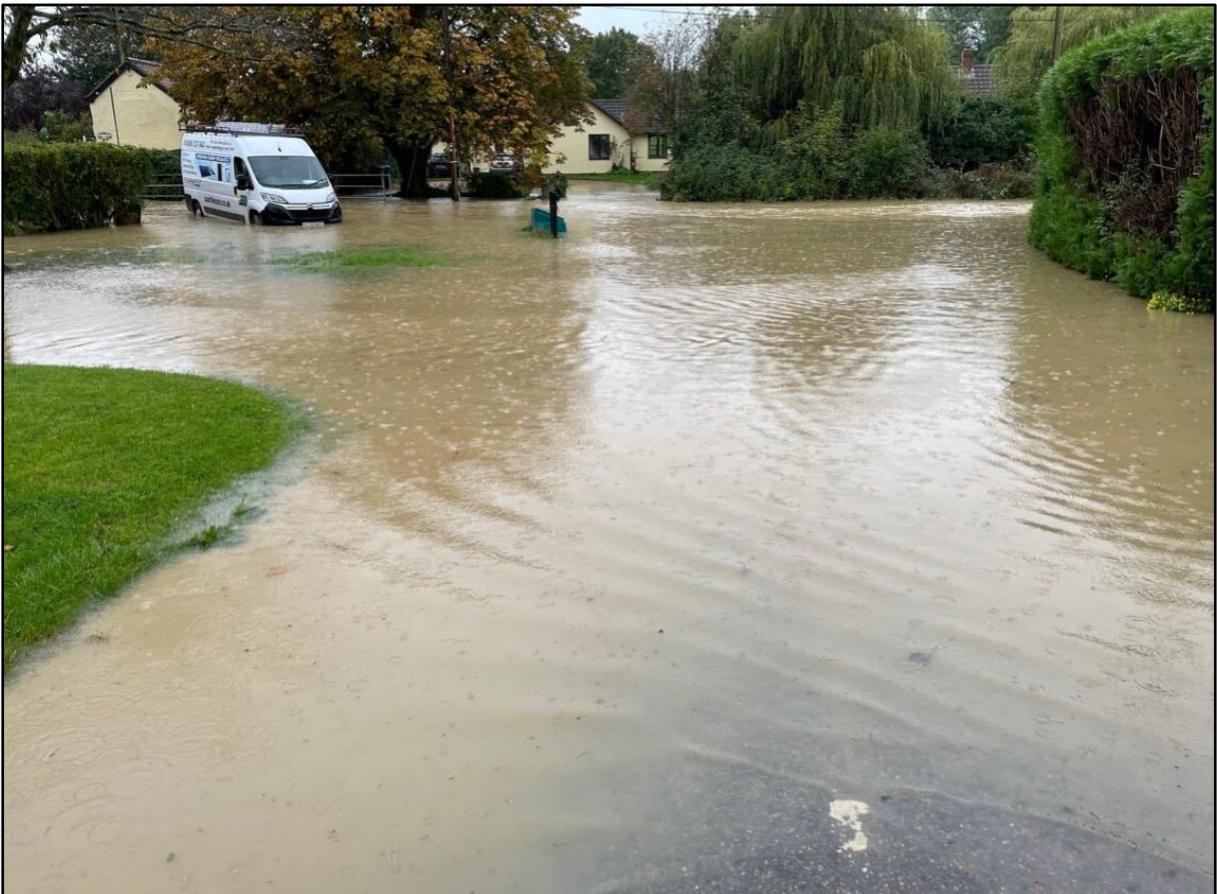
At the Galley Road junction with Lower Road, floodwater depths of up to 30cms were observed (see Image 3). At the junction of Lower Road and Lower North Street the flood water had a maximum depth of approximately 1m (see Image 5). There have been reports of a blocked and/or damaged pipe below the crossroads prior to and after Storm Babet. Floodwater has been observed flowing out of a kerb offset onto the highway whilst the ditches are full of water and not flowing away under the road junction as normal.

Image 3. View from Galley Road towards Lower Road

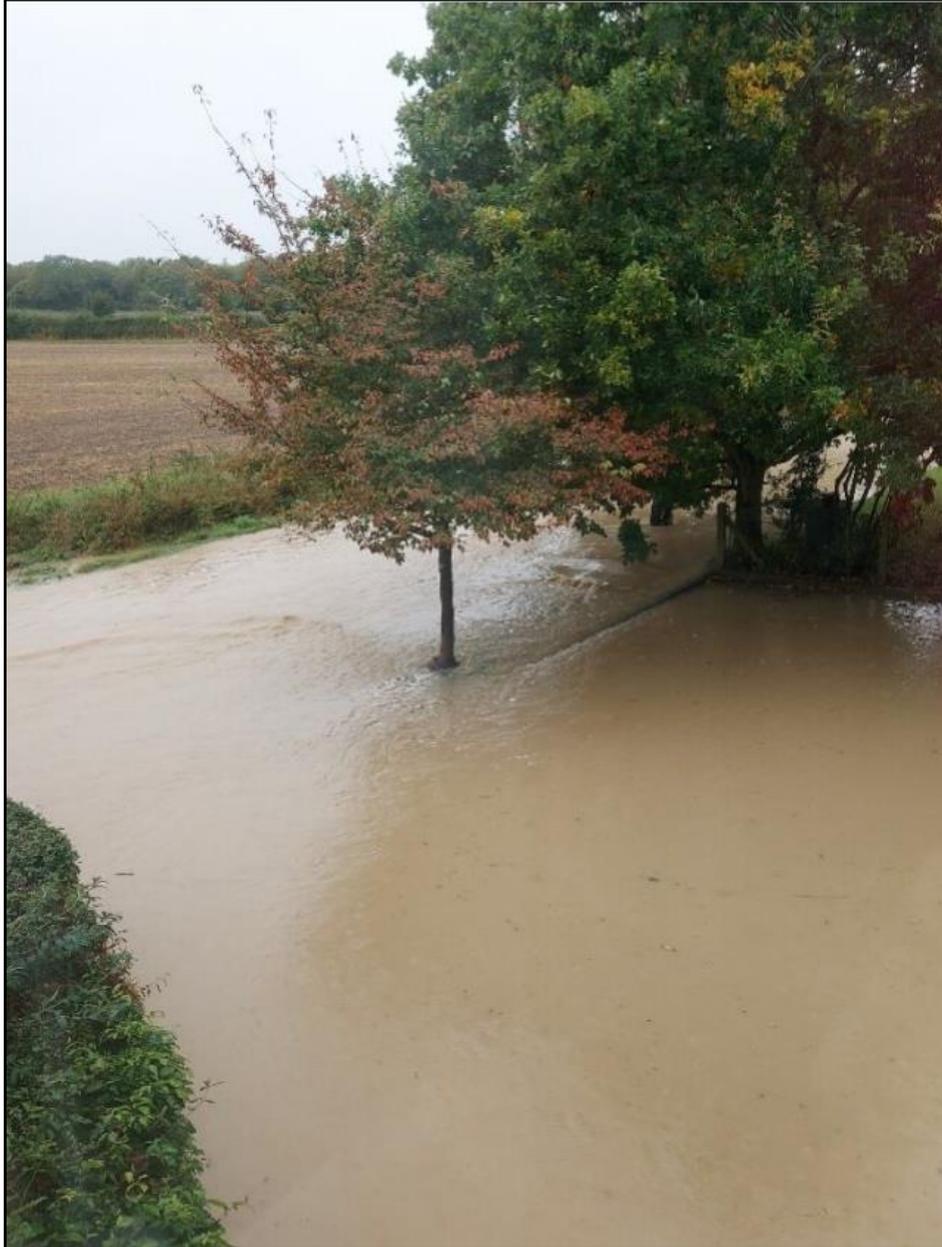
Wash and Lower Road were both flooded with fast flowing floodwater along almost their complete length (Image 4).

Image 4. Flooding on Lower Road

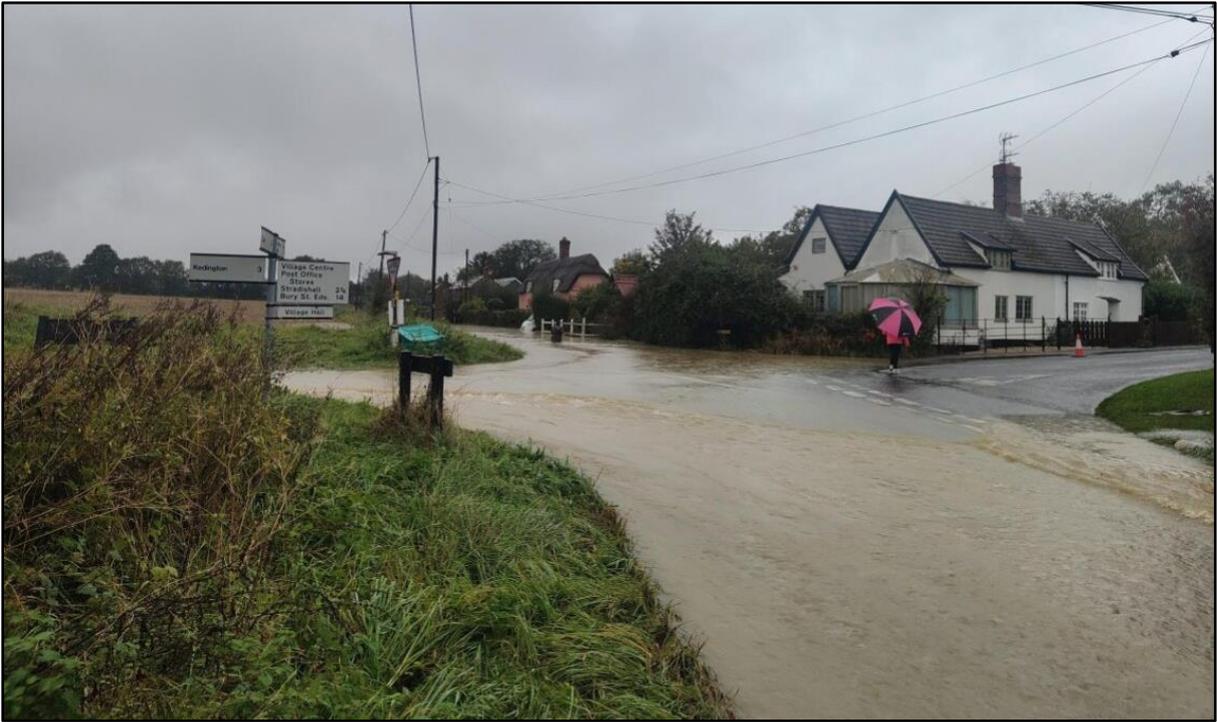
Image 5. Lower Road and Lower North Street Junction

- Suffolk Highways to investigate highway drainage assets at the crossroads of Lower North Street and Lower Road following reports of a blocked and/or damaged pipe below the road.

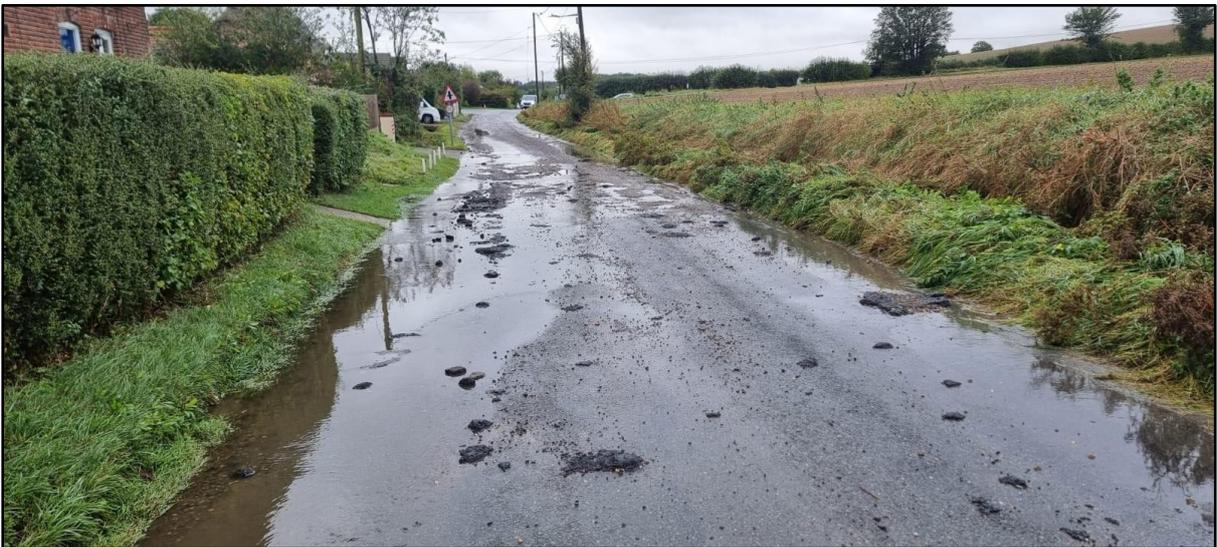
Image 6. Lower road after Storm Babet
