Section 19 Flood and Water Management Act 2010

Long Melford Flood Investigation – Storm Babet 2023

Name	Date
Report Author	Susie Clark	
Responsible Officer:	Susie Clark	
Checked by:	Ellie Becroft	06/03/2025
RMA Review:		21/03/2025
Approved by:	Matt Hullis	09/04/2025
Date Published		19/04/2025
Latest Update		27/10/2025
Date Report Closed

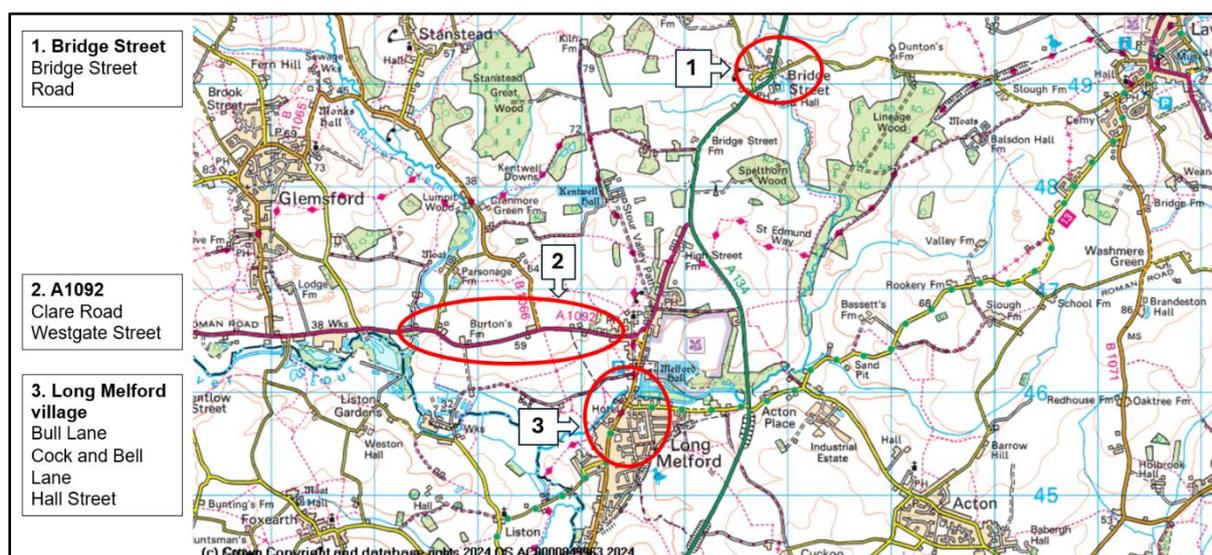
Figure 4. Locations where internal flooding of property was reported

Property was reported as flooding internally in three areas of the parish in the roads listed below:

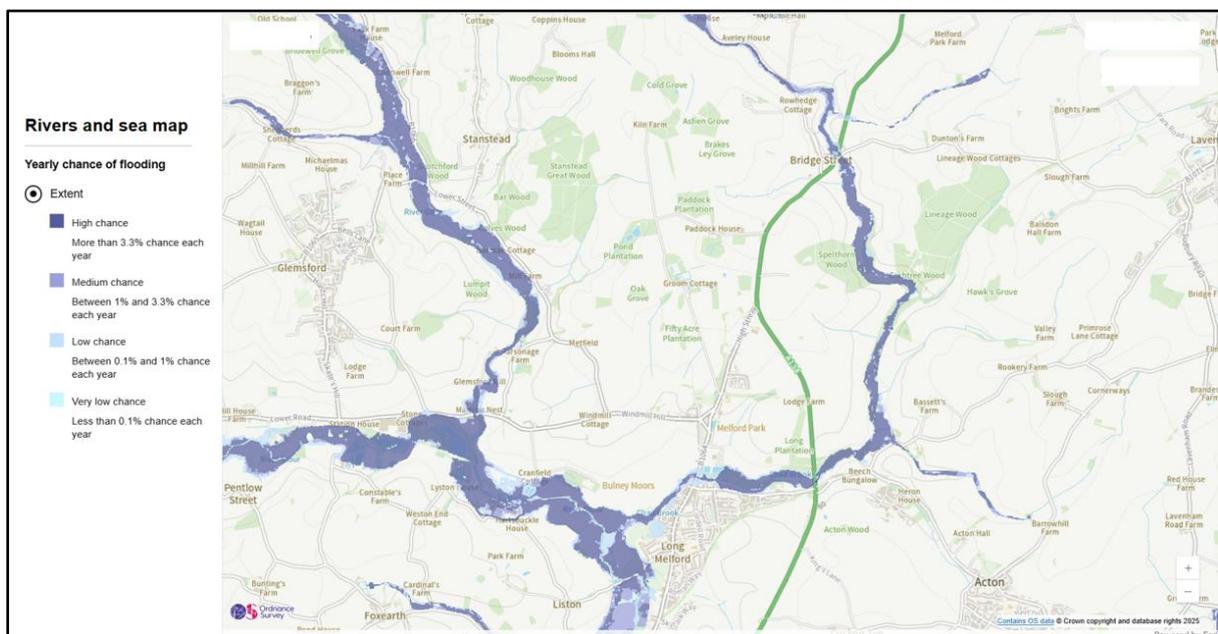
Figure 5. Predicted flood risk from river water (fluvial)

Fluvial flood risk in Long Melford village and Bridge Street is associated with Chad Brook, (Figure 5). Further west on the A1092, fluvial flood risk is associated with the River Glem. Projected fluvial flood risk corresponds with affected property in Bull Lane, Clare Road, Cock and Bell Lane, Hall Street and Bridge Street Road which reported being flooded from watercourses.

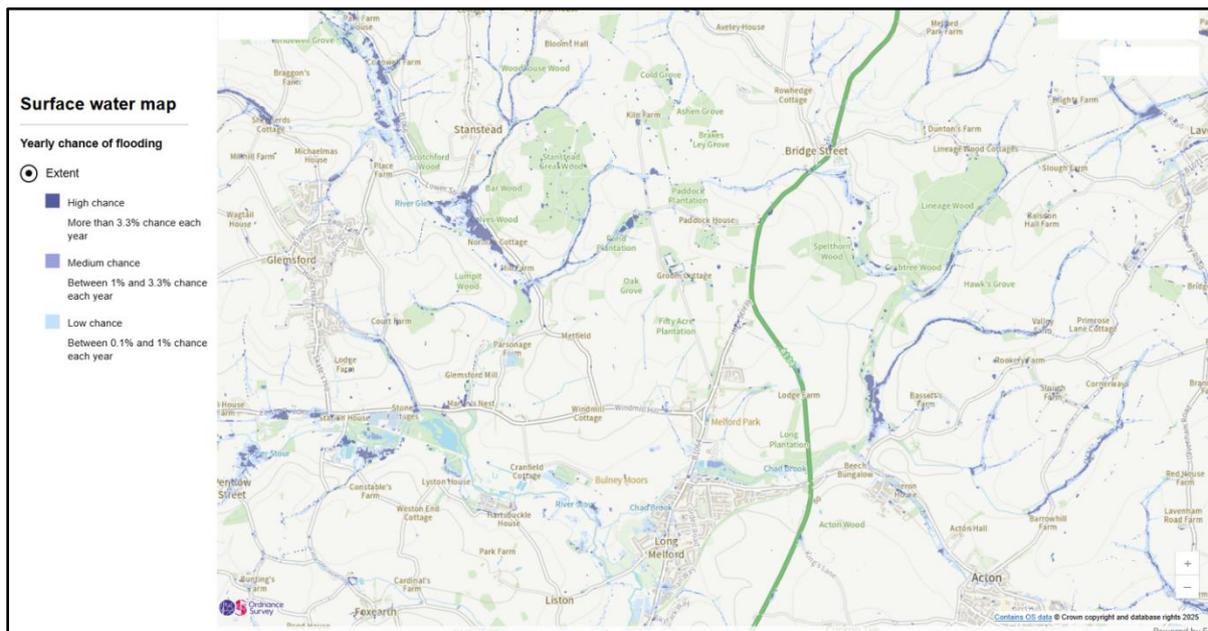
Figure 6. Predicted flood risk from surface water (pluvial)

Most of the affected property was projected to be at surface water flood risk, or adjacent to areas of surface water flood risk (Figure 6). Surface water flood risk was projected to be the sole flood risk for affected property in Westgate Street.

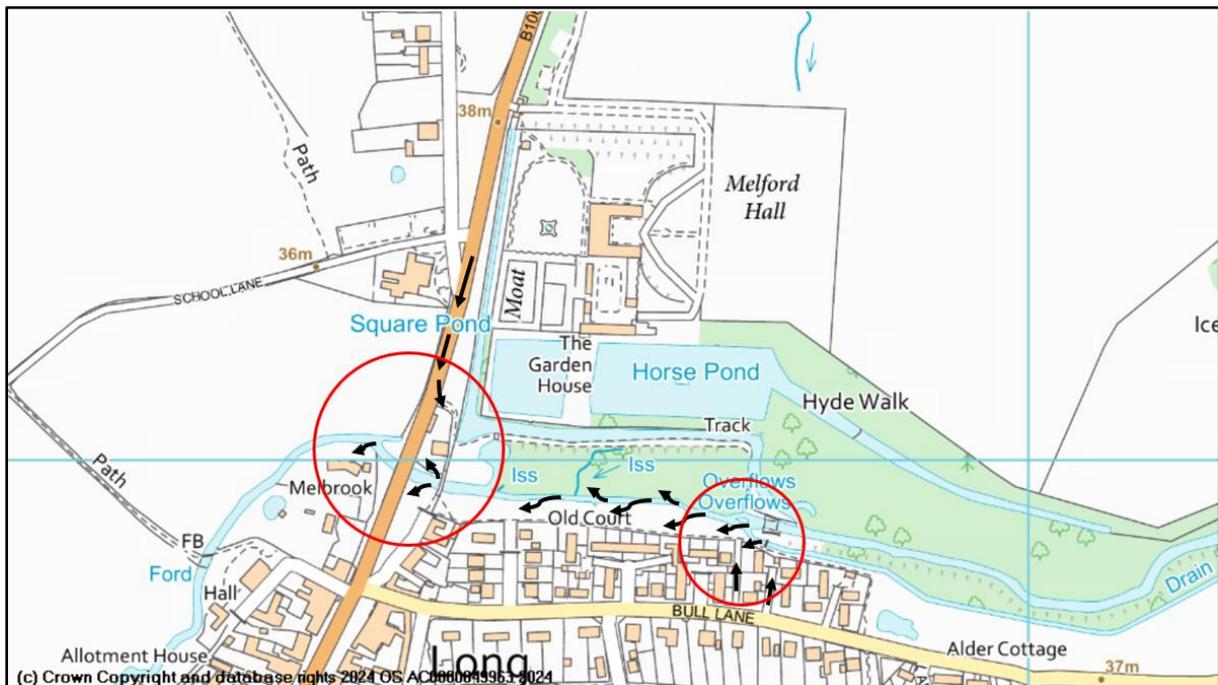
Figure 10 Approximate flood water flow paths in Bull Lane and north Hall Street indicating areas of affected property

Affected property on Bull Lane was located to the north of Bull Lane and adjacent to the drain parallel to Chad Brook. During Storm Babet, the drain and Chad Brook exceeded capacity and overtopped their banks to the rear of property on Bull Lane. Low-lying property began to experience internal flooding at approximately 7.30pm, reaching an internal flood level of about 13cm. Surface water also flowed from higher ground on the south of Bull Lane northwards towards the drain and Chad Brook.

Vegetation and fallen trees were reported to be obstructing flow due to a lack of maintenance in Chad Brook adjacent to Bull Lane. Affected property was projected to be at low risk of surface water flooding and high risk of flooding from river water.

- Chad Brook overtopped its banks, flooding property in Bull Lane from the rear.
- Surface water flowed northwards from higher ground on the south of Bull Lane, contributing to floodwater on the north side of Bull Lane.
- Vegetation and fallen trees were reported to be obstructing flow due to a lack of maintenance in Chad Brook adjacent to Bull Lane.

Affected property was located in close proximity to the bridge over Chad Brook on the east and west sides of the bridge and on both sides of the river. Property was reported as being flooded to approximately 36cm internally from ground floor level from Chad Brook. Floodwater levels were reported to have peaked at approximately 10pm on the 20th October and subsided by 7am on the 21st October.

On the north side of the river, surface water flowed south down Hall Street, including down a lower level driveway. This flow of water was reported to be increased by blocked drains on Hall Street and the south of the High Street. Subsequent investigations have shown that highway drainage has been damaged and consequently blocked in the vicinity and repairs are currently being commissioned. It should be noted however, that the capacity of the drains would have been limited in such extreme rainfall. On the south side of the bridge a gully was reported as slow running during routine cyclical maintenance prior to Storm Babet. However, this presumably drains to Chad Brook so more efficient functioning would also have contributed further floodwater to Chad Brook.

Silt build up either side of the bridge on the north side of Chad Brook may have contributed to flooding of property in the vicinity of the bridge. However, the original design of the bridge may exceed the natural width of the river, causing the river to flow more slowly in the past and the corresponding slow flows would have allowed more silt to settle. Therefore, future removal of silt on the north bank may again cause the

river to flow more slowly, encouraging a faster rate of silt deposition in future. In the interim, flood risk may be increased for properties downstream in more extreme events. Further investigation would be required to ascertain potential benefits and harms of silt removal in this area.

- Chad Brook overtopped its banks, flooding property on the east and west sides of the bridge over Chad Brook and on the north and south sides of the river.
- Surface water flowed southwards from higher ground north of the bridge. The volume was increased by damaged and blocked highways drainage.
- Vegetation and trees were reported to be obstructing flow due to a lack of maintenance in Chad Brook adjacent to Bull Lane.
- The role of silt build up on the west and east side of the bridge in flood risk would need further investigation to be determined.

- Residents to install Property Flood Resilience (PFR) via grant funded scheme.
- Landowners to carry out watercourse maintenance to reduce flood risk as necessary in accordance with their riparian responsibilities.
- Explore potential natural flood management measures (eg. leaky dams, attenuation ponds and flood plain reconnection) to “slow the flow” and attenuate water upstream in the Chad Brook catchment.

- Residents to install Property Flood Resilience (PFR) via grant funded scheme.
- Landowners to carry out watercourse maintenance to reduce flood risk as necessary in accordance with their riparian responsibilities.
- Suffolk Highways to conduct repairs to damaged highways drainage and clear blocked drains on the north and south sides of the bridge over Chad Brook.
- Explore potential natural flood management measures (e.g. leaky dams, attenuation ponds and flood plain reconnection) to “slow the flow” and attenuate water upstream in the Chad Brook catchment.
- Investigate the potential benefits and harms of removing silt deposits adjacent to the Hall Street bridge on the northern side of Chad Brook.

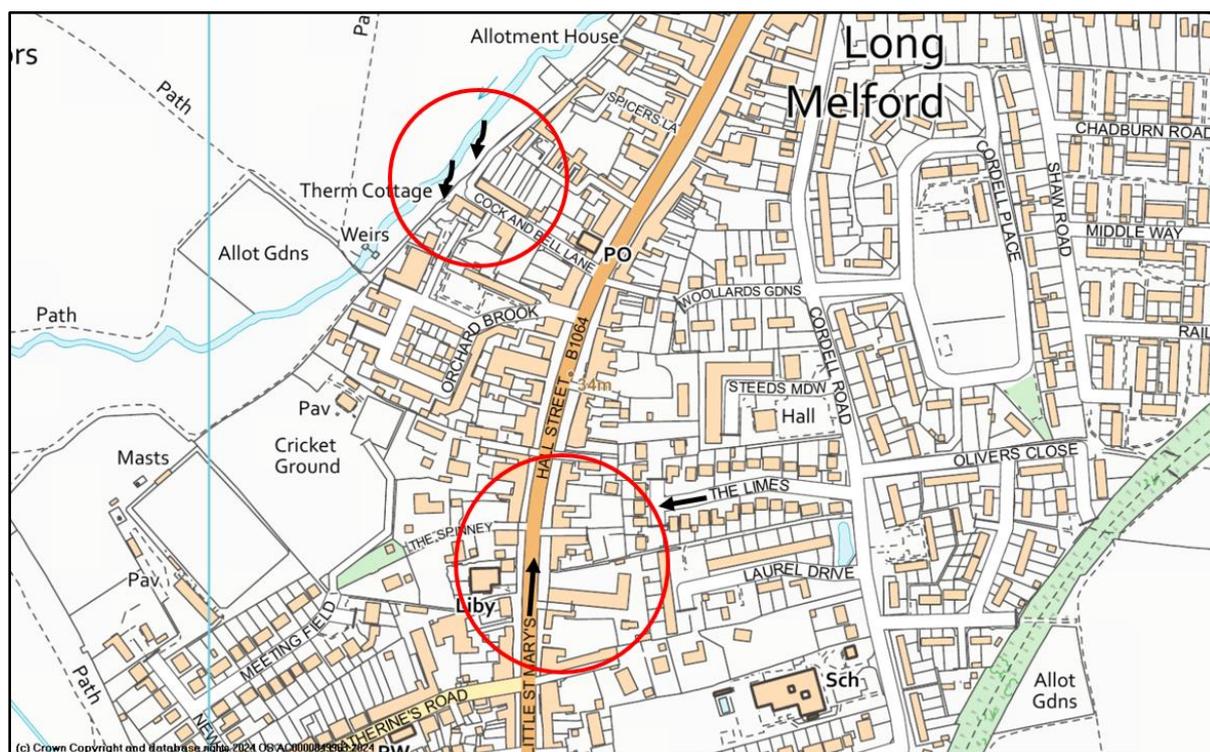
Figure 11 Approximate flood water flow paths in central Hall Street and Cock and Bell Lane indicating areas of affected property

Property in this area reported being internally flooded due to surface water flowing off roads into a low-lying area of Long Melford. Blocked drains in the vicinity were also reported to be a frequent issue. Many of the historic surface water drainage pipes and culverts in this area of Long Melford have relatively small capacities, contributing to water backing up and surcharging from drainage systems. Highways drainage at a low-lying location to the rear of affected property is reported to be free of blockages but to exceed capacity relatively frequently due to water collecting in this area. Two gullies in this area of Hall Street which could not be confirmed as running in May 2024 will be reviewed and jetted as appropriate. Affected property was projected to be at low risk of surface water flooding, i.e. it is at risk of flooding in the more extreme events.

- Surface water flowed down roads towards affected property which was at a lower level.
- Highways drainage in the vicinity exceeded capacity.
- Gullies in this area of Hall Street which are not confirmed as running to be reviewed and jetted as appropriate.
- High groundwater levels may also have been a contributing factor to flooding.

In this location, affected property was in close proximity to and on the east side of Chad Brook. The river was reported to have overtopped its banks and flooded property to an internal depth of approximately 15cm. This was compounded by surface water flowing down Cock and Bell Lane towards the river. Concerns were reported about the lack of maintenance of the river and the functioning of highway drains in the vicinity. There are no gullies in Cock and Bell Lane. Two gullies in Hall Street close to the entrance of Cock and Bell Lane could not be confirmed as functioning and need further investigation.

Impacted property was projected to be at low risk of river water flooding (ie. at risk of flooding in extreme events) and on the border of a medium surface water flood risk area.

- Chad Brook overtopped its banks, flooding property on the east side.
- Surface water flowed down Cock and Bell Lane towards affected property which was at a lower level.
- Highways drainage in the vicinity exceeded capacity.
- Gullies in Hall Street at the junction with Cock and Bell Lane which are not confirmed as running to be reviewed and jetted as appropriate.
- Vegetation growth resulting from a lack of maintenance, was reported to be obstructing flow in Chad Brook.

- Residents to install Property Flood Resilience (PFR) via grant funded scheme.
- Highways to ensure completion of cyclic maintenance of highway gullies.
- Suffolk Highways to jet blocked gullies in the area of Hall Street and investigate the condition of the existing drainage assets.

- Residents to install Property Flood Resilience (PFR) via grant funded scheme.
- Suffolk Highways to jet blocked gullies in the area of Hall Street and investigate the condition of the existing drainage asset.
- Landowners to carry out watercourse maintenance to reduce flood risk as necessary in accordance with their riparian responsibilities.
- Explore potential natural flood management measures (eg. leaky dams, attenuation ponds and flood plain reconnection) to “slow the flow” and attenuate water upstream in the Chad Brook catchment.

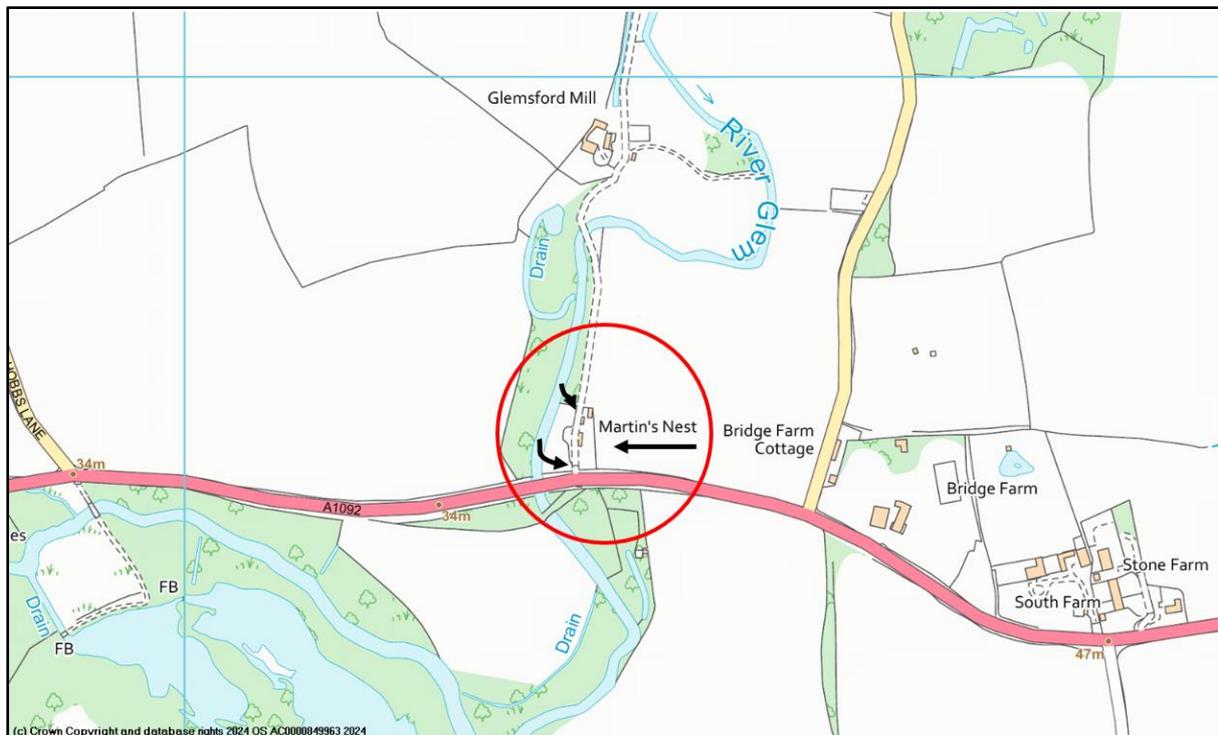
Figure 12 Approximate flood water flow paths in Clare Road indicating area of affected property

Impacted property in this area was on the north side of the A1092, in close proximity to and east of the River Glem. The river was reported to have overtopped its banks, causing internal property flooding. Surface water also flowed west down field slopes towards affected property, contributing to further flooding. Planting of cricket bat willow in the banks of the river was reported to have resulted in cut branches collecting in the river south of the A1092 bridge over the River Glem, hindering flow. Affected property is projected to be at medium river water flood risk and high surface water flood risk.

- The River Glem overtopped its banks, flooding property on its east side.
- Surface water flowed west down fields from the east towards affected property, which was at a lower level.

- Residents to install Property Flood Resilience (PFR) via grant funded scheme.
- Landowners to carry out watercourse maintenance to reduce flood risk as necessary in accordance with their riparian responsibilities.

- Explore potential natural flood management measures (eg. leaky dams, attenuation ponds and flood plain reconnection) to “slow the flow” and attenuate water upstream in the River Glem catchment.

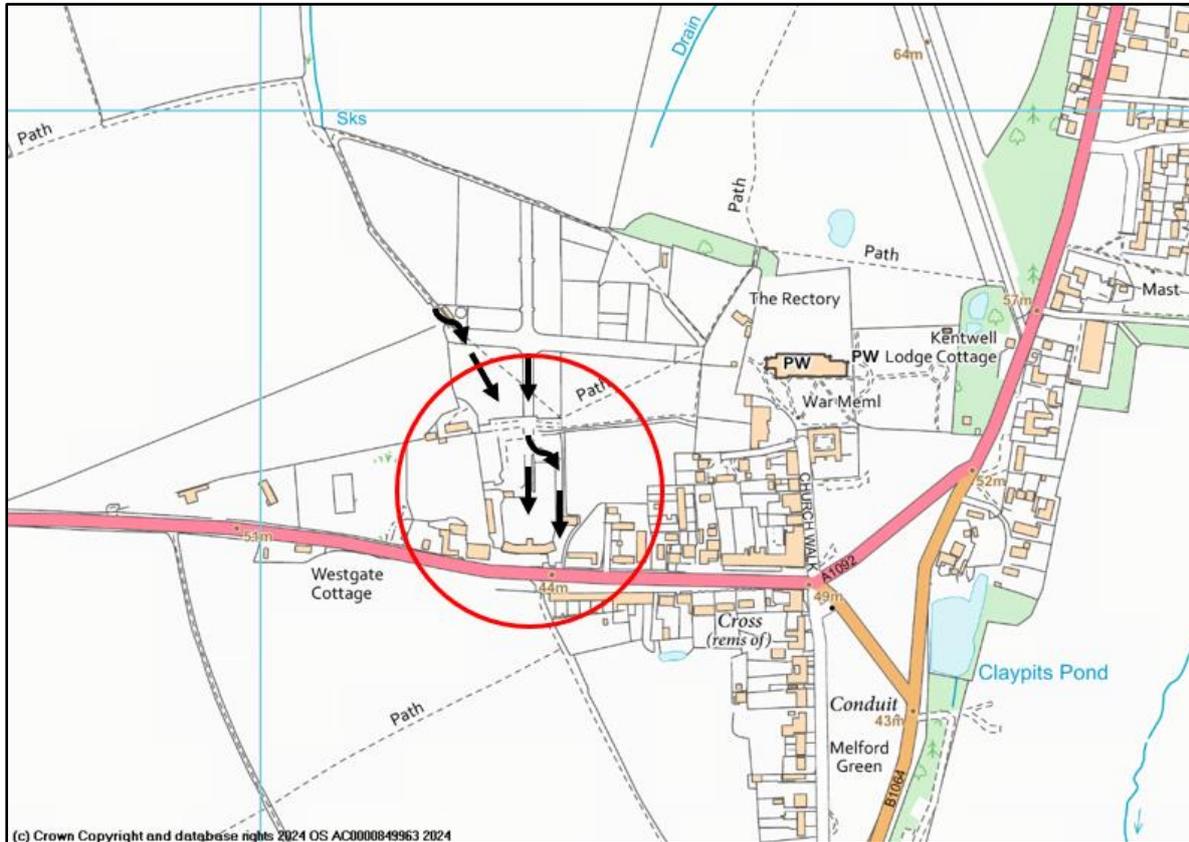
Figure 13 Approximate flood water flow paths in Westgate Street indicating area of affected property

On the north of Westgate Street, impacted property was reported to have been flooded from the rear by surface water flowing south from a ditch. The ditch becomes a piped watercourse as it flows south and the piped capacity was exceeded in the extreme rainfall conditions, causing the ditch to overtop above the piped section and floodwater to flow south down the slope towards the rear of impacted property. This was compounded by surface water also flowing from the fields to the rear. Subsequent investigations are reported to have identified blockages in the piped watercourse which connects with a brick culvert passing under the A1092 and emerges in a ditch on the south side of the highway.

- A ditch flowing south towards the rear of impacted property overtopped upstream of a piped section.

- Residents to install Property Flood Resilience (PFR) via grant funded scheme.
- Riparian owner to carry out piped and open watercourse maintenance to reduce flood risk as necessary in accordance with their riparian responsibilities.
- Explore potential natural flood management measures (eg. leaky dams and attenuation ponds) to “slow the flow” and attenuate water to the north of impacted property.

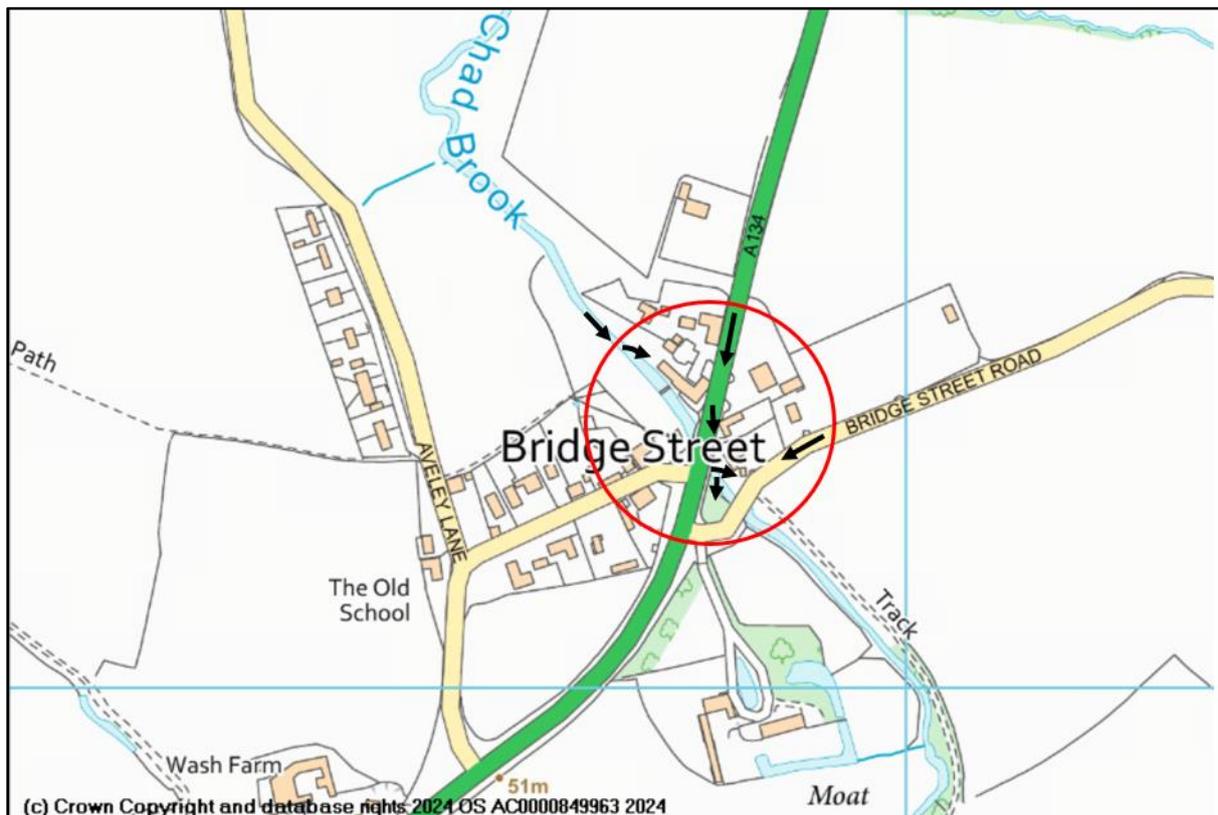
Figure 14 Approximate flood water flow paths in Bridge Street indicating area of affected property

Chad Brook was reported to have overtopped its banks, flooding property on the north side of the river and on both the east and west sides of the bridge adjacent to the

A134. Affected property was reported to have flooded to a maximum level of 90cm internally. Floodwater levels were reported as subsiding by 10pm. on 20th October.

- Residents to install Property Flood Resilience (PFR) via grant funded scheme.
- Riparian owner(s) to carry out piped and open watercourse maintenance to reduce flood risk as necessary in accordance with their riparian responsibilities.
- Explore potential natural flood management measures (eg. leaky dams and attenuation ponds) to “slow the flow” and attenuate water in the upstream Chad Brook catchment.
