## Section 19 Flood and Water Management Act 2010

### Marlesford Flood Investigation –

#### Storm Babet 2023

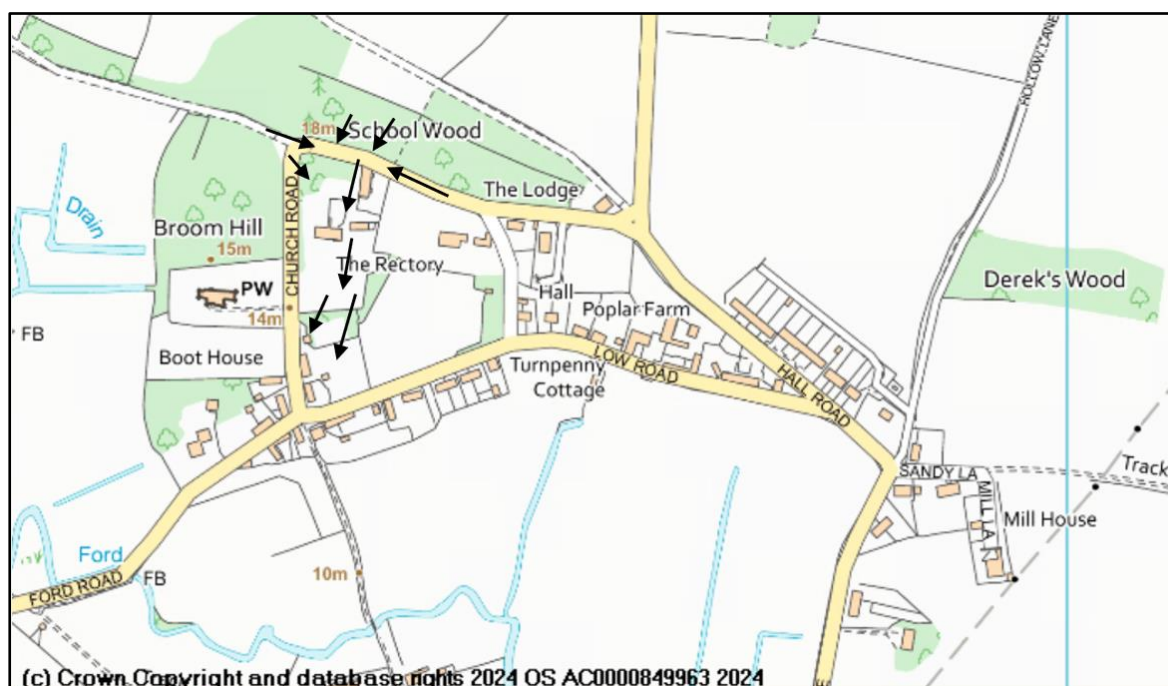
Figure 10. Approximate flood water flow routes along Church Road

The floodwater flowed south impacting additional properties further south on Church Road (see Figure 10). Residents here described entire gardens submerged as water flooded properties from the front and rear.

- Residents to install Property Flood Resilience (PFR) via grant funded scheme.
- Suffolk Highways to ensure the completion of highway drainage asset cyclic maintenance on Church Road.

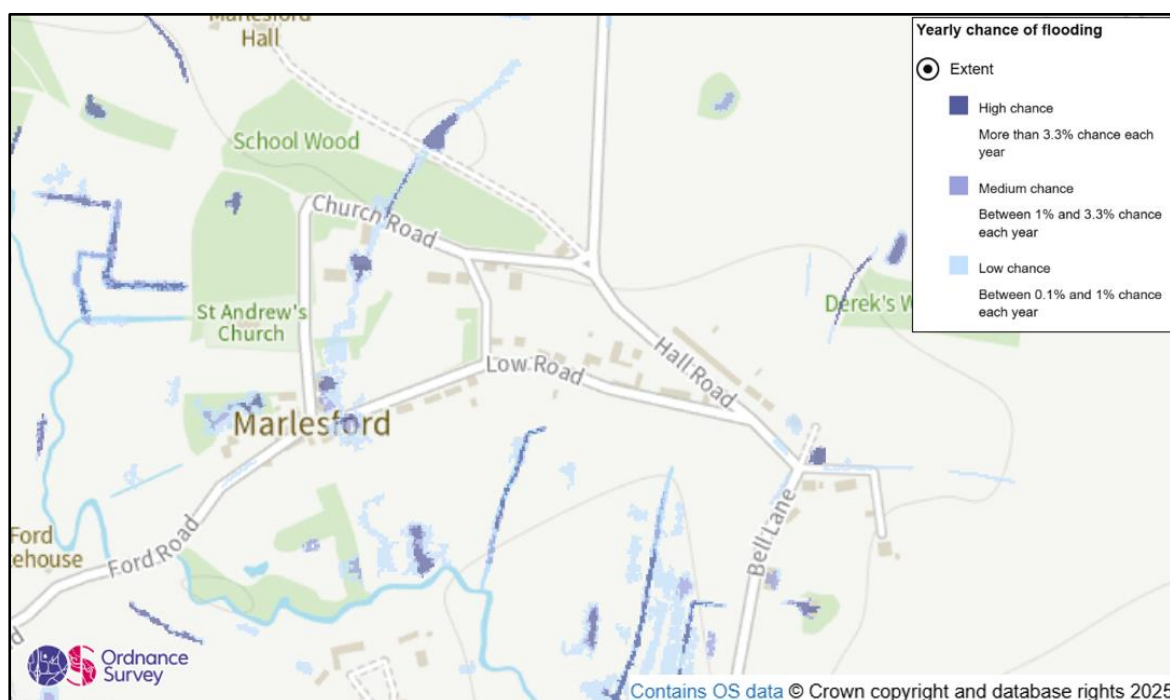
Figure 11. Surface water flood risk on Church Road

The floodwater flowpaths observed during Storm Babet closely match the national surface water flood risk mapping (see Figure 11). Parts of Church Road are characterised as having a high chance of surface water flooding.

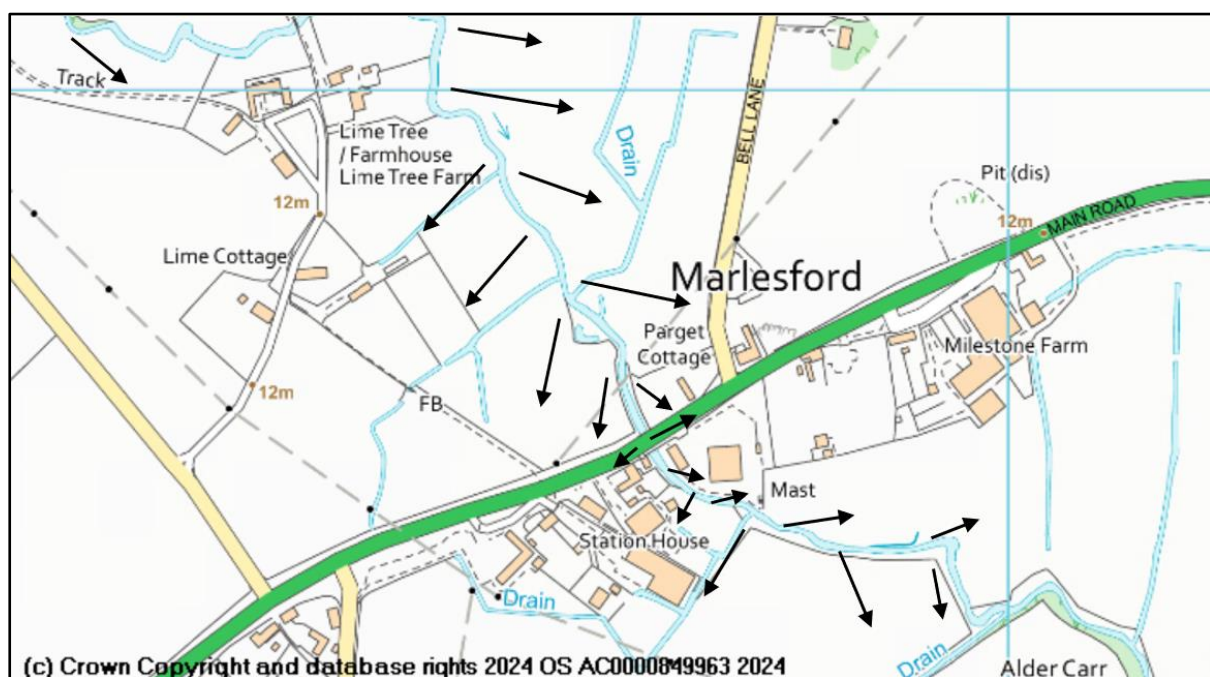
Figure 12. Approximate flood water flow routes next to Main Road and Bell Lane

Following heavy rainfall on the morning of 20 October, extreme water levels flowed down the river Ore from the catchments upstream of Marlesford. From late morning onwards, the swollen river levels exceeded the capacity of the channel and floodwater flowed across the floodplain between the village centre and the A12 Main Road (see Figure 12). Some properties in this area were flooded directly from the overwhelmed river Ore with residents citing the sheer amount of rain and runoff from the surrounding fields.

- Residents to install Property Flood Resilience (PFR) via grant funded scheme.
- Explore potential NFM measures which aim to attenuate water and 'slow the flow' on overland flow paths in the upper catchments above Marlesford e.g. storage ponds, wetland areas, leaky dams, woody debris installation and restoration of watercourses.
- The EA to investigate if there is flood risk benefit to carrying out in-channel maintenance of the river Ore through Marlesford adjacent to the A12 road bridge. Where maintenance is undertaken it is to assist with conveyance in regular winter flows and there may be limited benefit in an event the size of Storm Babet.

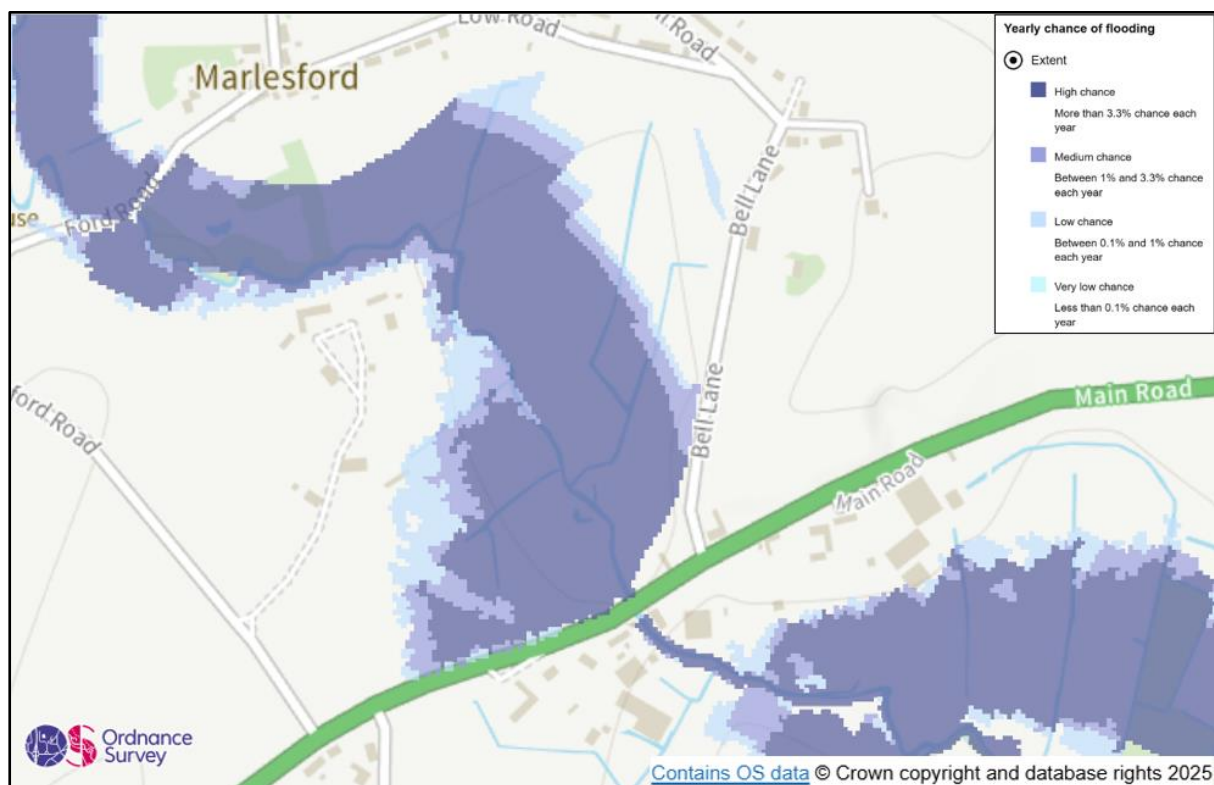
Figure 13. Fluvial flood risk next to Main Road and Bell Lane

The flooded properties located immediately south of the A12 Main Road are shown to be outside of the fluvial flood risk area (see Figure 13). This may highlight the unique nature of the Storm Babet event in terms of its impact on the ground or possibly indicates an issue with the current flood model at this specific location. When the Environment Agency updates the model, they will look carefully at this location to ensure it is represented correctly.

- Suffolk Highways to ensure the completion of highway drainage asset cyclic maintenance on Bell Lane and the A12 Main Road through Marlesford.
- Improved understanding of fluvial flood risk within the village through updates to the river Ore hydraulic modelling.

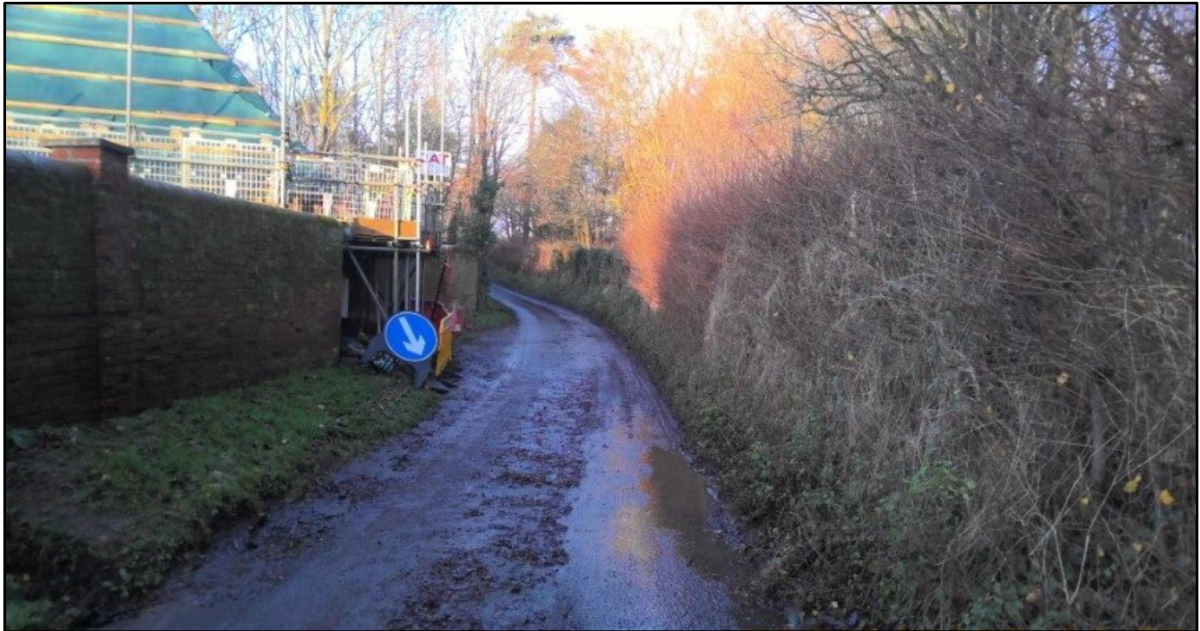
*Image 1 - Church Road looking west*

On the morning of 20 October, intense rainfall caused surface water to pool on Church Road and flow down the hill towards property entrances to the north (see Image 1). Residents reported torrents of water pouring through an open gate causing severe flooding as the floodwater flowed through gardens and along the driveway.

Multiple reports mention blocked drains on Church Road, drains being overwhelmed by the amount of floodwater and floodwater staying for several hours. There is also a report of a ditch bursting its bank and overflowing. There are also possible links to temporary building restoration works happening in the vicinity adding to the multitude of issues around the drainage on Church Road at the time of Storm Babet.

Church Road is narrow rural road and drainage here relies on grips. The grips had been recut in September 2023. Unfortunately, grips are a double edged sword, in normal rainfall they allow water to flow off the road, but conversely, they can provide a flow path from the ditch sooner than with a solid bank.

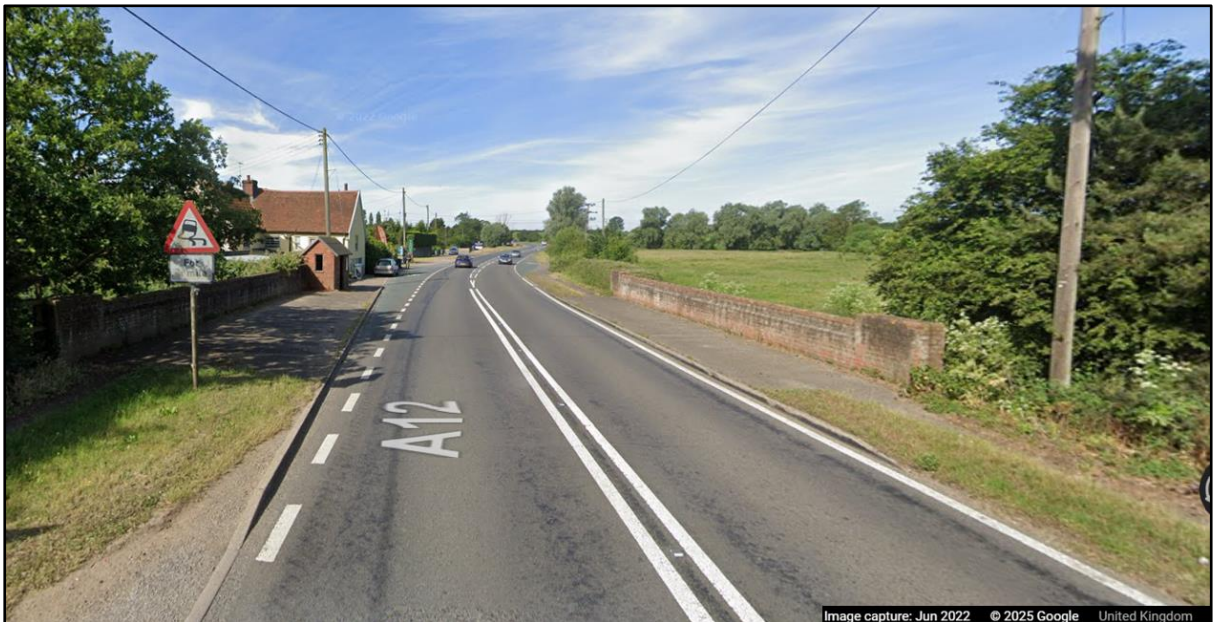
*Image 2 - A12 road bridge over the river Ore*

The section of the A12 next to the road bridge (see Image 2) over the river Ore was flooded. The floodwater is reported to have come off the Main Road towards adjacent properties. Floodwater also backed up and impacted nearby properties as the swollen river Ore also overtopped south of the Main Road (see Image 4) adding to the extent of the flooding.

The floodwater on the highway was slow to drain away, as the highway gullies were blocked up with mud and silt washed in with all the surface runoff during the storm. Prior to Storm Babet the highway drainage assets in this vicinity were cleaned and assessed to be operational in July 2023.
