Section 19 Flood and Water Management Act 2010

Needham Market Flood Investigation – Storm Babet 2023

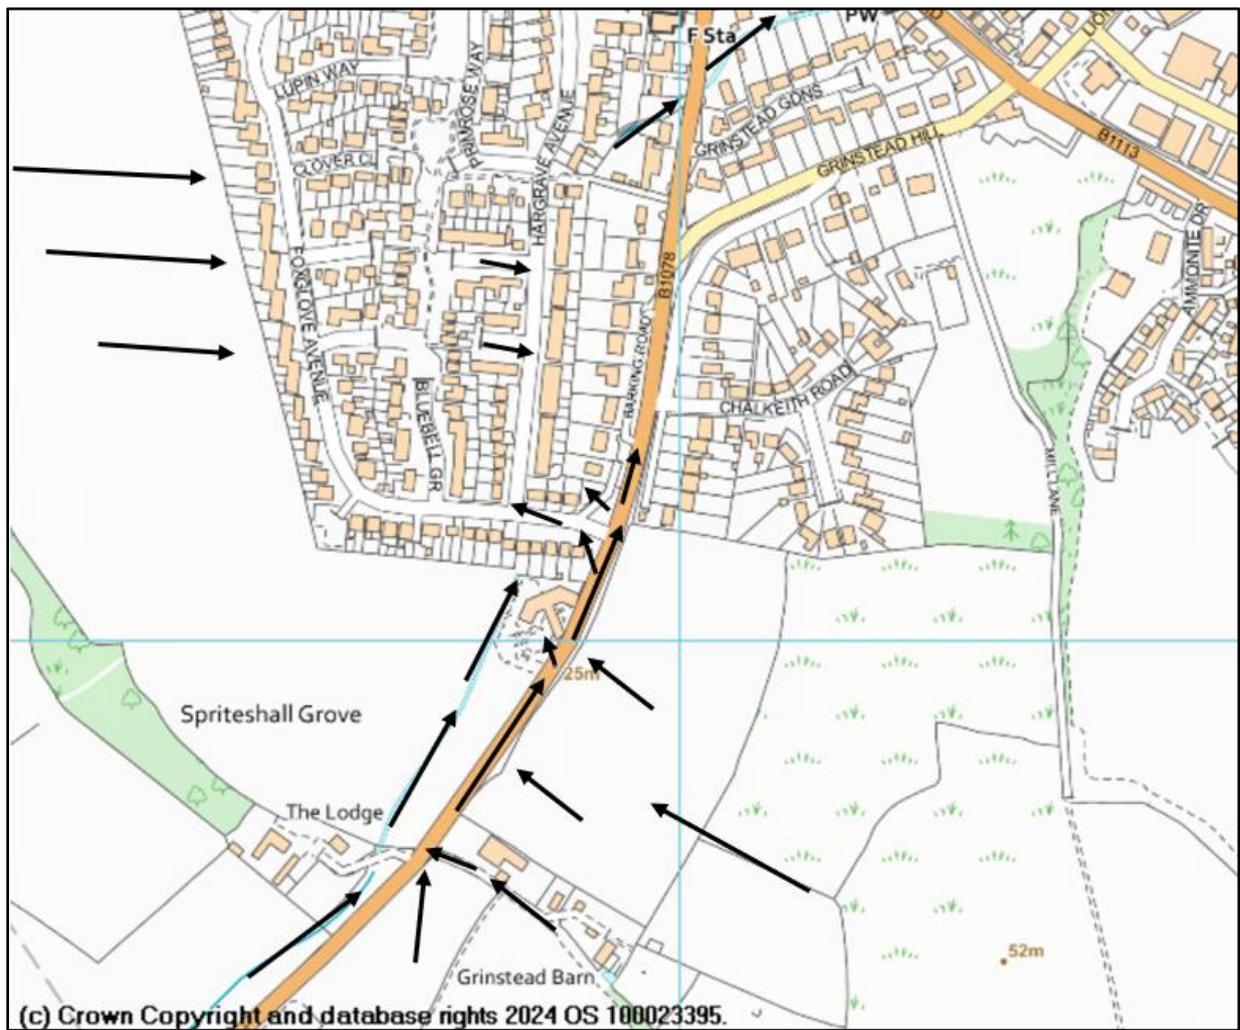
Figure 10 - Approximate floodwater flow routes on Barking Road, Foxglove Avenue, Hargrave Avenue and School Street

On the morning of 20 October 2023, a number of tributaries in the rural upper catchment directed water into the town. Floodwater flowed along Barking Road towards Foxglove Avenue originating from fields to the east around Grinstead Barn, before emerging onto the carriageway. There were additional overland (surface water run-off) flow paths merging onto Barking Road from fields to the south either side of Priestly Wood close to Barking. Outside the pharmacy entrance on Barking Road, water was starting to pool from 09:00am onwards and by 11:00am water was observed to be coming into the car park from the road (Image 1).

Water was also arising from a surcharging manhole at the entrance to the Grinstead Barn turnoff. Additionally, an inspection chamber in the field to the west of Barking Road was blocked and added to the floodwater flowing along the road. Since Storm Babet, there have been additional reports that water is still surcharging from the area near the entranceway to Grinstead Barn and flowing north-eastwards along the Barking Road and towards Foxglove Avenue. Suffolk Highways are aware of the issues at this location. Jetting and initial investigations have already happened, and further actions are planned to be carried out.

Properties near to the junction of Foxglove Avenue and Barking Road were impacted by water entering Foxglove Avenue from Barking Road later in the morning. A drop kerb immediately south of the junction created a low entry point from the road (Image 2). This low point allowed water to pass onto Foxglove Avenue at a quicker rate and bypass a raised traffic calming road bump on Foxglove Avenue close to the junction with Barking Road. Properties at this location were also flooded internally in early January 2024 during Storm Henk.

- Investigate potential NFM projects to 'slow the flow' and attenuate water on overland flow paths (leaky dams, restoration of watercourses, etc.) to the west and south of Needham Market.
- Explore options to reduce the field run off from the west of Foxglove Avenue. Possible use of a vegetation strip / break, bund or ditch between field and properties.
- Investigate the potential to raise the dropped kerb on Barking Road.
- Investigate the drainage problems below Barking Road near Grinstead Barn
- Ensure a maintenance regime is in place for the entrance to the Anglian Water culvert upstream Hargrave Avenue. A CCTV survey to be conducted.
- Investigate highway drainage infrastructure to ensure capacity and condition are sufficient.

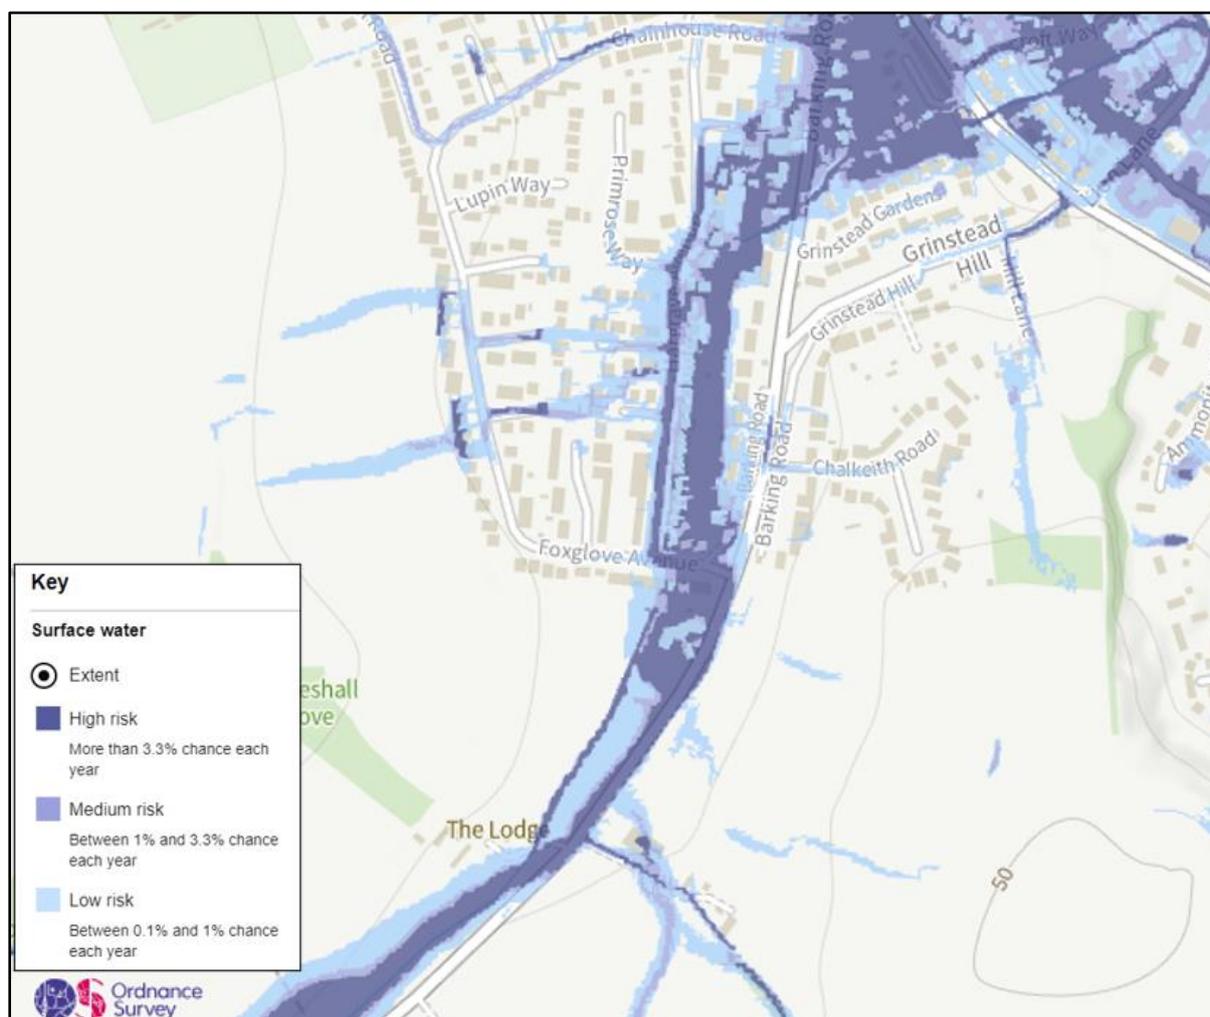
Figure 11 - Predicted Pluvial Flood Risk, Barking Road and Foxglove Avenue

Several properties along Foxglove Avenue were reported to have flooded from the fields to the west, at the rear of the properties. Local reports coupled with LIDAR imagery of the field, indicate the field slopes to the east funnel the surface water runoff towards the affected properties. This happened in the early hours of 20 October from around 03:00 am onwards. This closely matches the flow paths and extents shown in the predicted surface water flood risk mapping (Figure 11).

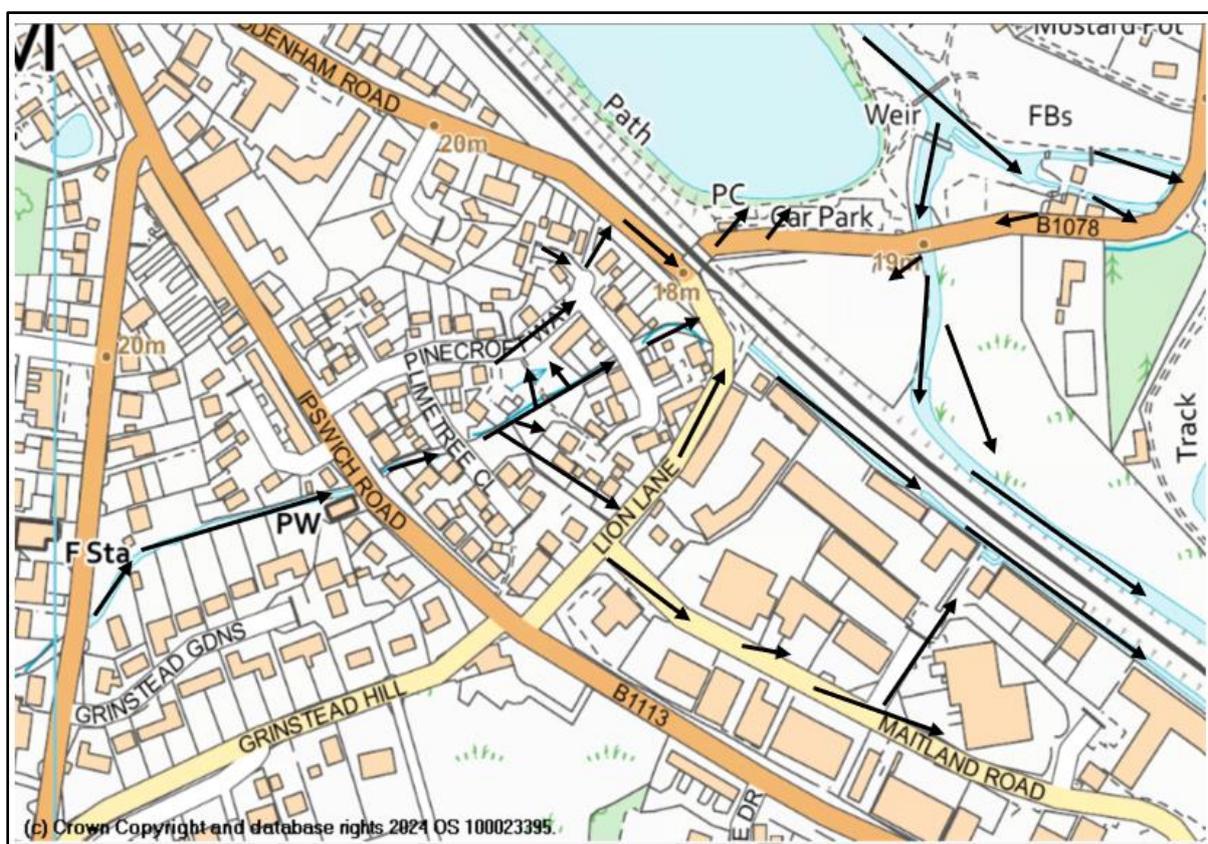
Figure 12 - Approximate floodwater flow routes on Pinecroft Way, Lime Tree Close, Lion Lane, Maitland Road and Coddendam Road

There were multiple flow pathways for the floodwater to travel across Pinecroft Way once water levels in the channel rose above the banks, resulting in water leaving the channel. Some of the floodwater flow paths followed the course of historic ditches and ponds that existed on the land prior to the housing estate. The channels and ponds have historically been infilled to aid the construction of the estate in the early 1980's. Historic maps that precede the development of Pinecroft Way show the alignment of a ditch and associated pond. It is this pathway that flooded properties on Lime Tree Close before flowing onto Lion Lane. Over time the ditch infill material has settled and created low spots in the landscape over which the floodwater could flow.

Floodwater overtopped the northern bank of the watercourse flooding properties on the northern side of Pinecroft Way and overtopped the southern bank flooding properties on the southern side of Pinecroft Way and Limetree Close (Images 4 & 5). It also backed up onto Lion Lane through another unflapped outfall, merging with floodwater on the corner with Coddendam Road from the railway bridge direction and then into Maitland Road, affecting buildings on the Lion Barn industrial estate (Image 6).

- Investigate potential NFM projects to ‘slow the flow’ and attenuate water on overland flow paths (leaky dams, restoration of watercourses, etc.) to the west and south of Needham Market.
- Fit non-return flaps on the outfalls along the Lion Barn drain through Pinecroft Way.
- Investigate capacity of the culvert under Lion Lane / Coddenham road corner. Carry out a de-silt / cleanse if required.
- Investigate options to enhance the flood risk benefit of the bund between Pinecroft and Coddenham way to allow drainage from the estate and defence from flooding from the main river Gipping.
- Investigate highway drainage infrastructure to ensure capacity and condition are sufficient.

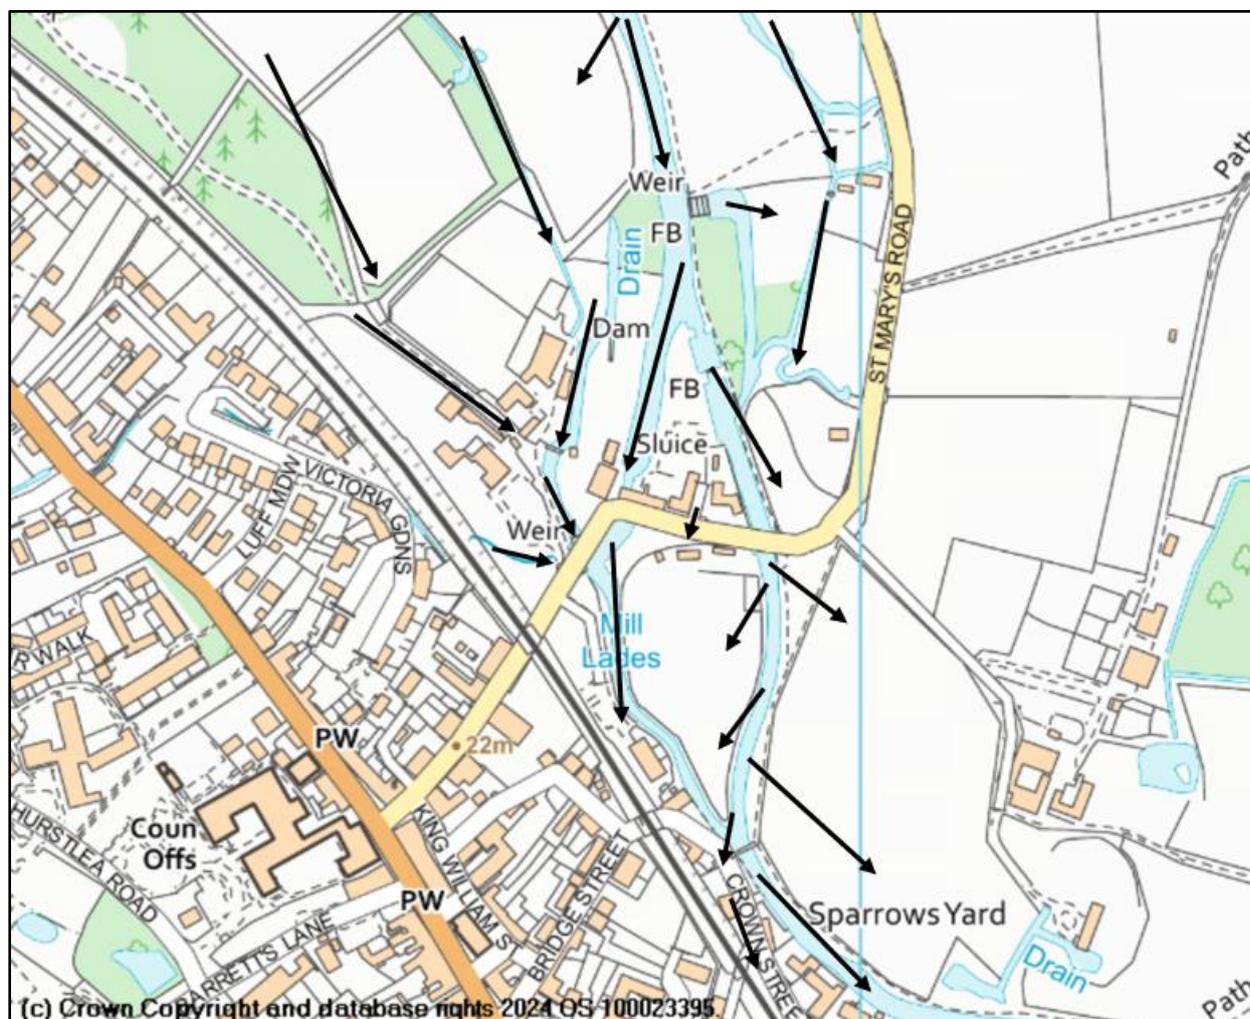
Figure 13 - Approximate floodwater flow routes on High Street, Hawks Mill Street, St Mary's Road and Crown Street

The primary source of flooding in the Hawks Mill and St Mary’s Road area was fluvial flooding, with flood water from the river merging with overland flows already on the fields and roads. The banks of the River Gipping overtopped upstream of Hawks Mill and combined with surface water flows and river tributaries coming across the fields from the Northwest. This meant much of the River Gipping flood plain was inundated and remained in flood for a considerable period of time (Image 8). The sluice gate

The Orchard Gate watercourse travels from Victoria Gardens and discharges into the Hawks Mill millpond via a highways culvert. The culvert, feeding into Hawks Mill millpond (marked Mill Lades in Figure 14) was found to be blocked with building material and watercourse debris. This restricted the flow and backed up water towards the railway embankment and the bottom of Victoria Gardens. Witness reports highlighted significant flows coming through the culvert below the railway embankment

- Investigate potential NFM projects to 'slow the flow' and attenuate water on overland flow paths (leaky dams, restoration of watercourses, etc.) to the west and north of Needham Market.

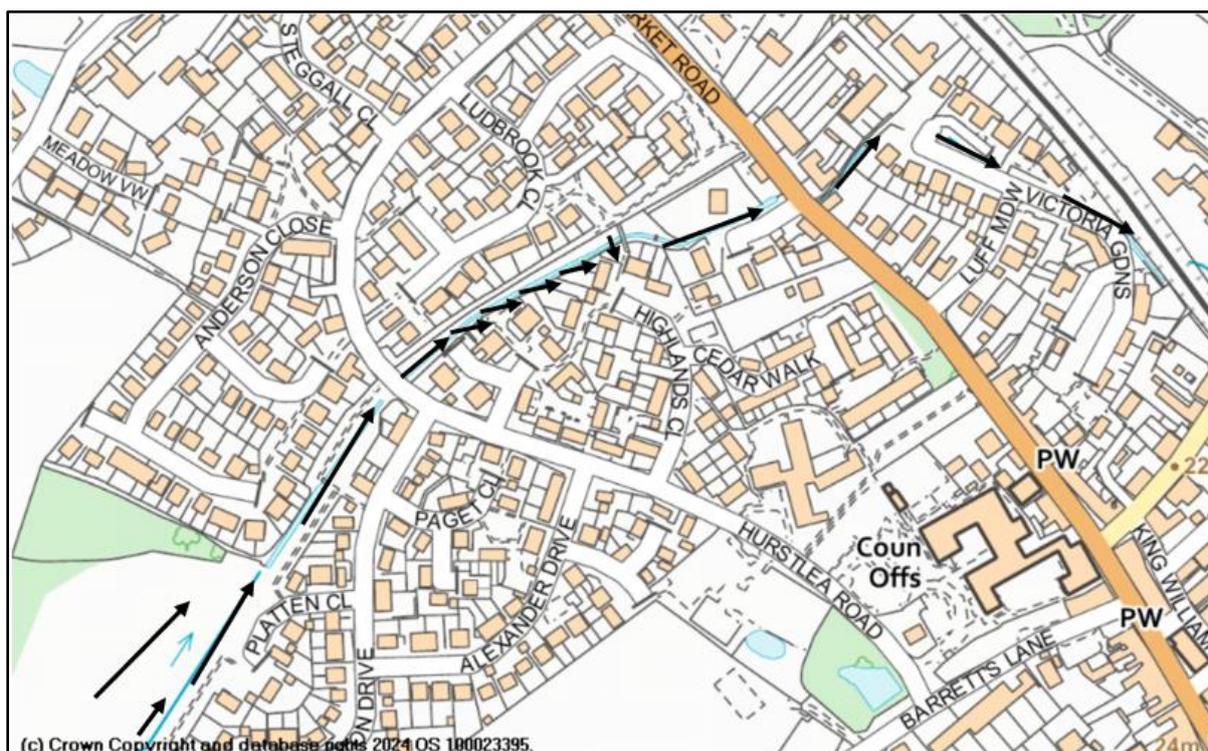
Figure 14 - Approximate floodwater flow routes on Highlands Close and John Swain Close

Flooding was likely caused by a combination of factors; a blockage in the culvert, the tall brick headwall of the footbridge blocking any flow downstream and the elevated height of the watercourse's northern bank. The observed floodwater extents and pathways from the watercourse match closely with the flood extents shown on the national surface water flood risk mapping (Figure 6).

- Investigate potential NFM projects to 'slow the flow' and attenuate water on overland flow paths (leaky dams, restoration of watercourses, etc.) to the west of Needham Market before entering the Orchard Gate watercourse.
- Ensure there is a channel maintenance regime in place for the upper section of the Orchard Gate watercourse (ordinary watercourse) in the urban areas.
- Ensure any observed blockages to bridges or culverts are reported to the relevant authority and removed.

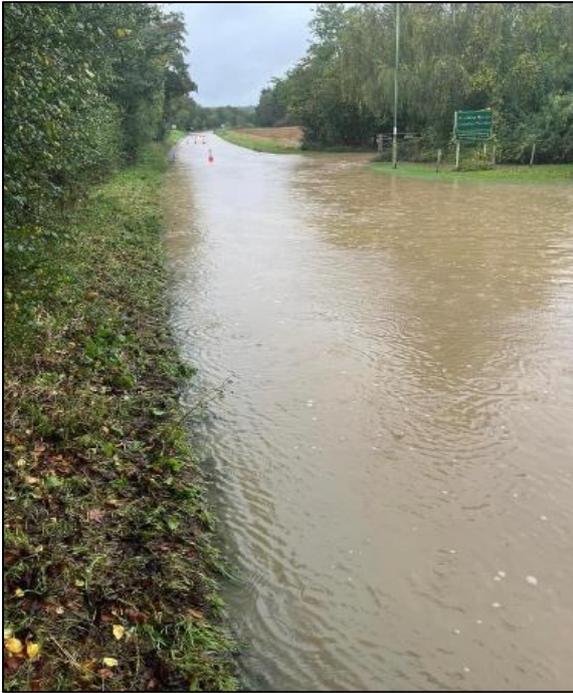
Image 1 - Flooding along Barking Road

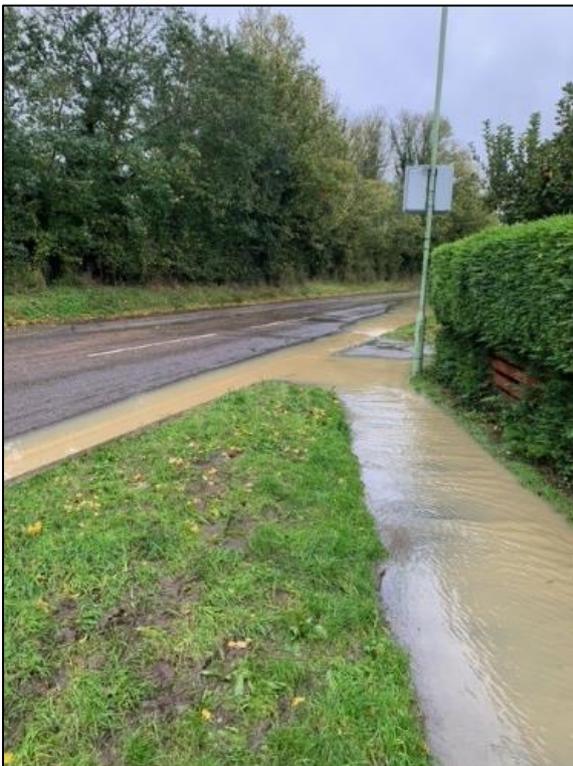
Image 2 - Barking Road floodwater showing flowpath over the dropped kerb

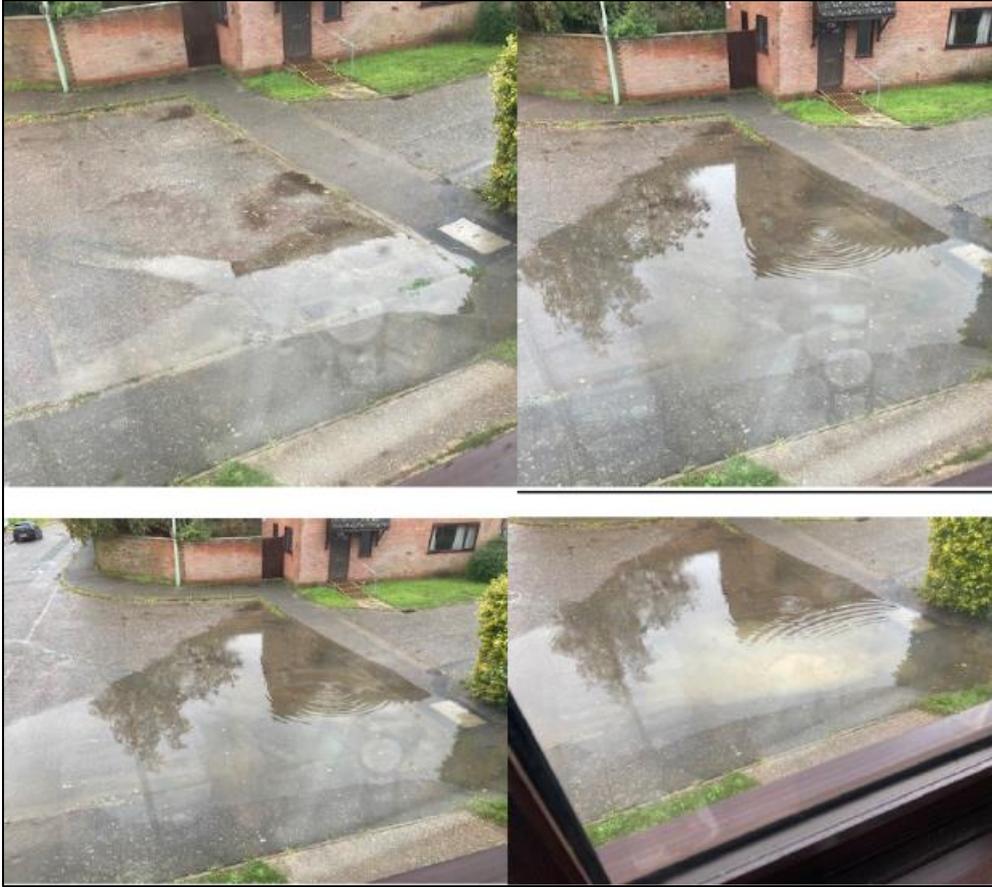
Image 3 - Sequence of flooding from a drainage gully on Pinecroft Way

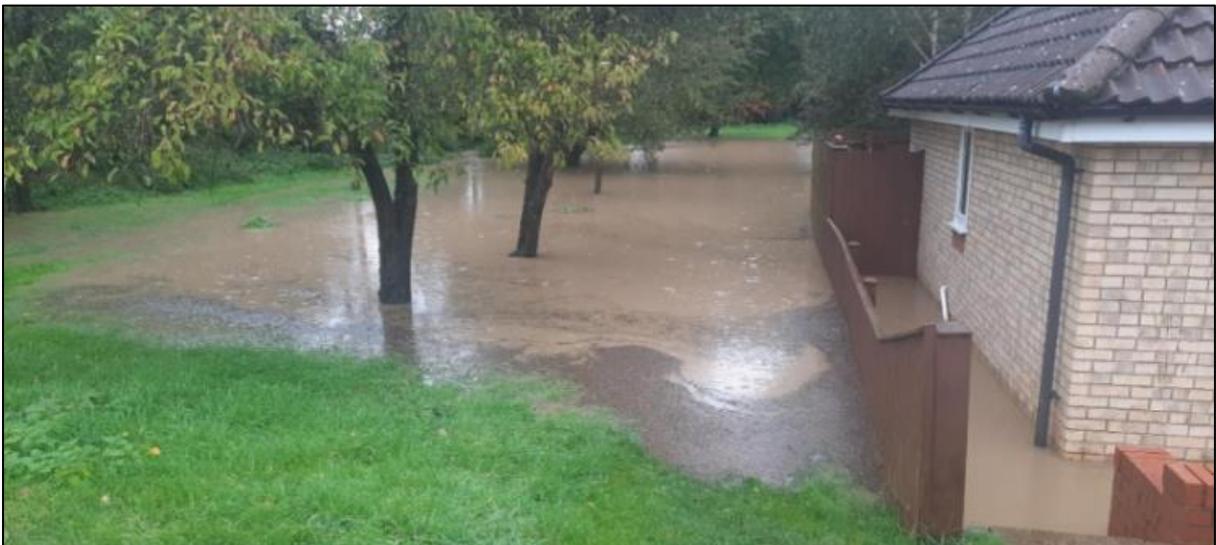
Image 4 - Flooding on Limetree Close next to the Lion Barn drain

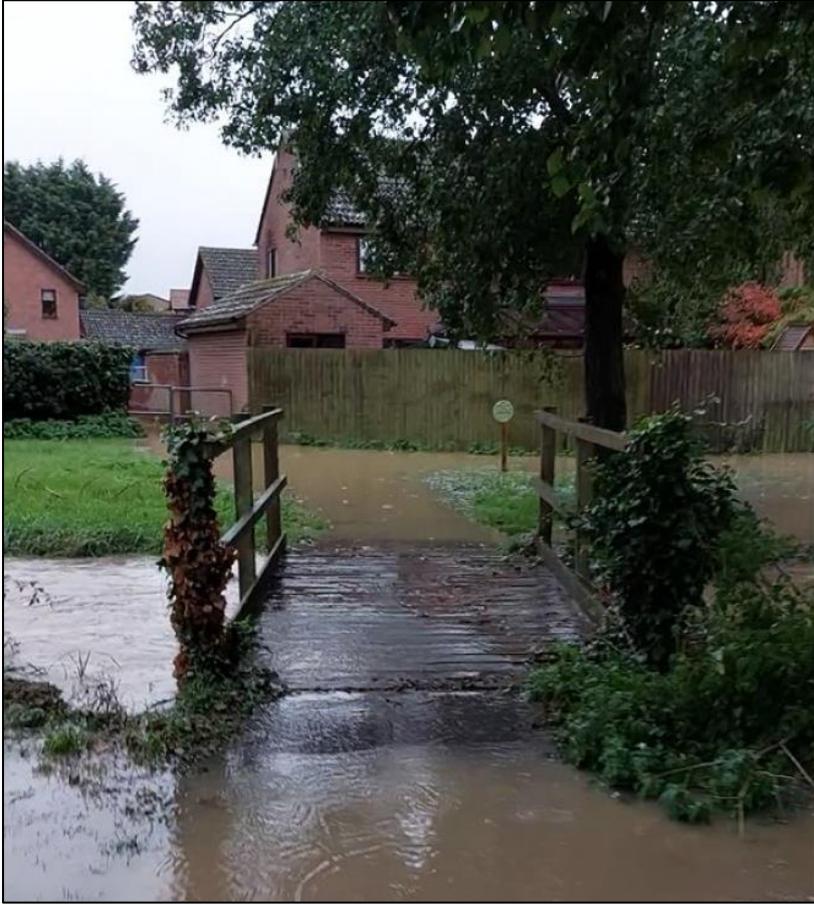
Image 5 - Flooding on Pinecroft Way from the Lion Barn drain

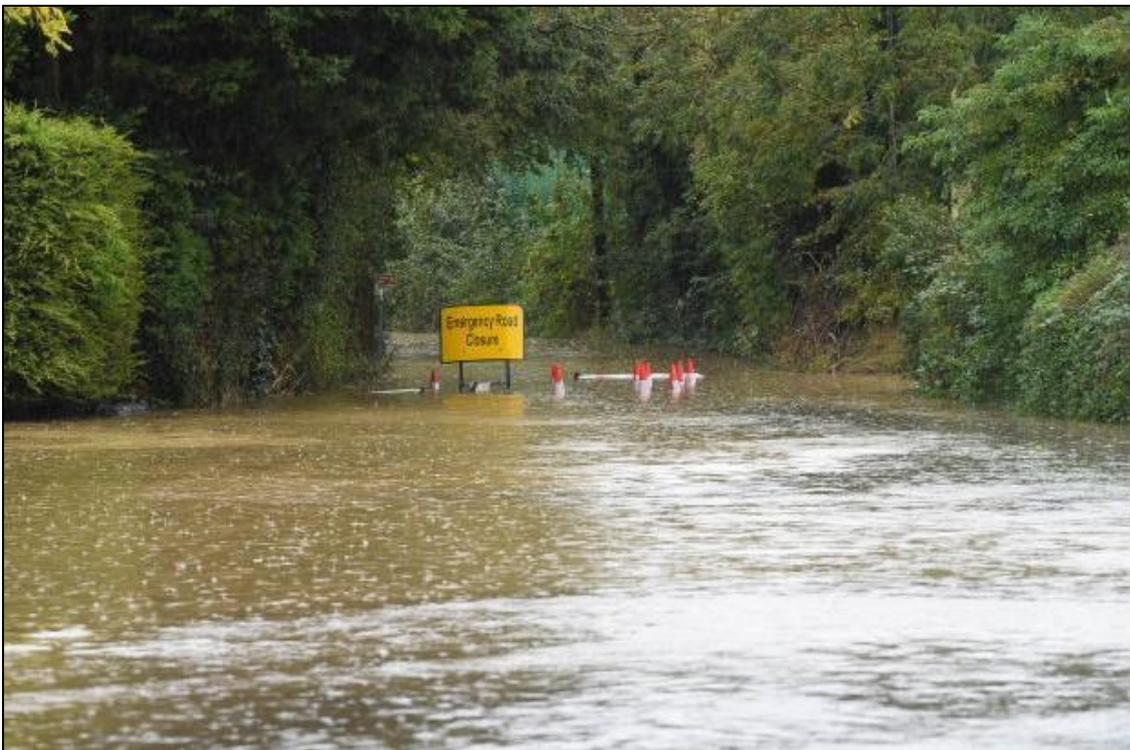
Image 6 - Flooding on Lion Lane

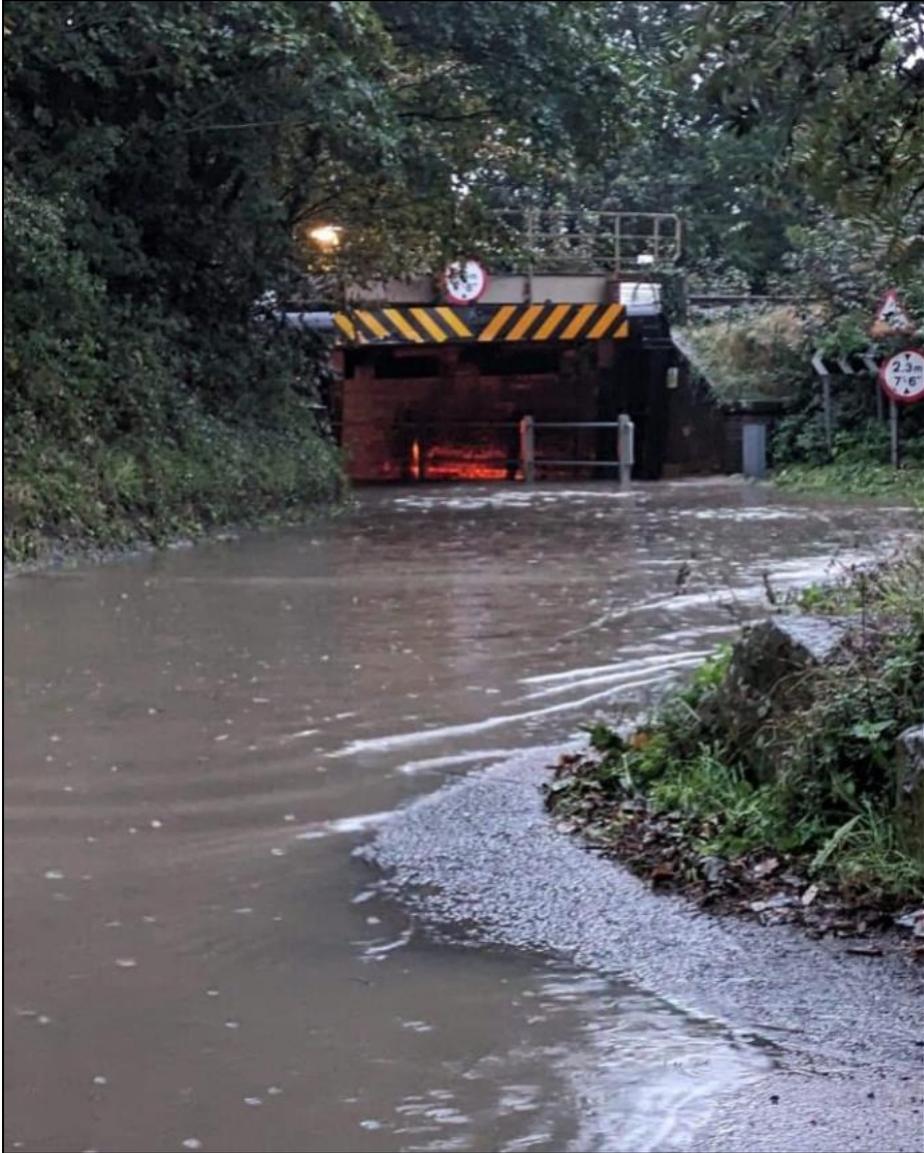
SCC Highways are aware of frequent issues at the Coddendam Road railway bridge. During heavy prolonged rainfall periods the road under the bridge is flooded and inundated by water.

Image 7 - Flooding under Coddanham Road railway bridge

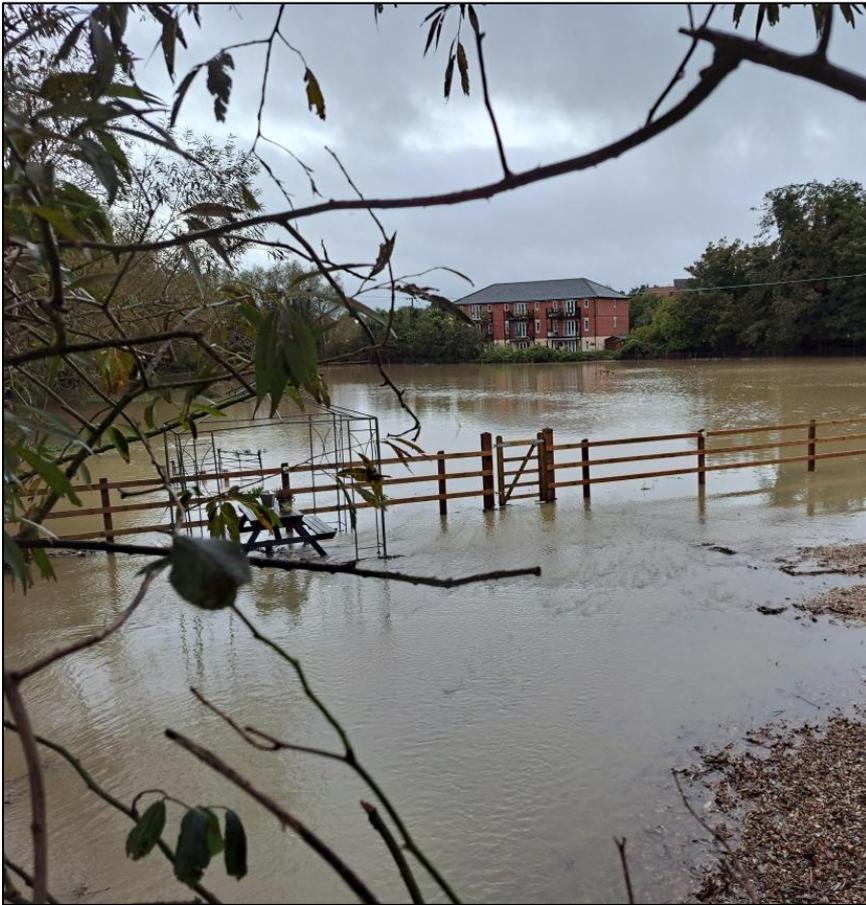
Image 8 - Flooding on Hawks Mill meadow

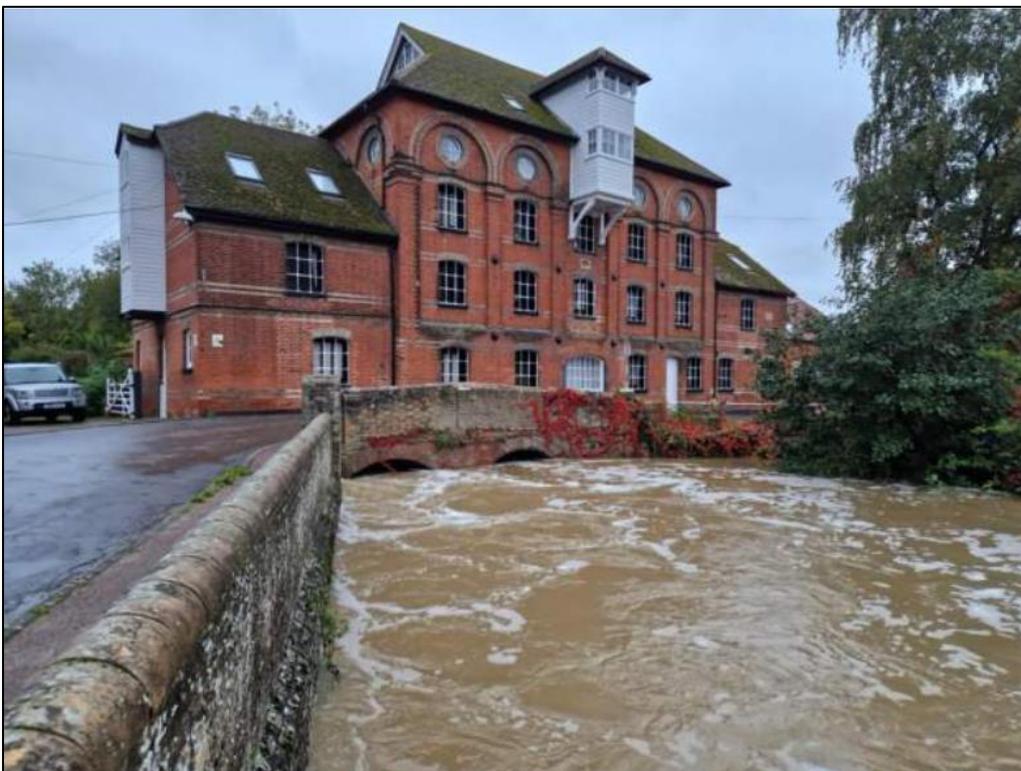
upstream of Hawks Mill which is operated and maintained by the Environment Agency was opened fully and functioned correctly throughout Storm Babet. The privately owned and operated gate below the mill was opened and operated at full capacity also (Image 9).

Image 9 - High river level in the Mill Pond on Hawks Mill Street

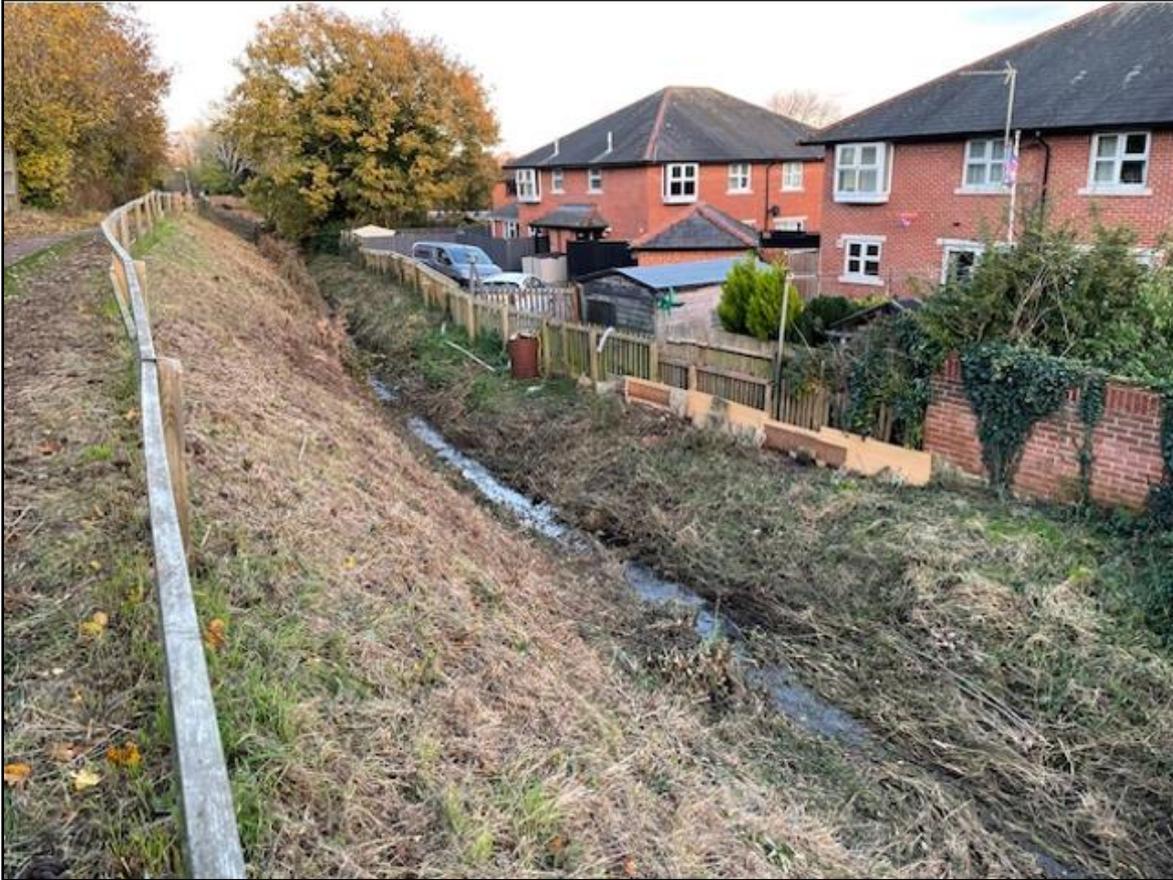
Upstream of the footbridge, the watercourse sits in a deep channel. The northern bank with the public footpath, is much higher than the southern bank. During site visits, Environment Agency officers noted an apparent low spot on the southern bank, potentially providing a flow pathway for the floodwater into the rear gardens on Highlands Close. There is also a low section of the southern bank to the rear of John Swain Close. At this location residents had created makeshift barriers to try to prevent water overtopping from the watercourse into their gardens post Storm Babet (Image 10).

Image 10 - Makeshift defences against floodwater overtopping from Orchard Gate watercourse
