Section 19 Flood and Water Management Act 2010

Report Title: Garrison Lane, Felixstowe

CRNos. 325731, 326167

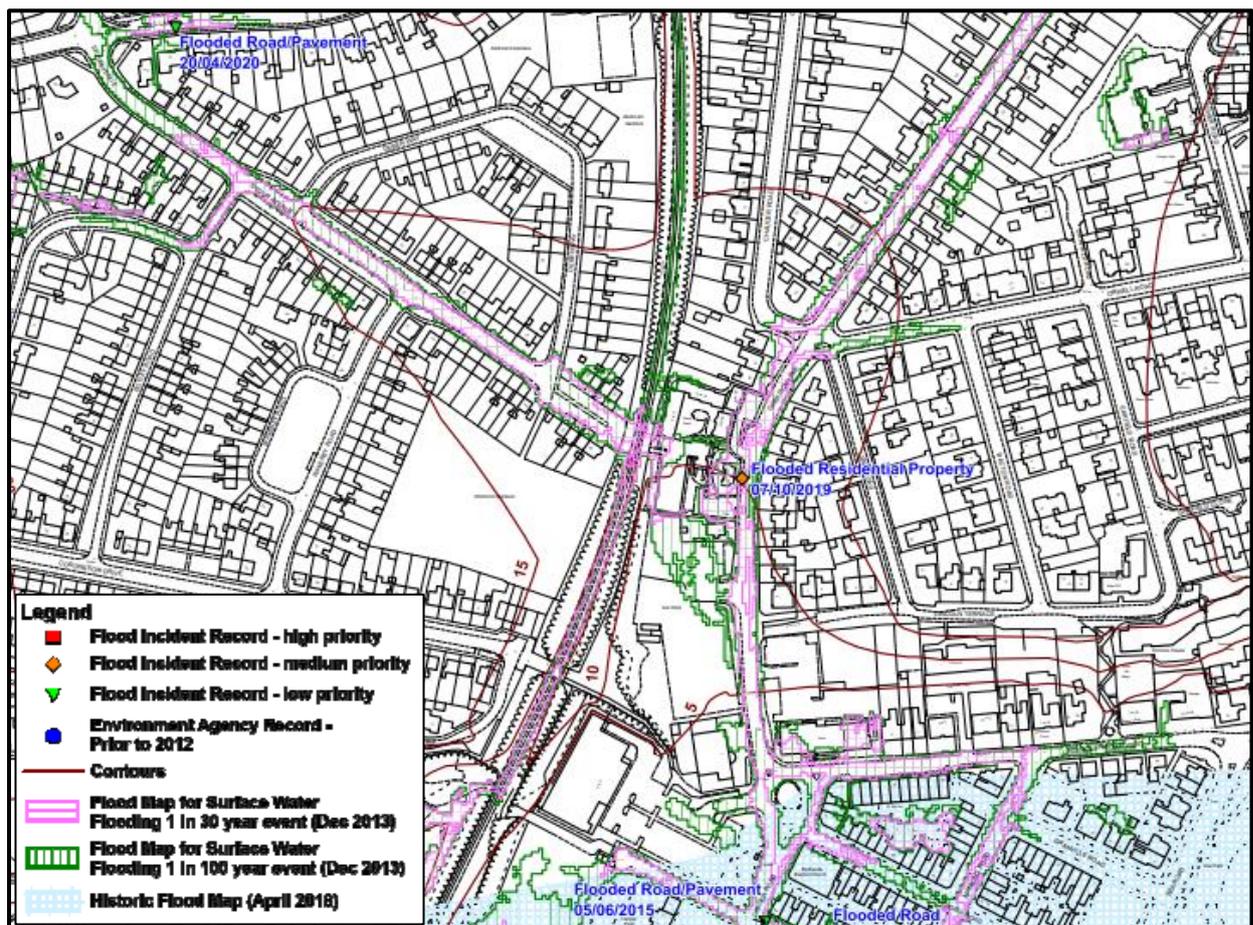
Figure 2 - Historical Pluvial Flood Incidents (to be updated once the 2021 events have been mapped)

Anecdotal evidence indicates that several of the properties in this area have experienced internal flooding on at least 3 occasions previously, the dates of these (including the most recent event) are as follows

- July 2015,
- October 2017,
- June 2019,
- June 2021.

Note three of the above events occurred in the summer which indicates this area is susceptible to flash flooding.

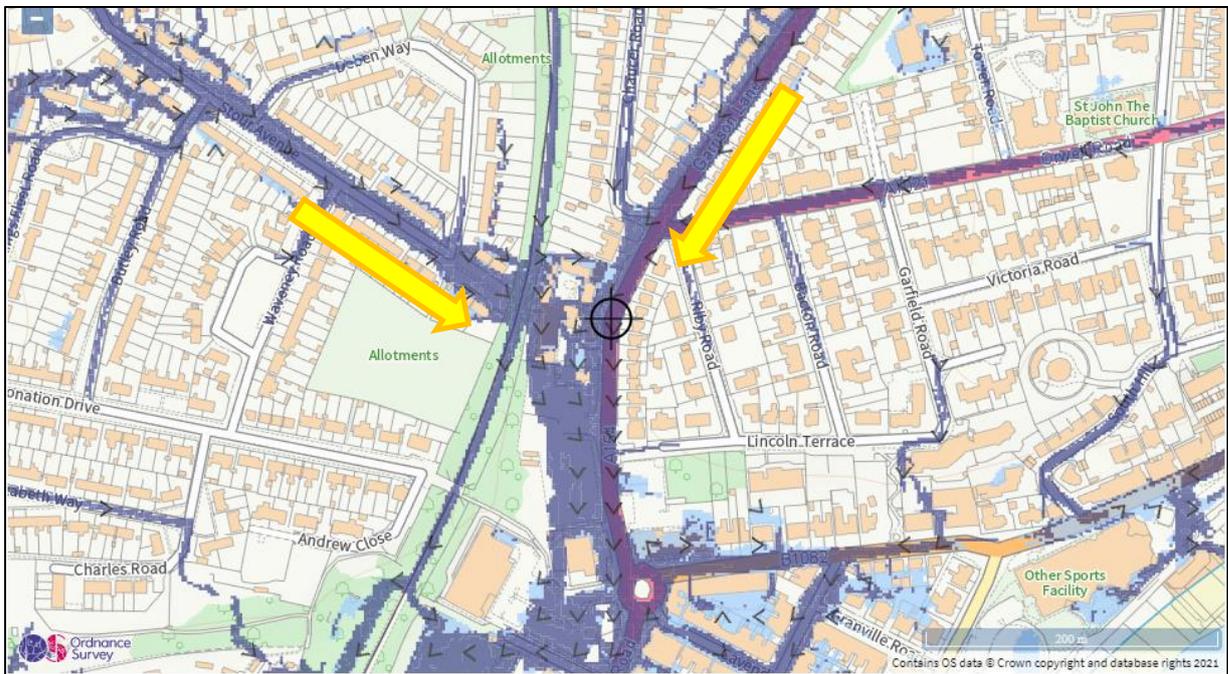
Figure 3 - Surface water flood risk: water velocity in low-risk scenario (main flow paths denoted by yellow arrows)

Stour Avenue marks a shallow “valley”, which also serves to funnel surface water (pluvial) runoff from surrounding areas towards the corner of Garrison Lane where the flooding occurred. These 2 flow paths can be seen in Figure 3.

The flow path down Stour Avenue and across the railway line, and the second flow path along Garrison Lane can clearly be seen in the above extract (yellow arrows). It is understood that these are the main contributing sources of surface water which inundated the properties.

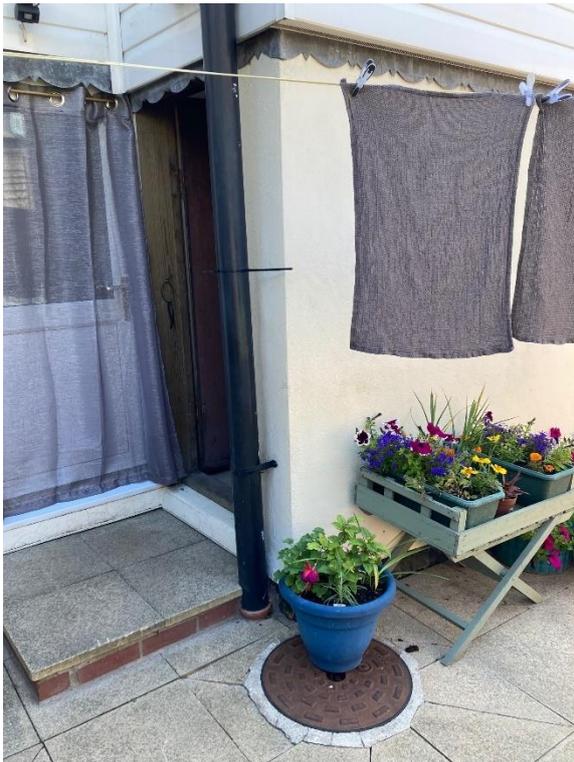
Flood depths within the basement areas reached 1.5m externally and over 0.6m internally. Bedrooms are located on upper floors and so safe refuge was available for the occupants temporarily until they could be rescued from the upper floors.

Depth of flooding externally adjacent semi-detached properties, marked by cable tie on downpipe

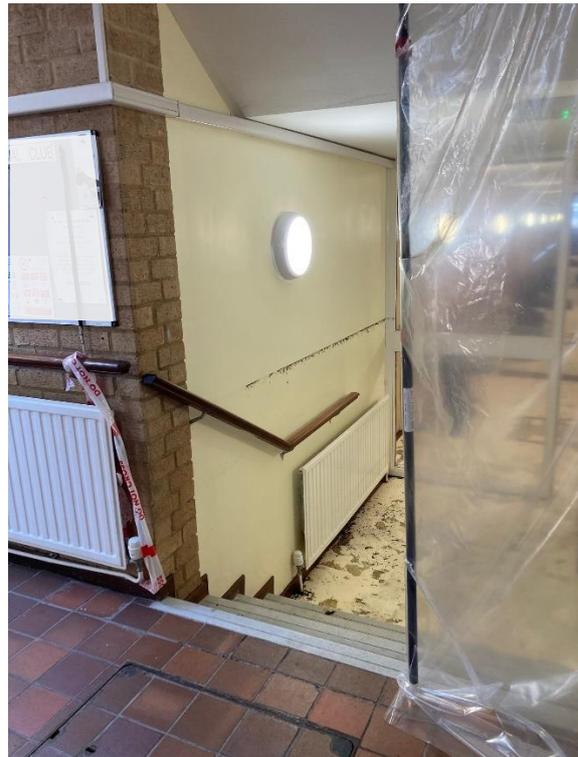
9 No. of the flats flooded internally. 8 No. of these are situated on a slope with ground levels to the rear higher than floor levels and thus experienced depths of flooding internally up to 1.2m within the access corridor and up to 0.6m in the flats. This resulted in deployment of the emergency services to pump out standing water and evacuate 12 No. residents. The 9th flat also experienced internal flooding but to a lesser extent due to its slightly elevated position.

Depth of flooding internally within the corridor serving the retirement flats, see watermark

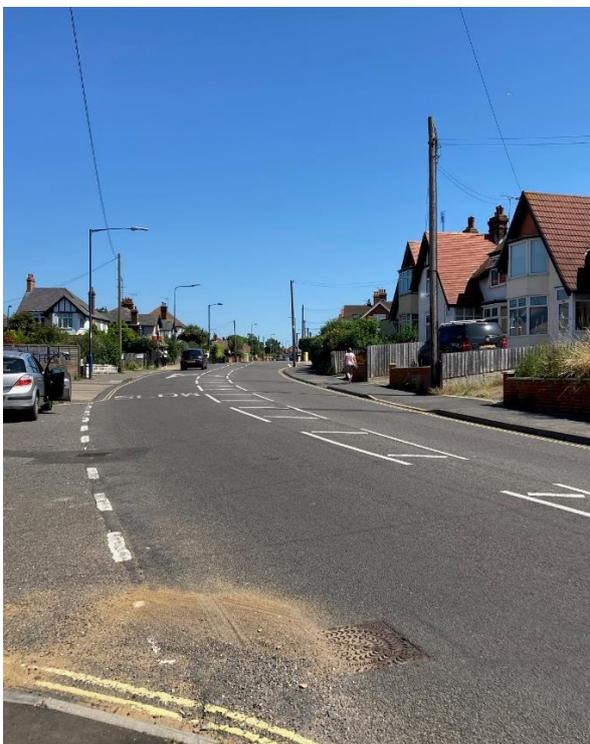
The intense nature of the rainfall resulted in a large volume of surface water flowing down Garrison Lane overwhelming the highway drainage infrastructure and heading southwards towards the properties. Surface water also flowed down Stour Avenue, across the railway line and down the embankment flooding the area from the north-west. Short power cuts were experienced locally.

Looking NE 'up' Garrison Road where surface water flows travelled, sediments/debris carried by floodwater

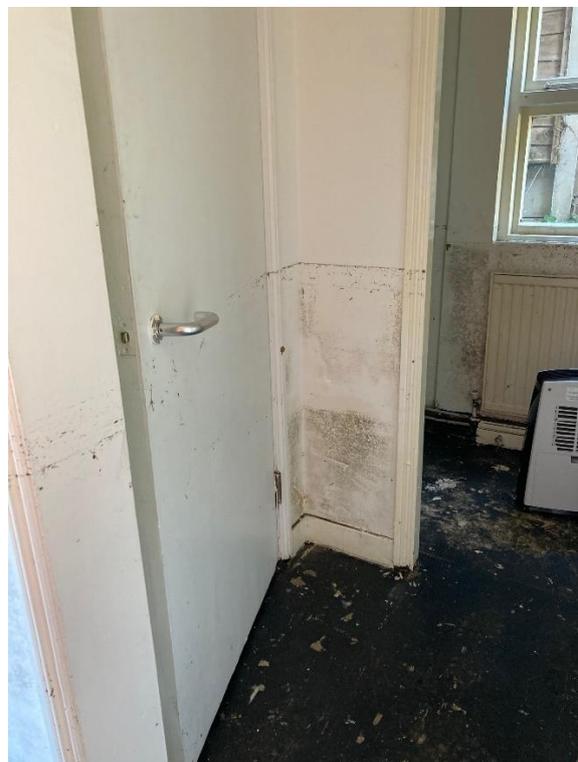
Depth of flooding internally within 'basement' floor of semidetached property, see watermark
