## Section 19 Flood and Water Management Act 2010

### Rickinghall Flood Investigation – Storm Babet 2023

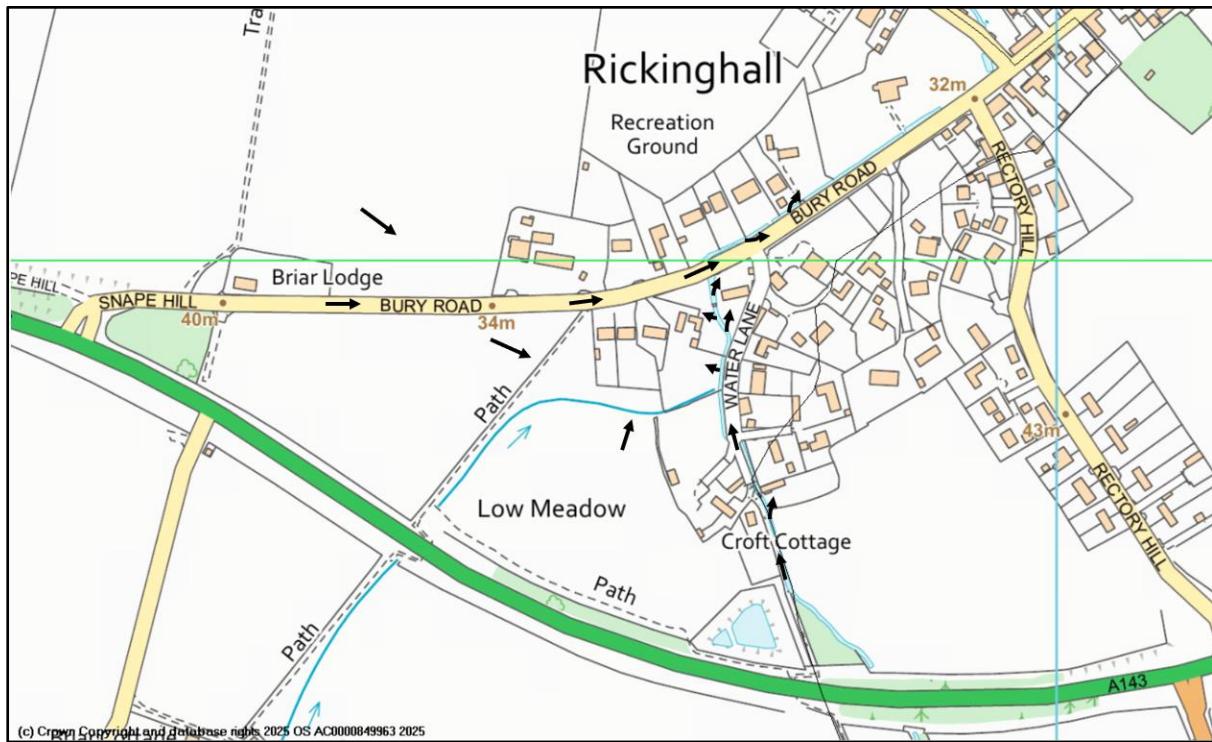
**Figure 10. Approximate floodwater flow paths surrounding the area of affected property in Water Lane and Bury Road**

Significant rainfall on a relatively large catchment caused considerable quantities of surface water to flow from fields and field drainage ditches primarily from the south and west of Rickinghall towards Water Lane. Water levels rose in a watercourse flowing from the south of Water Lane, which then crosses Water Lane from east to west through a culvert and flows north on the west side of Water Lane. A further watercourse joins this watercourse on the west side of Water Lane from the southwest. These watercourses reached capacity by 8am and had overtopped by 11am on 20<sup>th</sup> October, flooding adjacent property and fields.

Watercourses in the vicinity of Water Lane were reported to have been poorly maintained. A culvert and gullies in Water Lane and nearby Bury Road were also reported to be blocked and poorly maintained. In Water Lane, only one of the culverts (the one that carries the highway) is SCC owned and maintained. It was inspected in November 2023 and no significant defects were noted. In July 2024, deterioration of the highway retaining wall adjacent to the culvert in Water Lane was reported. Repairs have been ordered by SCC Highways for this retaining wall. Due to the extreme rainfall conditions during Storm Babet, the capacity of the wider drainage system, even if fully functioning, would have been exceeded by the amount of water present.

High groundwater levels were reported and may have been a contributing factor as floodwater was also described as rising through flooring. Sewage was also reported to be in the floodwater affecting some properties, the most likely cause being overwhelmed private sewage treatment facilities.

Floodwater in Water Lane was reported to have reached 1 metre depth and to be flowing fast northwards. Internal property floodwater levels in Water Lane exceeded 30cm. Late in the evening of 20<sup>th</sup> October it was reported that council staff (presumed to be SCC) came and cleared the gullies and pumped some water away. Floodwater took 24 hours to drain away.

Surface water also flowed from fields on to Bury Road and down Bury Road from the west into driveways and towards the Water Lane road junction. Flood water levels in Bury Road reached approximately 50cm and were fast flowing. The watercourse on the west side of Water Lane flows under Bury Road and then eastwards on the north side of Bury Road, where it was also reported to have overtopped. Internal property flood water levels in this area on the north side of Bury Road reached 15cm.

- A culvert and gullies in Water Lane and nearby Bury Road were reported to be blocked and poorly maintained. The only culvert in Water Lane which is owned and maintained by SCC was inspected in November 2023 and no significant defects were noted.

- Residents to install Property Flood Resilience (PFR) measures.
- SCC Highways to investigate the highways drainage system in Water Lane and nearby Bury Road for potential blockages.
- SCC Highways to ensure completion of highway drainage asset cyclic maintenance.
- Explore potential natural flood management measures on surface water flow paths in the upstream catchment (eg. leaky dams, buffer strips, tree planting and attenuation ponds and floodplain reconnection) to “slow the flow” and attenuate water.
- Landowners to carry out watercourse maintenance, to reduce flood risk as necessary in accordance with their riparian responsibilities.

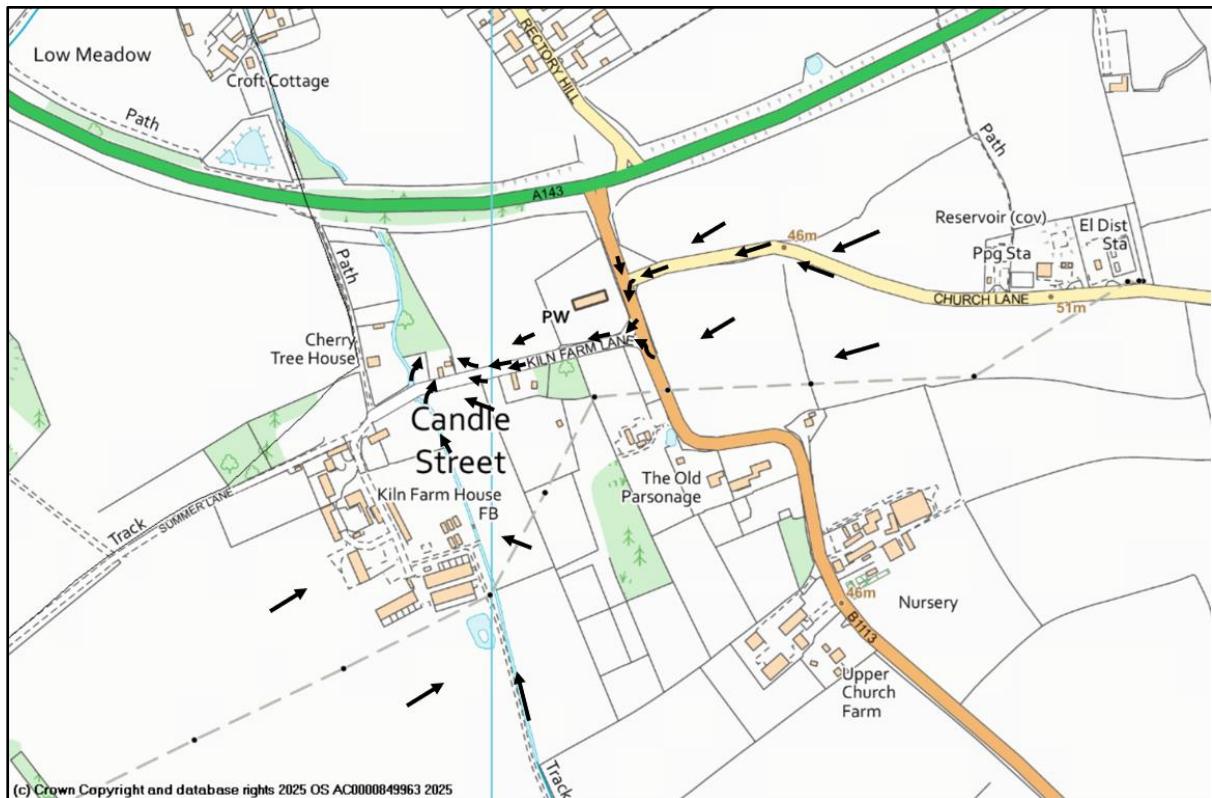
**Figure 11. Approximate flood water flow paths in Candle Street**

Surface water runoff from fields was reported to have combined with surface water on Church Lane and flowed west on Church Lane and across the B1113 into Kiln Farm Lane. Field drainage ditches adjacent to Church Lane and Kiln Farm Lane were reported to have been in poor condition with overgrown vegetation and overtopped. It was reported that this floodwater may have been supplemented by floodwater being released by a waterworks on Church Lane which flows onto the highway and continues to be described as a persistent issue. Essex and Suffolk Water have previously reported that the volume of discharge was within permissible levels.

Significant rainfall on a relatively large catchment caused considerable quantities of surface water to flow from fields and into a watercourse which flows north through a culvert under Kiln Farm Lane and towards Water Lane, subsequently contributing to the watercourse that flows on the west side of Water Lane. The culvert was reported to be obstructed by debris collecting at the entrance which contributed to flooding. (During subsequent cyclical maintenance inspections by SCC Highways the culvert was reported to be clear, but with overgrown vegetation on the adjacent banks. However, the culvert has a central support which makes the culvert more prone to obstruction from floating debris becoming trapped at the upstream end of the culvert. This watercourse also overtopped adjacent to affected property on the north side of Kiln Farm Lane, causing floodwater levels to rise. Floodwater entered property in Kiln Farm Lane at 10am on 20<sup>th</sup> October and started to clear at 6pm.

- Surface water runoff from fields combined with surface water on Church Lane and flowed west, across the B1113 into Kiln Farm Lane.
- This floodwater may have been supplemented by water released from the Essex and Suffolk Water treatment plant on Church Lane.
- Field drainage ditches adjacent to Church Lane and Kiln Farm Lane were reported to be poorly maintained and overtapped.
- Significant rainfall and a large catchment caused considerable quantities of surface water to flow from fields in the south towards Kiln Farm Lane and the join the watercourse flowing under it.
- This watercourse overtapped in the vicinity of Kiln Farm Lane.
- The culvert on Kiln Farm Lane was reported to be obstructed by debris, exacerbating flooding. The culvert was found to be clear subsequently, but with adjacent overgrowing vegetation.

- Residents to install Property Flood Resilience (PFR) measures.
- SCC Highways to ensure completion of highway drainage asset cyclic maintenance.
- Essex and Suffolk Water to investigate the discharges from their treatment site on Church Lane and ensure these do not increase flood risk.
- SCC LLFA to investigate the discharges from their treatment site on Church Lane and ensure these do not increase flood risk.
- Explore potential natural flood management measures on surface water flow paths in the upstream catchment (eg. leaky dams, buffer strips, tree planting and attenuation ponds and floodplain reconnection) to “slow the flow” and attenuate water.
- Landowners to carry out watercourse maintenance, to reduce flood risk as necessary in accordance with their riparian responsibilities.

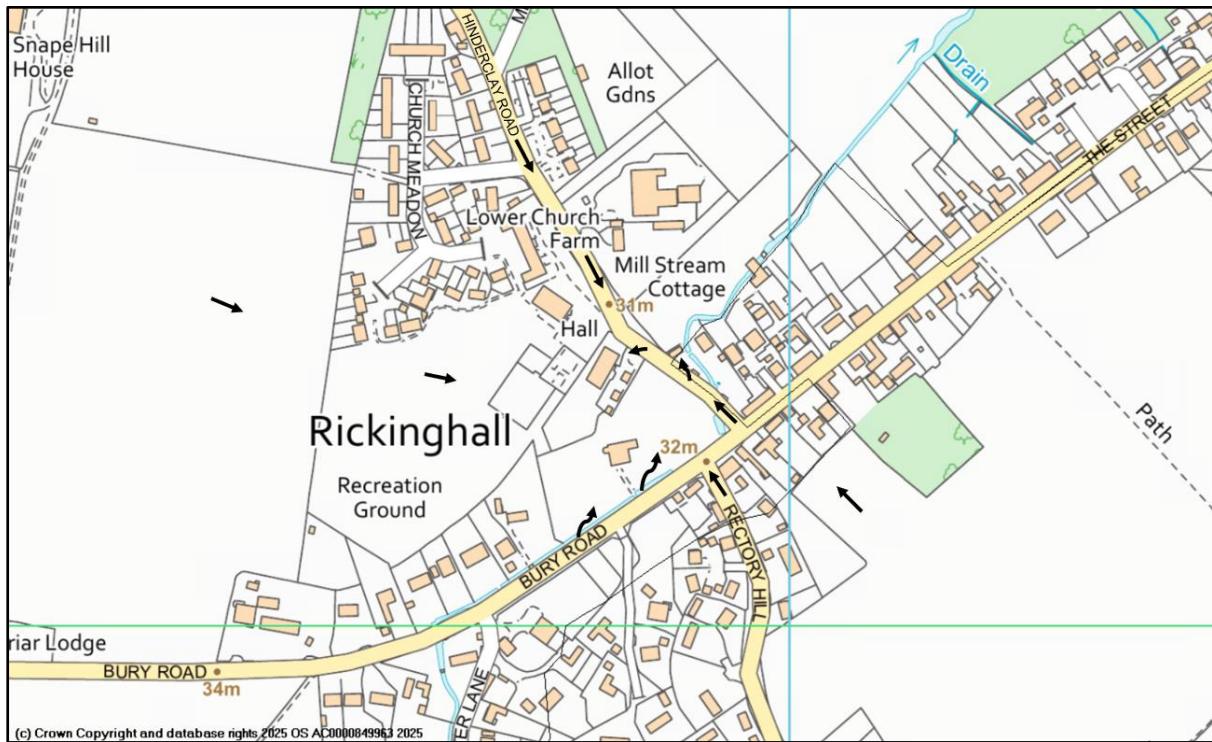
**Figure 12. Approximate floodwater flowpaths, Hinderclay Road**

Significant rainfall on a relatively large catchment caused considerable quantities of surface water to flow from fields and into a watercourse which flows north on the west side of Water Lane and then east along the north side of Bury Road. This watercourse overtopped its banks to the west of Hinderclay Road and floodwater flowed northeast across the grounds of St Mary's Church towards Hinderclay Road. Surface water also flowed down Rectory Hill into Bury Road and surface water from Bury Road then flowed down Hinderclay Road. Affected property is in a low-lying location on Hinderclay Road, towards which flood water converged.

Blockages in highways drainage were reported to be an ongoing issue in Hinderclay Road and on 18<sup>th</sup> October 2023, a drain near to affected property in Hinderclay Road was reported to be compacted with earth. However, due to the extreme rainfall conditions, the capacity of the wider drainage system, even if fully functioning, would have been exceeded by the amount of water present.

Affected property reported flooding at 1pm on the 20<sup>th</sup> October, causing internal floodwater levels to reach approximately 10cm. Floodwater ceased to enter property by 4.30pm. Preliminary jetting and clearing has subsequently been undertaken on the highways drainage system in Hinderclay Road. However, further investigation for blockages by SCC Highways is required.

- Significant rainfall on a relatively large catchment caused considerable quantities of surface water to flow from fields and into a watercourse which flows east along the north side of Bury Road.
- The watercourse overtopped.
- Floodwater flowed northeast towards the low point of Hinderclay Road, combining with surface water flowing from land and roads to the southeast.
- Highways drainage was reported to be blocked in Hinderclay Road.
- Preliminary jetting and clearing of highways drainage has been undertaken but further investigations are required.

- Residents to install Property Flood Resilience (PFR) measures.
- SCC Highways to investigate further the drainage system for blockages in the vicinity of affected property on Hinderclay Road.
- SCC Highways to ensure completion of highway drainage asset cyclic maintenance.
- Explore potential natural flood management measures on surface water flow paths in the upstream catchment (eg. leaky dams, buffer strips, tree planting and attenuation ponds and floodplain reconnection) to “slow the flow” and attenuate water.

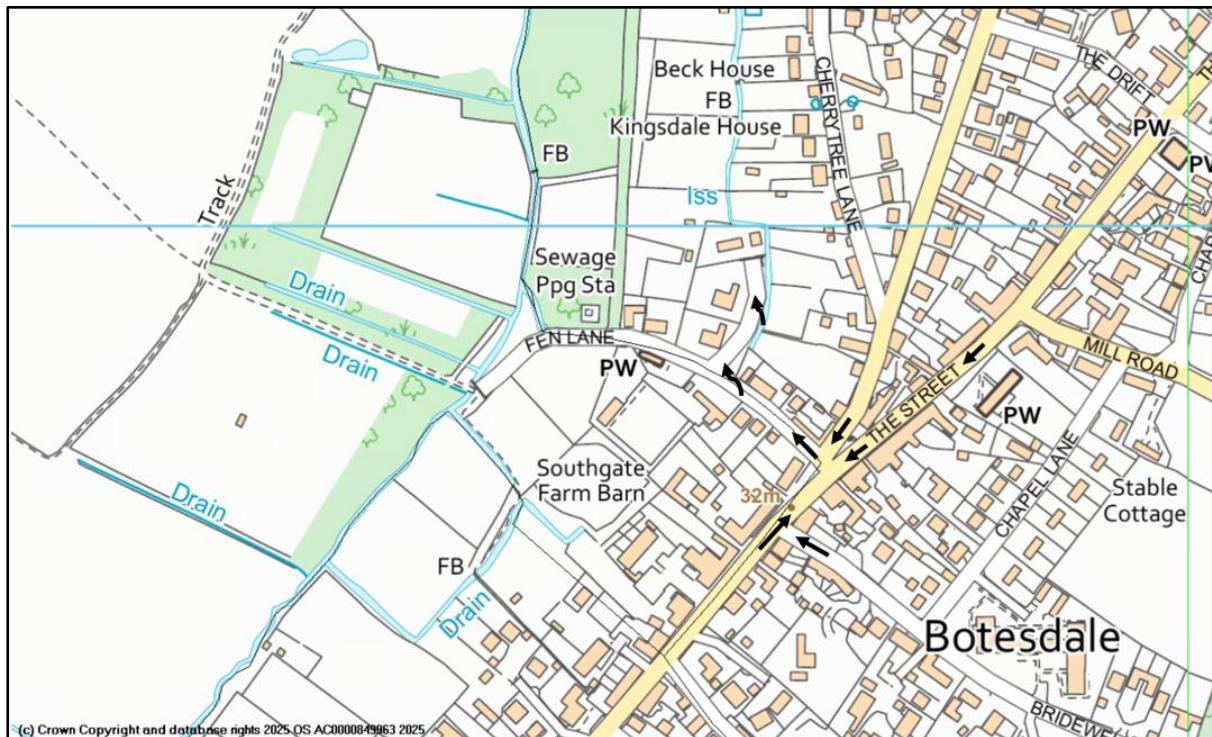
**Figure 13. Approximate flood water flowpaths, Fen Lane**

Surface water flowed from roads east of Fen Lane towards the lower-lying junction between The Street and Fen Lane and then down into Fen Lane and its northern cul-de-sac. Surface water also flowed from land east of the northern cul-de-sac towards it. Surface water flowed into the ditch on the eastern side of the cul-de-sac and the ditch overtopped, flooding adjacent property. A manhole in Fen Lane is reported to have surcharged during Storm Babet and a large quantity of silt and hard debris such as bricks and tiles were reported at the exit point of the drain into the watercourse after floodwater subsided. It was reported that the surface water drainage for Botesdale converges on this drain and this merits further investigation by Anglian Water. However, due to the extreme rainfall conditions, the capacity of the wider drainage system, even if fully functioning, would have been exceeded by the amount of water present during Storm Babet.

- Surface water flowed from roads and land east of Fen Lane towards the junction between Fen Lane and The Street.
- It flowed down Fen Lane and into the ditch on the east side of the northern cul-de-sac.
- It flowed across land from the east towards the cul-de-sac in Fen Lane.
- A manhole in Fen Lane surcharged.
- The ditch on the east side of the cul-de-sac overtopped flooding adjacent property.

- Subsequently, a considerable quantity of hard debris and silt was found at the exit point of the drain into the ditch.

- Residents to install Property Flood Resilience (PFR) measures.
- SCC Highways to investigate the highways drainage system in Fen Lane for potential blockages.
- SCC Highways to ensure completion of highway drainage asset cyclic maintenance.
- Anglian Water to identify their surface water drainage system converging in Fen Lane and investigate for blockages in Fen Lane.
- Explore potential natural flood management measures on surface water flow paths in the upstream catchment (eg. leaky dams, buffer strips, tree planting and attenuation ponds) to “slow the flow” and attenuate water.
- Landowners to carry out watercourse maintenance, to reduce flood risk as necessary in accordance with their riparian responsibilities.
