# Section 19 Flood and Water Management Act 2010

## Tunstall Flood Investigation

### Storm Babet 2023

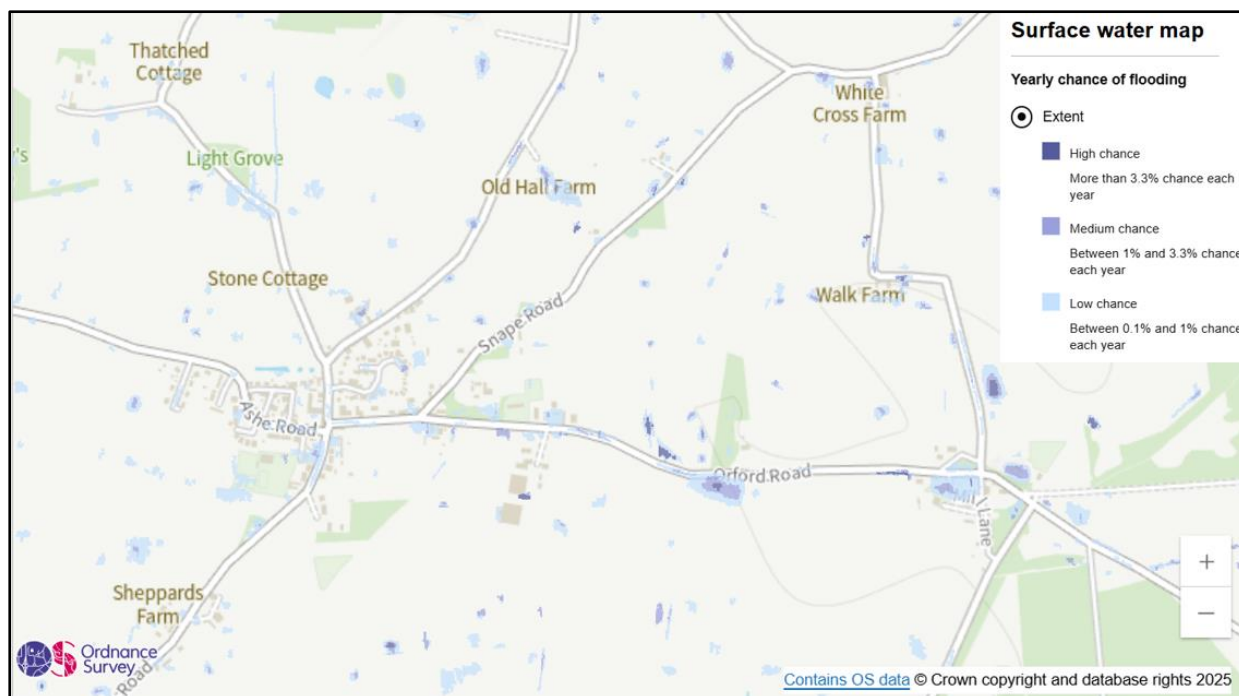
**Fig. 4. Predicted flood risk from surface water**

The parish of Tunstall is at significant risk of pluvial flooding (Fig. 4).

Affected property in Ashe Road, Woodbridge Road, School Road and Orford Road were all projected to be in or immediately adjacent to areas at medium or low risk of surface water (pluvial) flooding.

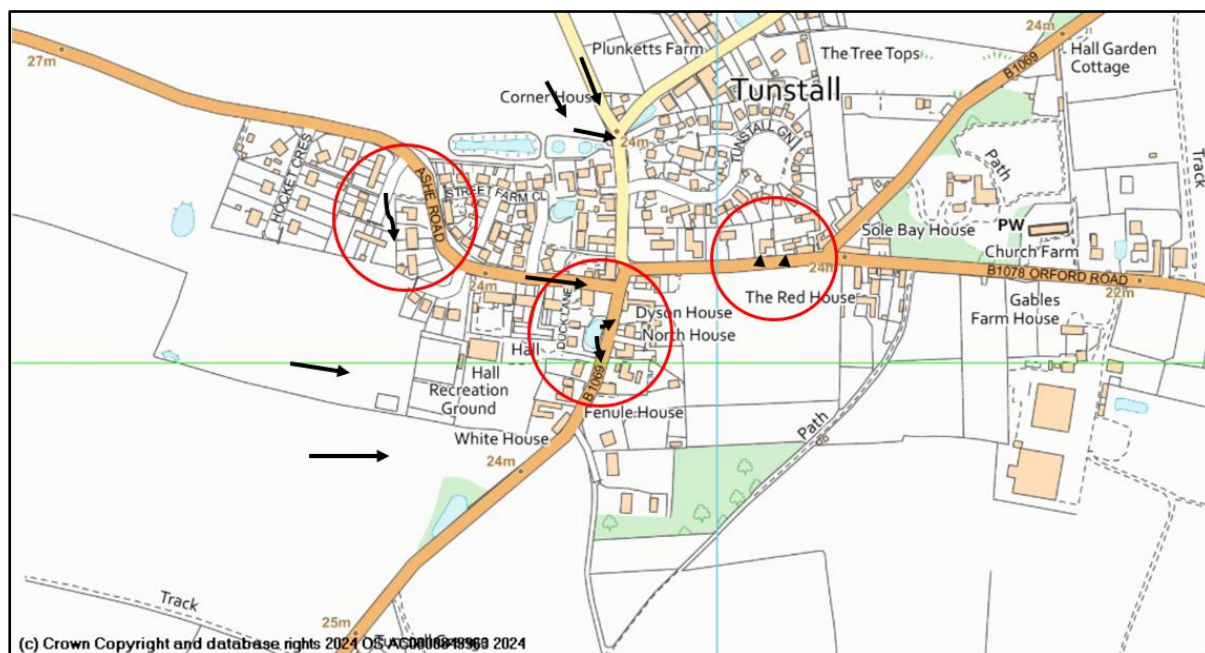
**Fig. 8. Approximate floodwater flow paths in Ashe Road, Woodbridge Road and Orford Road showing areas of flooded property**

The westernmost area in Tunstall parish where property was affected by internal flooding was on the southwest side of Ashe Road. One property is known to have internally flooded in this area. Affected property was projected to be at low risk of surface water flooding (ie. at risk during more extreme rainfall events).

Significant rainfall is reported to have caused drains to surcharge in Hockett Crescent, resulting in surface water flowing towards Ashe Road and flooding property from the rear. Gullies in Hockett Crescent were inspected on 27/9/23 and again on 23/1/24 and found to be functioning. The low-lying nature of the area means that surface water tends to collect here and in prolonged extreme rainfall such as Storm Babet, the drainage capacity is exceeded.

- Intense and prolonged rainfall exceeded the capacity of drainage systems.

- Gullies in Hocket Crescent surcharged and floodwater flowed towards Ashe Road, flooding property from the rear.

Impacted property on the east of Woodbridge Road was projected to be at low or no risk of surface water flooding. Affected property on this western section of Orford Road was projected to be at low risk of surface water flooding, ie. at risk during more extreme rainfall events.

Six properties were reported as flooding internally in this area of Tunstall village.

Significant rainfall resulted in surface water flowing from fields and field drainage ditches to the west of Woodbridge Road. Green Man Pond overtopped, reported to be partly exacerbated by an outflow being silted up and downstream drainage in the vicinity being blocked. (The outfall from Green Man Pond was reported to be blocked in August 2023). Recently installed drainage ditches adjacent to the attenuation pond (which also acts partly as a soakaway) at the rear of the bowling green were also reported to be contributing floodwater to the attenuation pond, in turn contributing to the flow into Green Man Pond and its subsequent overtopping. Properties on the east side of Woodbridge Road were internally flooded to a depth of 30cm. Tankers were used to try and manage the floodwater during Storm Babet and residents pumped floodwater from Green Man Pond into a nearby well. Sewage was also reported to be present in floodwater on a driveway east of Woodbridge Road. There have been repeated blockages of sewer systems in the vicinity exacerbated by accumulations of fats, oils and grease, including in Storm Babet, which would have contributed to sewers surcharging in extreme rainfall conditions. Gullies in the vicinity of Green Man Pond on Woodbridge Road were reported by Suffolk Highways to be operational during maintenance on 27/9/23, prior to Storm Babet.

Green Man Pond on Woodbridge Road has an outfall to a piped watercourse which currently follows the line of the road junction to connect with a ditch flowing east, adjacent to Orford Road. Affected property on this section of Orford Road was reported to be flooded from surcharging gullies in the vicinity. All gullies in the vicinity were operational at the time, with the possible exception of one and in the extreme rainfall conditions, the drainage capacity was exceeded. Low-lying driveways with dropped kerbs facilitated floodwater access from Orford Road to affected property.

Drainage capacity is limited in this area close to the road junction due to Woodbridge Road and Orford Road being congested with utility services and also due to the

surrounding area being relatively flat and low-lying. The latter means that outfall gradients are reduced which contributes to low drainage velocities and increased deposition of silt. The gradient between the invert level of the manhole after the pond outfall and the ditch adjacent to Orford Road is approximately 1:300. (Subsequent to Storm Babet, Suffolk Highways has implemented an interim measure, including repairs to the most severely damaged sections of the piped water course between Green Man Pond and the ditch in Orford Road and lining its entire length. It is planned to replace this pipe and reroute the piped watercourse across Kings Arms Yard to the ditch adjacent to Orford Road in 2025).

The extreme rainfall, drainage capacity and low drainage gradients taking flow away from the village all contributed to the problems witnessed in the drainage system from Green Man Pond. The practical difficulties in draining floodwater away from this area around the junction once floodwater is present means opportunities to reduce flood risk are limited. However, further reducing and attenuating surface water flows from the fields to the west of Woodbridge Road may provide some flood resilience benefit (and drought resilience benefit if water is stored).

- Significant rainfall resulted in surface water flowing from fields and field drainage ditches to the west of Woodbridge Road.
- Green Man Pond overtopped, partly due to the outfall being blocked.
- A drainage ditch to the rear of the bowling green contributed further water to the soakaway/attenuation pond which in turn flowed into Green Man Pond.
- Silt in the drainage system was reported to have decreased drainage capacity.
- Drainage capacity was exceeded primarily due to extreme rainfall conditions, exacerbated by very low gradients.
- Agglomerations of fat, oil and grease contributed to blockages of the sewage system, causing surcharging.
- Low-lying driveways in Orford Road increased vulnerability to flooding of property.

- Residents to install Property Flood Resilience (PFR) via grant funded scheme.
- SCC Highways to ensure gullies in Tunstall are on an enhanced twice yearly cleansing cycle.

- Residents to install Property Flood Resilience (PFR) via grant funded scheme.
- Explore potential natural flood management measures (eg. leaky dams on ditches, buffer strips, bunds, hedgerows and tree planting and additional attenuation ponds) to “slow the flow” and attenuate water in the fields to the west of Woodbridge Road.
- SCC Highways to ensure gullies in Tunstall are on an enhanced twice yearly cleansing cycle.
- Complete replacement of pipe between Green Man Pond and the ditch adjacent to Orford Road, rerouting the piped watercourse through Kings Arms Yard. (Suffolk Highways have already investigated options).

- Relevant property to receive advice regarding reducing risk of sewer blockages (already enacted).
- Landowners to carry out watercourse maintenance to reduce flood risk as necessary in accordance with their riparian responsibilities.

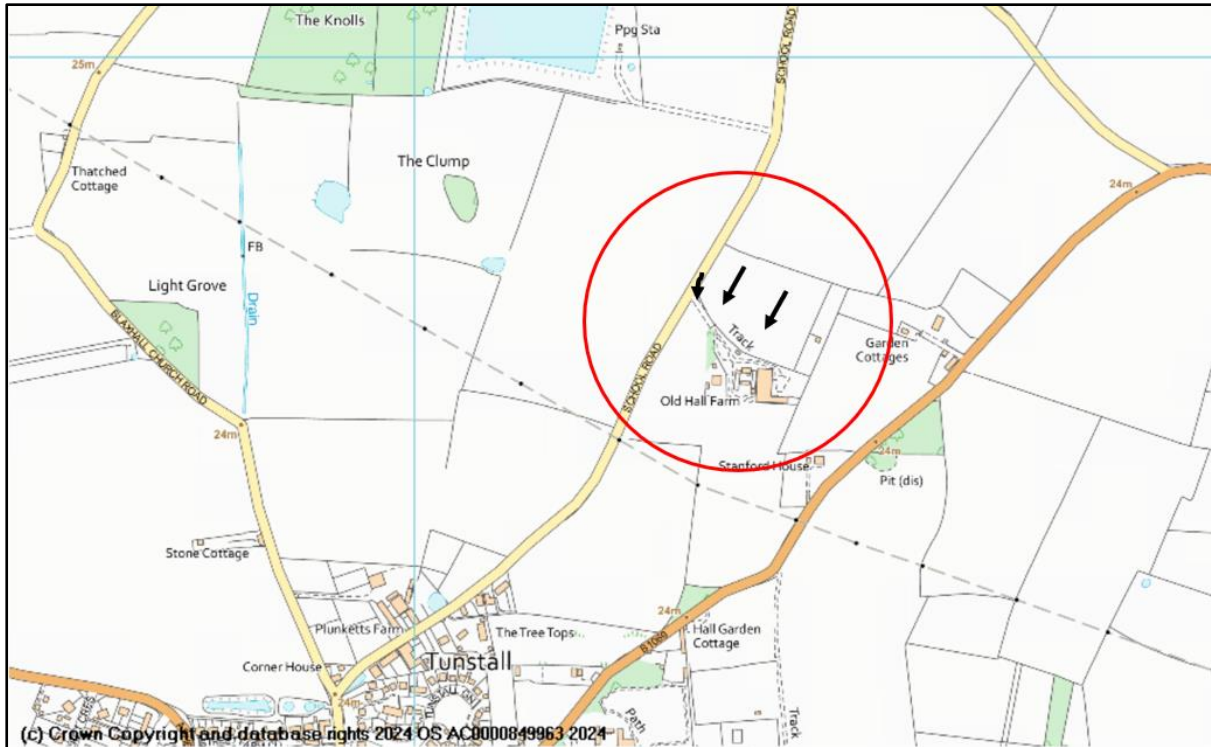
**Fig. 9 Approximate floodwater flow paths in School Road showing areas of flooded property**

This area is north of Tunstall village and one property is reported to have internally flooded (Fig. 9). Affected property is projected to be at medium surface water flood risk.

Surface water was reported to have flowed from fields to the northeast and down School Road, on to a track leading to affected property. Impacted property was internally flooded to a depth of 20cm.

On 07/08/23, School Road was reported to be flooded in the vicinity of the track which was partly attributed to a lack of maintenance and silt buildup in two soakaways on School Road. However, during Storm Babet these would have been of limited benefit with sudden extreme rainfall in large volumes, particularly when ground was already saturated.

- Surface water flowed from fields to the northeast and down School Road, on to a track leading to affected property.

- Silt buildup in two soakaways increased flooding on School Road but this would have had limited impact on floodwater quantities in extreme rainfall.

- Residents to install Property Flood Resilience (PFR) via grant funded scheme
- SCC highways to consider the installation of silt trap(s) to enable the cleansing of the silt trap in line with the cyclical gully cleansing regime.
- Explore potential natural flood management measures (eg. buffer strips, bunds, hedgerows and tree planting and additional attenuation ponds) to “slow the flow” and attenuate water in fields to the northeast of affected property on surface water flow paths.

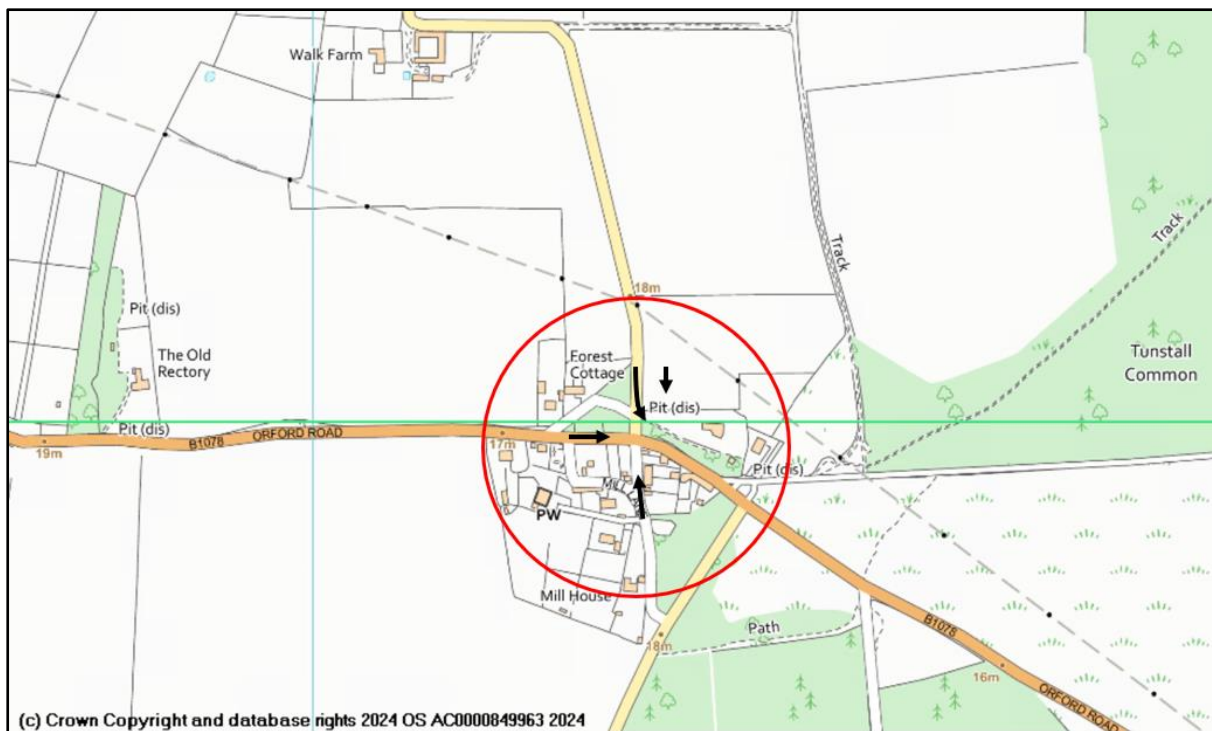
**Fig. 10 Approximate floodwater flow paths in Mill Lane and Orford Road (east) showing areas of flooded property**

This area is adjacent to Tunstall Common, in the east of the parish. Two properties were reported to be affected by flooding in this area. Affected property in Mill Lane was projected to be at no surface water flood risk and affected property in The Common was projected to be at medium surface water flood risk. Two properties are reported to have flooded internally in this area.

Surface water was reported to have flowed south down Walk Farm Road and across fields adjacent to Walk Farm Road, flooding property at a lower level which is east of Walk Farm Road and north of Orford Road. Surface water also flowed north down Mill Lane, flooding property which was at a lower level on the east side of Mill Lane.

Surface water flowing down Orford Road also contributed to floodwater in the area of the road junction. Three gullies which are closest to the road junction, located on Walk Farm Road, The Common and Mill Lane were reported to be non-operational or slow running during cleaning and maintenance in January 2024 and may have been non-operational or slow running during Storm Babet. Investigations have since confirmed pipes from these gullies run to ground. They may have originally run to a ditch and into the lagoon on the north side of Orford Road, or just to lower ground to soak/evaporate. Jetting and cleansing with investigations were carried out in October 2024. Further works to link some of the gullies east of the lagoon and to clean out the lagoon are planned for autumn 2025, which may need to be a two stage process).

- Surface water flowed south down Walk Farm Road and adjacent fields, flooding property east of Walk Farm Road and north of Orford Road.
- Surface water flowed north down Mill Lane, flooding property on the east side of Mill Lane.
- Surface water flowing down Orford Road also contributed to floodwater in the area of the road junction.
- Gullies close to the road junction were reported to be non-operational or slow running after Storm Babet but it is not known if they were functioning fully during Storm Babet.

- Residents to install Property Flood Resilience (PFR) via grant funded scheme.
- SCC Highways to complete works to link some of the gullies east of the lagoon and clear out the lagoon.
- Explore potential natural flood management measures (eg. buffer strips, attenuation ponds) to “slow the flow” and attenuate water in fields to the north of affected property east of Walk Farm Road and north of Orford Road.
- SCC Highways to ensure gullies in Tunstall are on an enhanced twice yearly cleansing cycle.
- Landowners to carry out watercourse maintenance to reduce flood risk as necessary in accordance with their riparian responsibilities.
