**Section 19 Flood and Water Management Act 2010**  
**Wetheringsett-cum-Brockford Flood Investigation – Storm**  
**Babet 2023**

<b>Name</b>	<b>Date</b>
<b>Report Author</b>	John Jousiffe	
<b>Responsible Officer:</b>	John Jousiffe	
<b>Checked by:</b>	Ellie Beecroft	17/09/2024
<b>RMA Review:</b>		08/10/2024
<b>Approved by:</b>	Matt Hullis	08/11/2024
<b>Date Published</b>		11/11/2024
<b>Latest Update</b>		10/02/2026
<b>Date Report Closed</b>

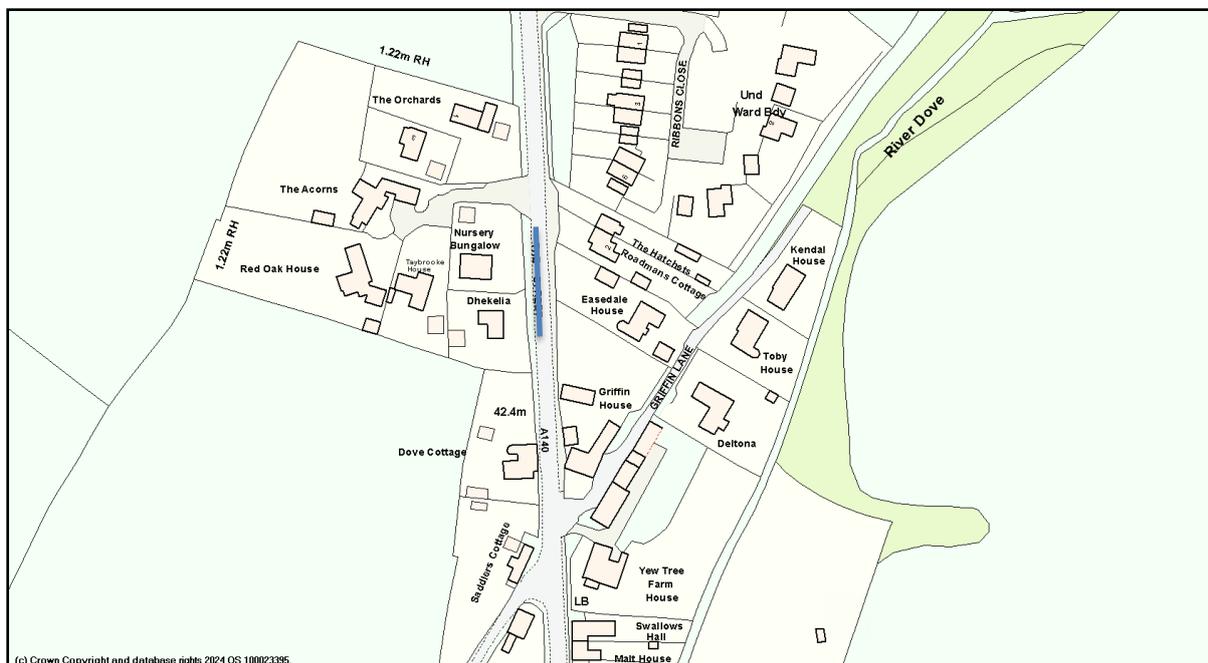
Figure 13 - Small section of watercourse on A140

There is a short section of open watercourse to the north of the main affected area, which borders the A140 to the west (see figure 13). This section of watercourse was reported to have been quickly overwhelmed and caused water to spill onto the highway where it flowed south towards the river. Following a site investigation, this section of watercourse appears to be piped to the north, but no continuation to the south was visible upon inspection. It is presumed that once the capacity was reached, the water

had no continuation route and consequently overspilled onto the highway before continuing down the road.

This watercourse appears to be a Suffolk County Council Highways asset, And following consultation with the Highways Authority, maintenance of the feature is planned to take place. There are several outfall pipes situated in the western bank of the watercourse, likely to be servicing the housing to the west by means of a surface water or sewage discharge points. Modern development standards are required to attenuate water on site and only discharge it at rates the same or lower than predevelopment and as such, it is unlikely that the new development on the western side of the highway was a significant contributing factor. Most Highways drainage assets in the area were shown to be working on the last inspection (July 2022), except one non-operational gully, which should be draining into this watercourse. It is unlikely however that this individual gully would have had any significant impact on the flooding event due to the rainfall experienced. The highway authority has maintenance planned for this short section of watercourse, but timescales are not confirmed.

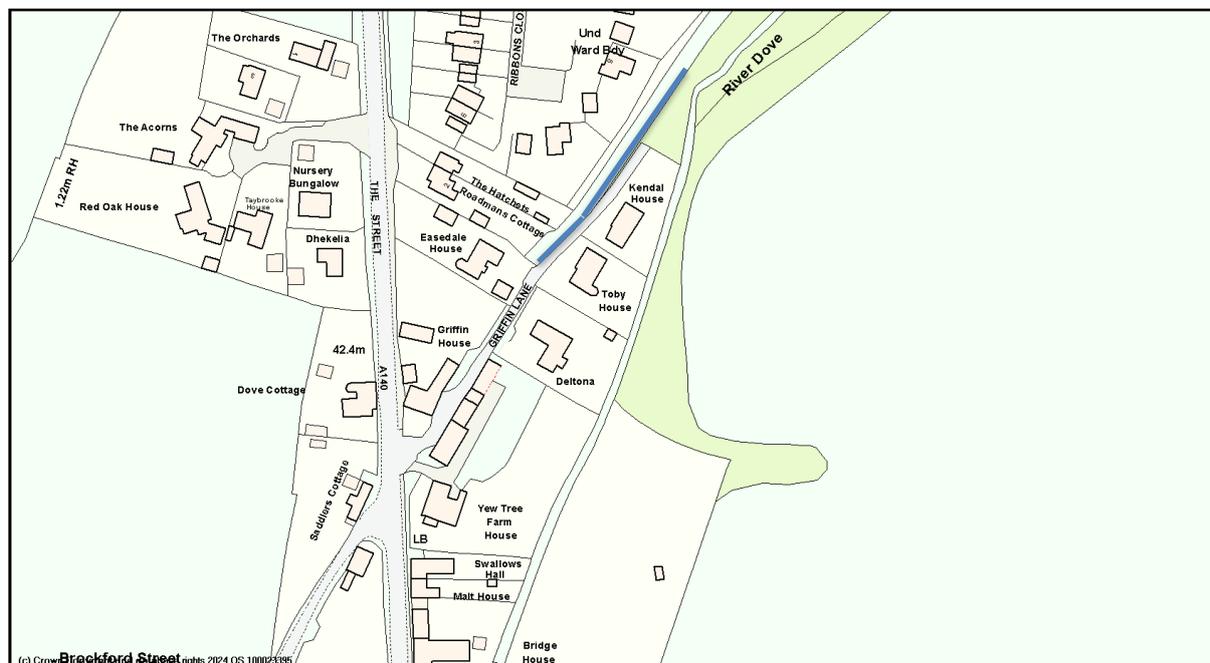
Figure 14 - Griffin Lane watercourse

River to the east, and from the ordinary watercourse and A140 to the west, it travelled across griffin lane and into properties. The main flow of the water was heading southeast in order to rejoin the river.

Approximate location of ordinary watercourse west of Griffin Lane

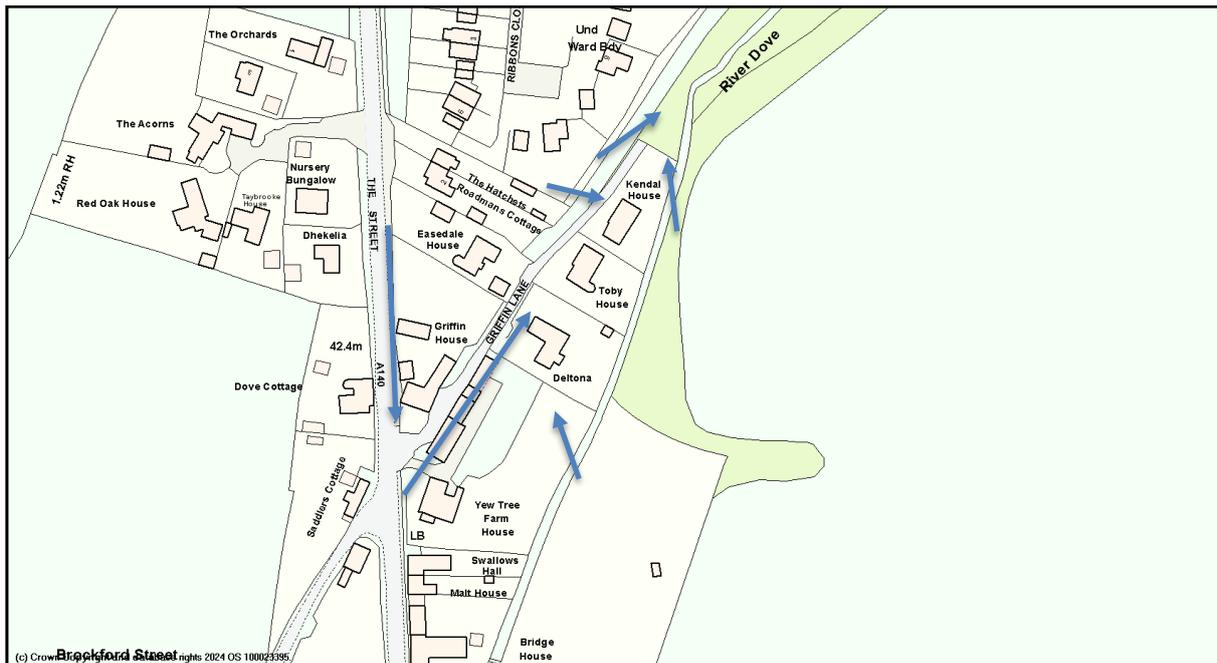
Figure 15 - Waterflow paths in north Brockford Street

Reports taken from community feedback is that there have been some tree felling activities further to the north which may have left debris in the Dove River, possibly causing an impedance to the flow of water. It is possible that this blockage caused the water to back up faster than is natural and as such, cause the river to overtop it banks earlier, although given the scale of the event, it is likely that the river would have overtopped anyway, although the impacts may have been less severe. Following consultation with the Environment Agency, they were made aware of the felling activity in June 2023 and larger branches were found to have been left in the river, however due to the location of the activity (distance from properties, gradient of the channel and capacity of the surrounding floodplain), it was evaluated as not to contribute to increased flood risk to Brockford Street and no further action was taken.

Clearance of debris from a watercourse or river is an activity that the riparian owner can undertake and the LLFA would encourage issues such as this to be reported to the relevant landowner who can then remove obvious debris and blockages as part of their riparian maintenance duties.

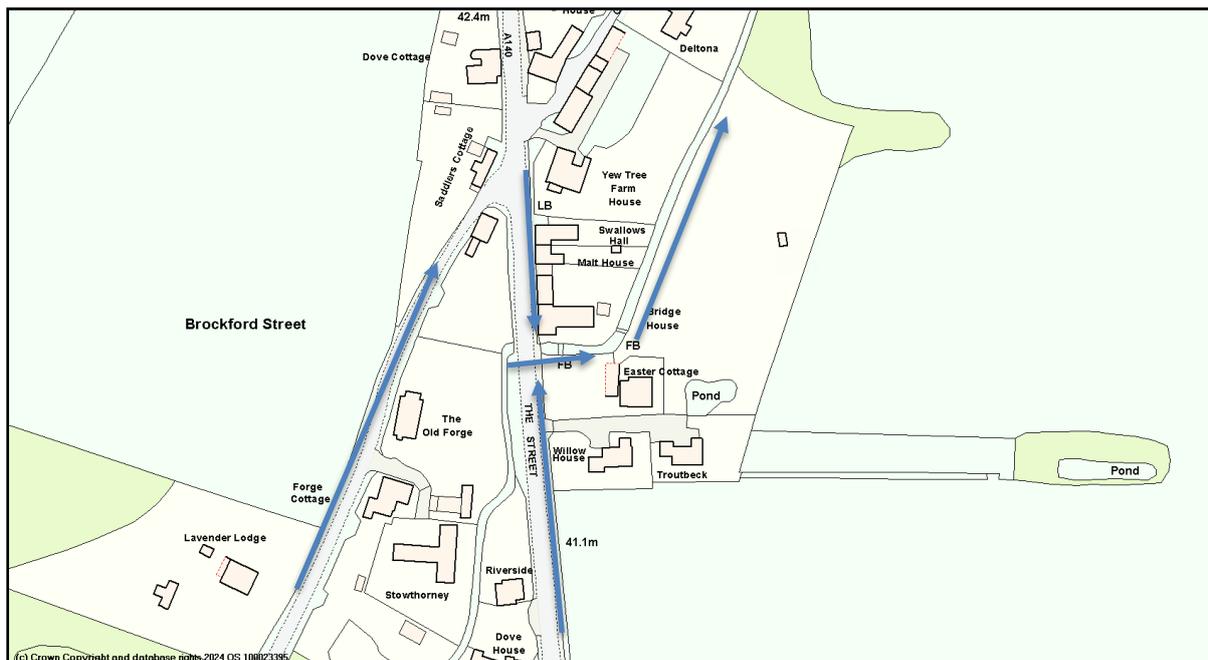
*Figure 16 - Waterflow paths in south Brockford Street*

Sewage was reported as being present in the flood water in this area and continues to be an issue going forward with reports of toilets backing up regularly during rainfall events. There are no Anglian Water assets in the area and instead sewage systems are considered to be private, managed and maintained by individual property owners.

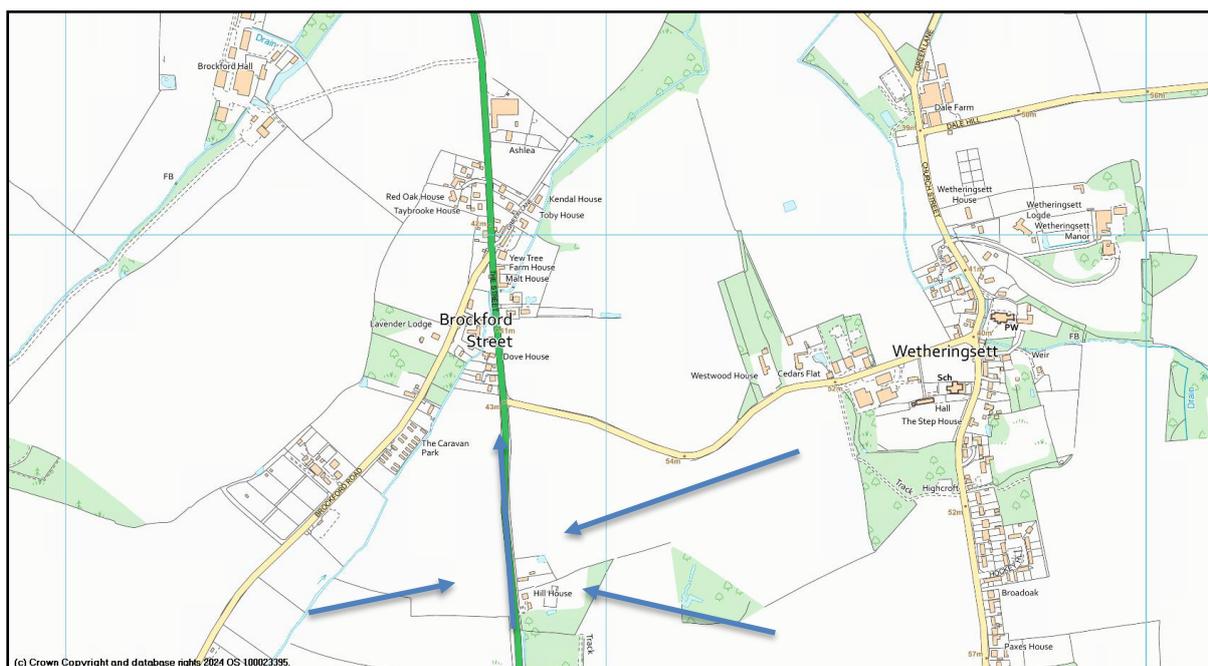
Figure 17 – Flow path map of south of Brockford Street

South of the bridge, properties have been reported to have been affected by significant surface water runoff from surrounding fields to the east and south. There have been reports from the residents that some possible infilling of a watercourse has taken place in this area. A loss of watercourse features could have exacerbated the impacts within this area. The lead local flood authority has visited the area to investigate the possible infilling and have sent letters detailing landowner riparian responsibility to all possible owners of the watercourses in question.

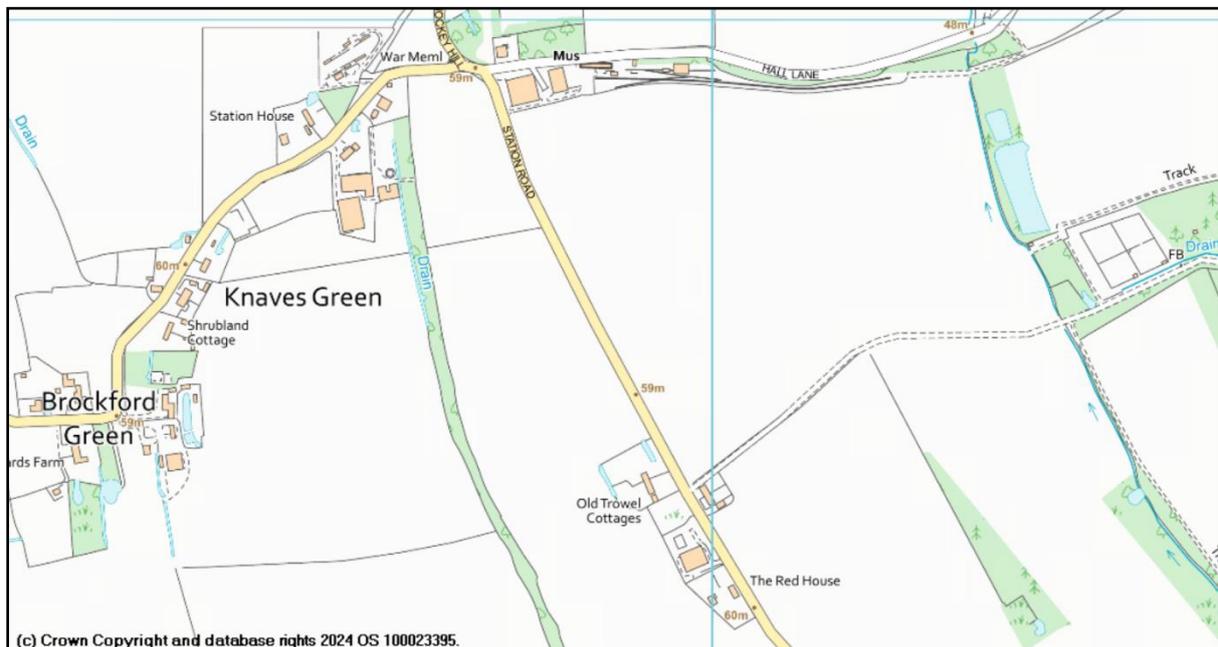
Figure 19 - Map of station road

The flooding at Station Road was different to the other locations, instead being an isolated incident in which surface runoff came from the surrounding fields, and flooded a single property located in a dip in the road. The event caused the shared septic tank to flood and overflow into the garden. Reports suggest the watercourses in the nearby fields may not have been maintained possibly exacerbating the event.

Reports from the community suggest maintenance of these watercourses has since been undertaken and the flooding issue has not reoccurred.

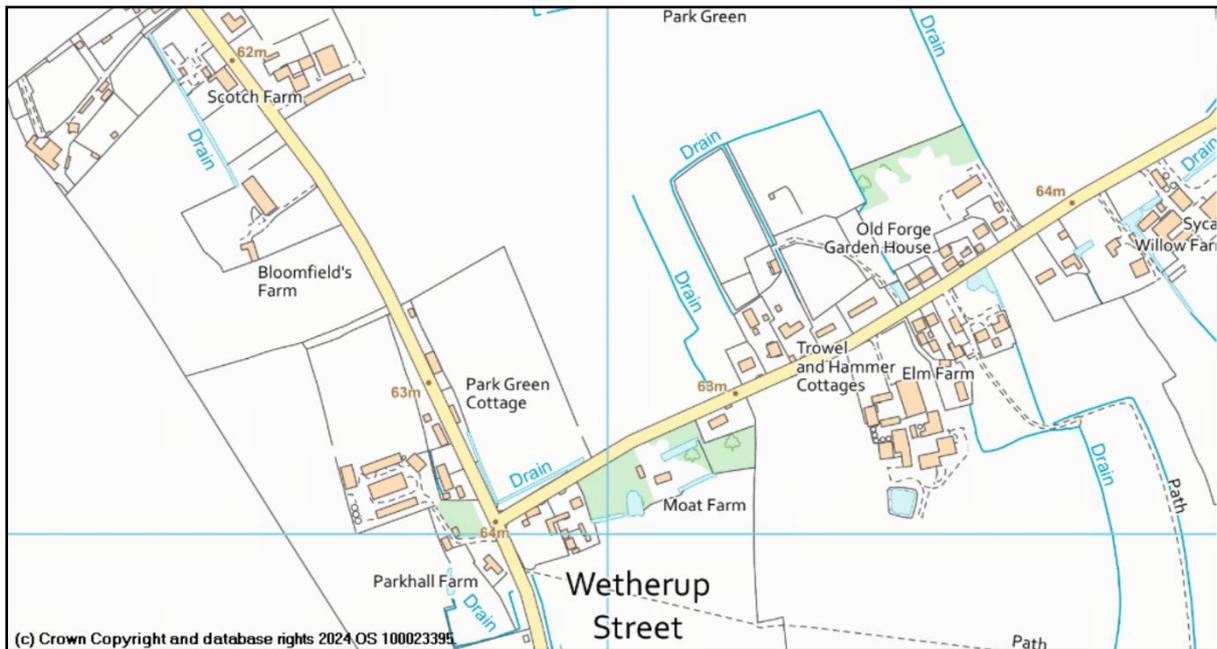
Figure 20 - Map of Park Green and Wetherup Street

Reports from the community in Park Green suggested high levels of surface water overwhelmed the drainage systems and surface water ingress into homes was a combination of runoff from both the highway and surrounding fields as saturated ground could not cope with the volume of rainfall.

Reports from Wetherup Street suggested similar issues with the addition of watercourses and ponds also overflowing. The area contains no mains drainage and agricultural land around the affected properties was already saturated, resulting in watercourses flooding and the village pond, located to the west of the affected properties, being unable to cope with the volume of water. Due to the prolonged precipitation event, flood water began to pool in the isolated dips and flood water ingress was through the floorboards of the affected properties.

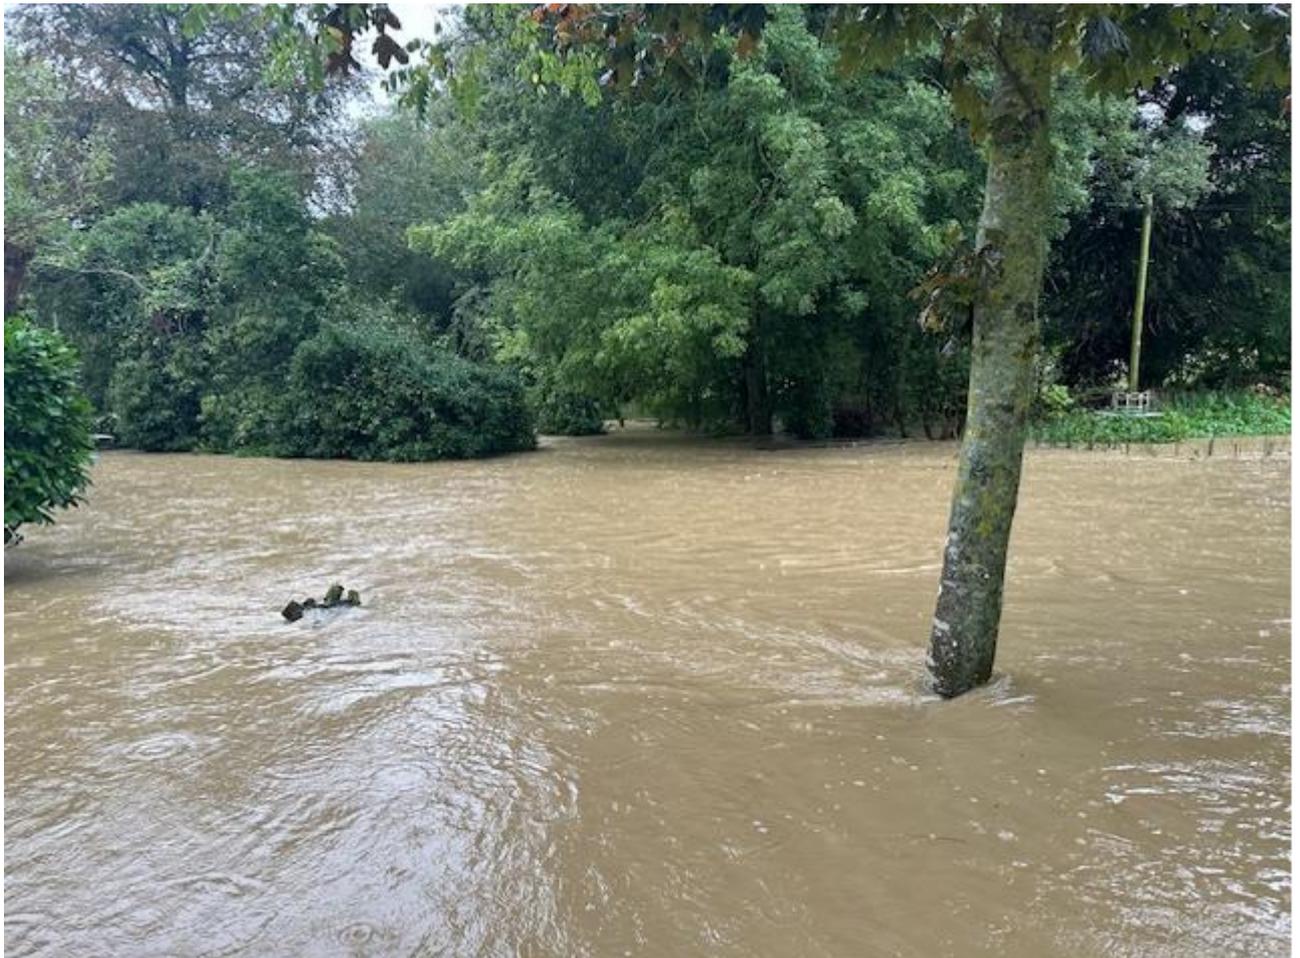
Flooding event in east Wetheringsett

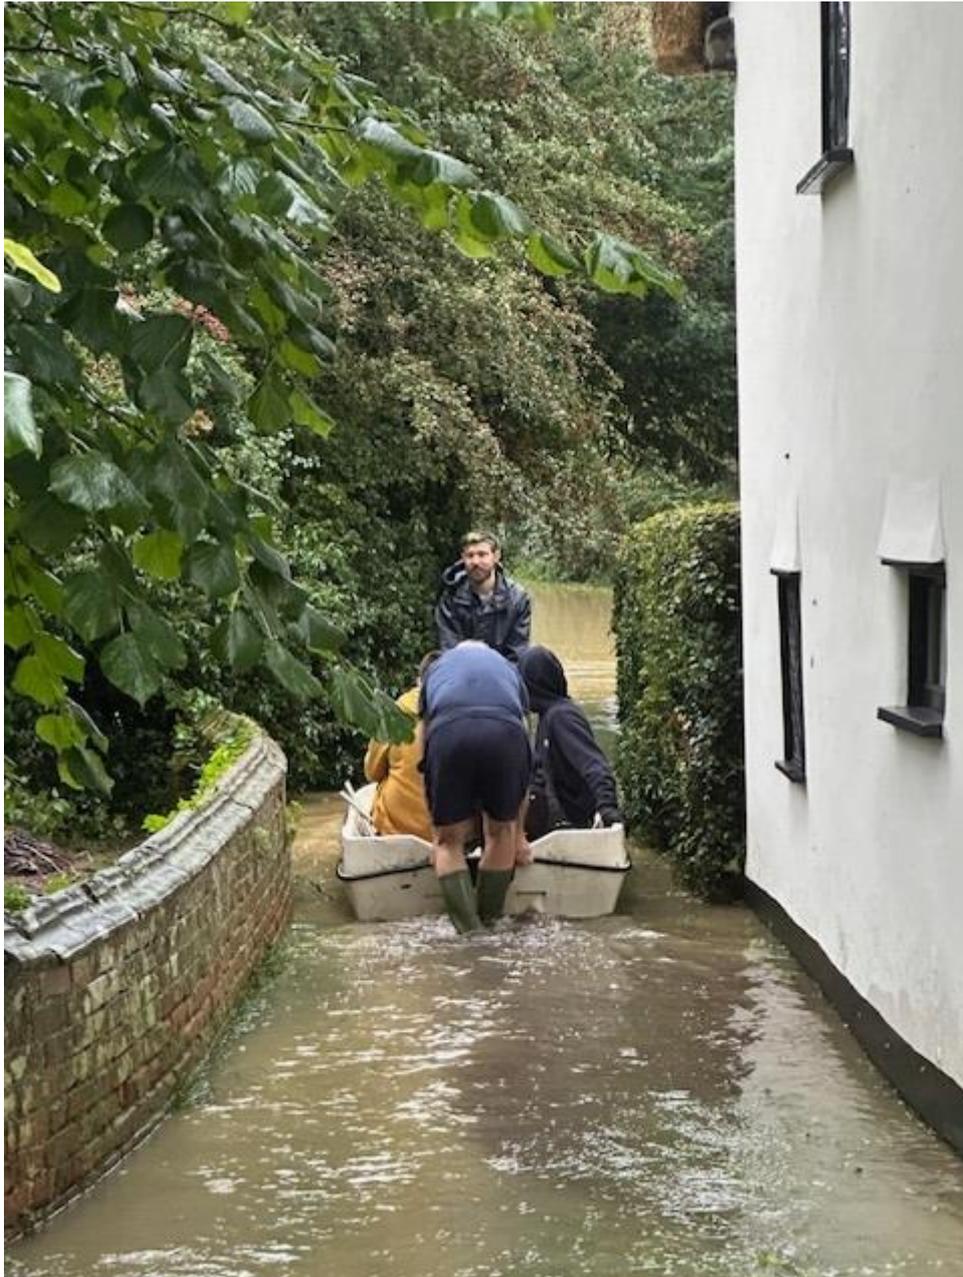
Flooding close to the church in Wetheringsett

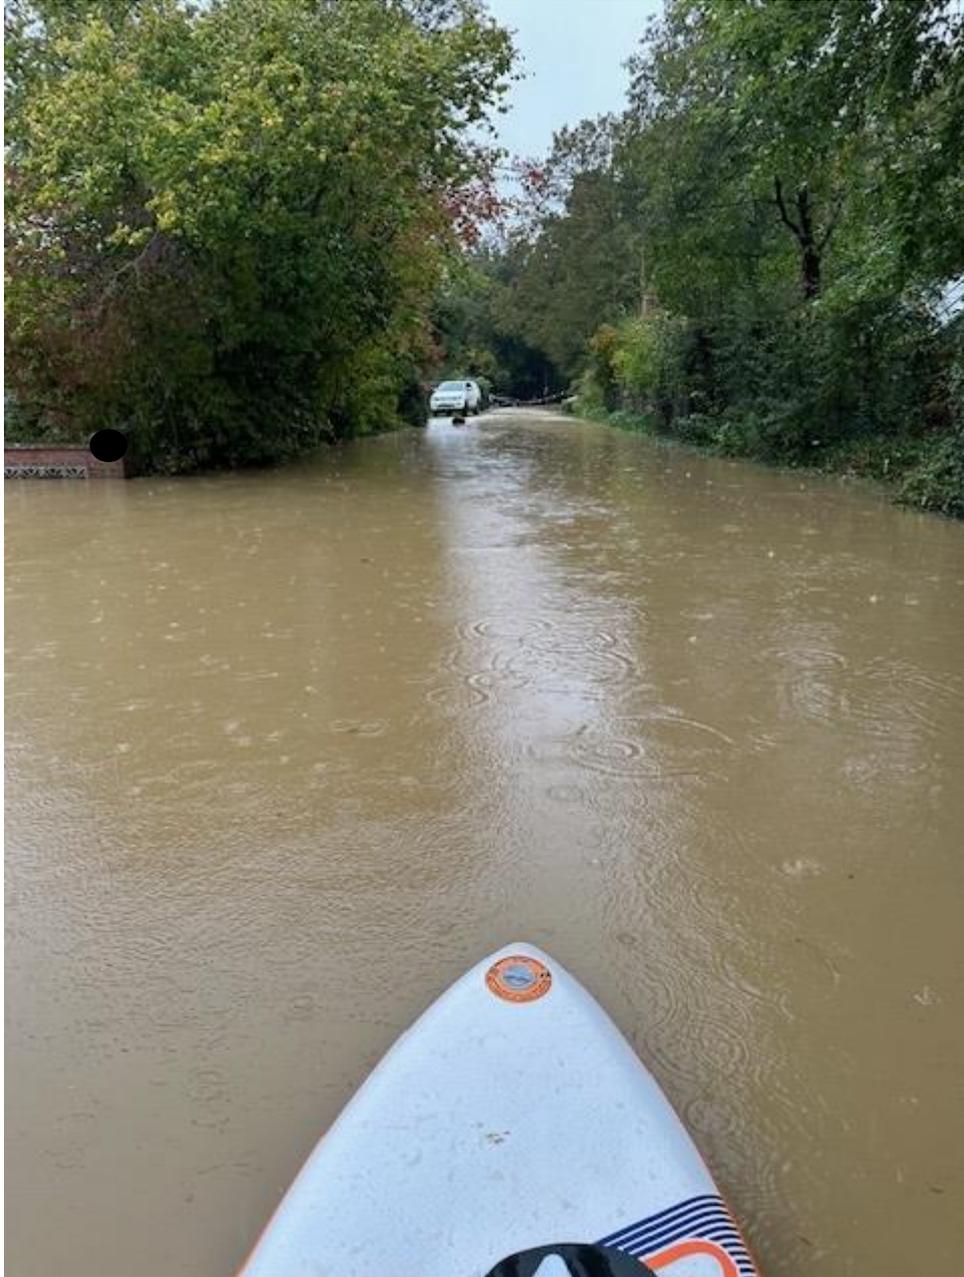
View of Church Street during the event

<p>SCC Highways to carryout repairs to drainage features on Church Street in Wetheringsett</p>	<p>SCC Highways</p>	<p>6-12 Months</p>	<p><b>Complete</b>  SCC Highways have completed repairs to the drainage features on Church Street in Wetheringsett.</p>

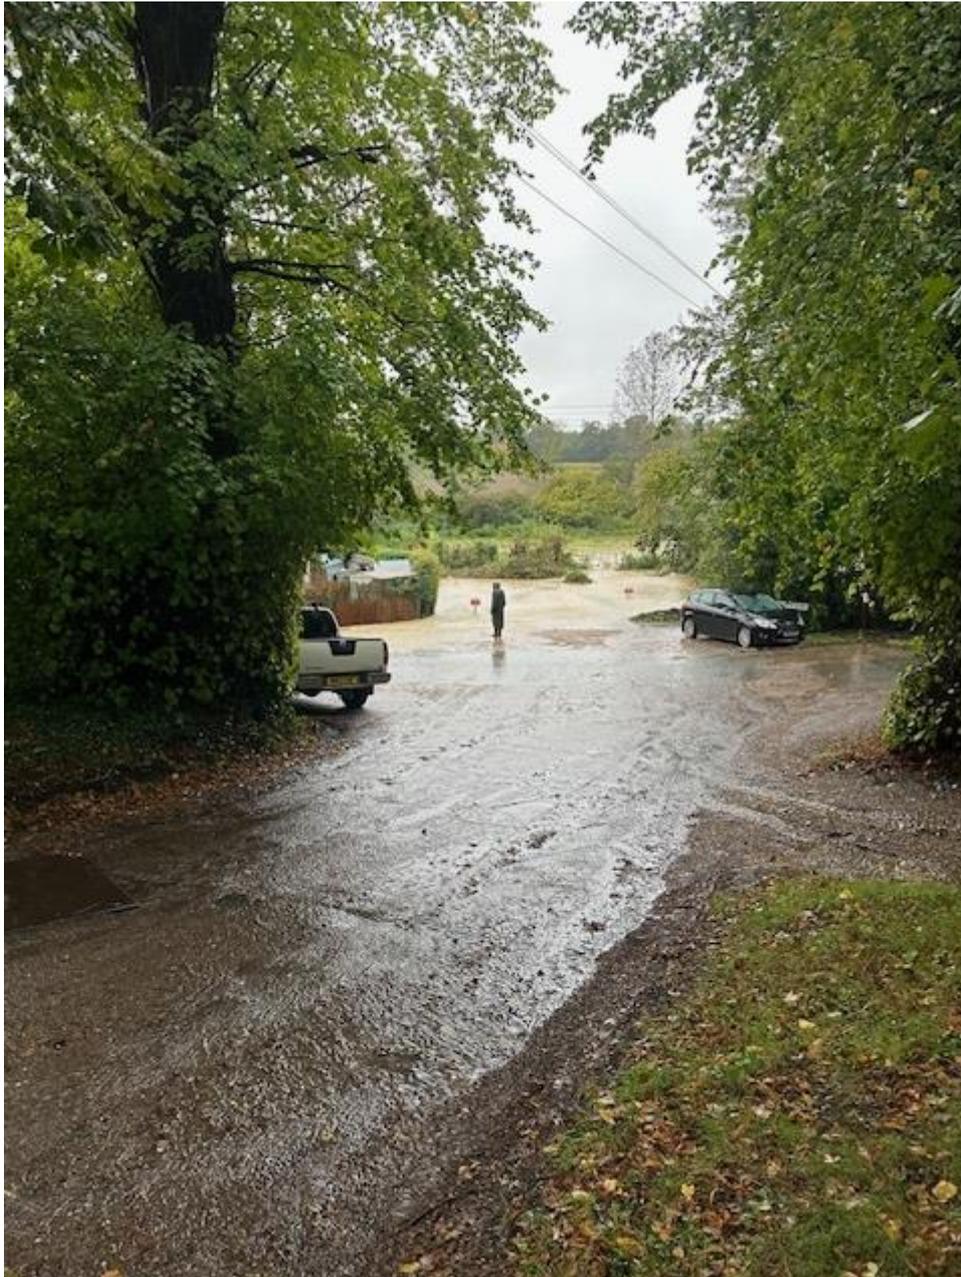
increase in surface water flowing down Manor Drive in the months preceding Babet and there are concerns that changes to the Manor itself could be a possible cause of this. Following discussions with the present occupiers of the manor, significant work has been undertaken on the driveway to the manor, with new soakaways being constructed and historic pipework being replaced and regular maintenance taking place on the current large capacity soakaways already in place. Building works have not increased the size of the impermeable area and as such, it is unlikely that any changes which have taken place would have increased the flood risk.

View down Manor Drive during the event

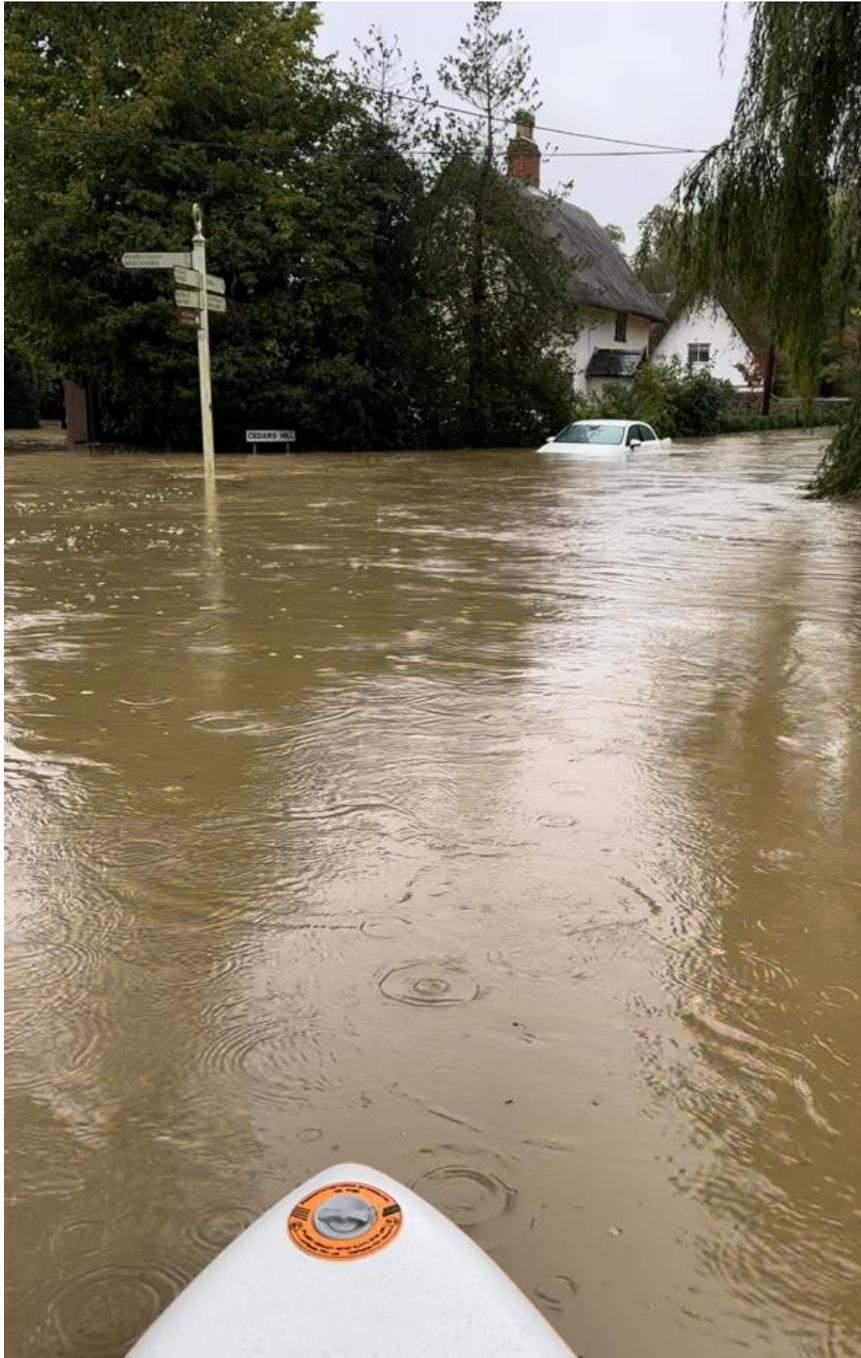
Church Street and Cedars Hill Junction
