Section 19 Flood and Water Management Act 2010

Wickham Market Flood Investigation - Storm Babet October 2023

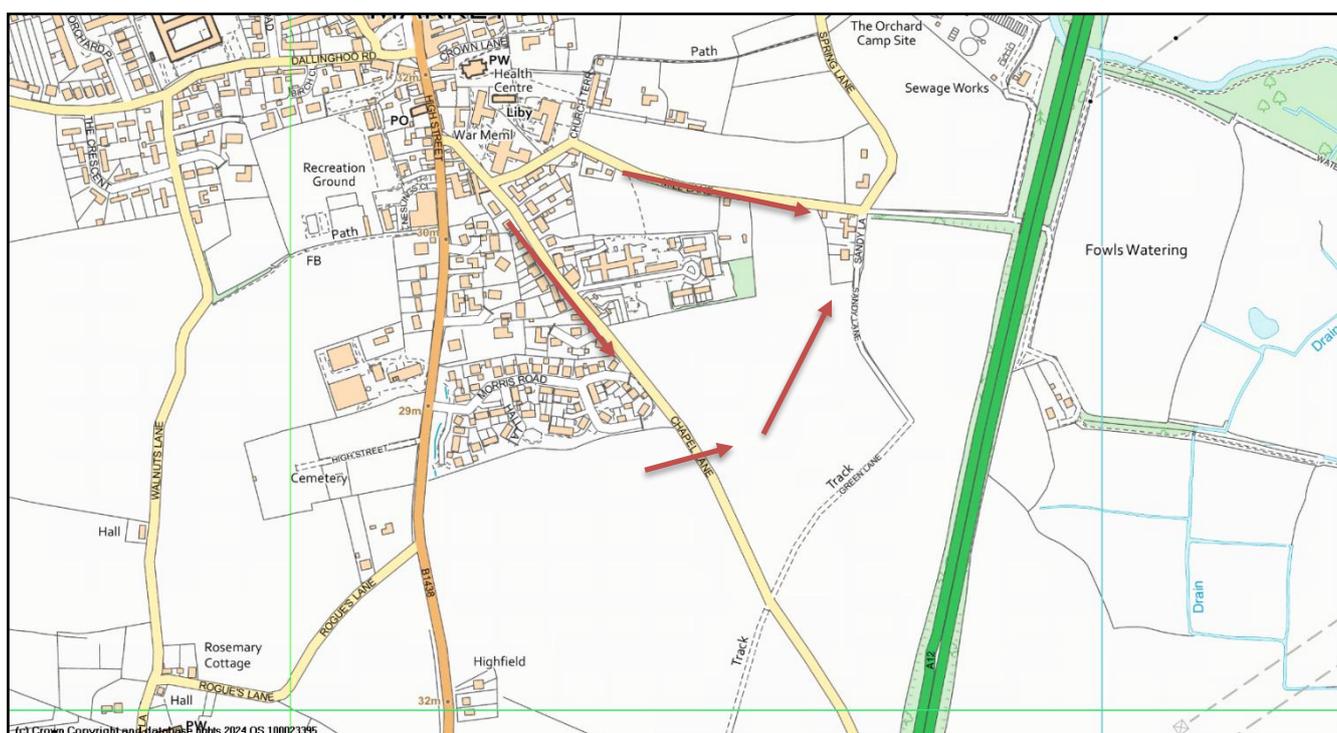
Figure 8 - Event flow paths (east)

- Mill Lane is a high risk area for surface water flooding and the sheer volume of water from rainfall is likely to be the main cause of the flooding in this area.
- Possible ordinary watercourse maintenance in the area will allow a better flow path for the water to escape.
- Possible natural flood management opportunity which may reduce flood risk in this area.

- Ensure correct maintenance of the watercourses in the area are regularly carried out and any issues/obvious blockages are highlighted to the relevant RMA/landowner/Parish as soon as possible.
- Investigate the possibility of NFM in field to the south of the area affected.

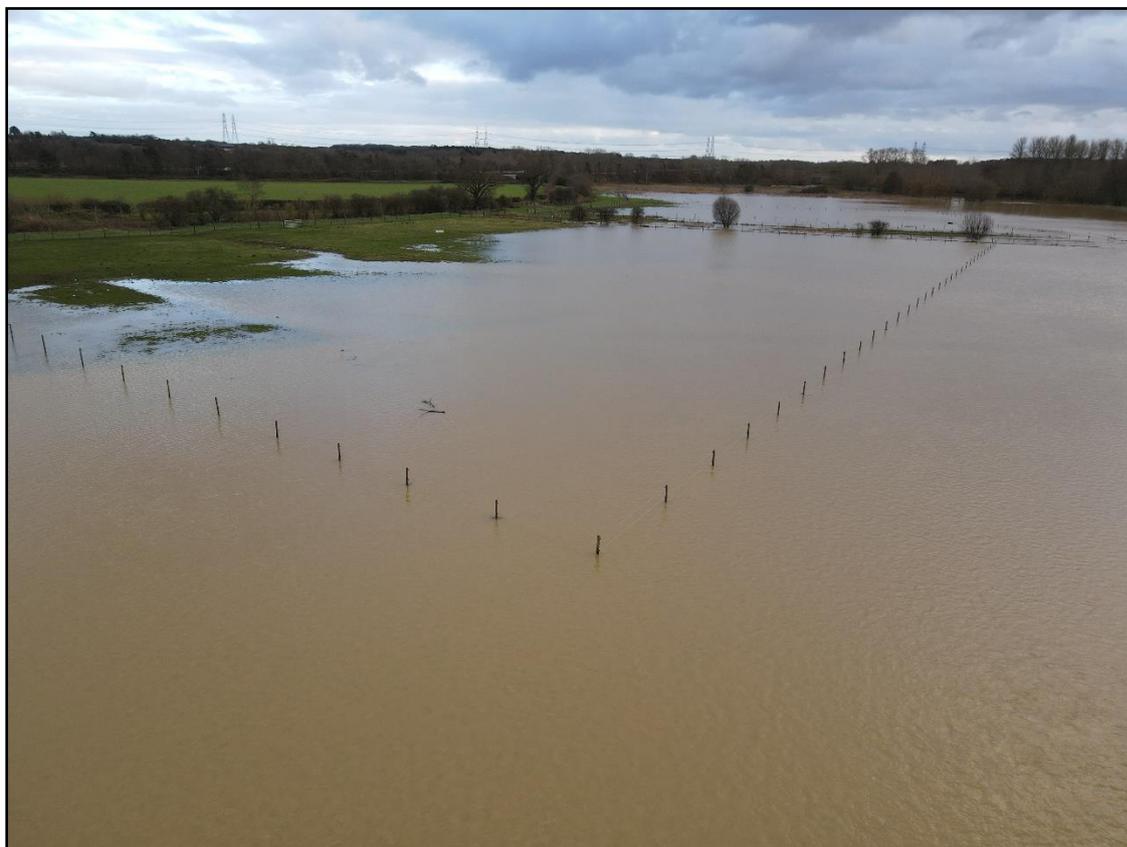
Image 1 - Flooding to pastureland in north Wickham Market

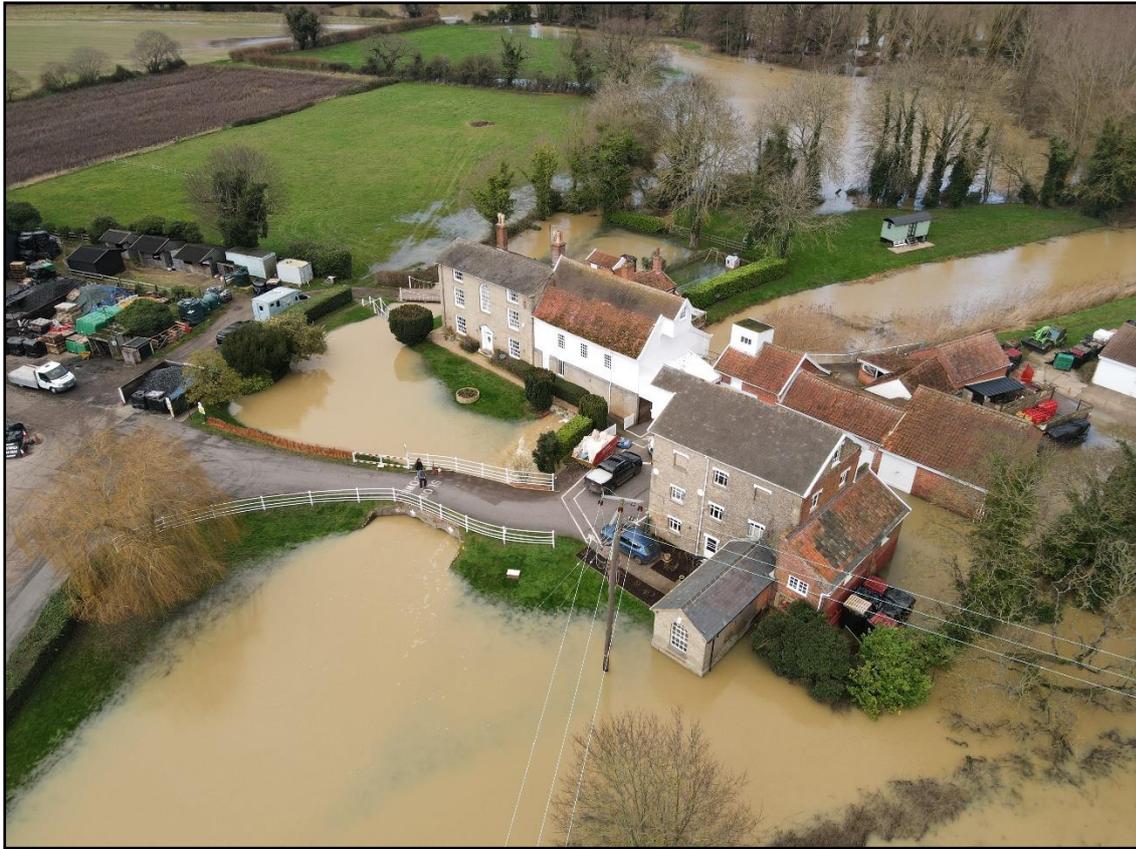
Image 3 - Deben Mills

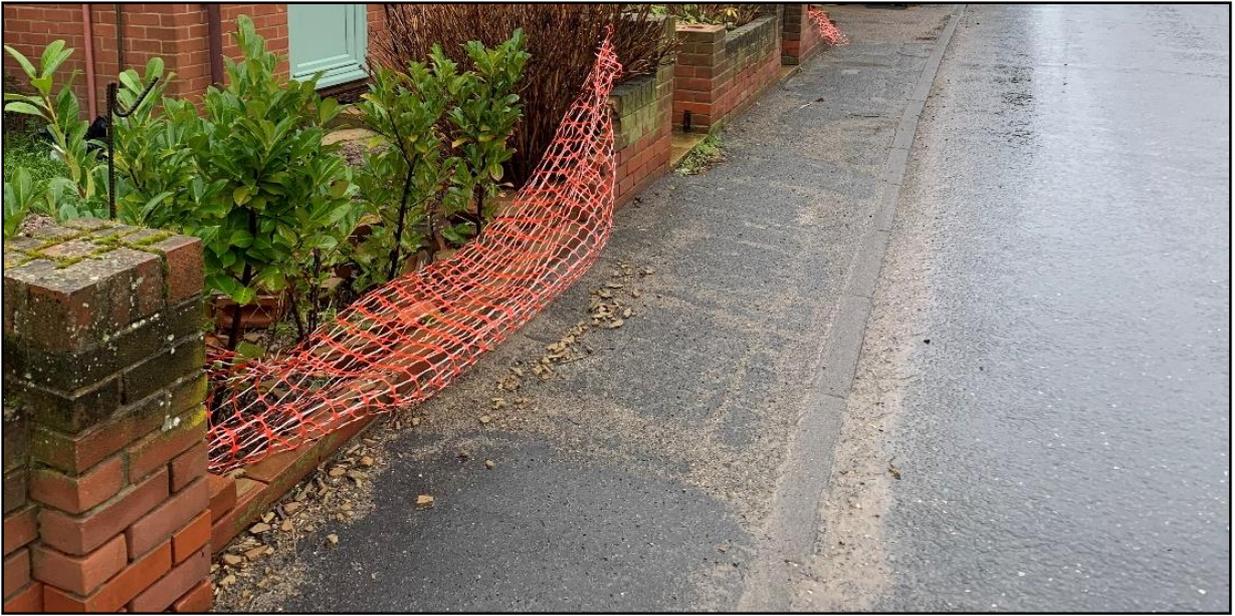
Image 5 - Post event damage

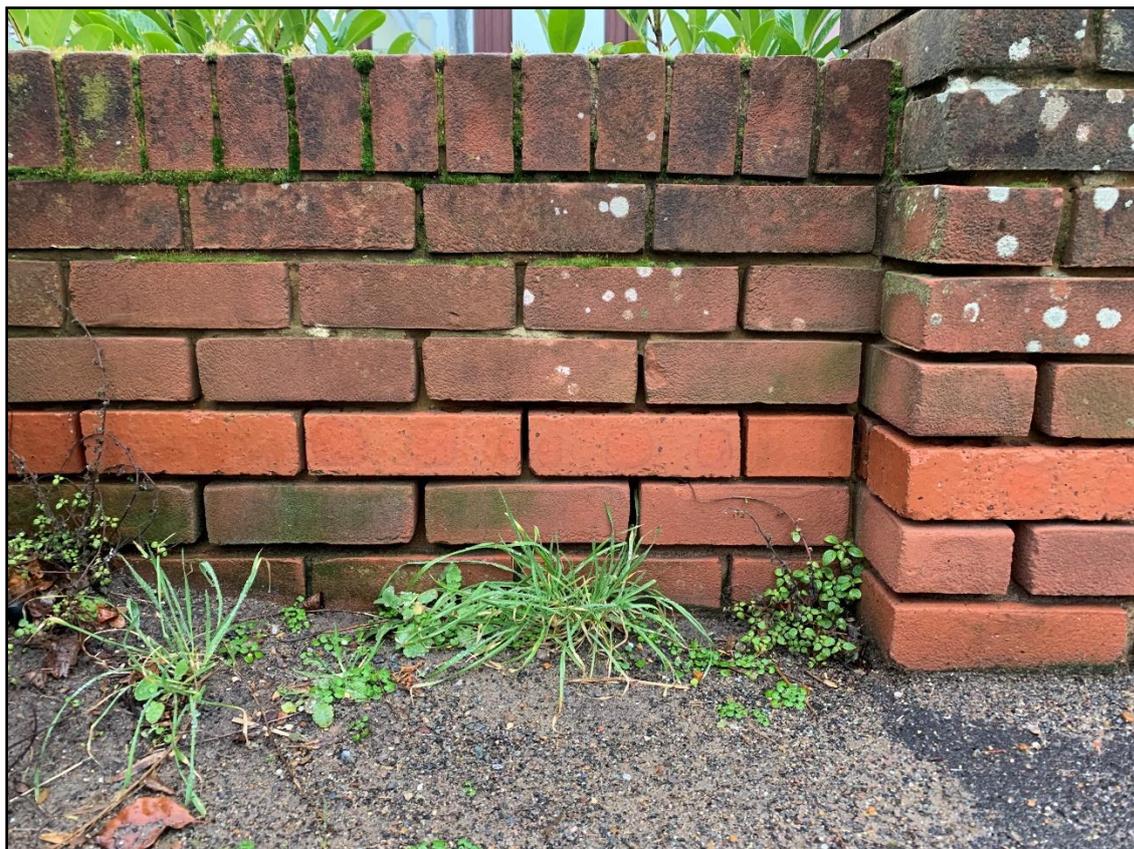
Image 6 - Post event damage

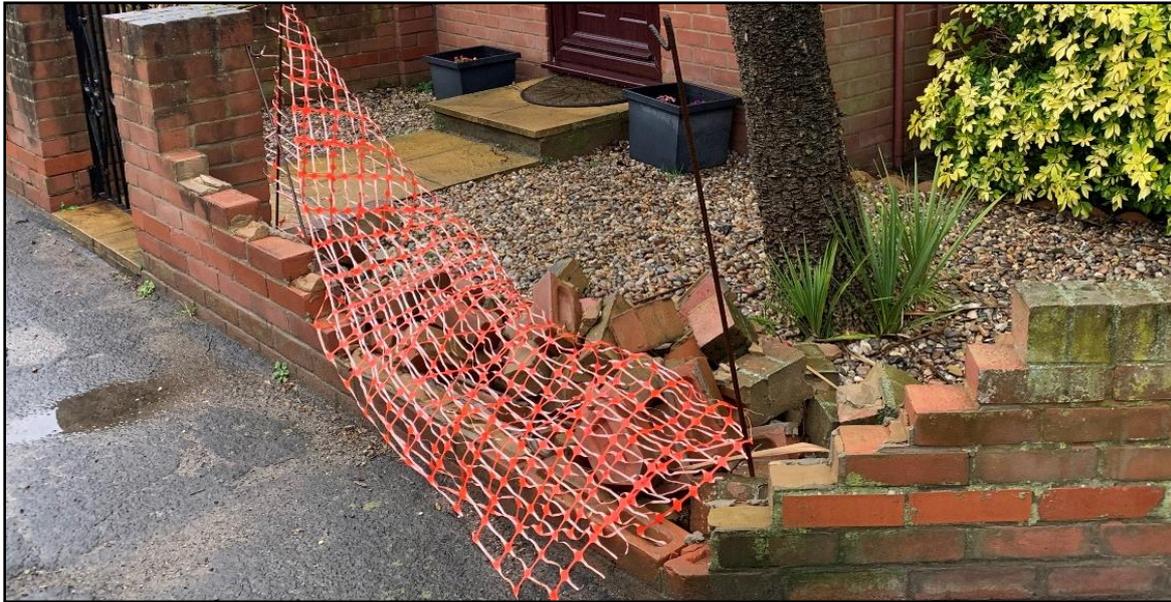
Image 7 - Post event damage
