Section 19 Flood and Water Management Act 2010

Witnesham & Swilland Flood Investigation –

Storm Babet 2023

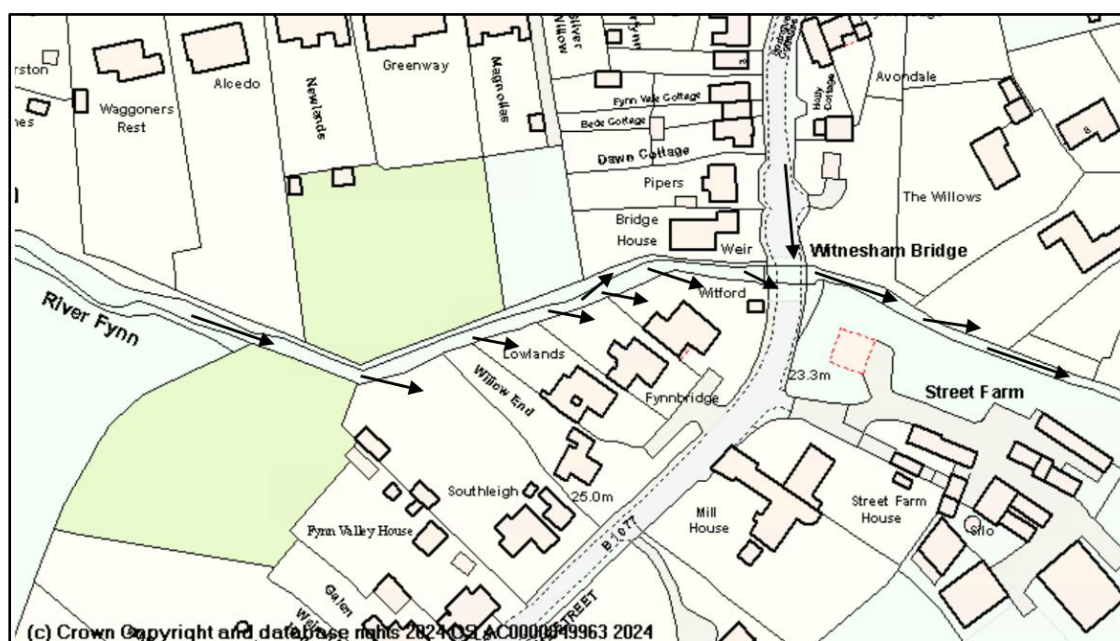
Figure 12. Approximate flood water flow routes along The Street

Following heavy rainfall on the morning of 20 October, extreme water levels flowed down the River Fynn from the upper catchments towards the road bridge on The Street, Witnesham. From late morning onwards the swollen river levels exceeded the capacity of the channel and floodwater flowed across gardens directly towards properties on The Street from the rear, which were then internally flooded to depths of approximately 50cm (see Figure 12).

Residents reported that the road bridge inhibited the high flows, blocking the water from passing along the river. Floodwater also backed up onto the highway either side and over the road bridge (see Images 1 & 2). Surface water flows on the highway coming down the hill added to the extent of the floodwater. Local residents also stated a lack of river channel maintenance downstream of the road bridge, may have contributed to the heightened flood levels. The observed flood extents along The Street match closely with the national fluvial flood risk mapping (see Figure 13).

- Residents to install Property Flood Resilience (PFR) via grant funded scheme.
- Landowners to carry out appropriate watercourse maintenance to reduce flood risk as necessary as per their riparian responsibilities.
- Explore potential NFM projects to ‘slow the flow’ and attenuate water on overland flow paths (leaky dams, restoration of watercourses, etc.) in the upper catchments and west of Witnesham.

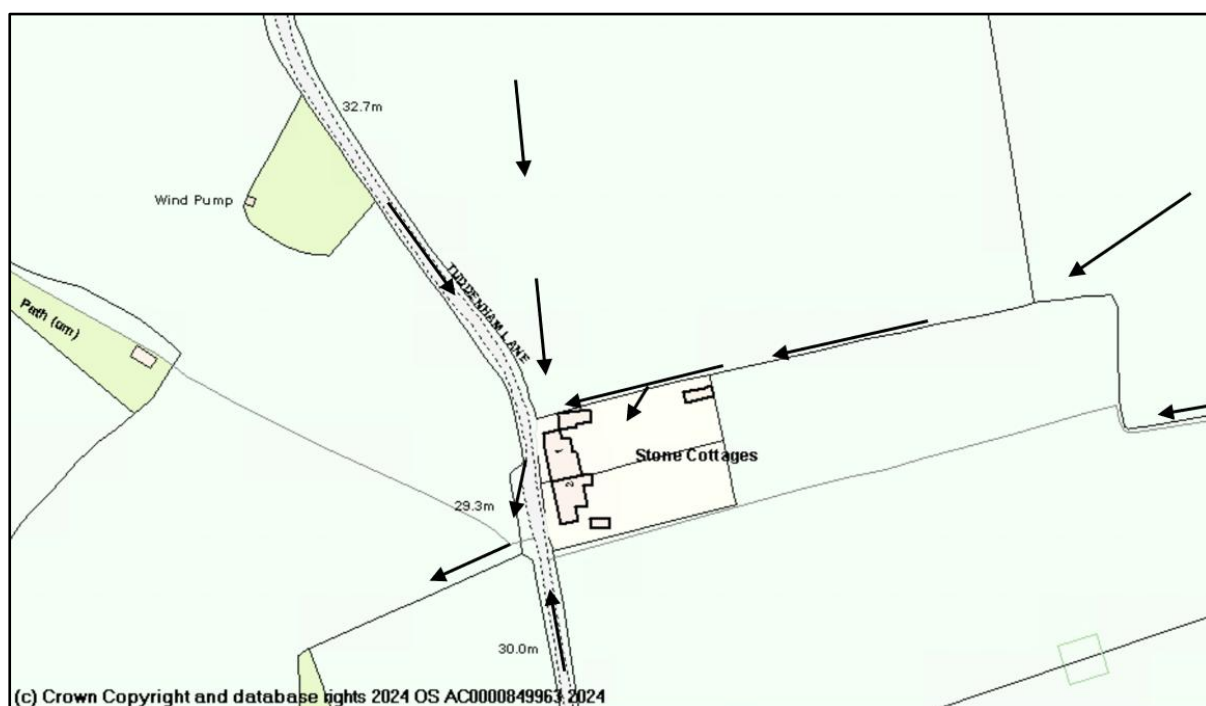
Figure 14. Approximate flood water flow routes on Tuddenham Lane

On the morning of 20 October, intense rainfall caused surface water to flow across the fields to the east and overwhelm the watercourse to the north of the properties on Tuddenham Lane. Some of the floodwater overflowed from the watercourse directly into and across the gardens, impacting the properties from the rear (see Figure 14 below). The majority flowed out onto the highway surrounding the houses from the

The watercourse received additional surface water flows from the north via a presumed surface water land drain. This additional flow, together with significant quantities of surface water flowing down the highway, greatly contributed to the expanse of floodwater on Tuddenham Lane.

- Residents to install Property Flood Resilience (PFR) via grant funded scheme.
- Suffolk Highways to CCTV the culvert below the road from the watercourse connection to the brick outfalls, to check for blockages, capacity size and or defects and fully establish the drainage routes.

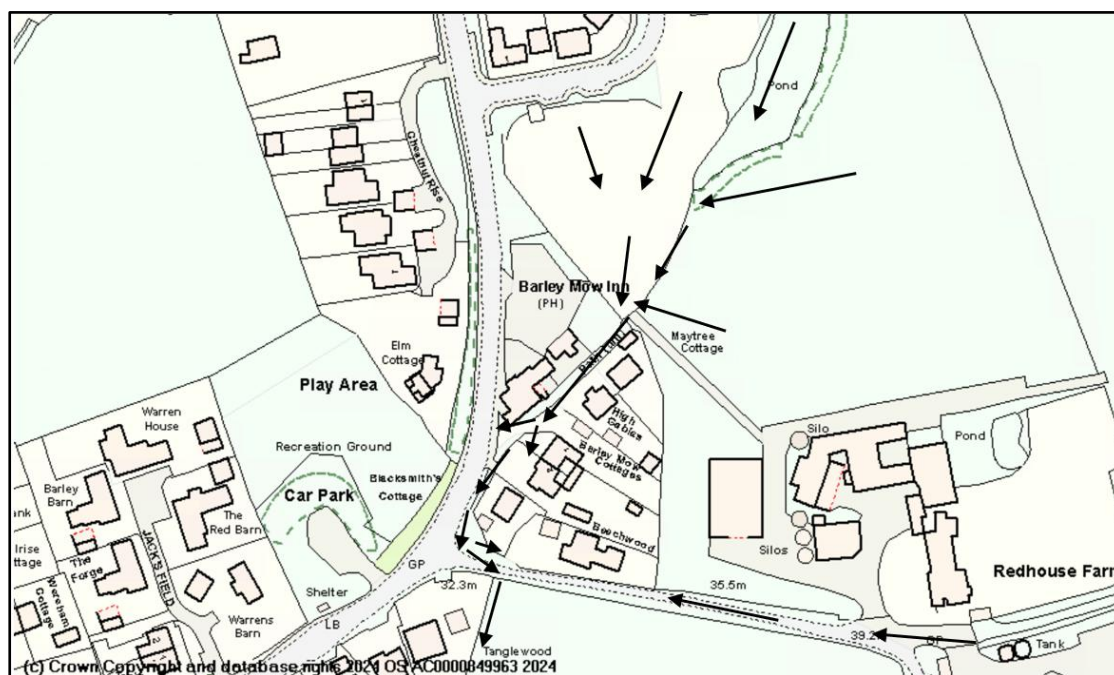
Figure 16. Approximate floodwater flow routes on Mow Hill

During Storm Babet, excess flows from adjacent farmland flowed overland to the south and west, bypassing the Gull and converged with flows from the development site before flowing overland towards Mow Hill. This flow is in addition to water in the piped watercourse that was flowing at full capacity. Surface water on the highway also added to the floodwater flows on Mow Hill and into the piped watercourse (see Figure 16).

The amount of water flowing into the piped watercourse far exceeded its capacity, resulting in floodwater surcharging from manhole covers along its length and directly flooding adjacent properties from the front (see Image 6). Significant internal flooding of the properties began from late morning onwards, with highest floodwater levels reported around 2pm. Some properties were entirely surrounded by the floodwater.

- Suffolk Highways to investigate if the existing highway drainage assets on Mow Hill and the Mow Hill / Tuddenham Lane junction are operational.
- Landowners to repair and or improve the drainage capacity of the piped watercourse from Mow Hill to Giles Way.

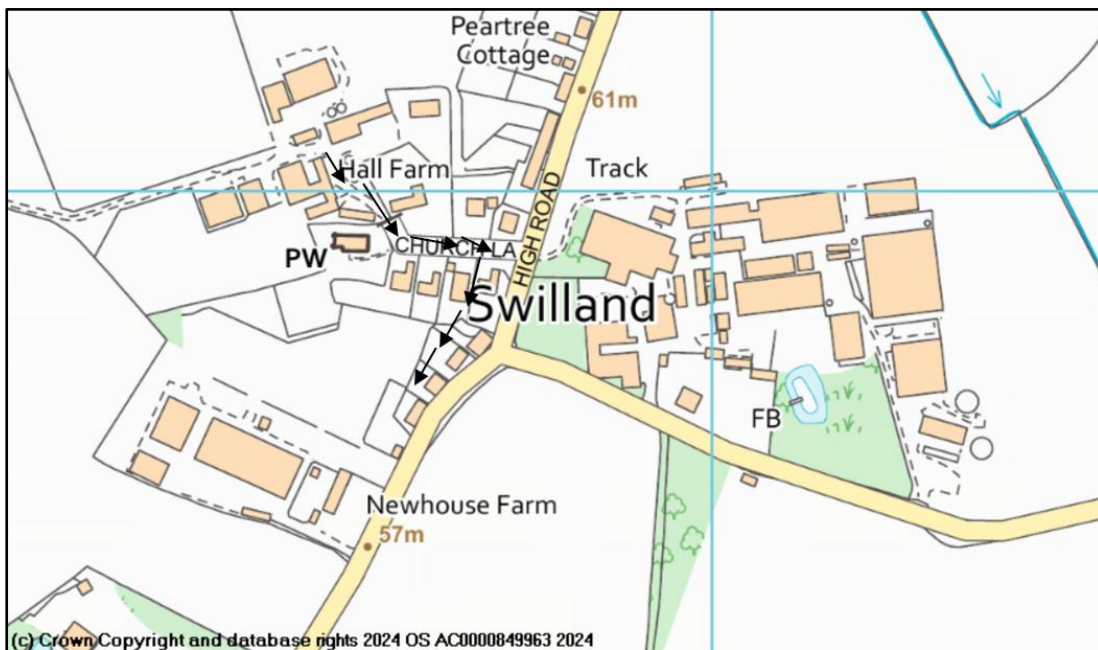
Figure 19. Approximate floodwater flow routes in Swilland

The primary cause of flooding in Swilland was pluvial flooding. Surface water run off originated from the hard surfaces (concrete or compacted ground) on the farmyard to the north of the church. Following heavy rainfall on the morning of 20 October, surface water flowed off the site onto Church Lane. The floodwater continued along Church Lane (see Image 7) towards High Road and began pooling around the highway drainage gully near to the road junction. The gully was overwhelmed by a combination of the high volume of runoff and it being blocked up with fallen leaves. As the floodwater on Church Lane increased, it flowed onto the nearby driveway and across the rear gardens of properties on High Road. The houses were flooded internally from the side and rear (see Figure 18) from late morning with levels peaking between 12 – 2pm. There was little to no surface water on the carriageway along this section of High Road.

Further south along High road another property was badly impacted by surface water flooding from the fields to the west. The house and garden are lower lying than the field behind which was described by residents as being waterlogged throughout the year. Historically there had been a ditch between the property and the field, this was subsequently infilled with a piped land drain installed.

It is presumed that during Storm Babet the pipe capacity was overwhelmed, with exceedance flows from the fields flowing into the garden and property.

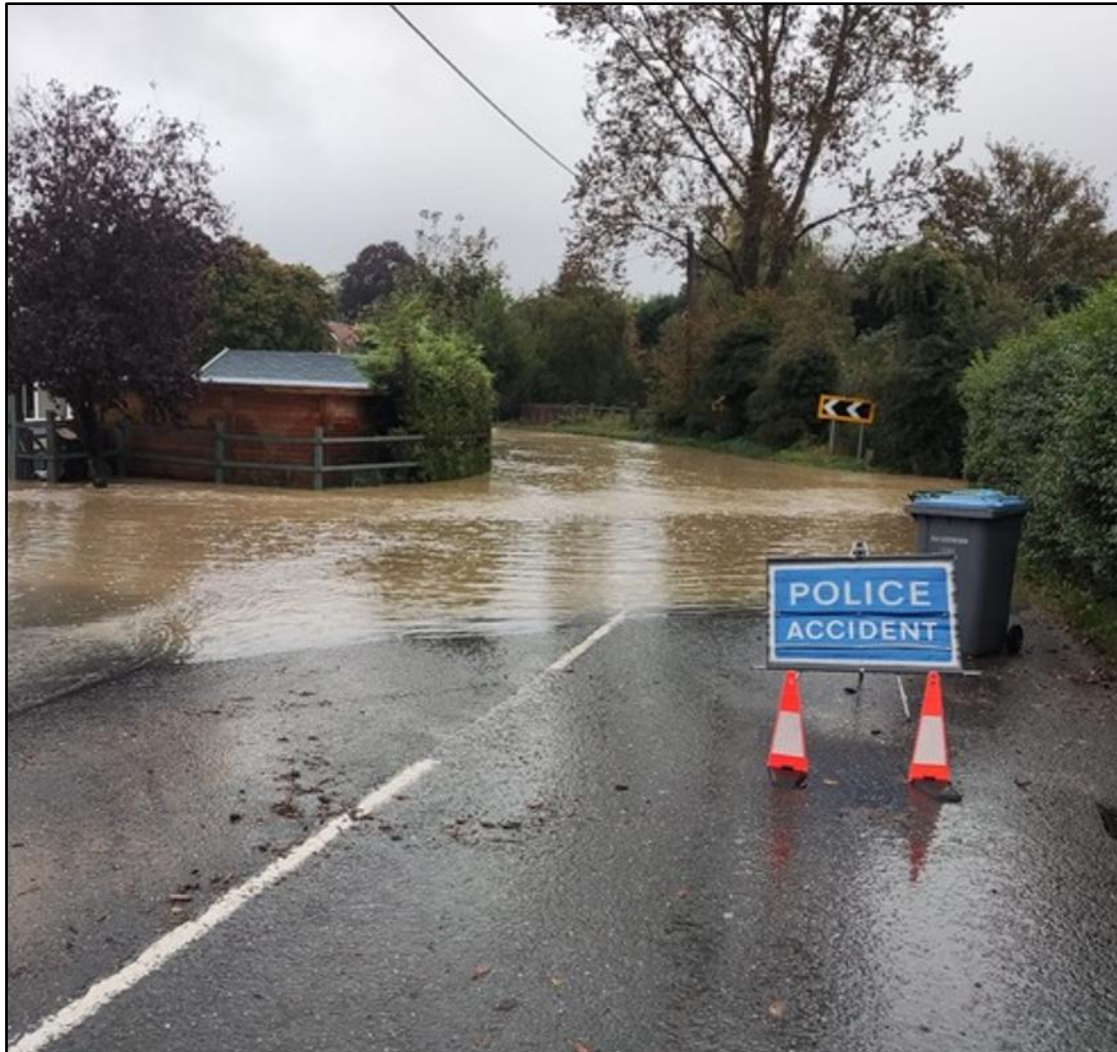
Image 1 - Looking north towards River Fynn road bridge

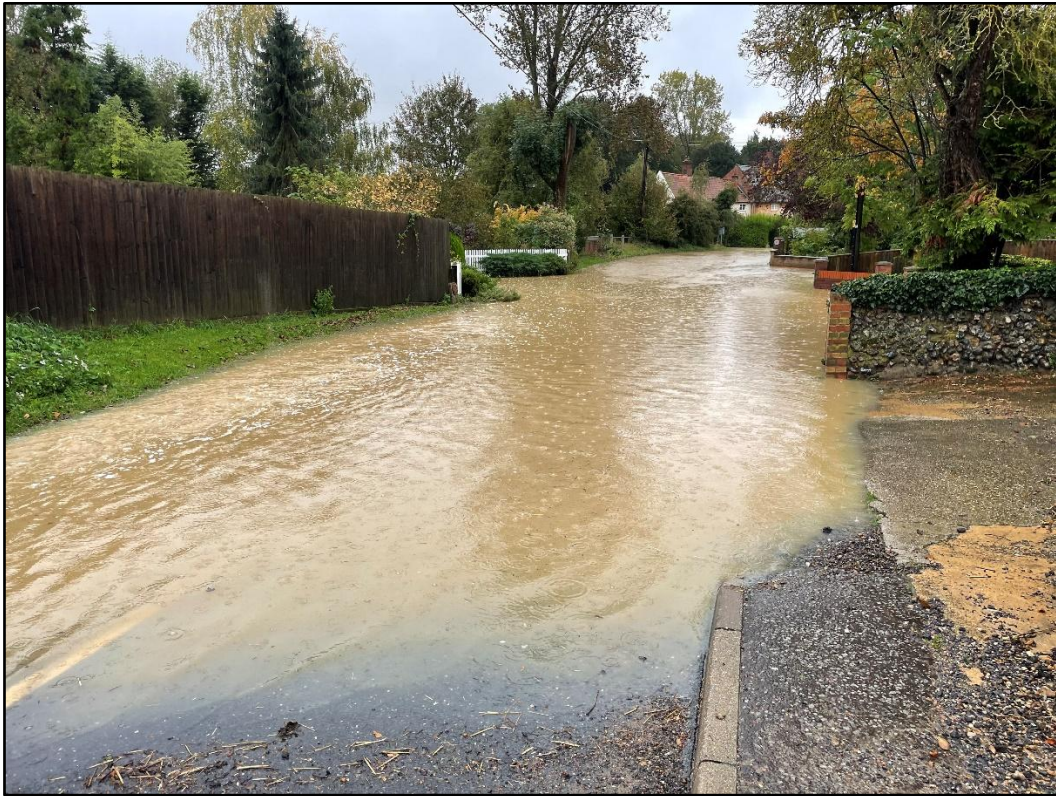
Image 2 - Looking south towards River Fynn road bridge

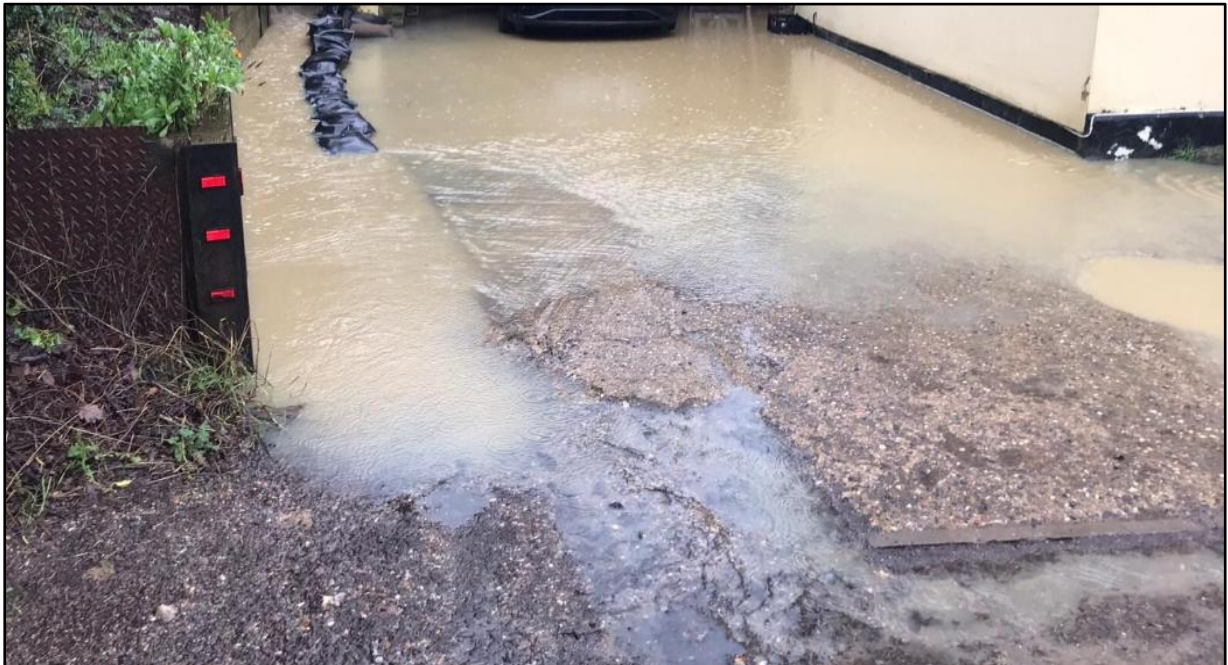
front and side as the capacity of the culvert below the road was exceeded (see Image 3). There is a culvert under Tuddenham with a restricted inlet from the upstream watercourse. It was reported that the culvert may have been partially blocked or damaged during the event. The small inlet connection from the channel into the culvert likely acted as a particular pinch point, due to its size, reducing the ability of the pipe to convey the floodwater. The floodwater on Tuddenham Lane reached its highest level sometime between 10 – 11am.

Image 3 - Watercourse overflowing onto Tuddenham Lane

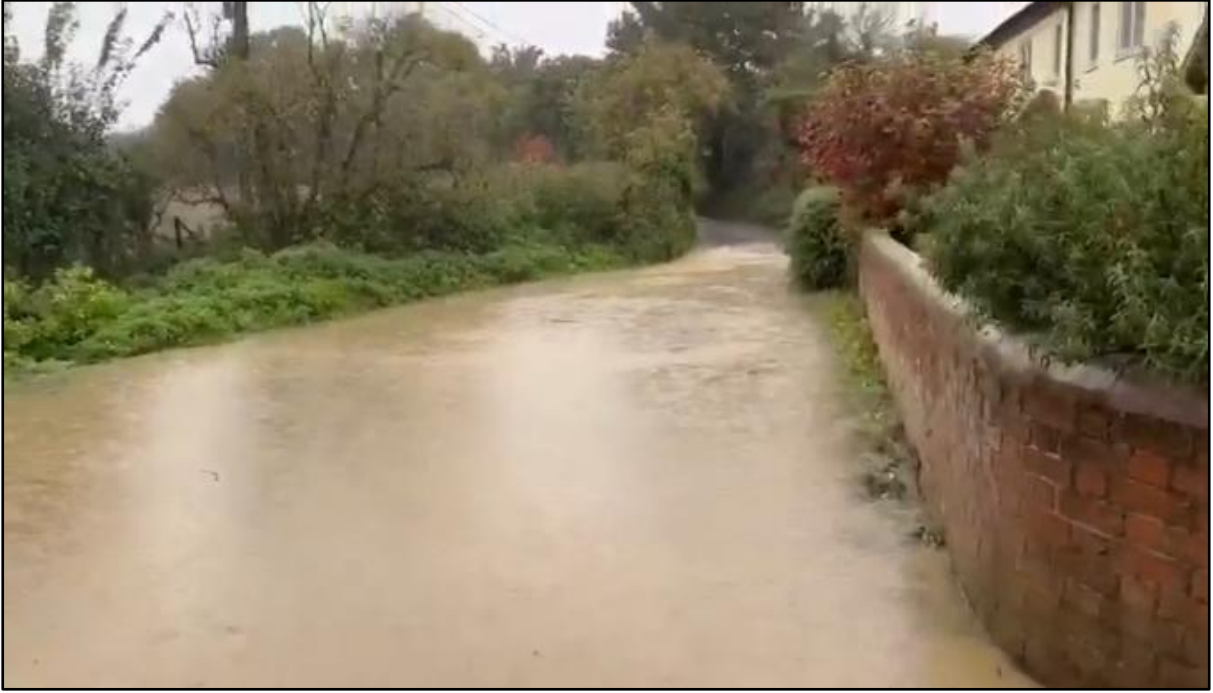
The floodwater on the highway was unable to drain away, as the highway gullies and kerb offlets were blocked up with silt (see Image 4). The roadside ditch was overgrown with vegetation reducing conveyance capacity, and it overflowed further adding to the floodwater (see surface water flood risk on Tuddenham Lane, Figure 16). This ditch has been subsequently cleared post Storm Babet, with the blocking vegetation and debris removed.

Image 4 - Floodwater on Tuddenham Lane

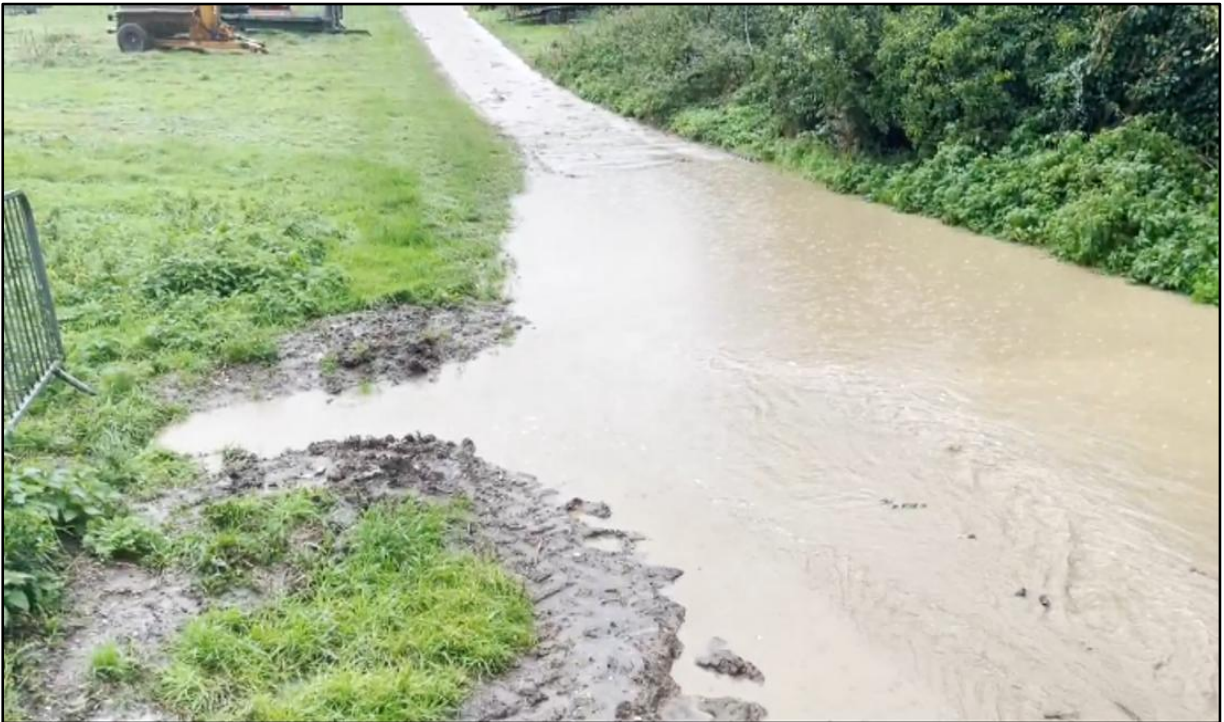
Image 5 - Surface water runoff from Witten's Meadow construction site towards Mow Hill (photo looking southwest)

Ultimately the developer had failed to comply with their required mitigation of construction surface water run off over an area of ground compaction of over 2 hectares in area.

The large amount of surface water which was unattenuated on site in the absence of the surface water management features which had not been constructed before any other development began was observed flowing south into The Gull and accumulating at the entry into the piped watercourse. This was immediately recognised as a potential contribution to the flooding.

- Suffolk Highways to ensure the completion of highway drainage asset cyclic maintenance on Mow Hill.
- East Suffolk Council (as Local Planning Authority) and LLFA to implement an improved process to ensure developer compliance with planning conditions that mitigate surface water run off during construction (see Appendix 1 for further details).

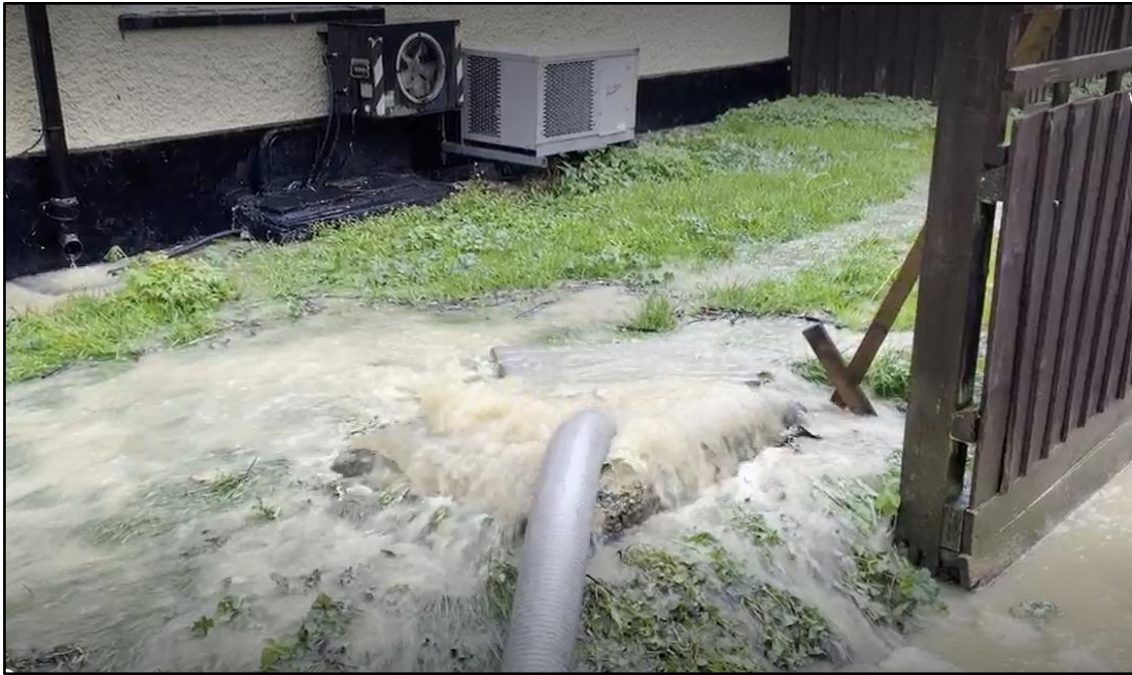
Prior to Storm Babet the piped watercourse, that travels from the Gull, had failed (possibly due to an unknown blockage) and surcharged, creating a hole in the garden of a property next to the Giles Way estate. During Storm Babet water emerged from the hole, flowed overland and down Giles Way before entering a surface water sewer system and into the River Fynn.

Image 6 - Surcharging manhole outside Barley Mow public house

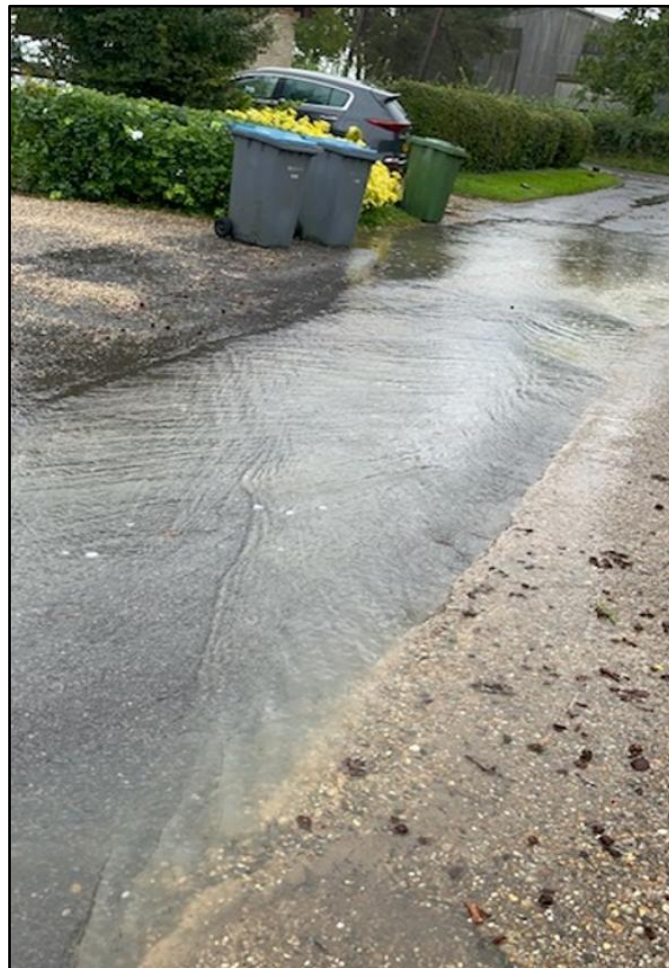
Surface water flooding is characterised as low risk along Church Lane on the national flood risk mapping, and the observed pathway the floodwater followed is not shown (see Figure 19).

Image 7 - Surface water flowing along Church Lane, Swiland

areas. Primary areas are the upper catchments of Mow Hill, Tuddenham Lane and the Street. (See Appendix 2)			
Investigate if there is any potential for additional highway drainage assets on Church Lane, Swiland to better manage surface water flows.	SCC Highways Authority	12 - 24 months	No update expected at this time
CCTV the culvert below Tuddenham Lane from the watercourse connection to the brick outfalls, to check for blockages, capacity size and or defects and fully establish the drainage routes.	SCC Highways Authority	12 - 24 months	No update expected at this time
Investigate the feasibility of upsizing the connection from the ordinary watercourse to the culvert under Tuddenham Lane.	SCC Highways Authority and Landowner	12 - 24 months	No update expected at this time
Investigate the feasibility of enlarging the culvert under Tuddenham Lane.	SCC Highways Authority	12 - 24 months	No update expected at this time
