Section 19 Flood and Water Management Act 2010
Worlingworth Flood Investigation – Storm Babet October
2023

Name	Date
Report Author	John Jousiffe	
Responsible Officer:	John Jousiffe	
Checked by:	Ellie Beecroft	07/08/2024
RMA Review:		19/09/2024
Approved by:	Matt Hullis	27/09/2024
Date Published		02/10/2024
Latest Update		10/02/2026
Date Report Closed

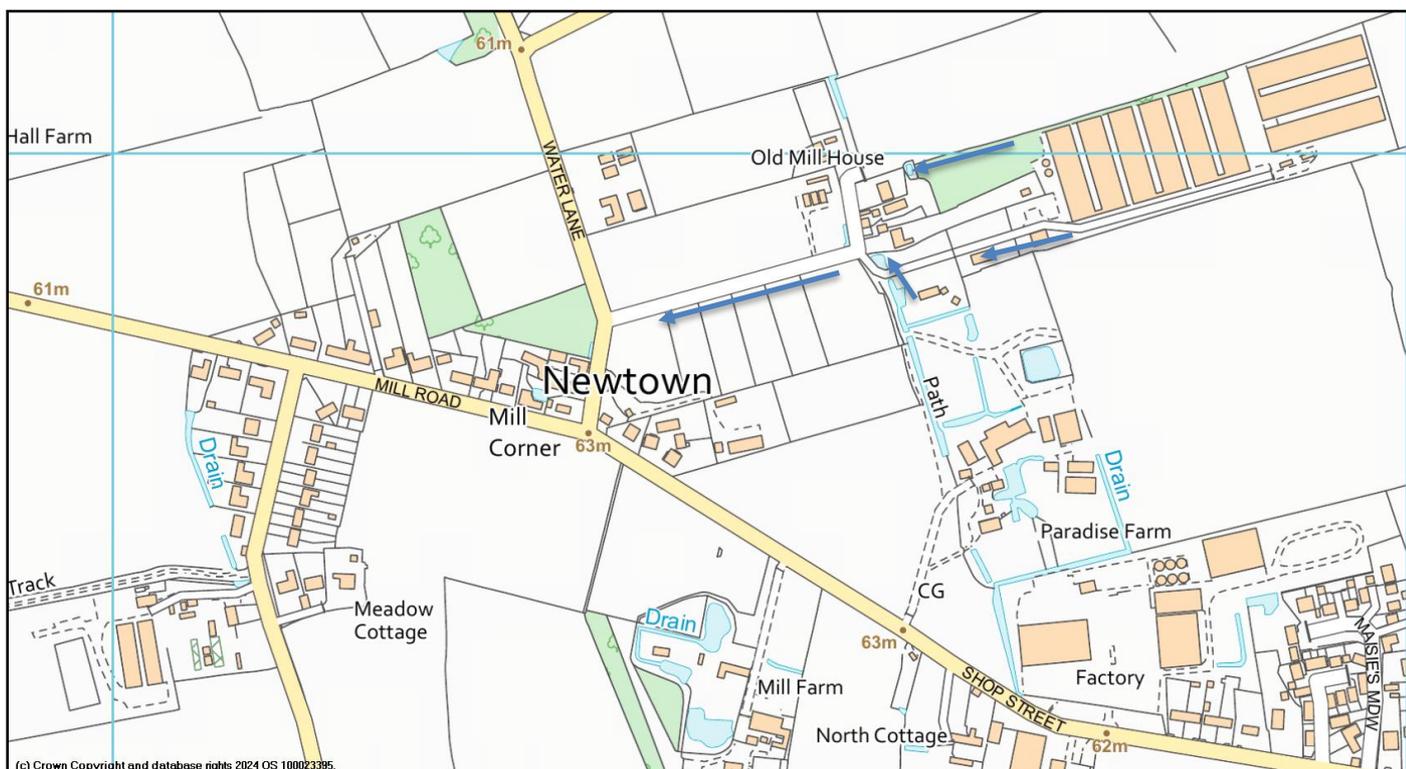
Figure 12 - Flow routes of water in west Worlingworth

A small number of properties suffered from internal flooding in the western part of the catchment with Newtown being the most affected area. Reports from Mill Lane have also been received, although little is known about the severity or impact in this area.

Reports from Newtown suggest that there are several issues, many of which relate to maintenance of watercourses, ponds and other water management features. Due to the flat nature of the ground in this area, it is particularly important that water management features are well maintained to allow for water to flow away in a timely manner or to be held safely in attenuation features such as ponds or wetlands, and again these will need to be well maintained to ensure a sufficient capacity. Many of the reports received and conversations with the residents suggested that debris and fallen trees in the channels of watercourses contributed to blockages, causing water to backup and overtop the features. This excess water then flowed to the lowest points, which in this location were often houses.

There are several ponds in the proximity of Newtown and some reports suggest that a lack of maintenance of these features has reduced their holding capacity through siltation and sedimentation, which may have exacerbated the severity of the event. However, due to the saturated conditions of the preceding months and severity of the rainfall event, it is likely that these features would have exceeded capacity anyway, although any increase in their capacity would have helped even if only in a small way.

There are several watercourses in the area which border the highway, properties and fields which are present to provide a route for water flow. These channels were reported to have been blocked or poorly maintained for some time which may have prevented effective water egress adding to flood water and worsening the event.

Highways drainage records show a gully on the junction with Water Lane and Newtown, (an unclassified road leading to the nearby farm), which was ineffective and slow draining upon the last two cyclical inspections. This gully could have caused the draining of the water in the area to slow down, although, as it is some distance from the properties affected, it is unlikely to have been a significant factor in the flooding experienced.

- Significant rainfall onto already saturated ground caused high levels of overland surface water flow, resulting in ponding of water in isolated low spots.
- Overwhelmed water management features, such as ponds, watercourses and wetlands caused and added to surface water flows.
- Poorly maintained water management features in the area may have exacerbated the issue.

- Report issues to relevant RMA or landowner/parish where known blockages or issues have occurred for relevant RMA/landowner to carry out remedial works where required.
- Highway authority to resolve slow draining gully asset on the junction with Water Lane and Newtown.
- Increase maintenance frequency of water management features in the area.
- Residents to install Property Flood Resilience (PFR) via grant funded scheme.

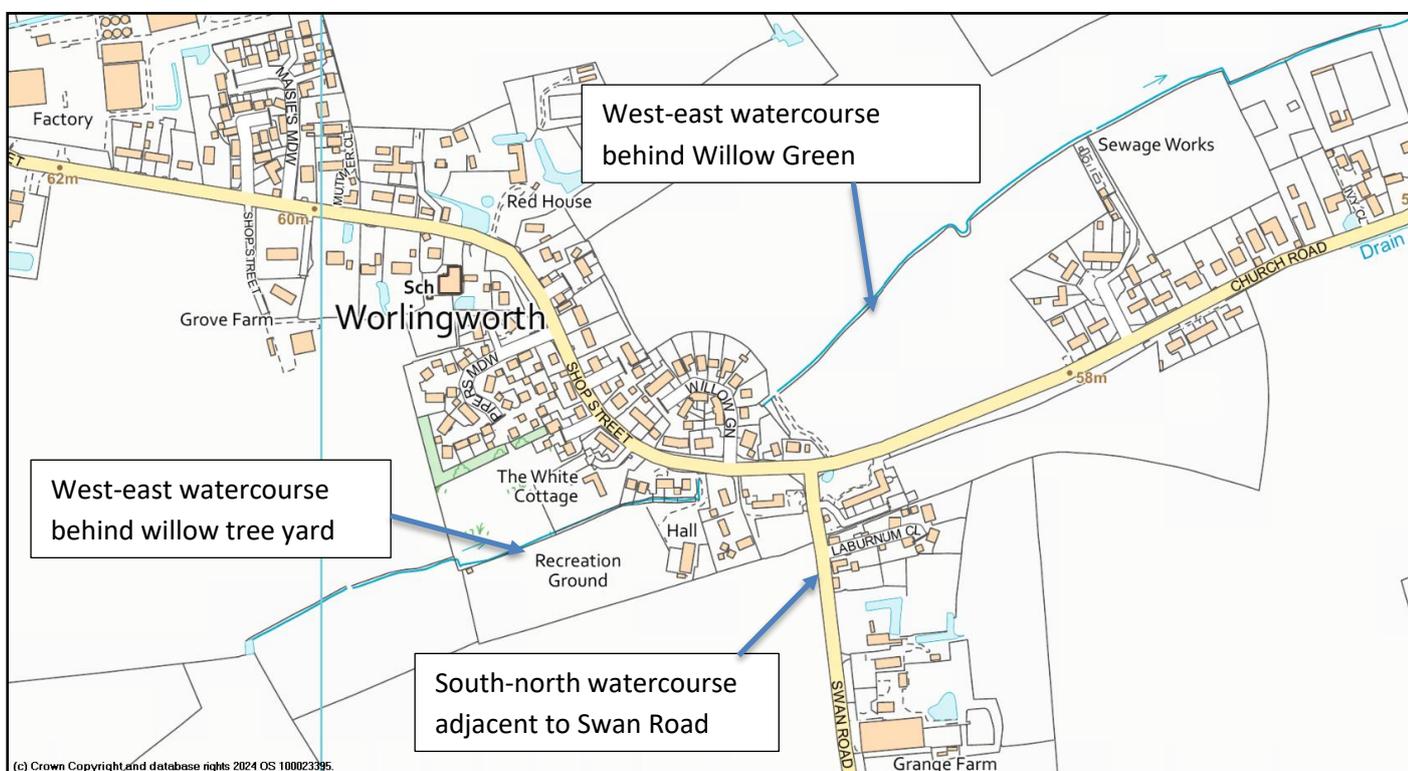
Figure 13 - Map of local watercourses

Flood water also came from overtopped watercourses within the area. Watercourses are located behind Willow Tree Yard; Willow Green and an additional watercourse runs roughly south to north down Swan Road and joins the west to east watercourse just on the northside of Church Road.

Several ordinary watercourses surround the housing developments on the south side of Shop Street, most of which convey water into the larger watercourse running between the recreation ground and Willow Tree Yard. This is where the first significant flooding event occurred on the day. The current level of maintenance of these smaller watercourses is unknown, although due to sheer volume of water during Babet, maintenance of these is unlikely to have been a significant issue.

Where the watercourse reaches the highway, it is then culverted and flows towards Willow Green. Reports from the day suggest this culvert was very quickly overwhelmed with volume

of water, causing significant overtopping, which added to the flood water on the highway already coming up through the drainage infrastructure. The current outfall of this piped section of watercourse is not clear, although there are outfalls located north of Willow Green in the watercourse which appear to be likely. The watercourse then continues to the east although the gradient of the land is much shallower this way and as such the waterflow is slower.

A further watercourse joins with the west-east watercourse on the north side of Church Road and makes its way around the back of the buildings along Church Road and Willow Green (where it passes through some gardens) before heading east across the surrounding fields. Following a site visit in May of 2024, both watercourses in question appear to be well maintained, suggesting a lack of maintenance is unlikely to have been an issue in the area and therefore it is more likely that this event was a capacity issue at the pinch point in the centre of the village.

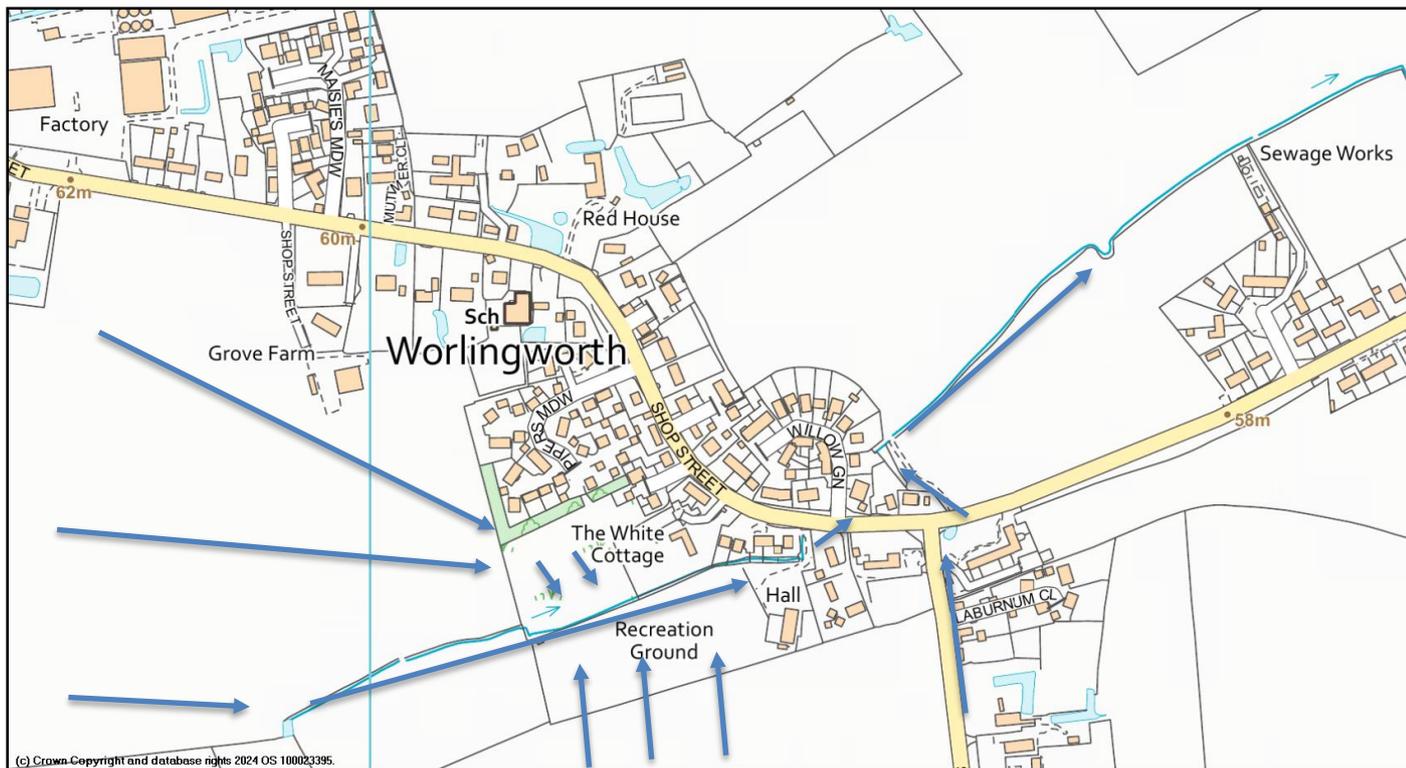
Figure 14 - Flow routes of water in central Worlingworth

Water flowed primarily from the west and south as runoff from the surrounding fields and down the watercourses. As it reaches the centre of the village the before mentioned issues of capacity and change in topography result in the water pooling and causing significant flooding to residential homes and businesses. Internal flooding reached levels of 37cm, and external flooding was considerably higher. Internal flooding was severe enough in several properties that even six months after the event, residents are yet to return home.

- Significant rainfall and saturated ground caused high-level of overland flow towards the centre of the village, overwhelming water management features and spilling out at the pinch points near the community centre.
- Change in topography in the village centre causes water flow to slow down at this point adding to the overcapacity systems.
- Watercourses exceeded capacity and saw water flow out of bank, contributing to overland flows within the area.
- Highways and Anglian water assets were overwhelmed, and water was forced back up manhole covers adding to the flood water.

- Investigate possibility of natural flood management scheme in watercourses to the east and south of the village to try and slow the rate at which the water reaches the village centre.

- Investigate the possibility of attenuation/infiltration 'overspill' areas on the recreation ground (south of Shop Street) and agricultural land (east of Willow Green).
- Investigate the possibility of incentivising the retrofit of SuDS or rainwater harvesting systems for properties which currently drain roof water into the foul system. These can reduce surface water runoff and help to ensure the foul system is not overwhelmed during rainfall events.
- Anglian Water to investigate potential ground water intrusion into the foul sewer and plan works to reduce the occurrence of any related foul water flooding.
- Investigate the feasibility of increasing the capacity of existing drainage networks belonging to both highways and Anglian Water.
- Residents to install Property Flood Resilience (PFR) via grant funded scheme.

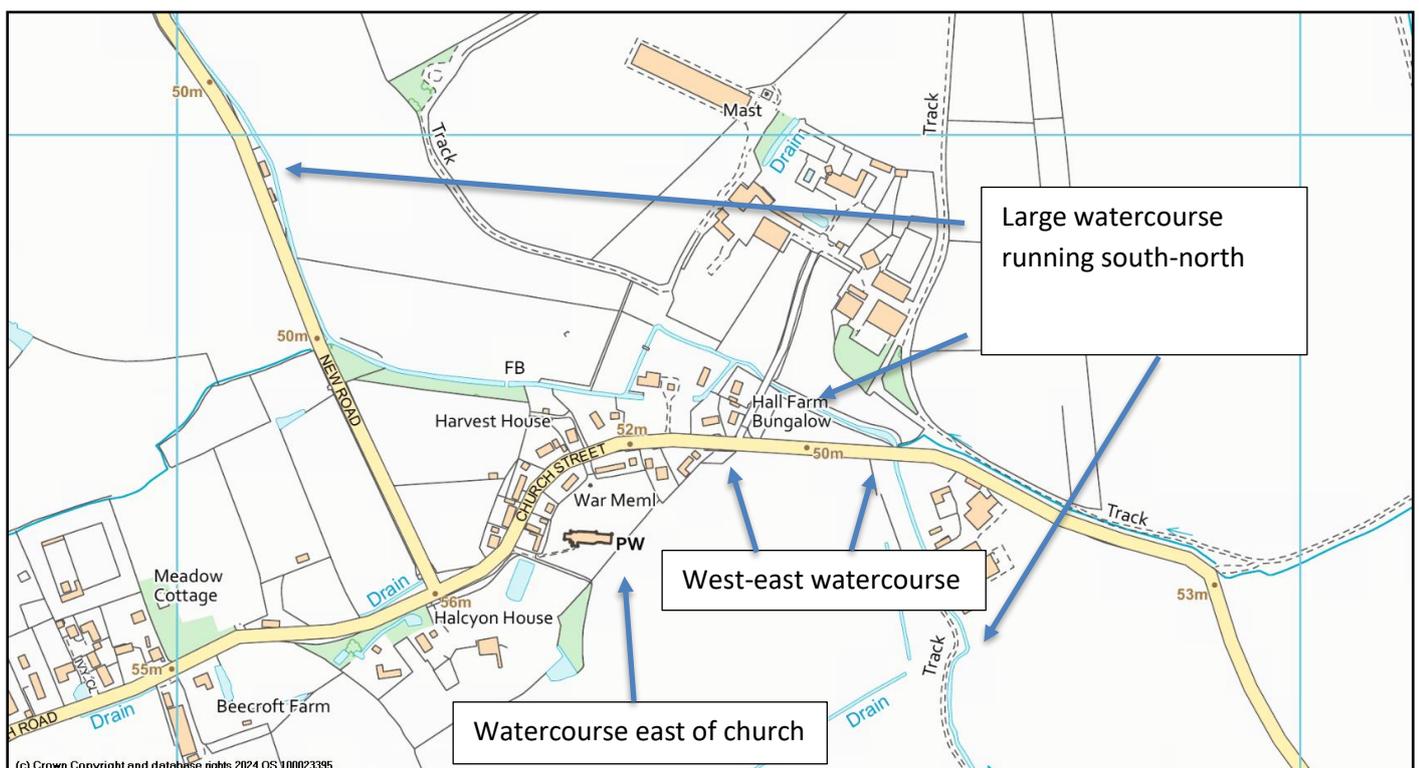
Figure 15 - Map of watercourses in east Worlingworth

According to residents there is a watercourse which runs south to north along the eastern edge of the church grounds. This comes to an abrupt stop as it meets the properties north of the church and there is no visible sign of a piped continuation of the watercourse. Reports

from the event suggested that as surface water runoff from the surrounding fields to the south and east flowed down this feature, it pooled at the northern end and eventually overtopped, and water flowed south through the gardens and outbuildings of the surrounding properties. Once it reached the highway it pooled at the lowest point and flowed into properties off the highway. There are several highway drainage assets in the area all of which were recorded as working on the inspection prior to the event (September 2022), these were again inspected in December of 2023 and said to be working, it is therefore likely that the drainage system was overwhelmed due to significant rainfall rather than a localised blockage being an issue.

Properties on the north side of Church Street were affected predominantly from water flowing off the highway due to the overland surface water flow and overtopped watercourses as described above. However, further to the north, the watercourses in the area provide a natural boundary between properties. Reports from residents suggest that this watercourse could be blocked by overgrowing trees which could have caused a backup of water flow resulting in the overtopping of the banks of the watercourse due to prevention of effective water egress.

Additionally, as you travel further north along the watercourse, it borders 'New Road' on the east side and residents have suggested that a newly formed culvert along this section of watercourse has caused water to back up more frequently which may have had some impact on the day by preventing water egress at a suitable rate. As the new culvert described above is some distance to the north of the properties, it is difficult to say if it is affecting the flood risk in the area, however the restriction of a watercourse here would have been unlikely to receive land drainage consent due to the high risk of flooding. SCC LLFA records show no Land Drainage Consent has been applied for in this area.

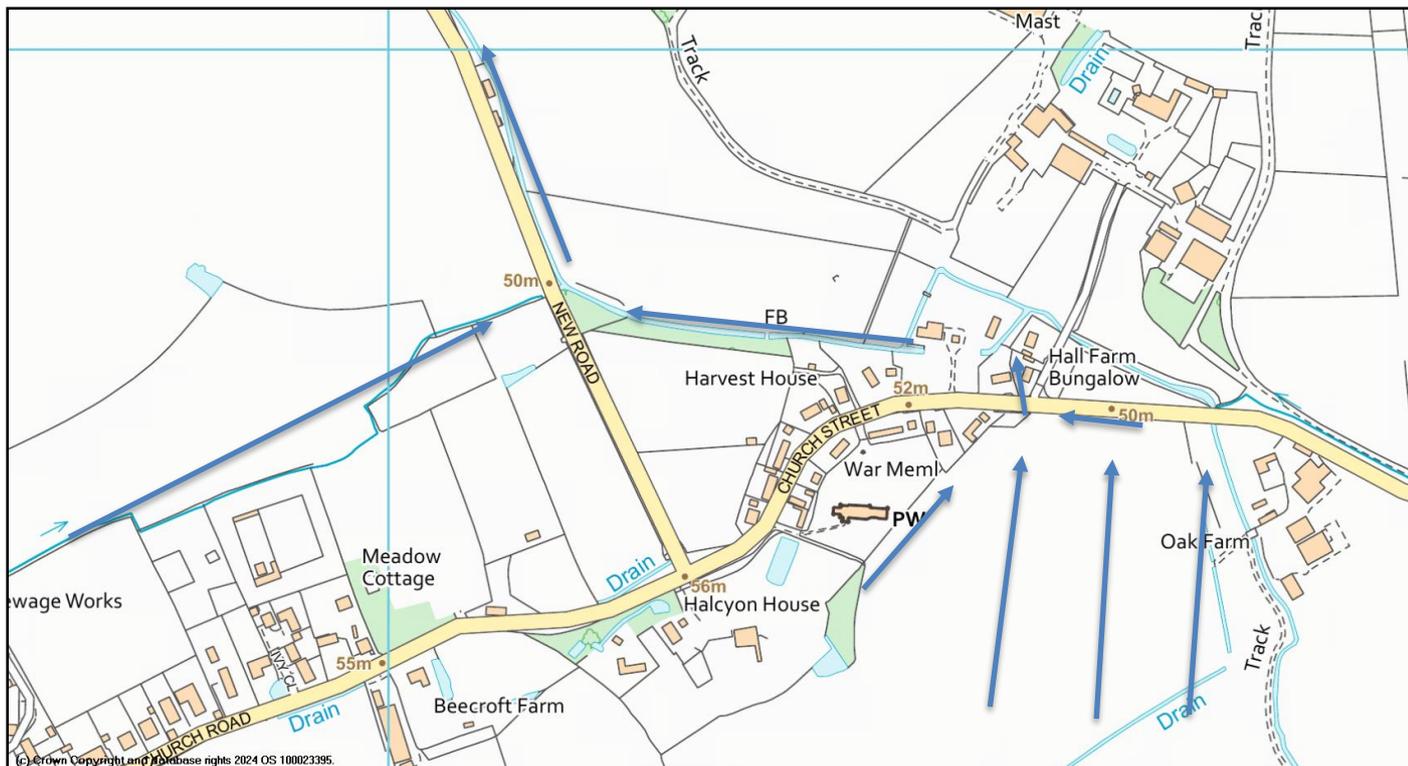
Figure 16 - Flow routes of water in east Worlingworth

Residential properties were affected by internal flooding to significant depths with some residents having to move out of their properties for several months. Other properties were affected by water flowing across gardens and outbuildings but not affecting the property internally.

- Significant rainfall and overland flows caused watercourses to overtop and localised low spots to quickly fill with water.
- Watercourses and water management features in the area may have been lost or incorrectly maintained over time resulting in a loss of capacity in the channels or ineffective flow paths for water to egress.
- Highways drainage assets were overwhelmed most likely due to sheer volume of water.

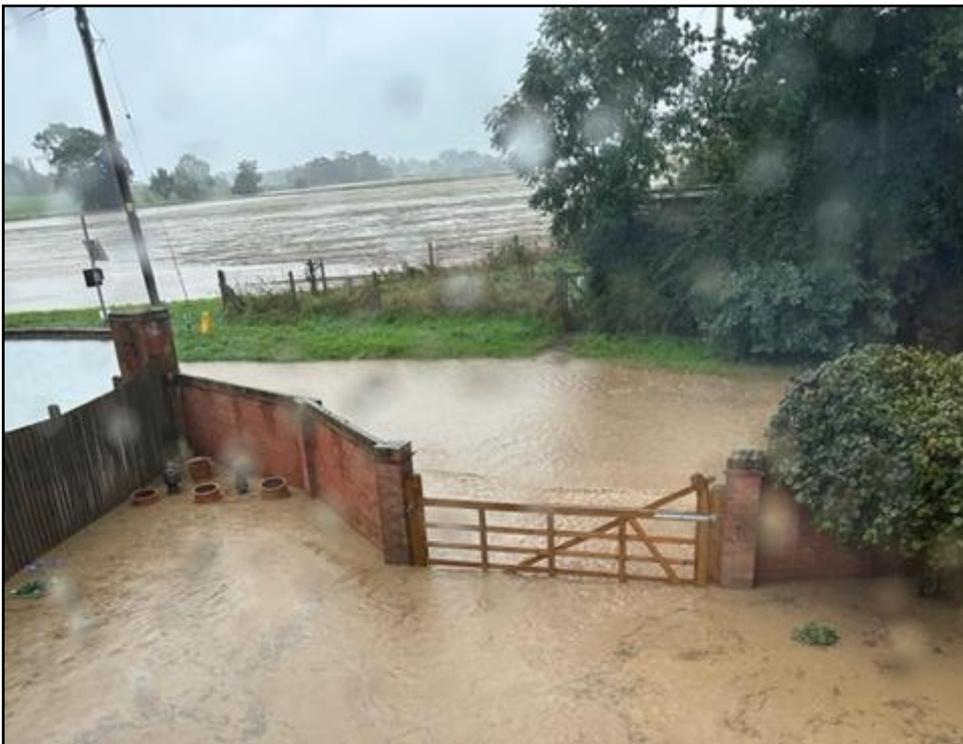
Image taken during the event from Eastern Worlingworth

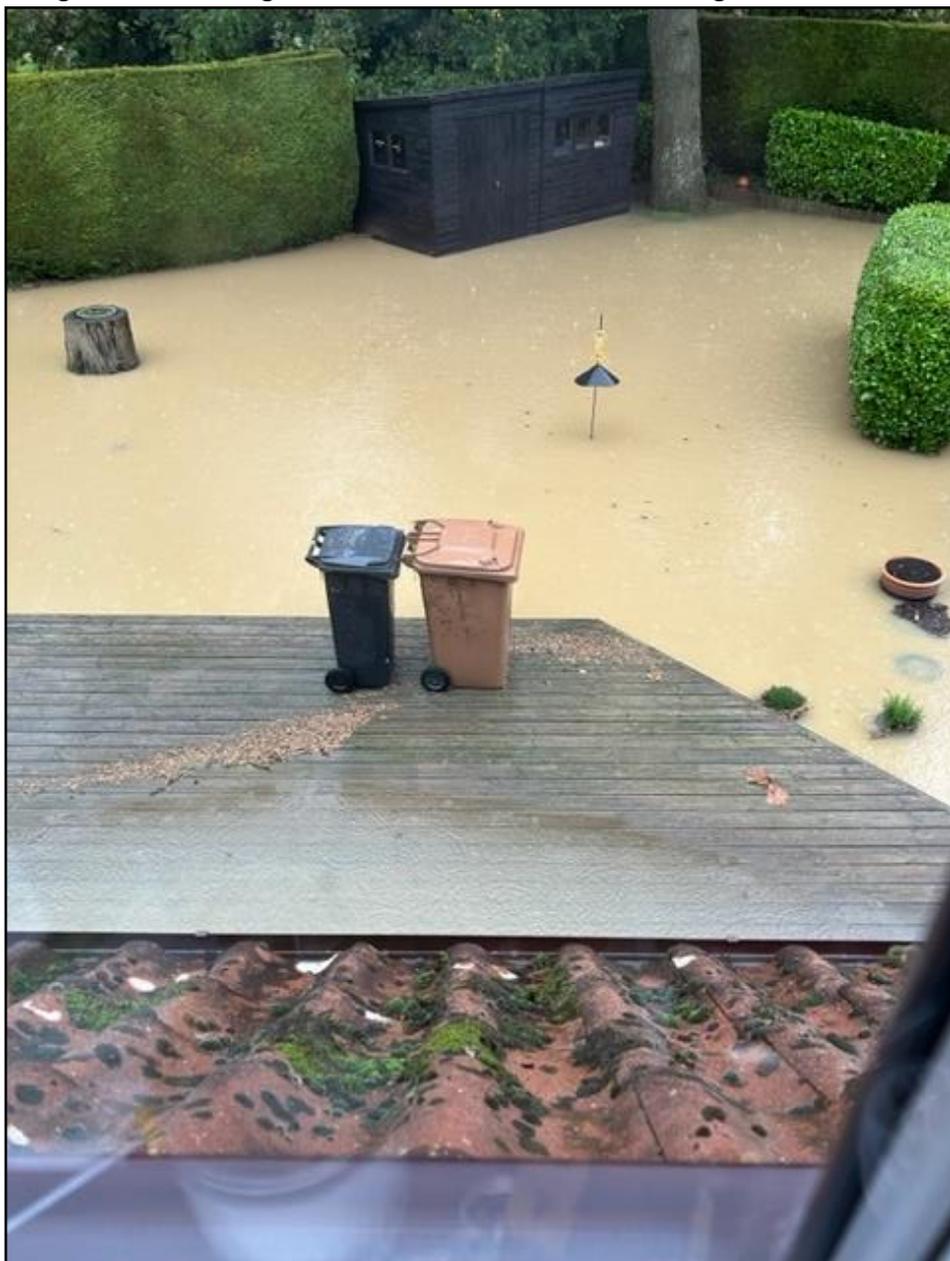
Image taken during the event from Eastern Worlingworth

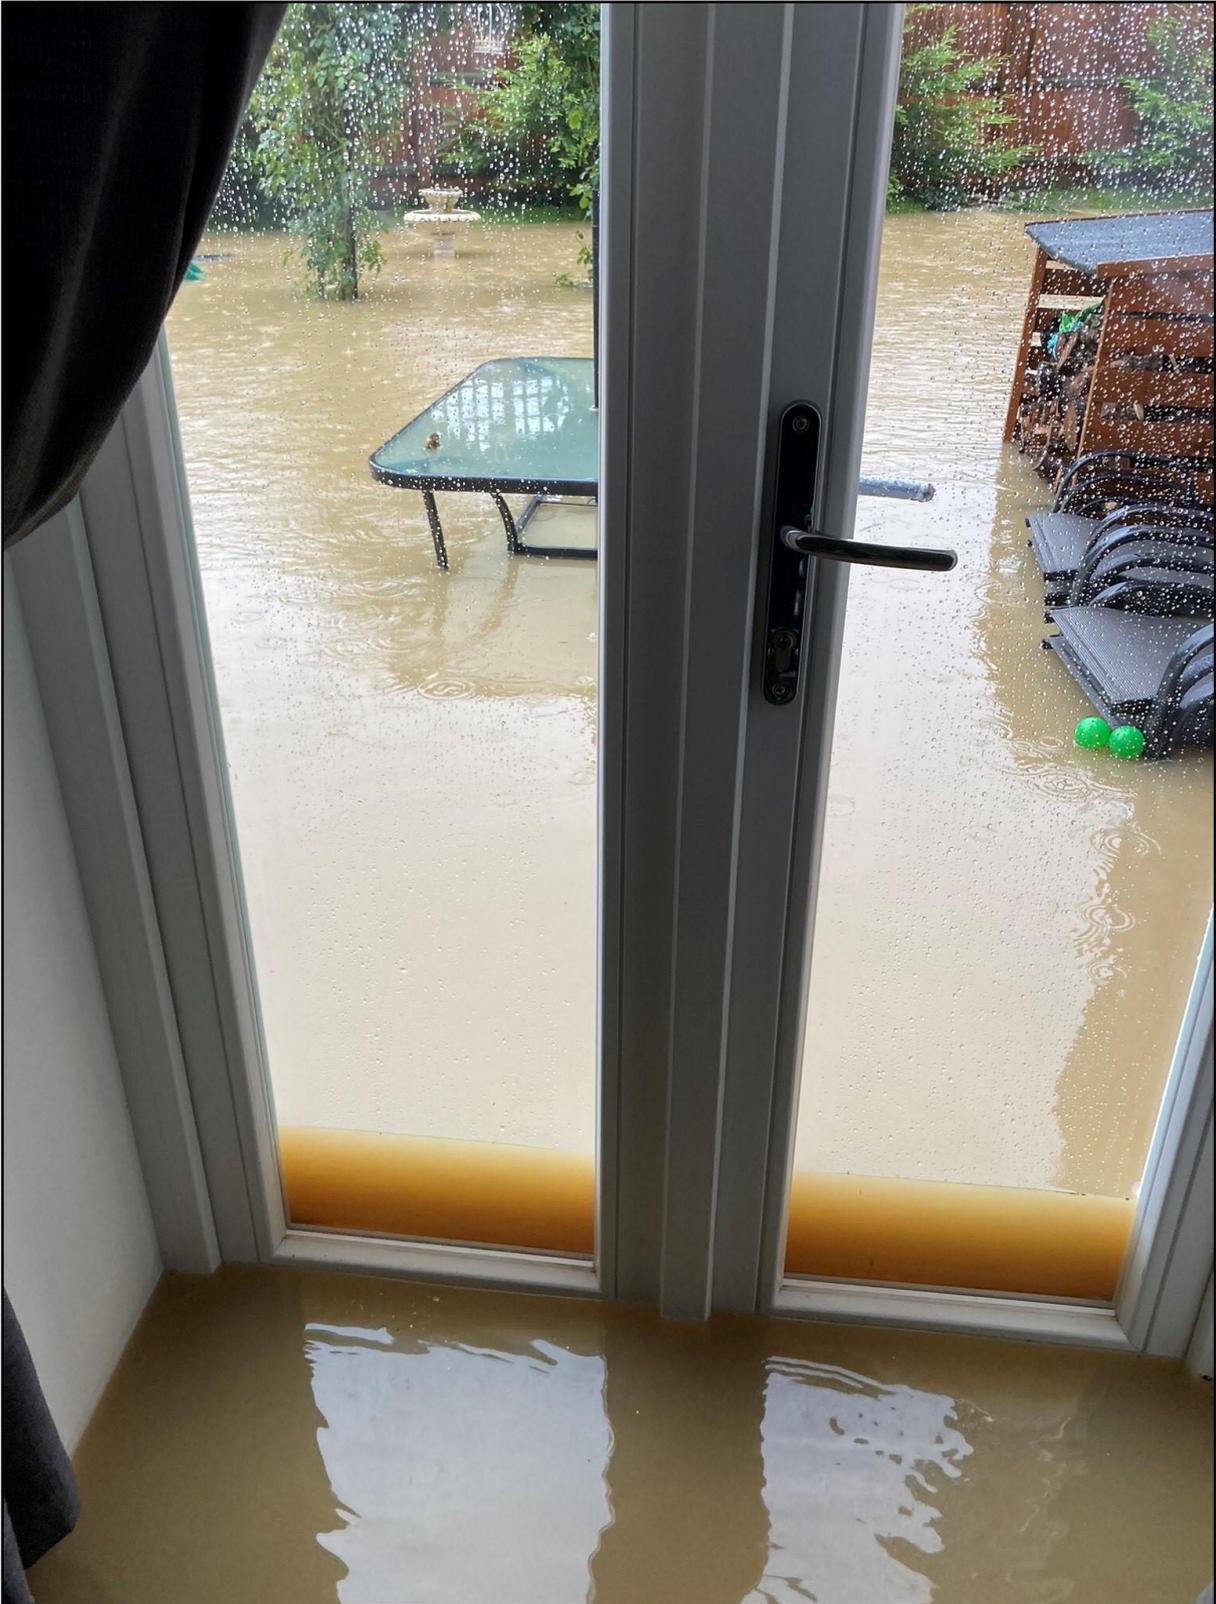
Image taken during the event from Eastern Worlingworth

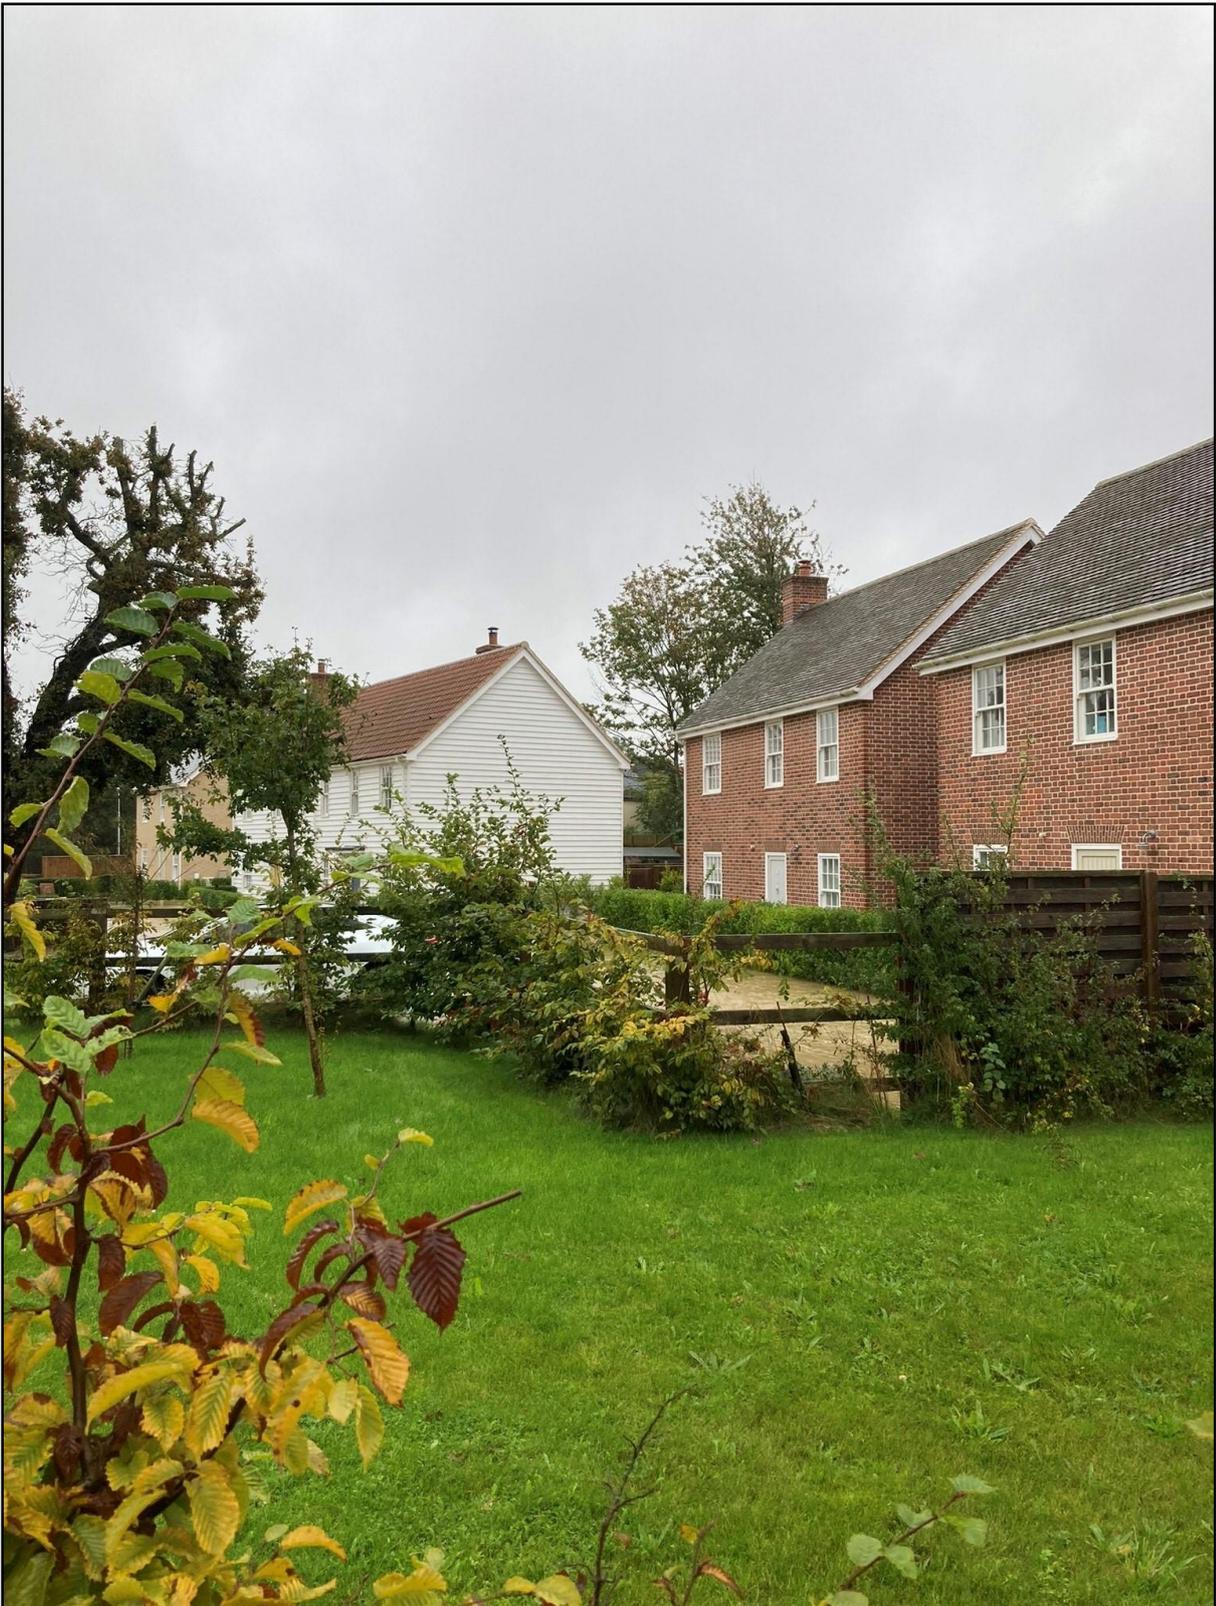
Image taken during event from central Worlingworth

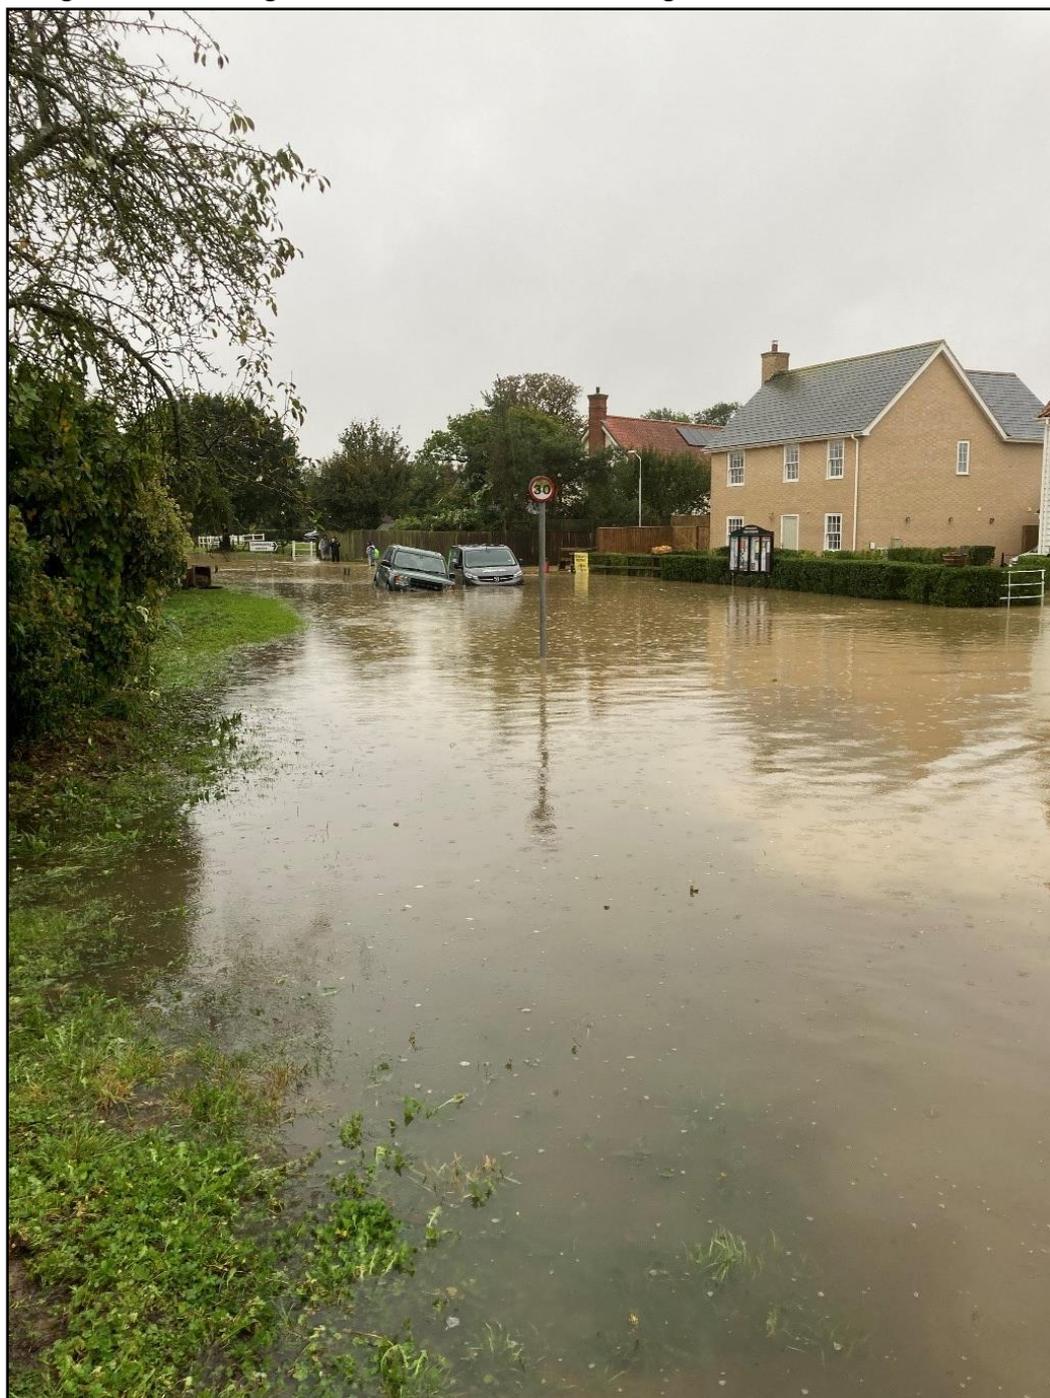
Image taken during the event in central Worlingworth

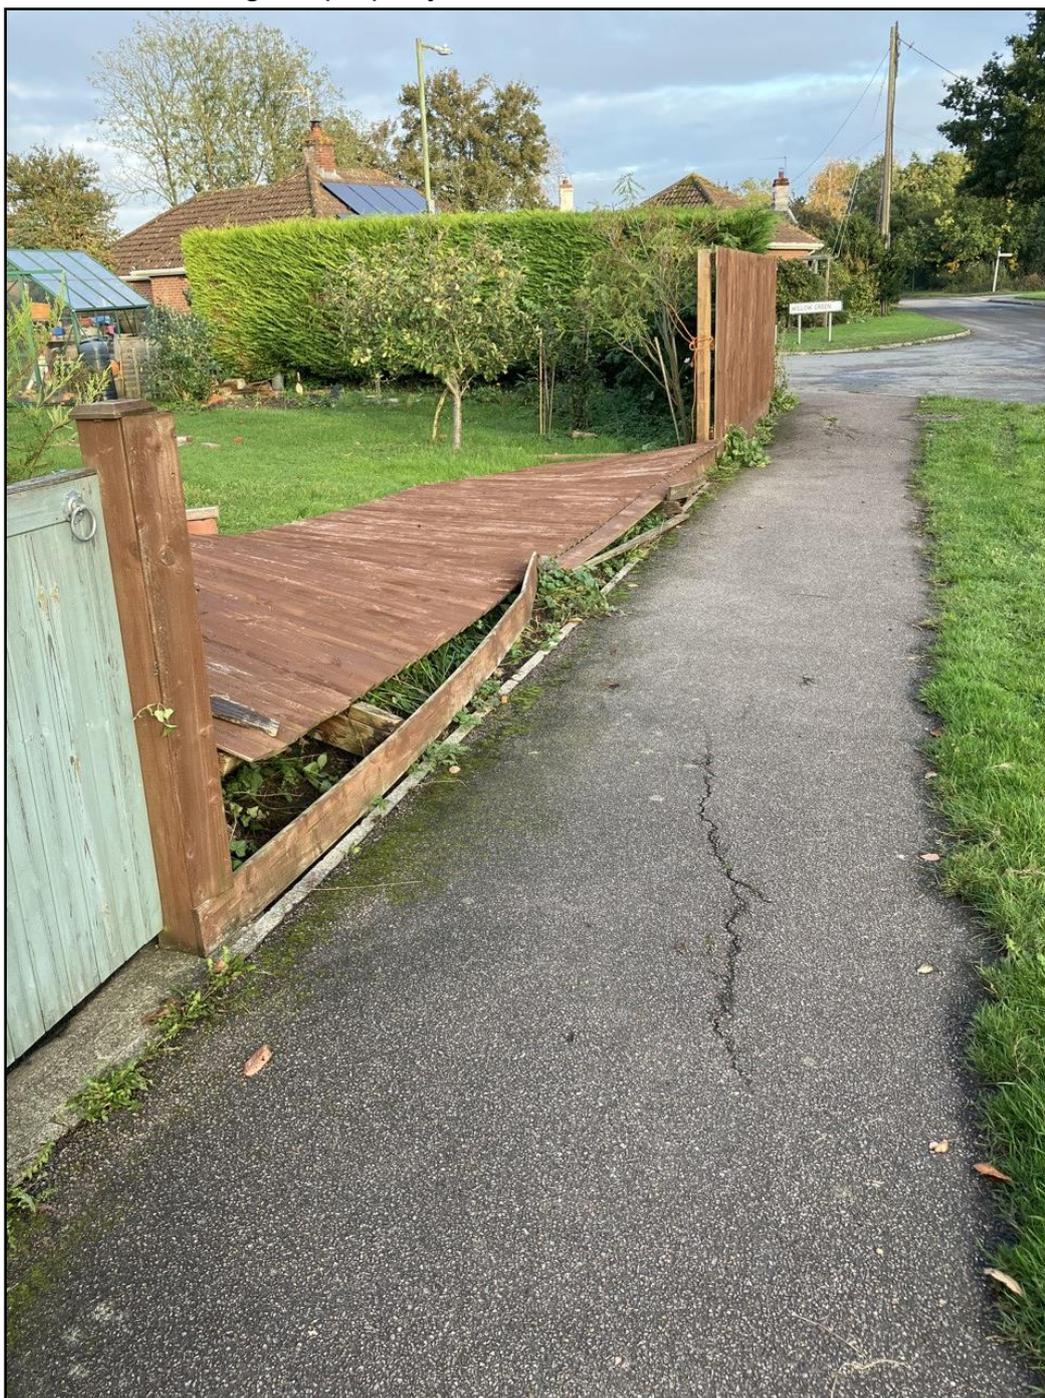
Post event damage to property

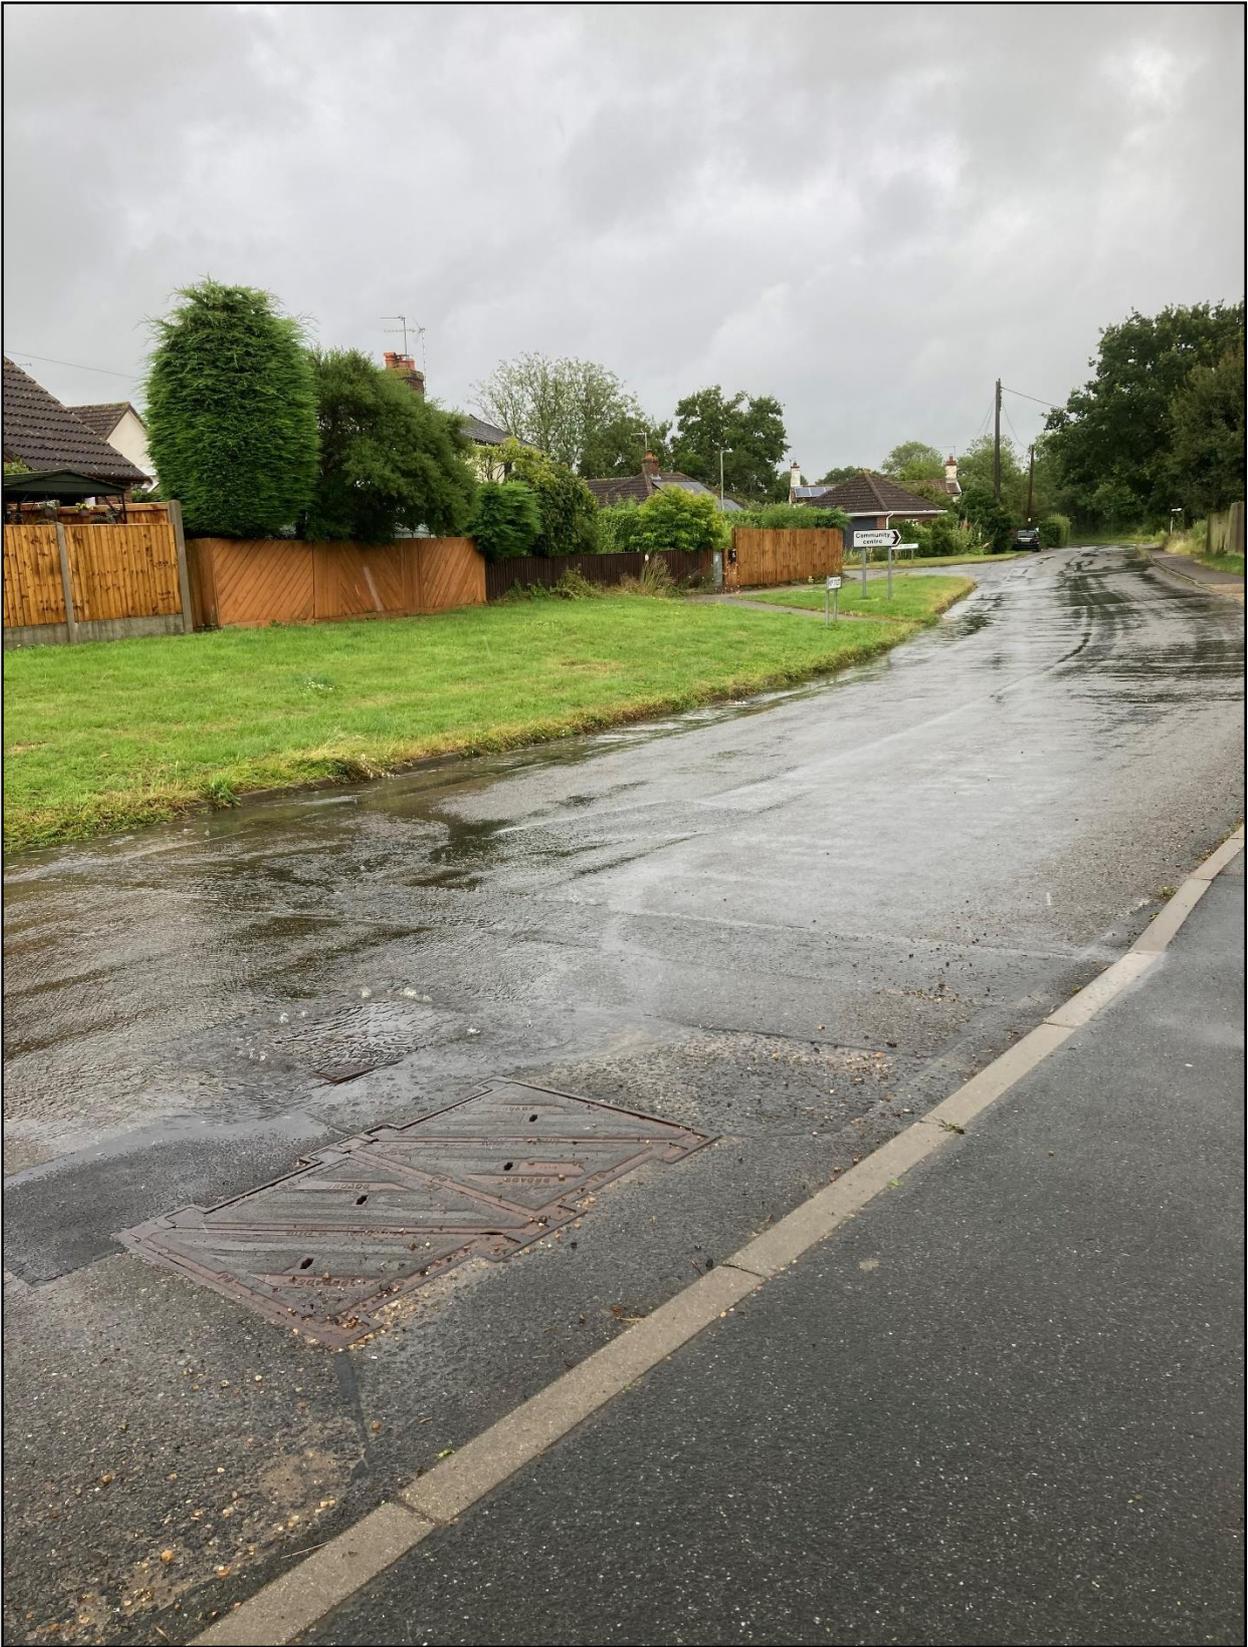
Image of the Sewerage network being overwhelmed by surface water (not taken during Babet)
