Section 19 Flood and Water Management Act 2010

Tunstall Flood Investigation

Storm Babet 2023

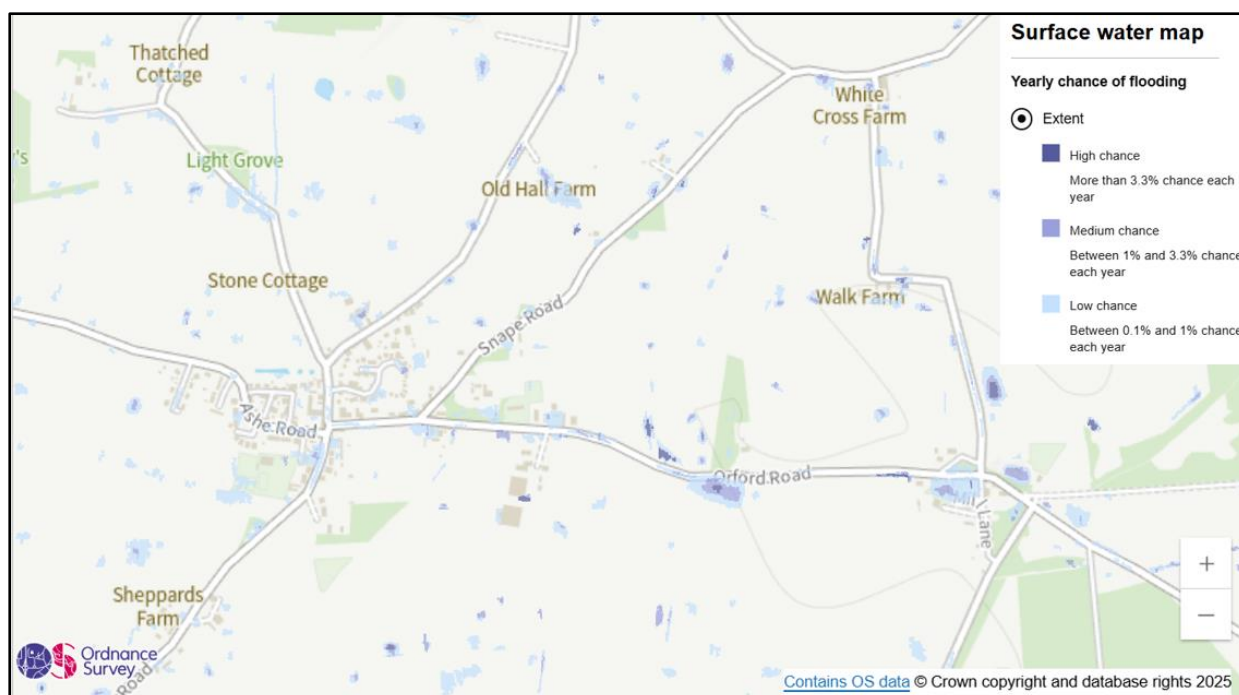
Fig. 4. Predicted flood risk from surface water

The parish of Tunstall is at significant risk of pluvial flooding (Fig. 4).

Affected property in Ashe Road, Woodbridge Road, School Road and Orford Road were all projected to be in or immediately adjacent to areas at medium or low risk of surface water (pluvial) flooding.

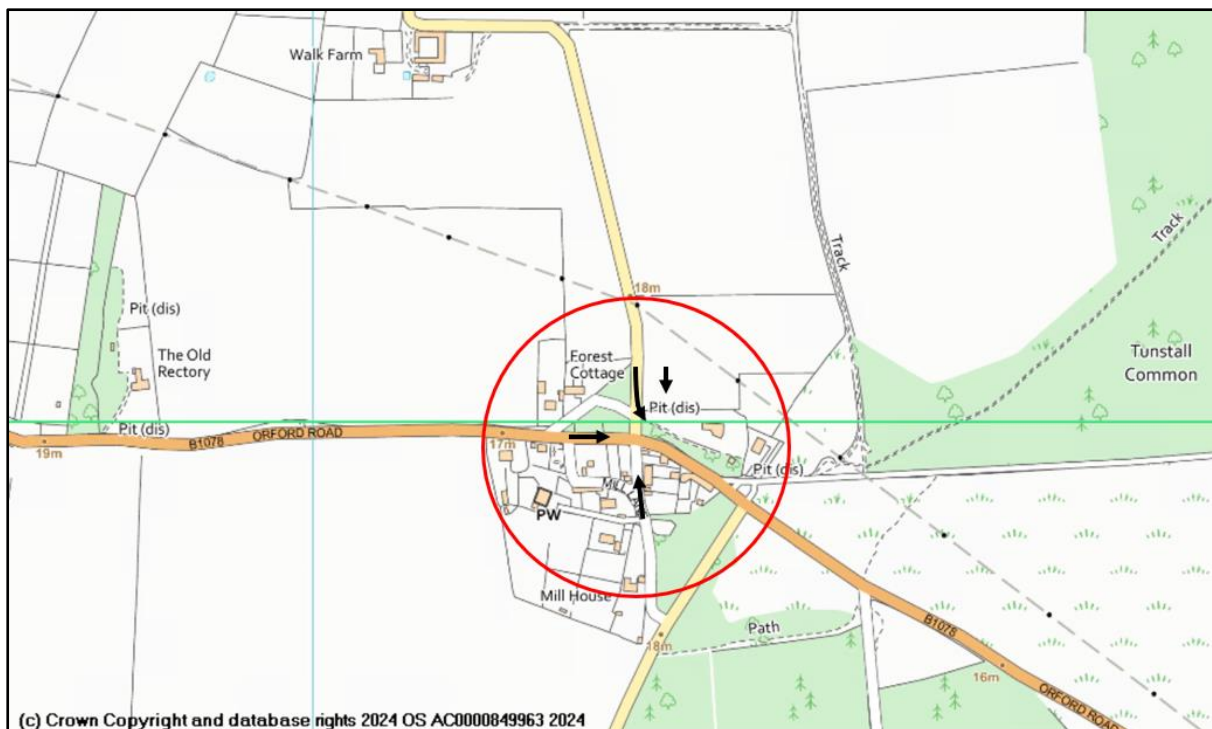
Fig. 10 Approximate floodwater flow paths in Mill Lane and Orford Road (east) showing areas of flooded property

This area is adjacent to Tunstall Common, in the east of the parish. Two properties were reported to be affected by flooding in this area. Affected property in Mill Lane was projected to be at no surface water flood risk and affected property in The Common was projected to be at medium surface water flood risk. Two properties are reported to have flooded internally in this area.

Surface water was reported to have flowed south down Walk Farm Road and across fields adjacent to Walk Farm Road, flooding property at a lower level which is east of Walk Farm Road and north of Orford Road. Surface water also flowed north down Mill Lane, flooding property which was at a lower level on the east side of Mill Lane.

Surface water flowing down Orford Road also contributed to floodwater in the area of the road junction. Three gullies which are closest to the road junction, located on Walk Farm Road, The Common and Mill Lane were reported to be non-operational or slow running during cleaning and maintenance in January 2024 and may have been non-operational or slow running during Storm Babet. Investigations have since confirmed pipes from these gullies run to ground. They may have originally run to a ditch and into the lagoon on the north side of Orford Road, or just to lower ground to soak/evaporate. Jetting and cleansing with investigations were carried out in October 2024. Further works to link some of the gullies east of the lagoon and to clean out the lagoon are planned for autumn 2025, which may need to be a two stage process).

- Surface water flowed south down Walk Farm Road and adjacent fields, flooding property east of Walk Farm Road and north of Orford Road.
- Surface water flowed north down Mill Lane, flooding property on the east side of Mill Lane.
- Surface water flowing down Orford Road also contributed to floodwater in the area of the road junction.
- Gullies close to the road junction were reported to be non-operational or slow running after Storm Babet but it is not known if they were functioning fully during Storm Babet.

- Residents to install Property Flood Resilience (PFR) via grant funded scheme.
- SCC Highways to complete works to link some of the gullies east of the lagoon and clear out the lagoon.
- Explore potential natural flood management measures (eg. buffer strips, attenuation ponds) to “slow the flow” and attenuate water in fields to the north of affected property east of Walk Farm Road and north of Orford Road.
- SCC Highways to ensure gullies in Tunstall are on an enhanced twice yearly cleansing cycle.
- Landowners to carry out watercourse maintenance to reduce flood risk as necessary in accordance with their riparian responsibilities.
