Section 19 Flood and Water Management Act 2010

Wickham Market Flood Investigation - Storm Babet October 2023

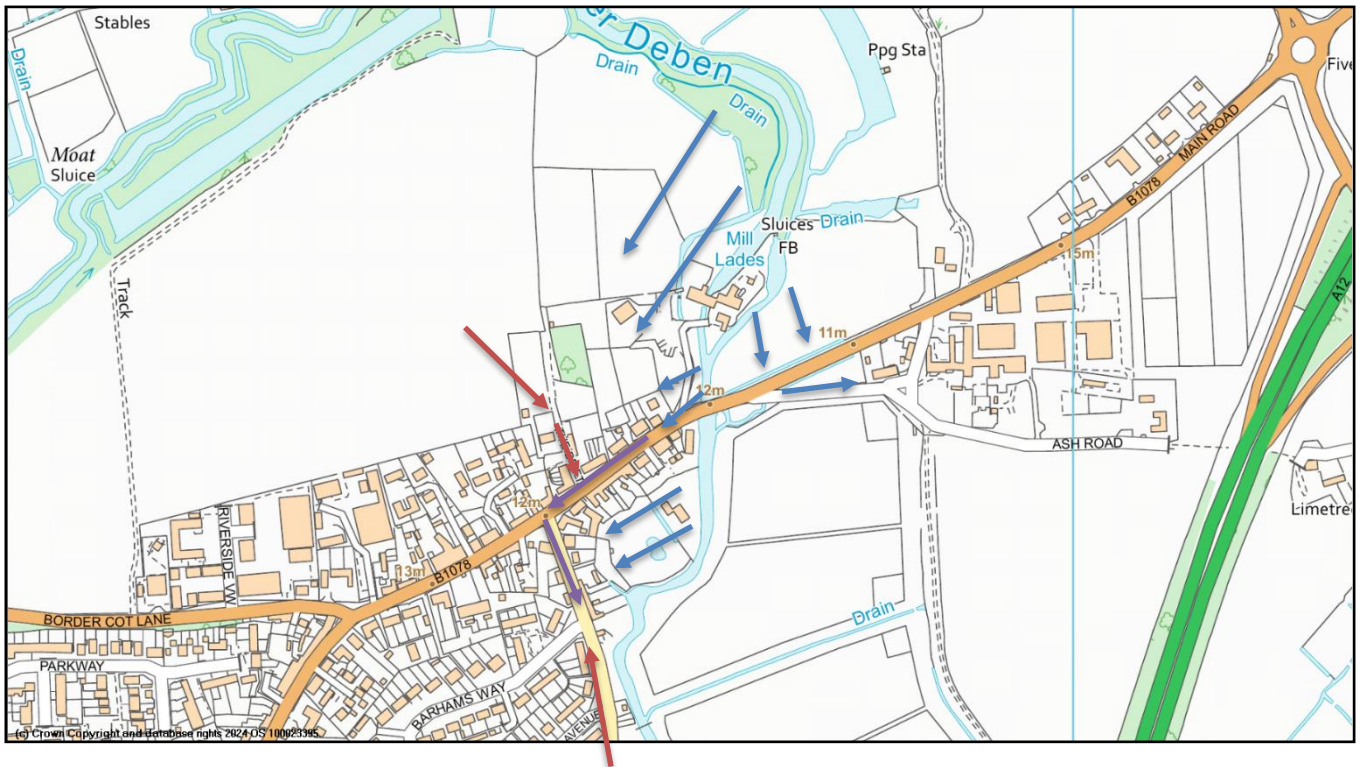
Figure 7 - Event flow paths (north)

The map below shows the main flow routes of the flood water in this area. It is important to note that following a site visit from the EA after the event, a significant build-up of silt in the main channel of the river has been identified adjacent to the B1078 road bridge over the River Deben. Investigations between Suffolk Highways

and the Environment Agency are ongoing regarding the removal of the silt to increase the capacity of the river channel under the bridge.

- Flood water from the Deben overtopping, flowed down High Street, Spring Lane and across Rackham's and Deben Mills estates. Some flows were not in line with currently predicted flood risk.
- Highway drainage gullies became overwhelmed due to significant rainfall and water from overtopped river.
- Anglian Water assets were overwhelmed due to significant water volumes entering the system predominantly from the overtopped river Deben.
- Significant silt build up in the river Deben to the north and south of the main road bridge may have reduced capacity in the channel.
- Surface water flow paths from the north and south exacerbated the severity of the event.
- Possible attenuation opportunity on the fields to the south.

- EA and SCC to investigate possibility of removing silt build up near main road bridge
- Investigate the possibility of Natural Flood Management (NFM) in the fields to the north-west and south-west to try and prevent these secondary flow paths from having such an impact.
- Anglian water to investigate the capacity of the pumping station in the area to ensure it is of adequate size.
- SCC highways to investigate the possibility of increasing the capacity of the drainage network in the area

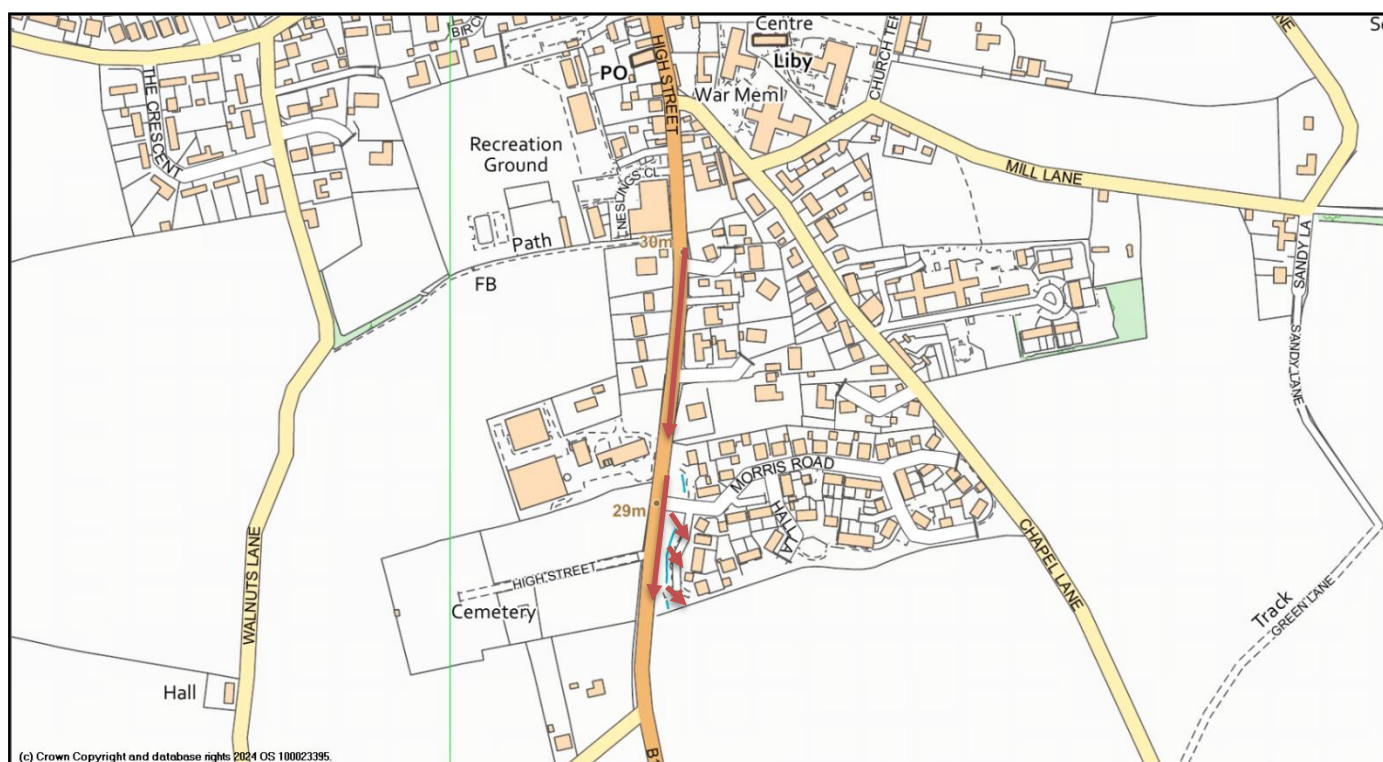
Figure 9 - Event flow paths (south)

- Significant rainfall resulted in high levels of surface water runoff, possibly exacerbated by a lack of effectively working highways drainage assets and poorly maintained watercourse preventing onward flow.

- SCC Highways to investigate area where significant number of drain gullies are blocked and try to get these working effectively again.
- As a result of the new development under construction to the south, a new footway is being put in place which due to the raised curb may channel the water into the new sites SuDS features which could make an improvement in future events.

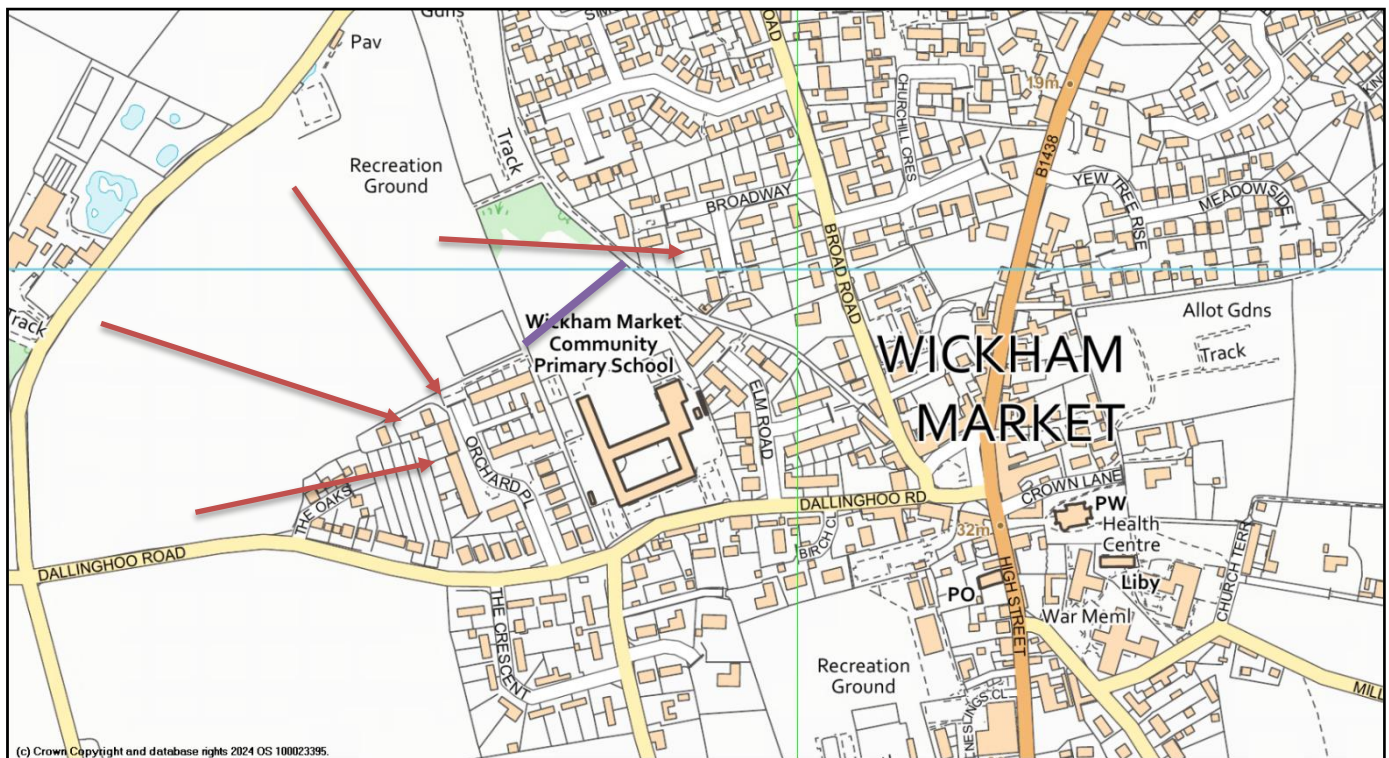
Figure 10 - Event flow paths (west)

Indicates rough alignment of unknown piped section

- Significant rainfall resulted in large volumes of surface water runoff from the fields to the west.
- Highway infrastructure became overwhelmed causing the flood water to flow to the lowest points and pool.
- Lack of maintenance and possible issues with underground pipework to the north of Orchard Place may have impeded the flow of water away from the area.
- Highways gullies were inspected and found to be working correctly in February of 2023, but reactive work took place on the day of the event in specific areas.

- SCC/Landowner/Parish to investigate ownership of the pipe work north of Orchard Place and confirm maintenance is carried out, to ensure its flow is maintained. CCTV of pipe may be required to ensure pipe is still in working order and to try and discover possible cause of water bubbling up.
- SCC highways to ensure regular maintenance is carried out in line with gully cleansing regime.
- Primary school to ensure gullies in the playground are regularly cleaned and maintained. CCTV inspection may be required to confirm pipes are still in working order.

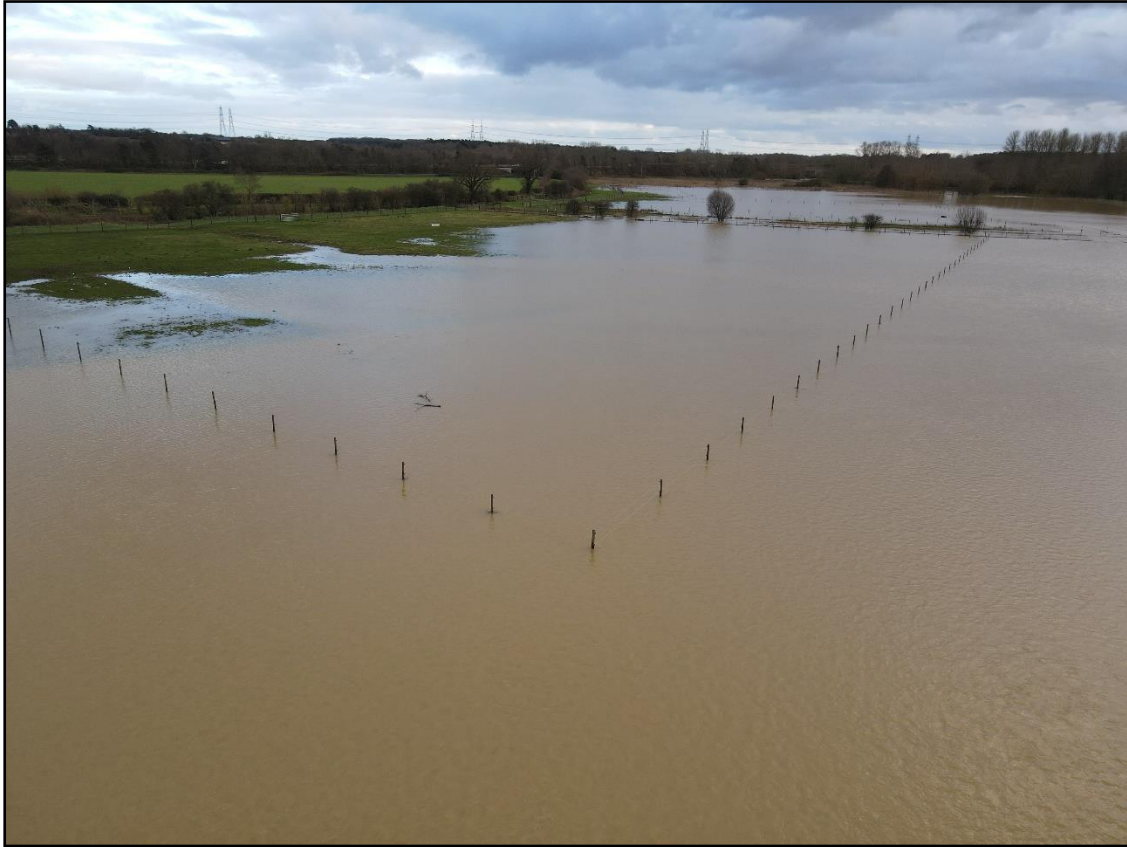
Image 1 - Flooding to pastureland in north Wickham Market

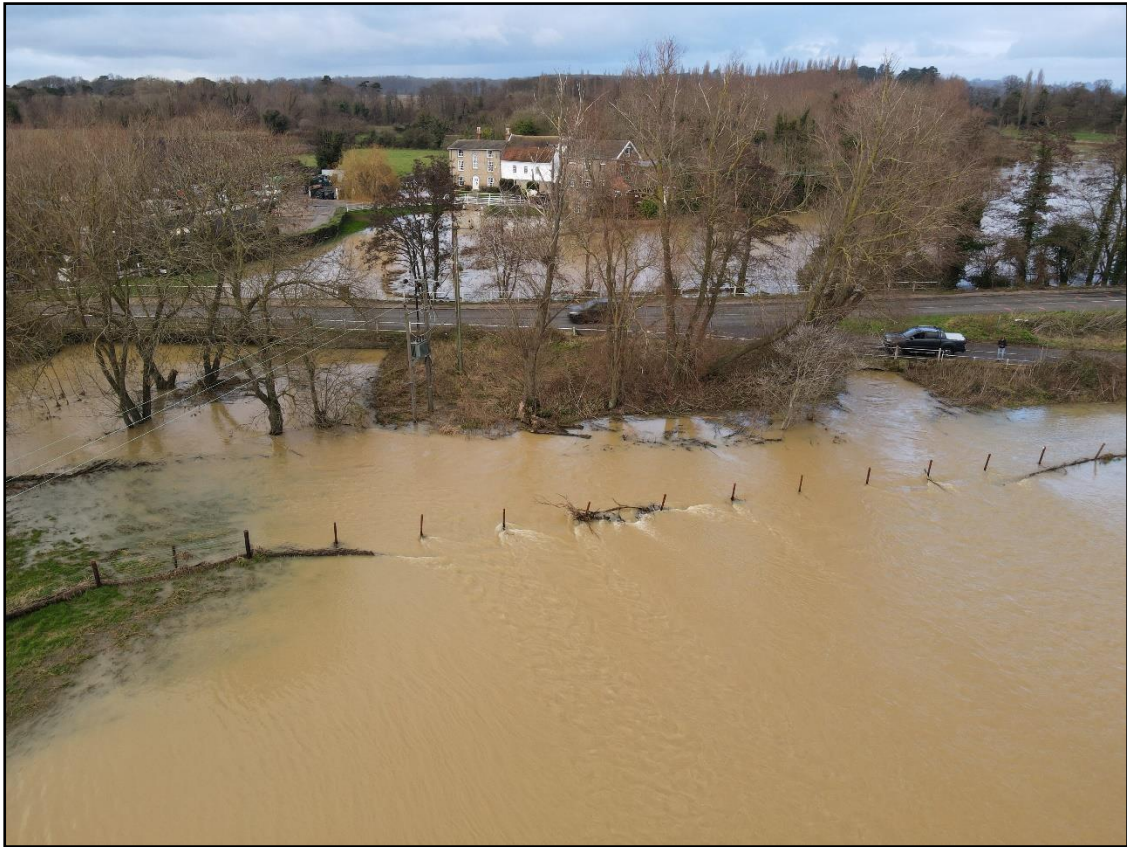
Image 2 - Wickham Market bridge

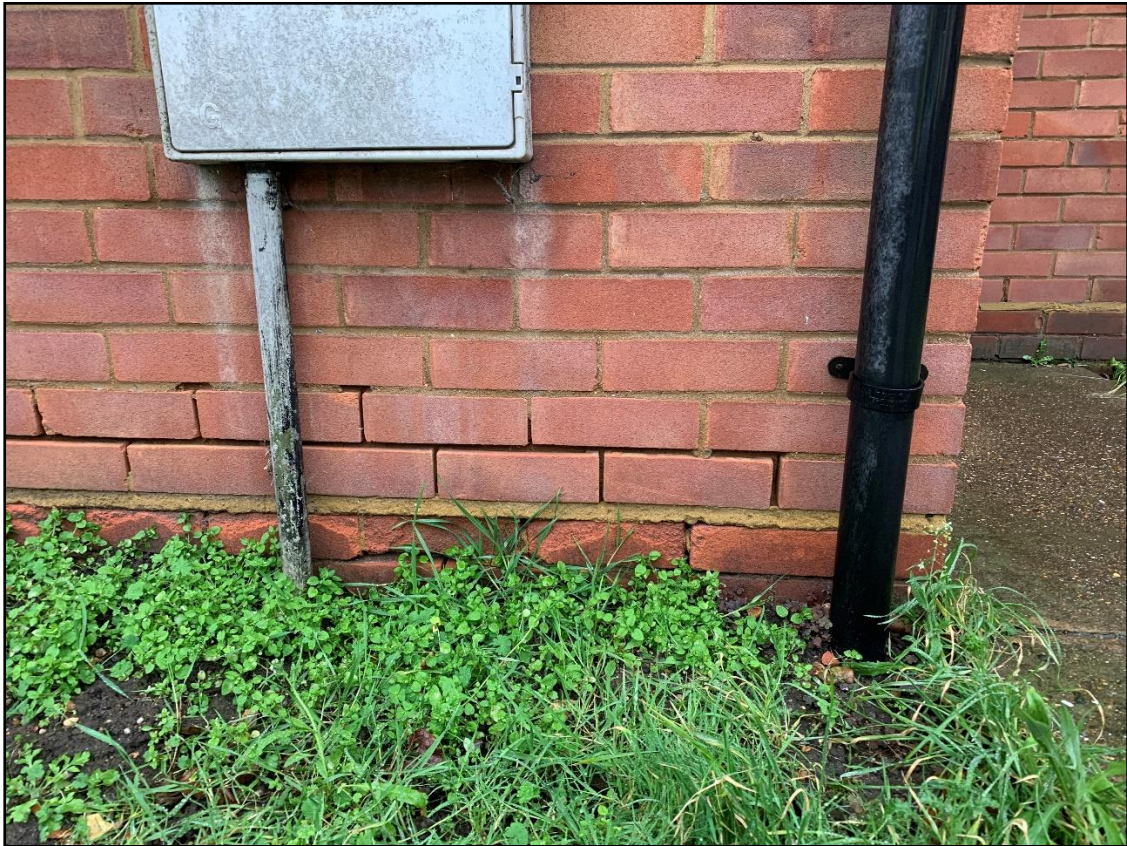
Image 4 – High water level marks post event showing erosion to brickwork

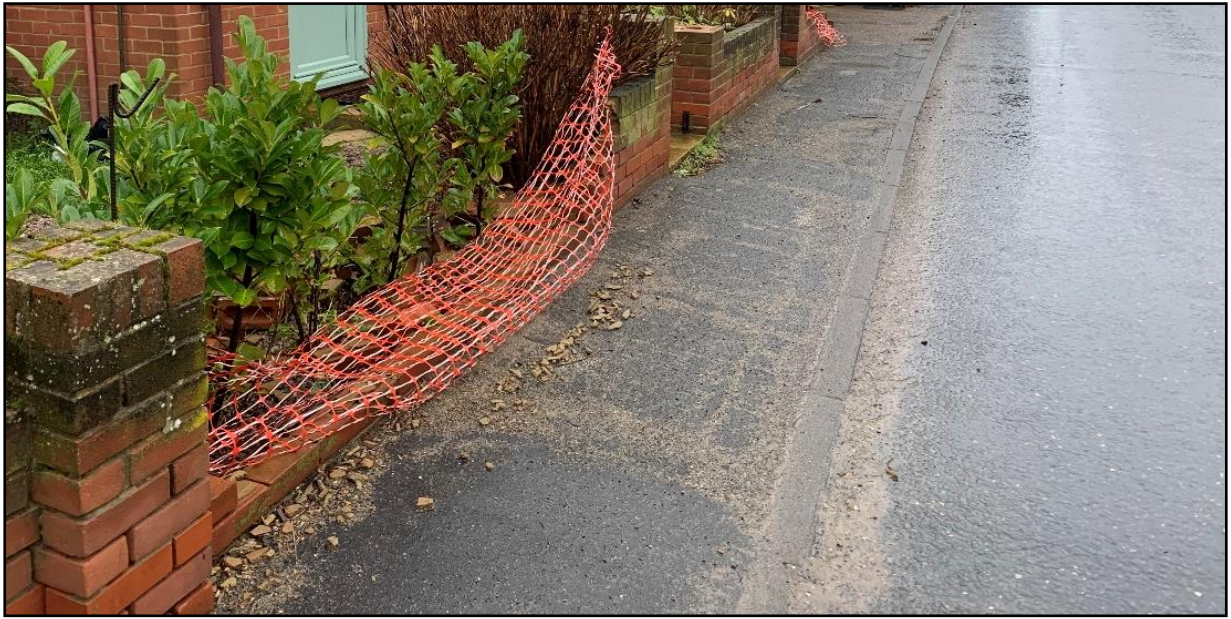
Image 5 - Post event damage

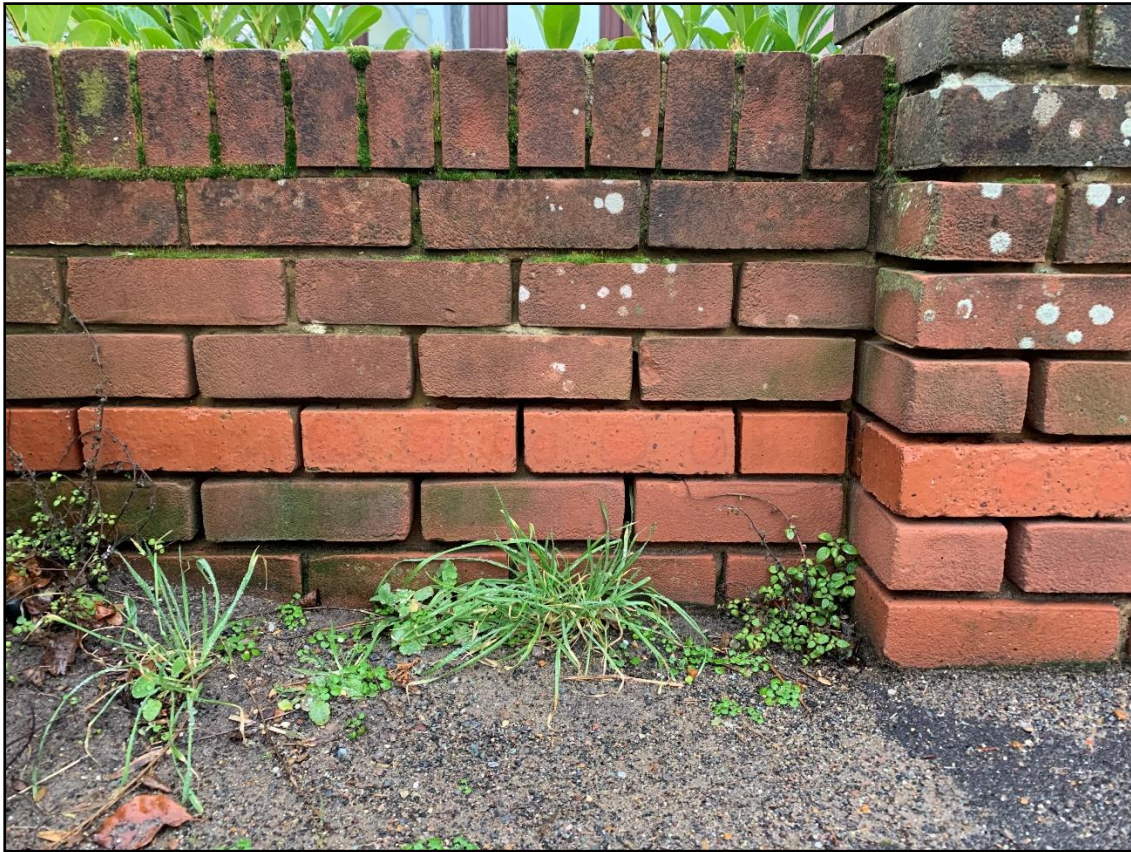
Image 6 - Post event damage

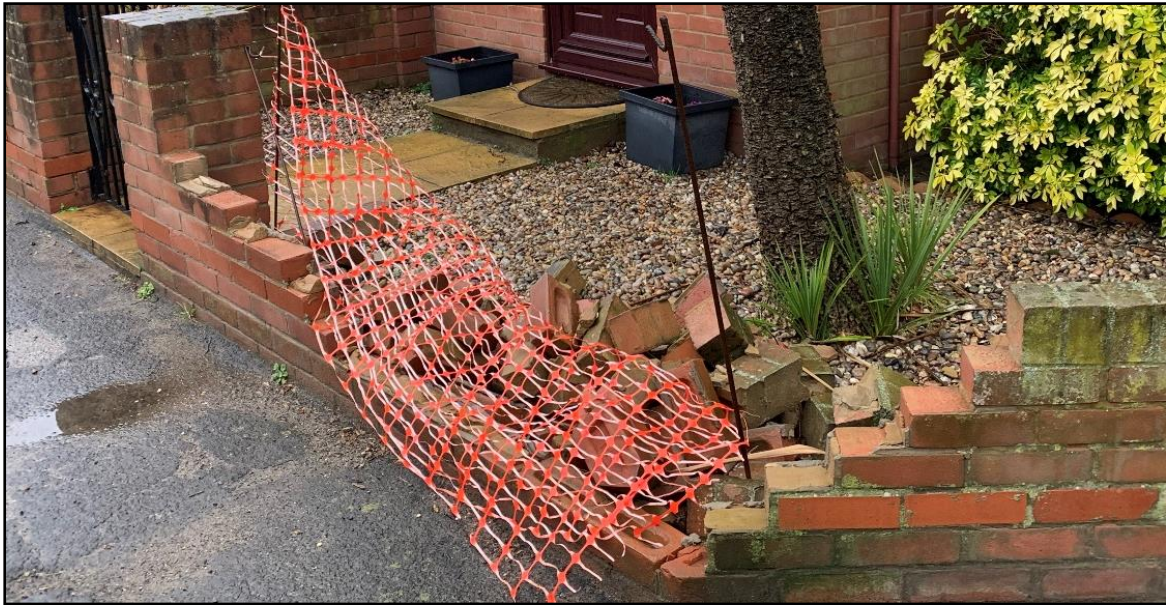
Image 7 - Post event damage
