Section 19 Flood and Water Management Act 2010

Bruisyard Flood Investigation –

Storm Babet 2023

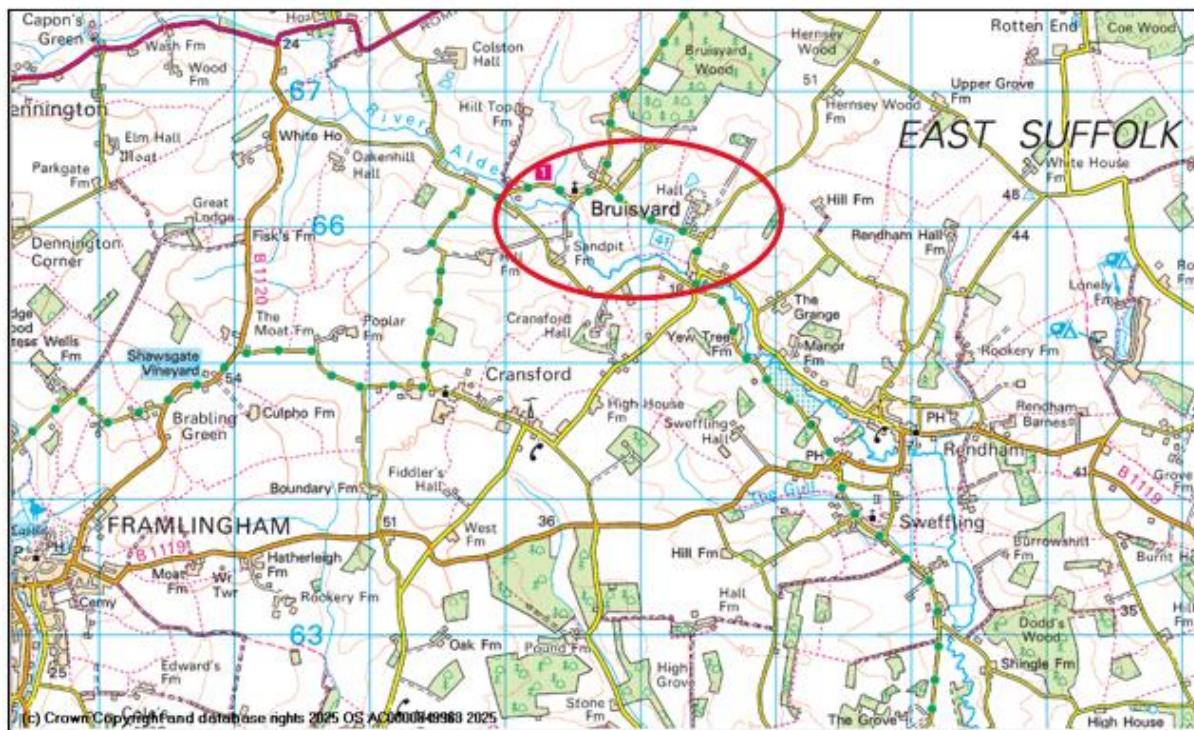
Figure 2 - Investigation area map

Bruisyard Street is part of Bruisyard, a village and parish situated in the Alde River valley. It is in the local authority district of East Suffolk. The village is approximately 4.5 miles northeast from the market town of Framlingham.
