## Section 19 Flood and Water Management Act 2010

### Crowfield Flood Investigation –

### Storm Babet 2023

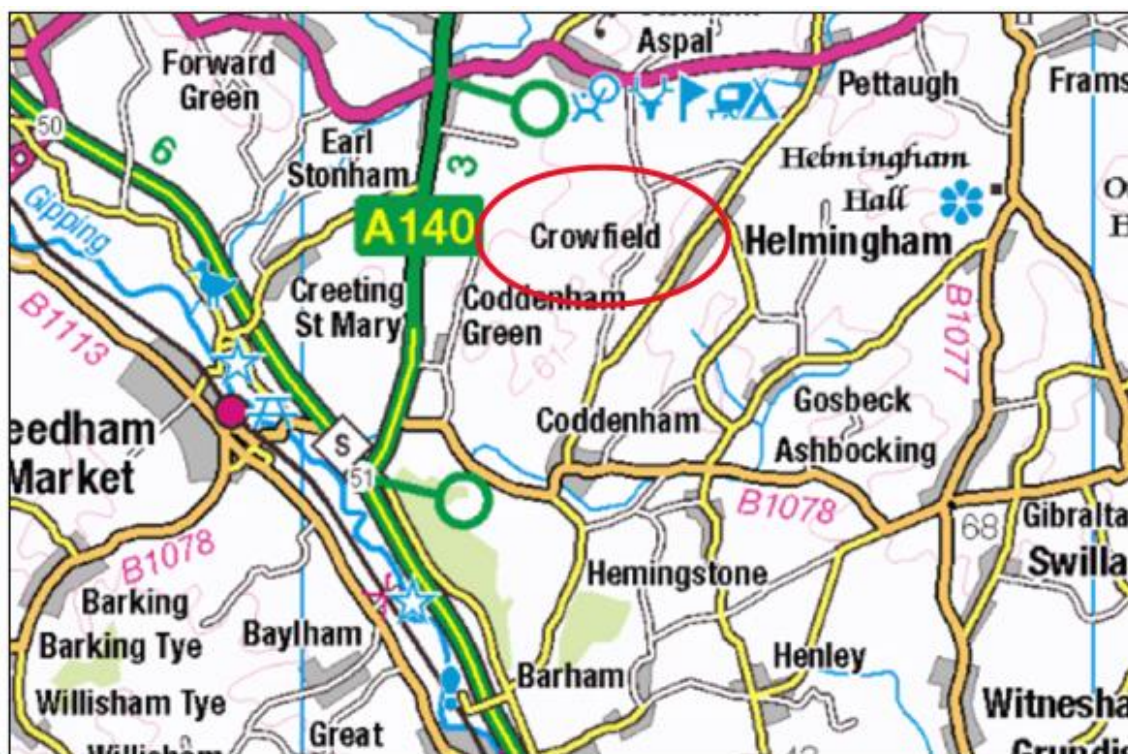
Figure 2. Investigation area map

Crowfield is a village situated approximately 9 miles Northwest of Ipswich. It is in the local authority district of Mid Suffolk.

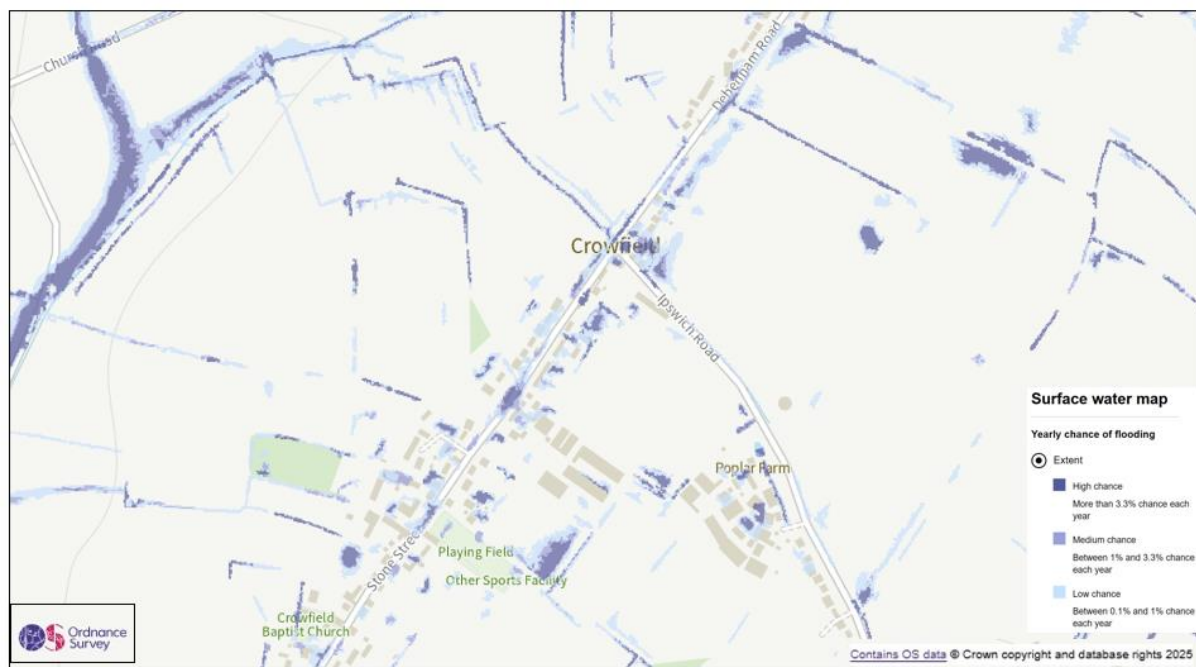
The floodwater flow paths observed on Debenham Road, Gosbeck Road and Stone Street during Storm Babet closely align the national pluvial flood risk mapping (see Figure 5). Pluvial flood risk varies across this location, ranging from low to high risk. Impacted locations including Debenham Road, Gosbeck Road and Stone Street, closely align with predicted flood risk for this area.

Figure 11. Pluvial flood risk on Debenham Road, Gosbeck Road and Stone Street

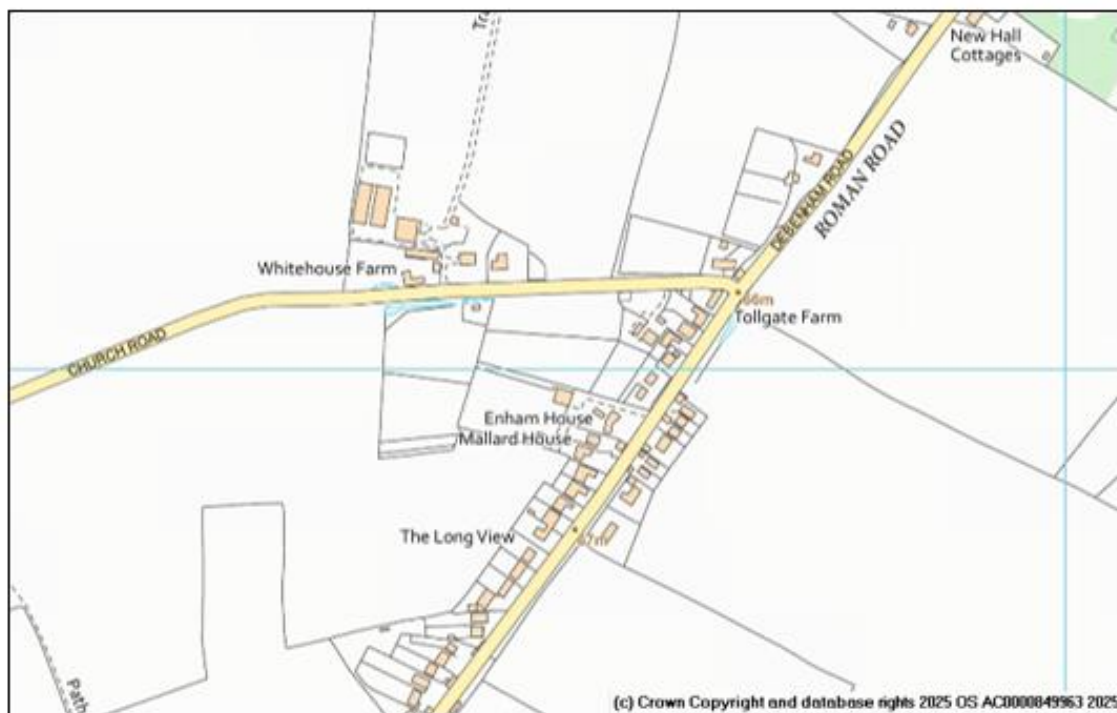
On 20 October, following a period of intense rainfall, the capacity of both the highway drainage system and Anglian Water infrastructure was exceeded. Hydraulic overload of these assets resulted in the highway flooding, loss of serviceability of utilities within adjacent properties, and surcharging of local drainage networks caused discharge into residential gardens.

This condition has recurred in this locality since 2021 during moderate to heavy rainfall events. Initial investigations by Anglian Water suggested that probable cause of flooding at this location is misconnections into the sewer system. Further investigation is required to determine the root cause of the flooding at this location.

*Figure 12 Church Road which was affected by surface water flooding*

### LLFA recommended action(s):

- Suffolk Highways to ensure the completion of highway drainage asset cyclic maintenance (with the inclusion of grips) on Church Road.
- Suffolk Highways to investigate the surface water drainage infrastructure at Church Road to outfall.
- Anglian Water to investigate the sewer system at Church Road.
- Following investigations Suffolk Highways and Anglian Water to coordinate efforts to resolve flooding at this location.
