# Suffolk County Council

## Section 19 Flood and Water Management Act 2010

### Sweffling Flood Investigation –

#### Storm Babet 2023

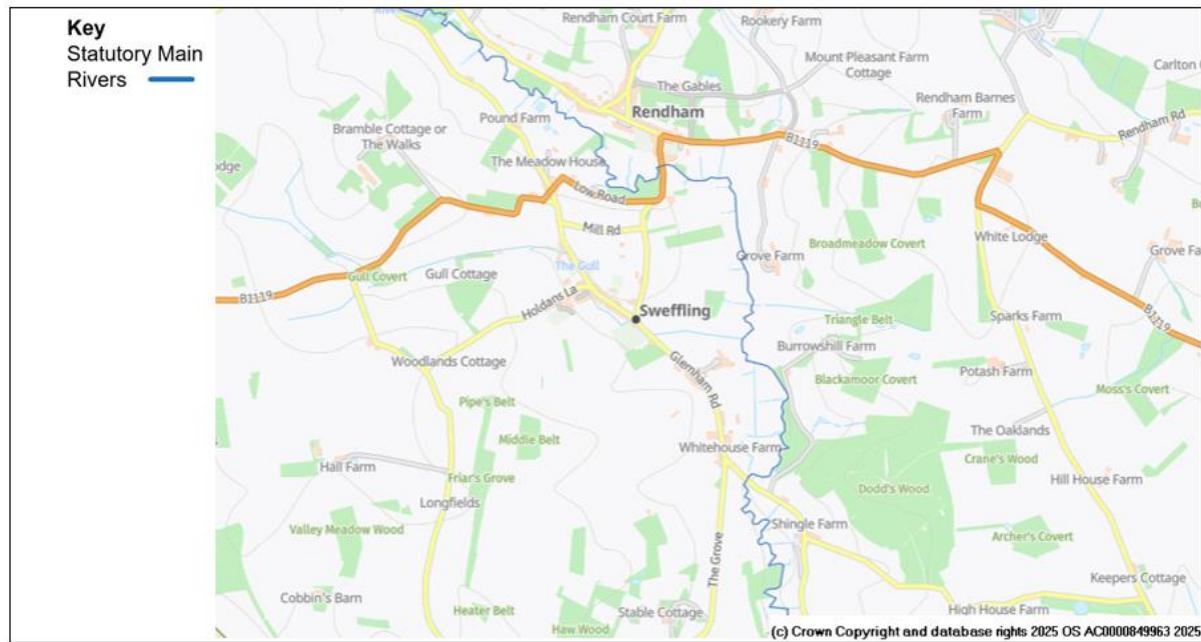
Figure 3 - Location of statutory main river and ordinary watercourses

Figure. 3 below, shows the most significant watercourses (designated main river) in and around Sweffling.

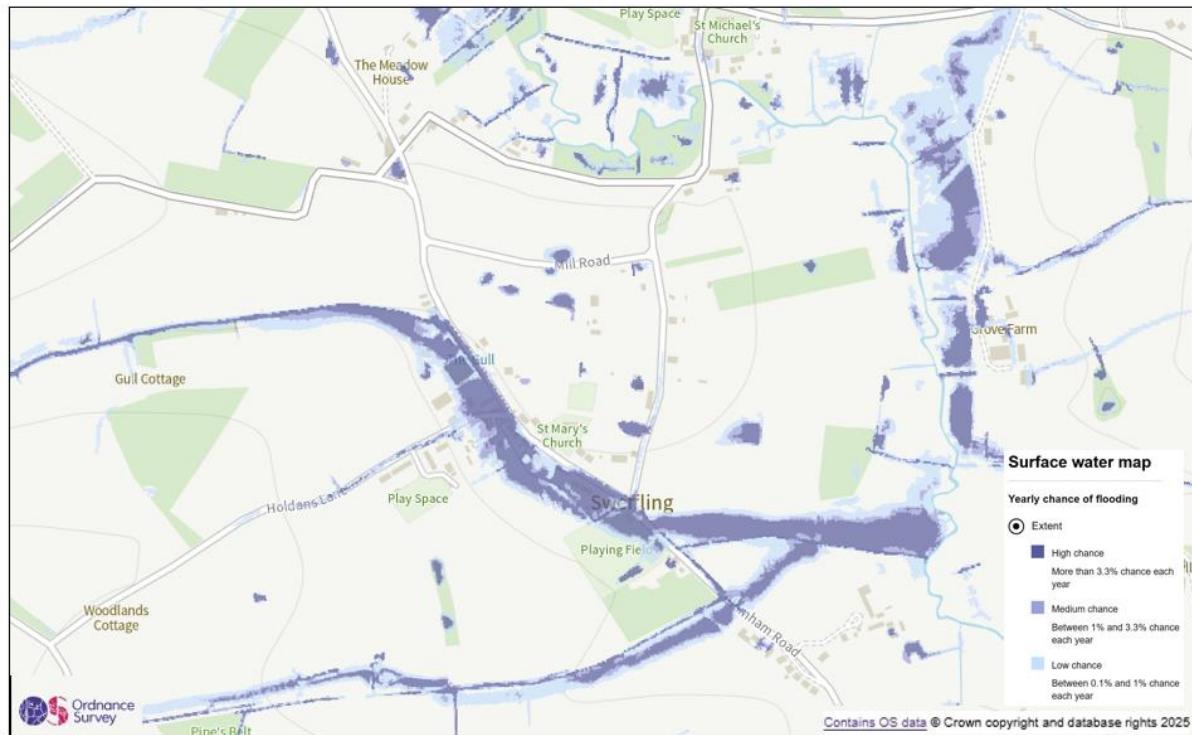
Figure 6 - Surface water flood risk

Figure 6. highlights the predicted pluvial (surface water run-off from surrounding land and highways) flood risk in Sweffling, with multiple flow paths travelling east through the village and into the River Alde.

Pluvial flood risk varies across the locations, ranging from low to high risk. Impacted locations including The Street, Holdens Lane and Low Road closely align with predicted flood risk for this area.

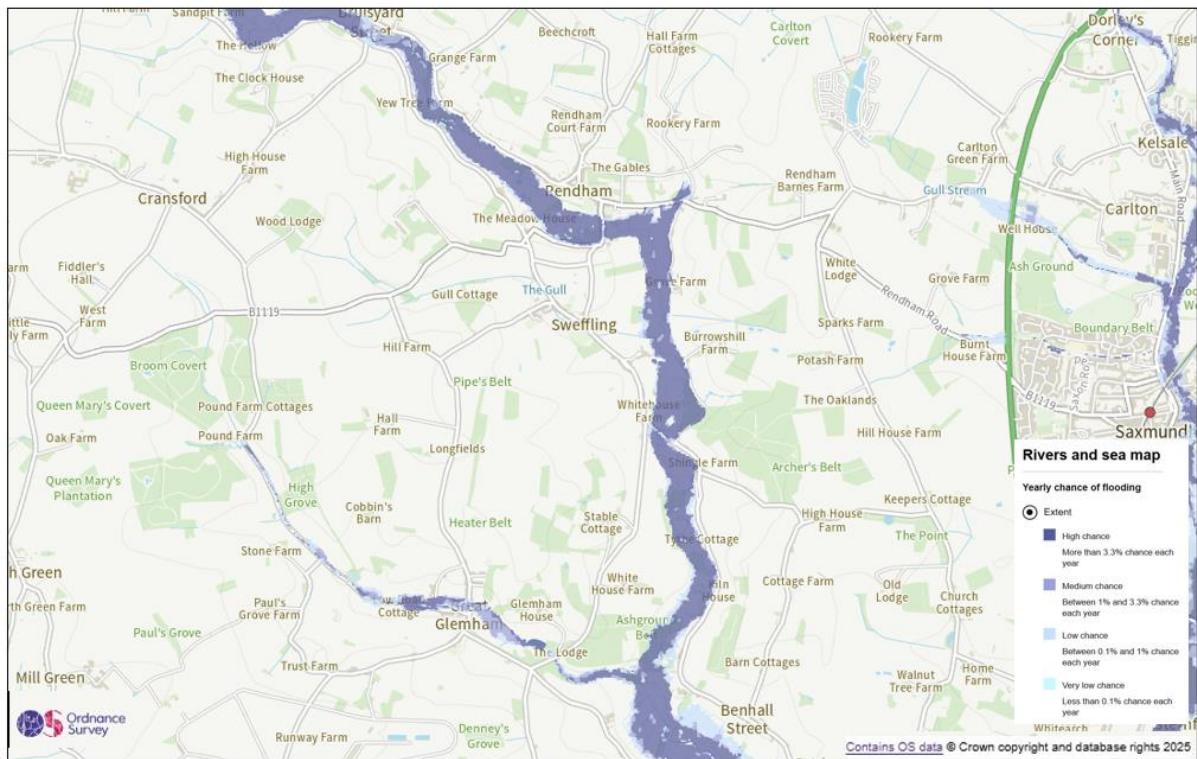
Figure 7 - Flood risk from rivers and sea

Figure 7 shows the predicted fluvial (from designated main river and ordinary watercourses) flood risk in Sweffling. The fluvial flood risk in Sweffling is predominantly associated with the Gull which is a tributary of the River Alde. The Gull flows west to east through the village, before connecting with the River Alde to the east.

There is a low to high chance of fluvial flooding on sections of The Street, Holdens Lane and Low Road.

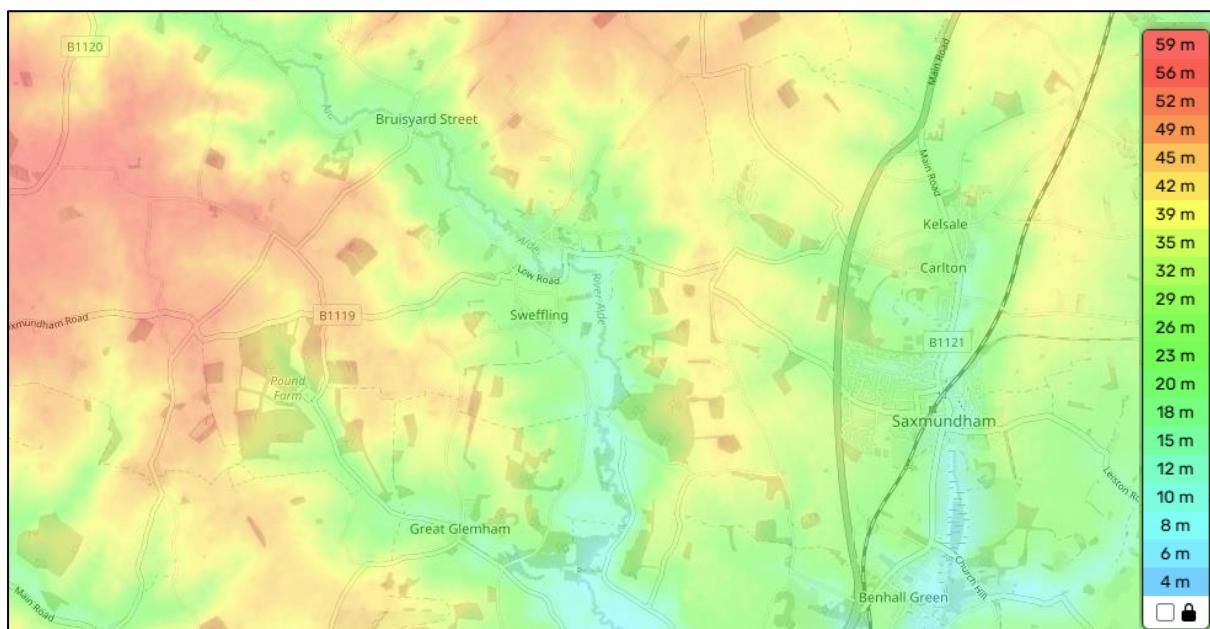
Figure 8 - Sweffling and surrounding topography (TessaDEM as cited in [topographic-map.com](http://topographic-map.com))

Figure 8 shows the topography surrounding Sweffling with gradient changes across the wider region. Sweffling village is situated low in the landscape and some of the lowest points in Sweffling are along The Street, Holdens Lane and Low Road. These locations were identified as being some of the worst affected areas during Storm Babet.

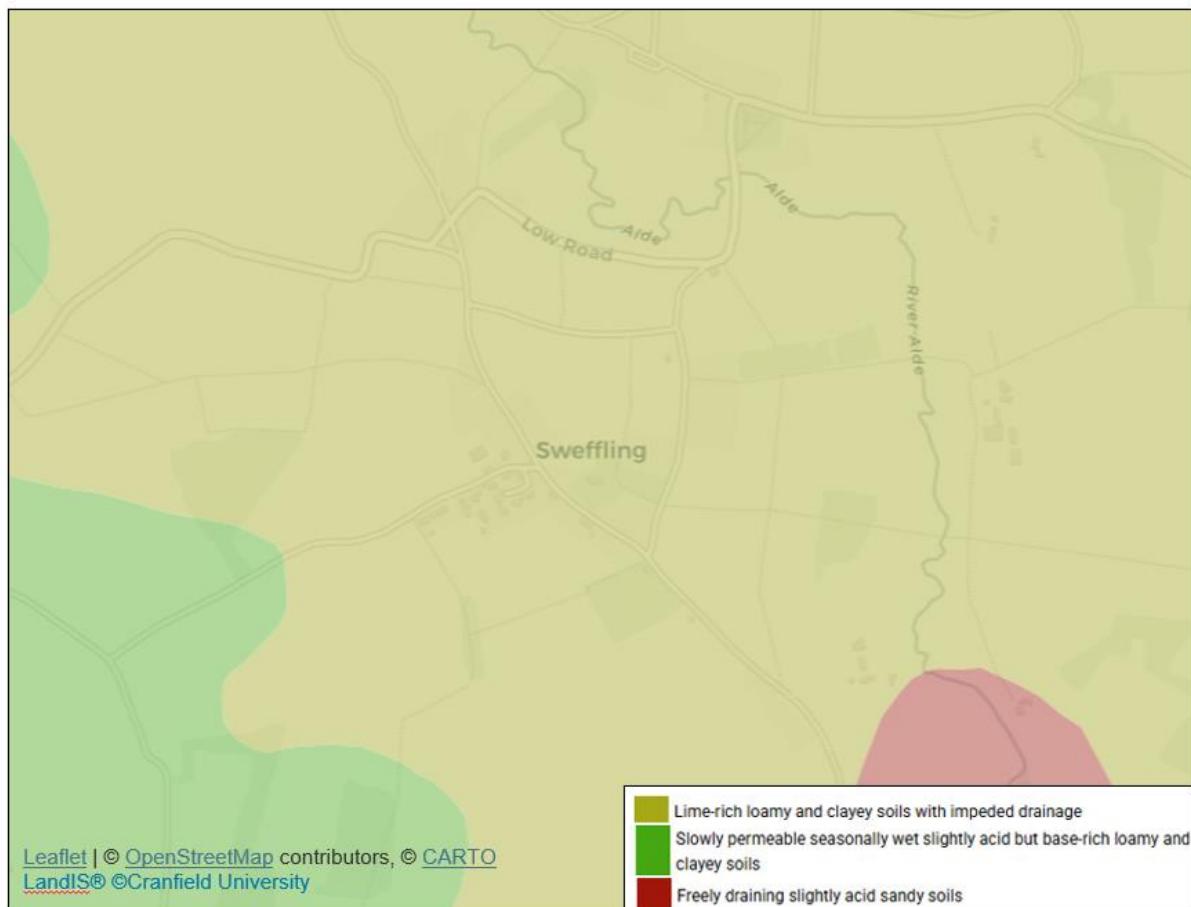
Figure 9 - Soil map (LandIS Soilscapes)

The soils surrounding Sweffling are loamy and clayey with impeded drainage, meaning that water permeates more slowly and surface water runoff is greater. The floodplain soils surrounding the River Alde are more freely draining with naturally high groundwater and tend to be wetter.

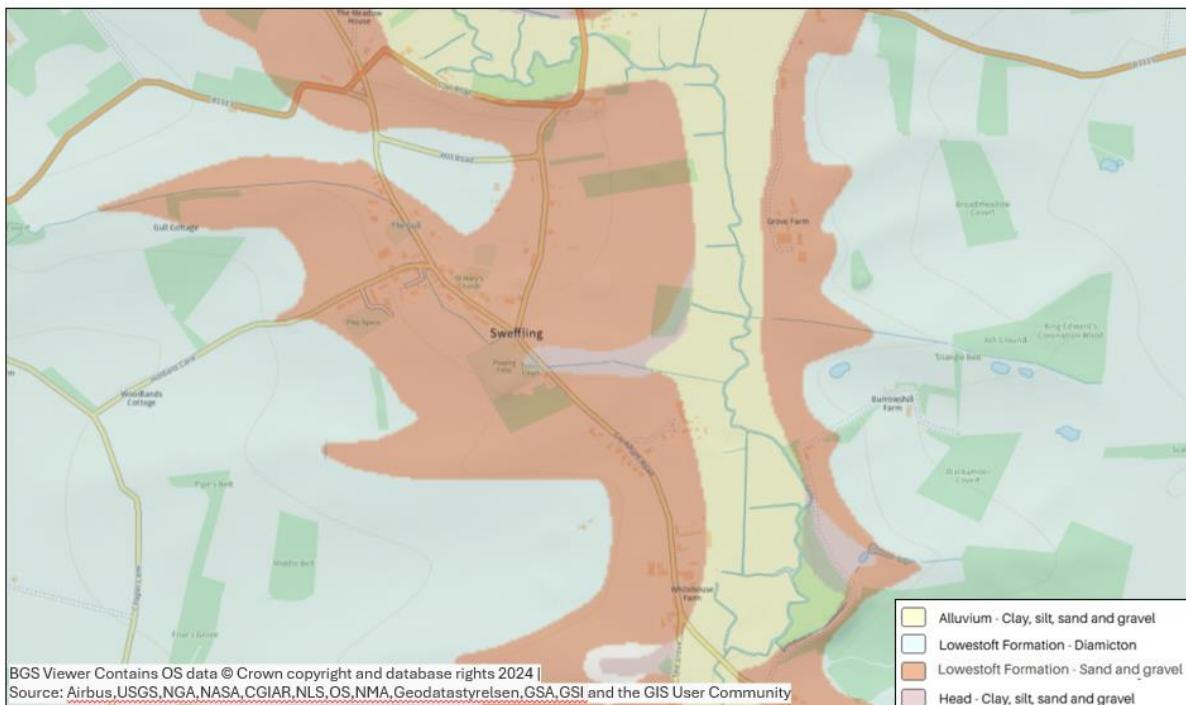
Figure 10 - Superficial Geology (BGS Viewer)

Lowestoft Formation 'Diamicton' surrounds Sweffling which is described by the British geological survey as a diverse mixture of clay, sand, gravel, and boulders varying widely in size and shape. This generally has a low permeability, meaning water will tend to flow off it before it can be infiltrated.

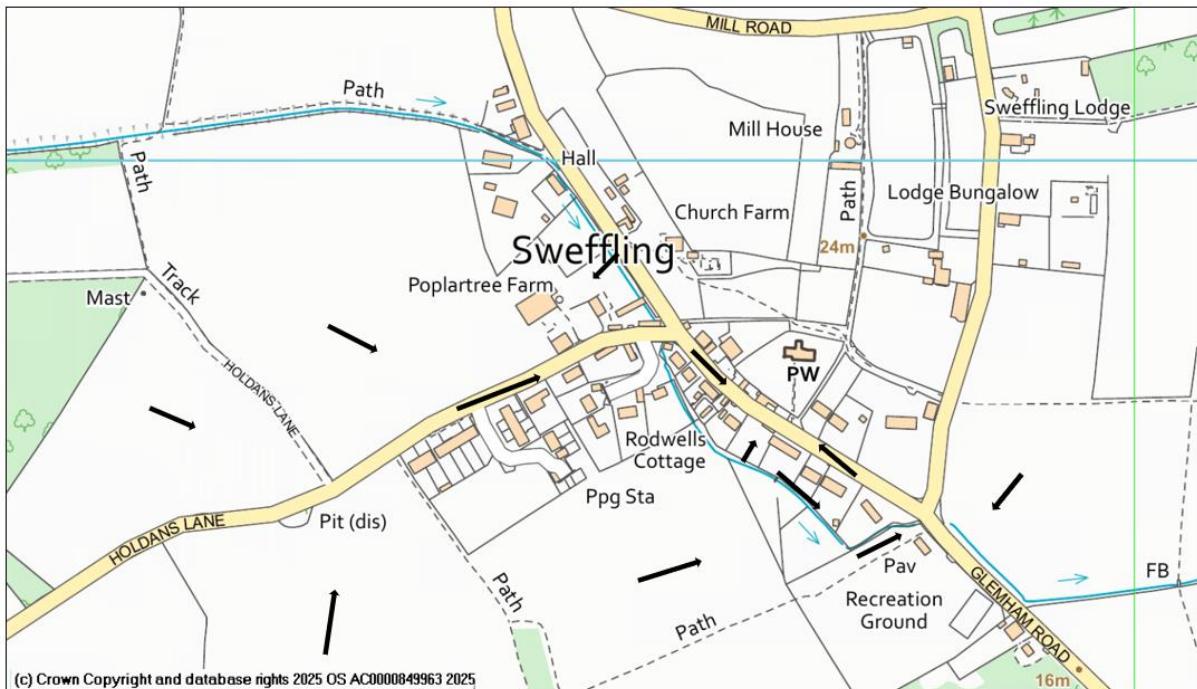
Following heavy rainfall on the morning of 20 October, large volumes of surface water from the surrounding agricultural land merged with floodwater from the highway, along with water from the overtopping banks of The Gull.

At approximately 10.30am, a significant volume of water travelling south along The Gull - originating from higher agricultural land to the east west and south of the village - spilled onto The Street, to a depth of about 30-40 cm. This was compounded by a very significant flow of water travelling at speed downhill, in an easterly direction from the fields at the top of Holdens Lane towards the junction with The Street. Along the way, flood water entered driveways of properties, subsequently flowing towards buildings, causing internal flooding. The two bodies of water converged at the junction, causing water to back up toward a nearby cul-de-sac, as there was nowhere else for

The source of the flooding is thought to have been contributed to by the large amount of pluvial and fluvial flood water overwhelming the capacity of the culvert. The eastern bank of The Gull, in some locations along The Street, was overwhelmed, allowing floodwater to flow through one or more gardens before discharging into The Street, where, it met water travelling from the south.

The floodwater flowpaths observed on Holdens Lane and The Street during Storm Babet closely match the national fluvial flood risk mapping (see Figure 11). Sections of Holdens Lane are characterised as having a high chance of pluvial flooding and low

Figure 11 - Approximate flood water flow routes along Holdens Lane and The Street

- Residents to install Property Flood Resilience (PFR).
- Riparian landowners to carry out appropriate maintenance to watercourse along Holdens Lane, The Street and Glemham Road to reduce flood risk as necessary as per their riparian responsibilities.

- Explore potential NFM projects to ‘slow the flow’ and attenuate water on overland flow paths on agricultural land to the north and south of Holdens Lane, to the west of the village e.g. storage ponds, wetland areas, field bund.

- Suffolk Highways to ensure the completion of highway drainage asset cyclic maintenance on Holdens Lane, The Street, Glemham Road and Rectory Road.
- Suffolk Highways to investigate the capacity of the drainage along Holdens Lane, including at the junction of The Street and Holden’s Lane.

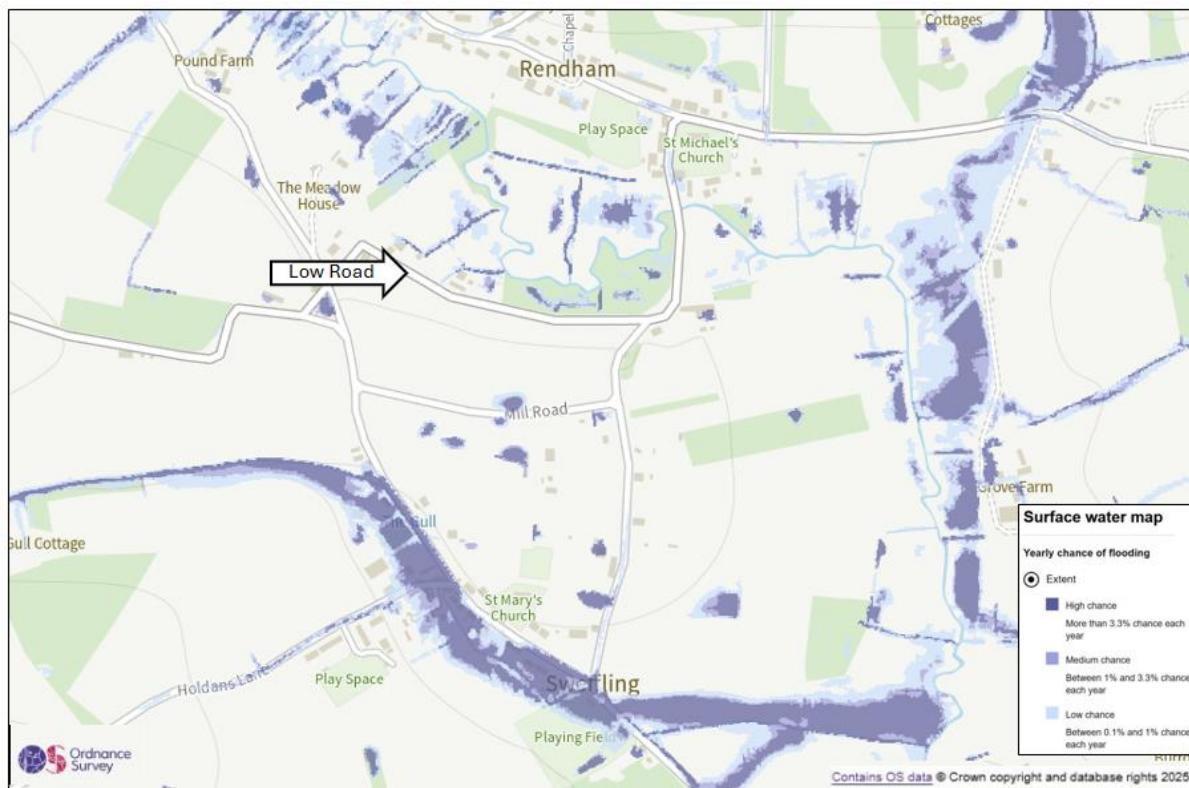
Figure 13 - Surface water flood risk on Low Road

While the recent flooding was primarily the result of the river overtopping its banks, there have also been previous reports of water running off adjacent fields and entering properties from the front during heavy rainfall. Recurrent drainage issues along Low Road, including blocked surface water drains, may have contributed to the extent of flooding experienced.

- Residents to install Property Flood Resilience (PFR).
- Suffolk Highways to ensure the completion of highway drainage asset cyclic maintenance on Low Road.
- Suffolk Highways to investigate operational performance of assets along Low Road

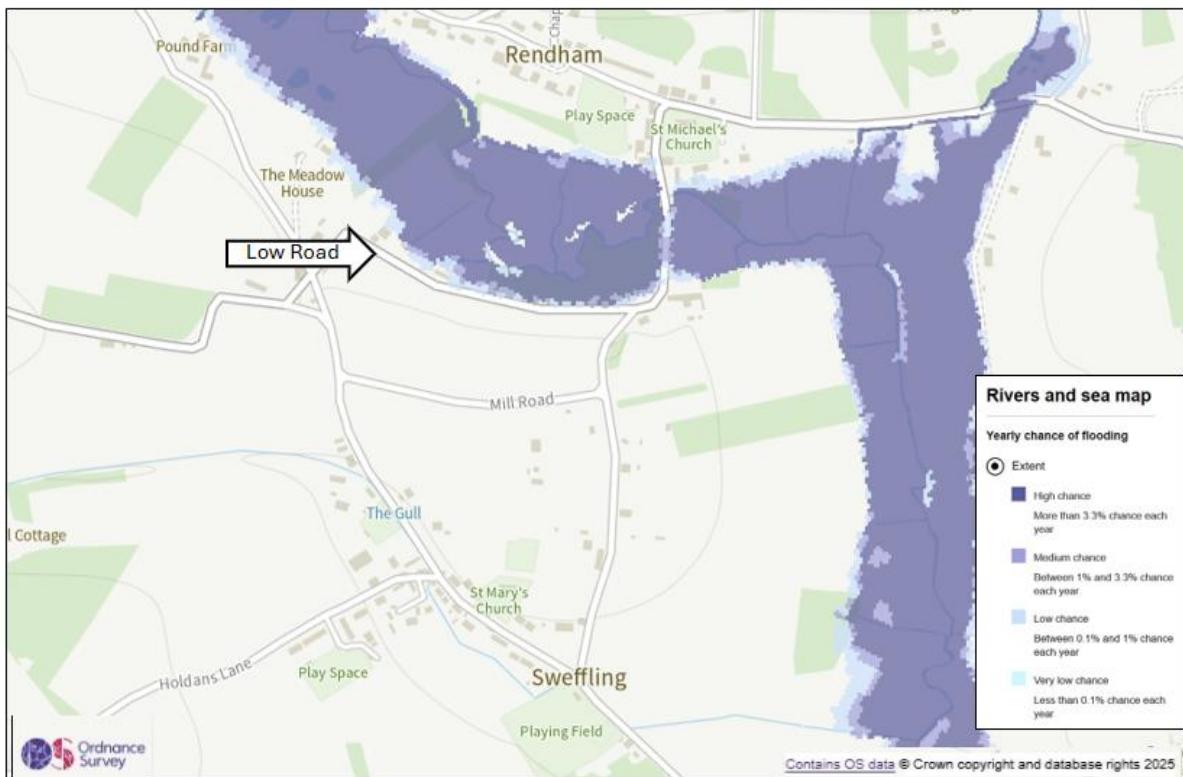
Properties were flooded directly from the watercourse located to the rear, which runs adjacent to Low Road, discharging into the River Alde. During storm Babet, floodwater quickly overwhelmed the capacity of the river, flowing into the floodplain before overtopping into rear gardens and properties. Properties impacted long Low Road are at high risk of fluvial flooding and the impacts experienced closely align with the predicted flood risk maps for this location (see figure 14).

Figure 14 - Fluvial flood risk on Low Road

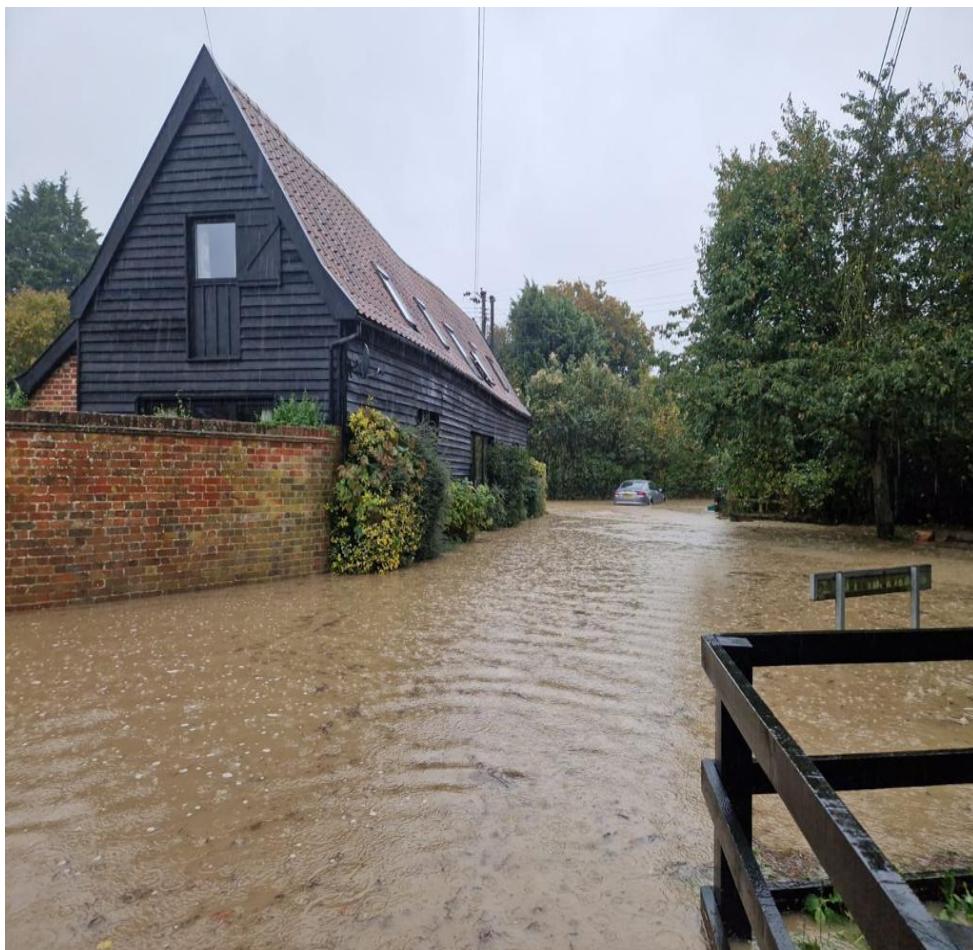
*Image 1 - Junction of Holdens Lane and Holdens Meadow and Junction of Holdens Lane and The Street, looking East*

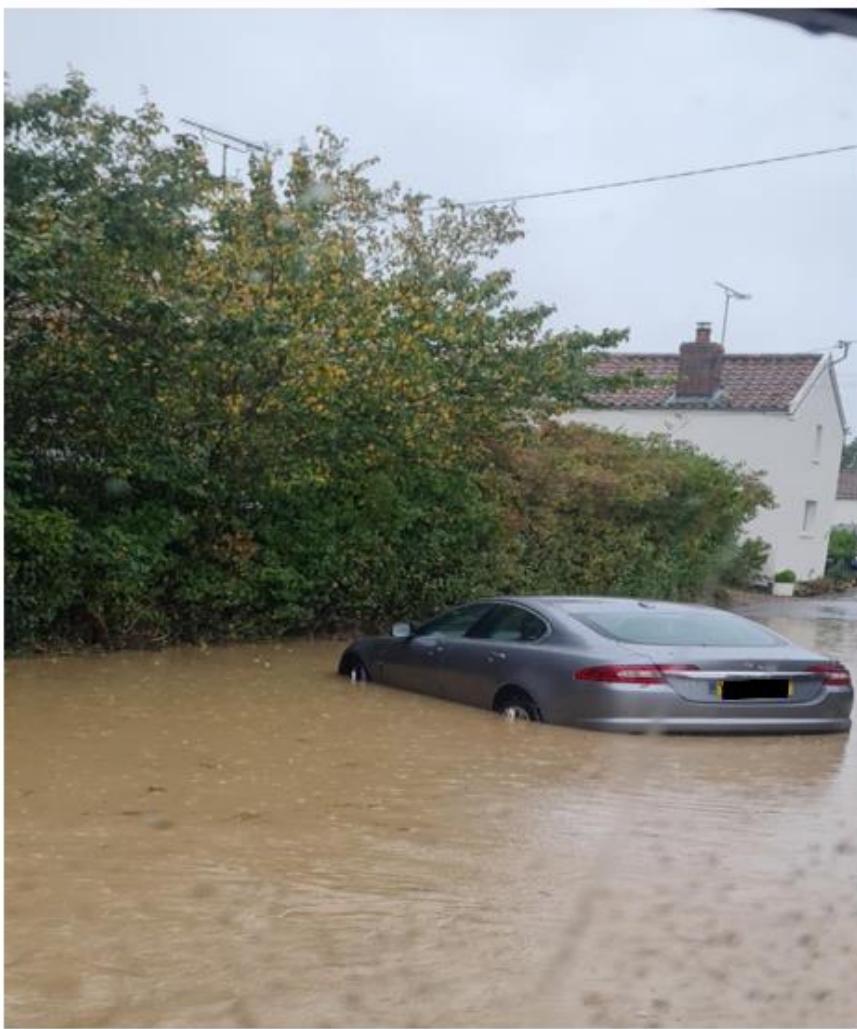
*Image 2 - The overflowed Gull, at Junction of Holdens Lane and The Street, looking Southeast.*
