## Section 19 Flood and Water Management Act 2010

### Report Title: Barton Drive, Kedington

**CRNos 422190 & 287453**

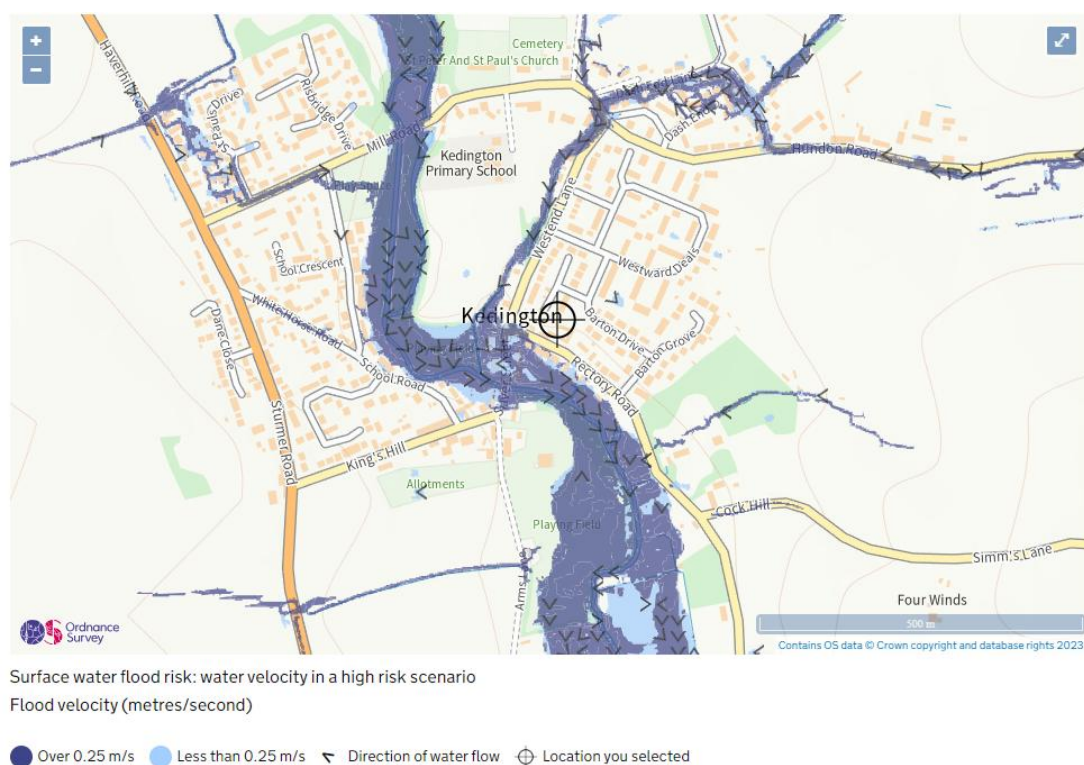
Figure 3 – Pluvial flood risk map with water velocity.

The national government indicative “flood risk for planning” map identifies that the fluvial (river) to the west of the Barton Drive is a medium to high risk (which means

that this area has a risk of flooding between 1% and 3.3% each year). Both groundwater and tidal flooding are unlikely in this area. Pluvial (surface water) flooding however is recorded to represent a high flood risk to the West of Barton Drive (which means that each year this location has a 3.3% risk of flooding).

Extracts of the pluvial flood mapping are shown below and overleaf for reference. These demonstrate the direction and speed of flow during the worst-case scenario. Dark blue denotes flows faster than 0.25m/s with light blue denoting flow speeds less than 0.25m/s. The small black arrows denote direction of flow. See figure 3.

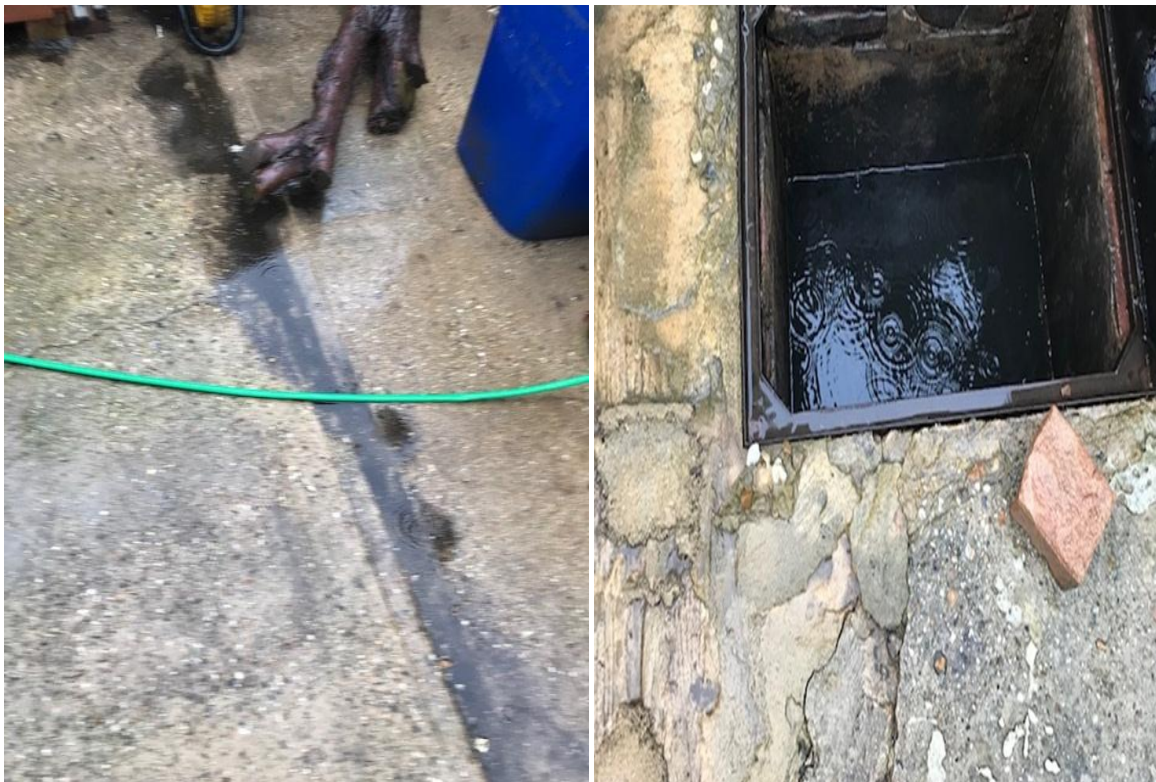
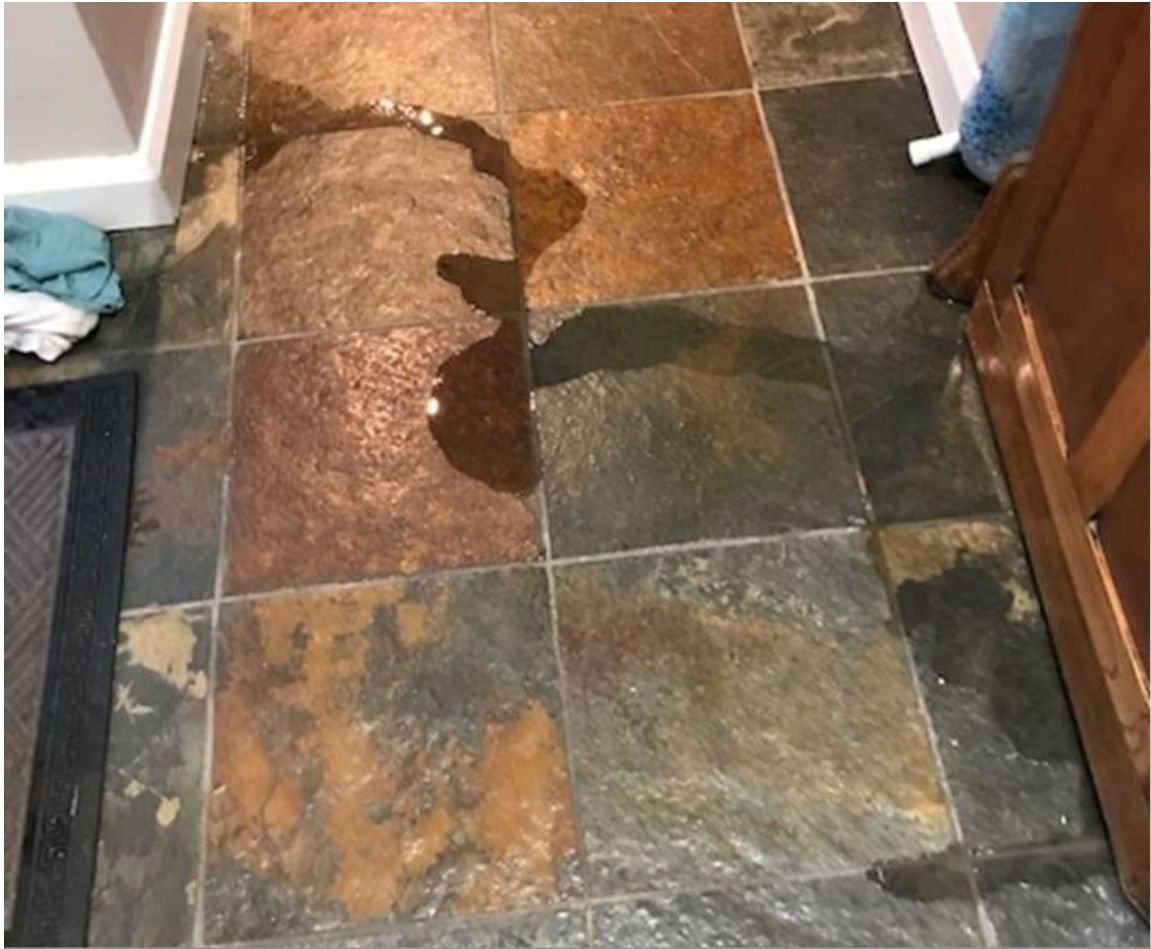
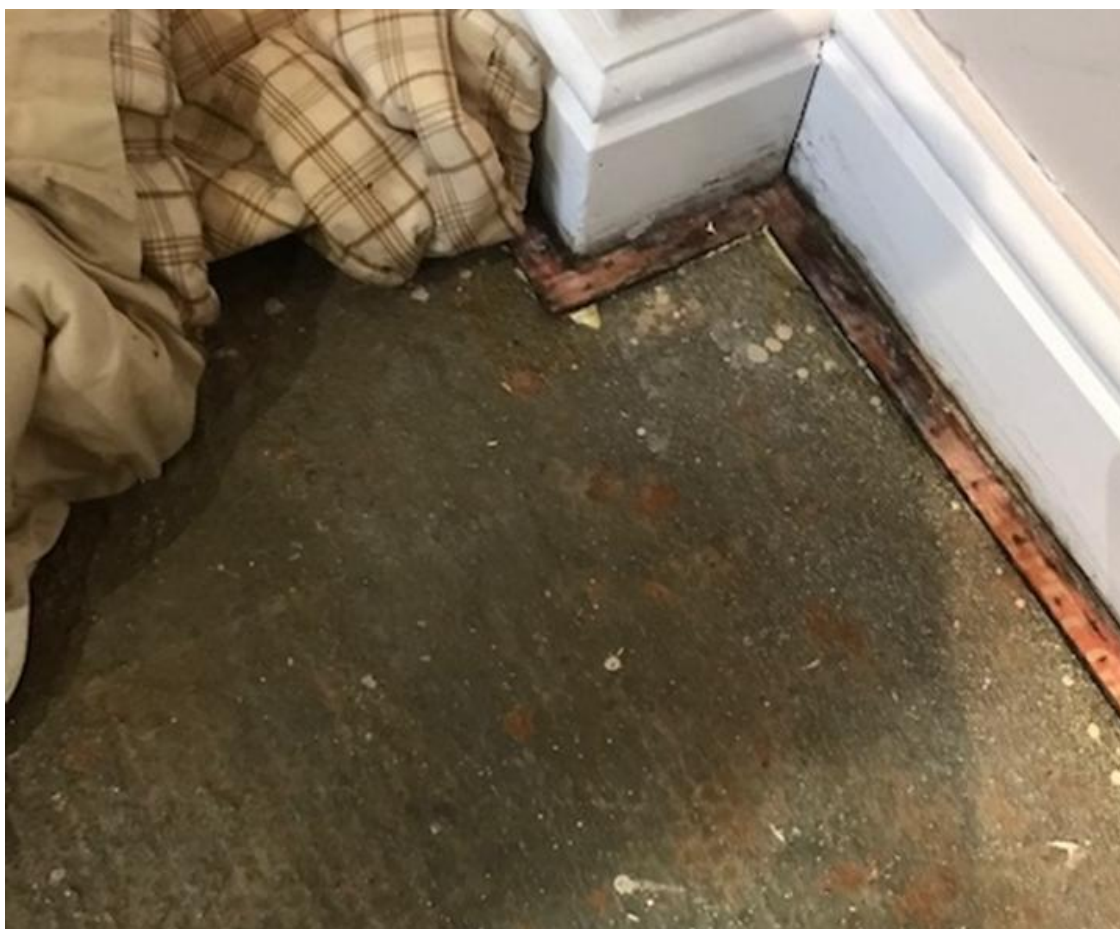
## 6. Photos of flooding

Storm Babet and storm Ciaran caused almost a month of rainfall to fall within only a few days. These storms have had a devastating impact upon Suffolk and have worsened existing flooding issues across the county. Minor flooding to the neighbours garden has been experienced on numerous occasions, and the resident mentioned the highway gullies pond and are quite vegetated.

- **Blockage to the drainage system:** there is a suspected blockage to the drainage system adjacent to the manhole in the rear garden of property B, shown on the map. This blockage will be isolated and cleared during any CCTV investigation.
- **Overwhelmed gullies/unknown highway drainage:** the intensity of the rainfall is likely to have been greater than the capacity of the highway gullies which capture runoff from the road and pavements. Further information is required regarding the highway drainage network, as whilst the gullies may have been recently checked and cleansed, there are no records of where these gullies discharge to, how the highway drainage system is connected to the drainage system at the rear garden of the neighbour's property, or how surface water is captured by these features and managed (e.g., directed to main river).

| Action | Responsible Party | Timescale for response | Latest Progress Update for Actions |
|---|---|---|---|
| Conduct a CCTV investigation to ascertain the assets in the drainage system, with jetting and cleansing to known assets in the area. | SCC Highways Authority | March 2024 | Highways drainage jetted, cleansed and surveyed January 2024. Some jetting into the accessible part of third-party land identified issues downstream. |
| Investigate to see if additional gullies should be installed on Barton Drive to improve the system capacity or whether the system could be re-directed towards maintainable highway for ease of access. | SCC Highways Authority | June 2024 | If the system downstream was fully operational the number of gullies should be sufficient to cope.<br><br>The slope of the land falls towards the dead end of the cul-de-sac so there is no option to replace the existing third-party section within maintainable highway. |
| Increase jetting frequency for gullies on Barton Drive. | SCC Highway authority | June 2024 | Pending |
