## **Environmental Information Regulations – Response - 27314**

*pothole on Wickham Road, Thornham Magna (approximately outside 148–184 Wickham Road). On 05.05.2026.*

**Insurance Claims Investigation Report**

**NSG Ref/Street Name:** 25502744 WICKHAM ROAD  
**Dates:** 5/5/2025 **to** 31/1/2026  
**Defects:** NONE  
**Requests:** POTH  
**Activities:** CSI,FIW,FID  
**Street Works:** NONE

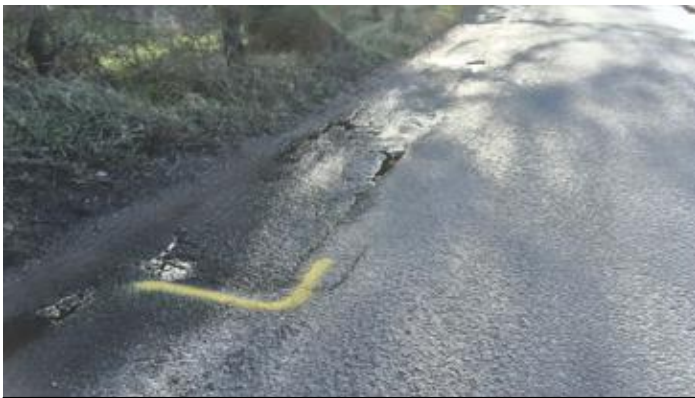
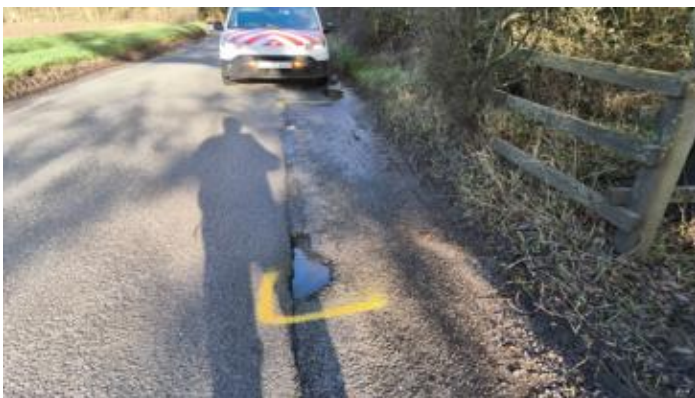
Action Number:	57090
Action Type:	Reactive Highways Maintenance
Asset Type:	Carriageway
Asset:	Wickham Road, Thornham Magna, Suffolk
Defect Type:	Matrix C - Carriageway Defects
Due Date:	20/02/2026 12:06
Ordered Date:	22/02/2026 15:31
Started Date:	18/03/2026 08:10
Completed Date:	18/03/2026 12:02
State:	Approved
Location:	Nr bridge
Description:	Pothole breaking out nr junction
Order Number:	3185
Priority:	P5 - 20 Working Days
Client Target Completion Due:	20 Day(s)
Contractor Target Completion Due:	20 Day(s)
Client Completion Due:	20/02/2026 12:06
Contractor Completion Due:	20/03/2026 16:30
Grid Ref.:	609858 270000
Likelihood:	Likely- 40-100mm
Defect length & width (specify mm or m):	500mm x 400mm
Defect depth / level difference (mm):	60mm unsafe to measure

Action required:	Patch
Position in road/footway/verge:	junction
Speed limit (mph):	National
Road width (m):	6
Footway width (m):	0
Available width for TM (m):	4
Marked up on site?:	No
Volume of traffic/pedestrian movement:	Light
Additional hazards:	bends, junction
HAO Area:	HAO - All Areas Merged, HAO - Halesworth 04
HAE Area:	HAE - Halesworth
M Group Area:	MOA - Central

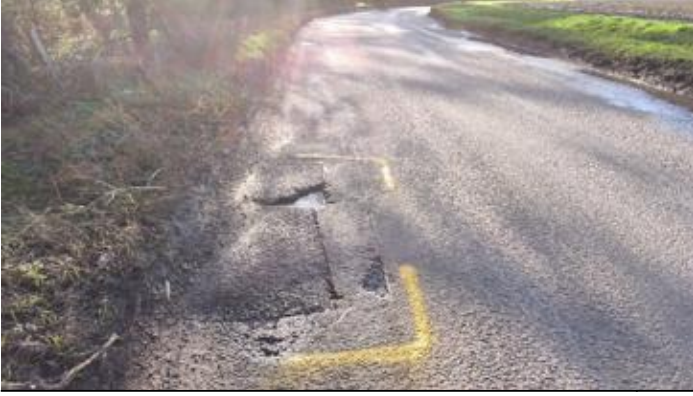
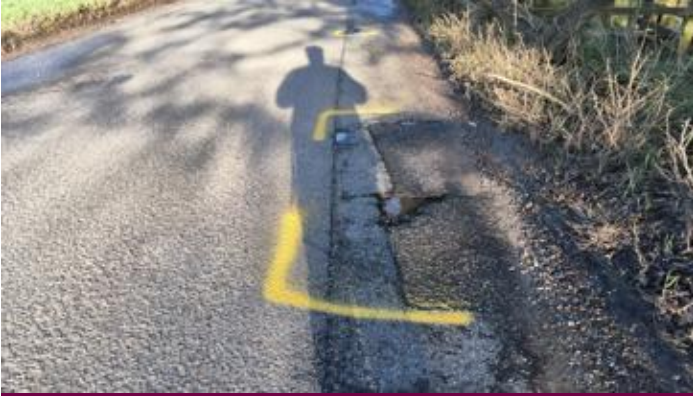
Defect Type:	Matrix C - Carriageway Defects
Due Date:	20/02/2026 12:06
Ordered Date:	22/02/2026 15:32
Started Date:	18/03/2026 09:03
Completed Date:	18/03/2026 12:03
State:	Approved
Location:	Nr bridge
Description:	Pothole breaking out nr junction
Order Number:	3186
Priority:	P5 - 20 Working Days
Client Target Completion Due:	20 Day(s)
Contractor Target Completion Due:	20 Day(s)
Client Completion Due:	20/02/2026 12:06
Contractor Completion Due:	20/03/2026 16:30
Grid Ref.:	609858 270000
Likelihood:	Likely- 40-100mm
Defect length & width (specify mm or m):	500mm x 400mm
Defect depth / level difference (mm):	60mm unsafe to measure
Action required:	Patch
Position in road/footway/verge:	junction
Speed limit (mph):	National
Road width (m):	6
Footway width (m):	0
Available width for TM (m):	4
Marked up on site?:	No
Volume of traffic/pedestrian movement:	Light
Additional hazards:	bends, junction
HAO Area:	HAO - All Areas Merged, HAO - Halesworth 04

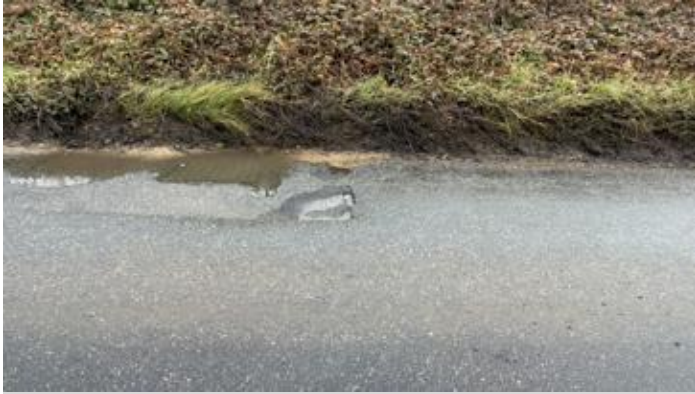
Customer Supplied Photograph:

Pothole size of 3 dinner plate size

Case Type:	Insight Legacy Report
Case Number:	40508
Asset Type:	Street
Originated Date:	25/01/2026 12:02
Service Level:	Standard
Location:	On left-hand side on bend before pink cottage on your right
Description:	Pothole size of 3 dinner plate size
State:	Cleared
Grid Ref.:	610263 270517
Insight CRNo:	552240
Insight Request Type:	Pothole (POTH)
Insight Service Code:	LIVE (SERV)
Insight Analysis Code 1:	Pothole (POTH)
Insight Analysis Code 2:	Fault Report (FLTR))
Insight Priority Code:	Standard (STD)

Action Number:	362182
Action Type:	DEF - Default Action
Stage:	APPROVED
Location:	On first left hand bend leaving village approx 20mtrs from Pink Cott
Chainage:	0.00
XSP:	
Grid Ref.:	610268 270528
Contract:	MILHR
Contractor:	MILESTONE
Defect:	RC2B - Cway Defects - Likely 40-100mm
Priority:	5 - 20 Working Days
Action Text:	
Action Reference:	
Duration:	0
Planned Start Date/Time:	20/02/2026
Planned End Date:	20/02/2026
Originated Date/Time:	26/01/2026 15:03
Ordered Date/Time:	26/01/2026 15:08
Completed Date/Time:	09/03/2026 14:33
Order Number:	300754

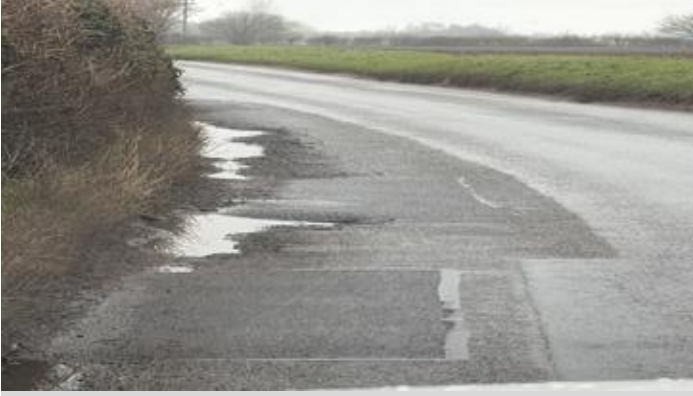
Customer Supplied Photograph:

A good 4 meters long on RHS

Case Type:	Insight Legacy Report
Case Number:	40510
Asset Type:	Street
Originated Date:	25/01/2026 12:06
Service Level:	Standard
Location:	These are on the right hand side, heading towards wickham skeith
Description:	A good 4 meters long on RHS
State:	Cleared - Maintenance
Grid Ref.:	609858 270000
Insight CRNo:	552243
Insight Request Type:	Pothole (POTH)
Insight Service Code:	LIVE (SERV)
Insight Analysis Code 1:	Pothole (POTH)
Insight Analysis Code 2:	Fault Report (FLTR))
Insight Priority Code:	Standard (STD)
Insight Stage:	RECORDED
