Environmental Information Regulations – Response - 27465

Location: Church Road, Ringsfield, Suffolk

Asset Location History Report Aurora

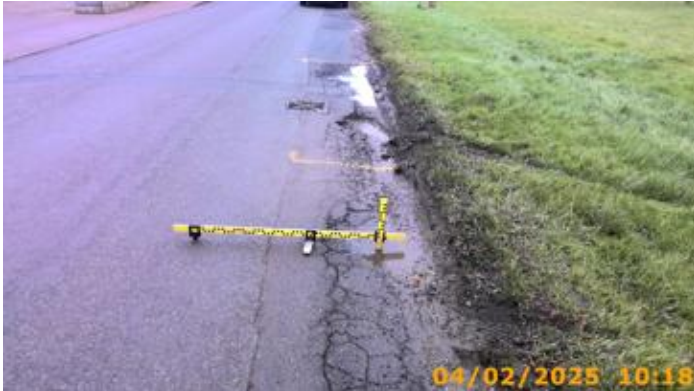
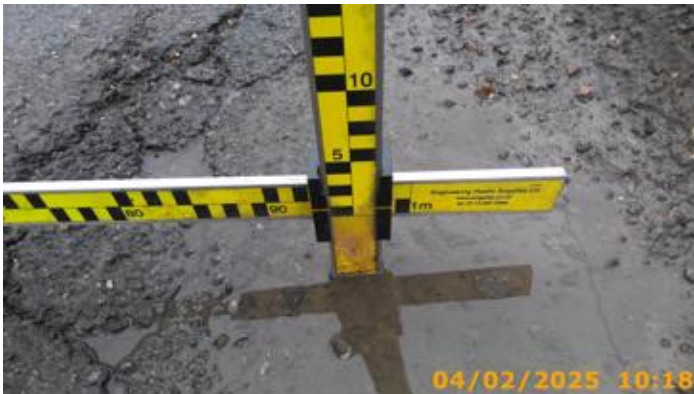
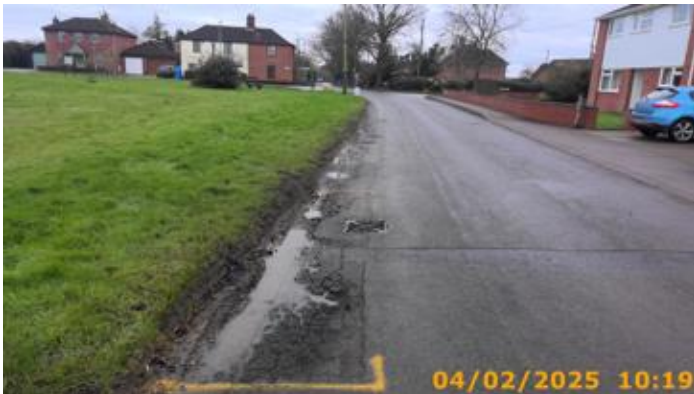
WIN_20250204_10_18_42_Pro.jpg:

Description: 2 large potholes dinner plate size. your staff have once again been down to look and have only marked up 4 metres of the 24 metres of this badly damaged road along this stretch of church Road. How come your workman can't ever do a proper job once and for all? I guess 4 months from now they will be back doing the same repair, and so on. This road is damaging my House, so I may be sending you a bill for the damage to my property very soon or deduct the cost off my council Tax.

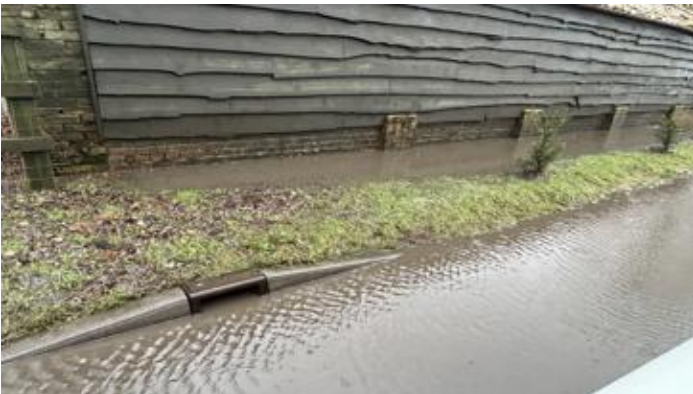
Customer Supplied Photograph:

This has previously been reported several times. Teams have attended approximately 4 times to attempt to clear. It was last updated as being fixed on 31 Dec . This picture has been taken since, showing that it is still not resolved. A more permanent solution is needed.

The flooding is causing damage to the adjacent building. It is causing cars to move to the other side of the road to avoid , and into oncoming traffic on a 60mph road with no pavement -where kids walk to school, dog walkers and horse riders are vulnerable.
