## **Environmental Information Regulations – Response - 27626**

NSG Ref/Street Name: 38606116 PLAYFORD MOUNT  
Dates: 1-7-2024 to 31-1-2026

# General Maintenance LA Code Details

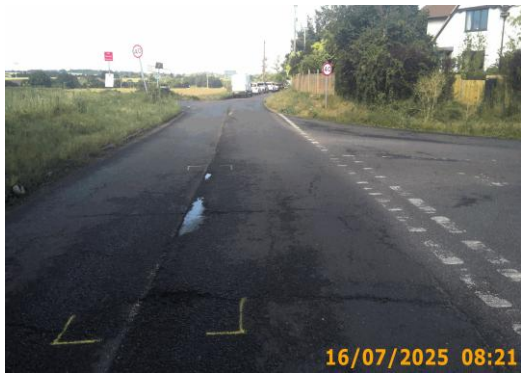
| Photo | \\gyr-data-014\DOC_SUFF_LIVE\Objects\SF\MAIN_G\2025_07\000347669_0001.jpg | | | | |

| Expenditure Code: | ET07532E73 | Defect: | RC2B | Cway Defects - Likely 40-100mm | |
| SR01 - Defect length and width (specify mm or m) | 4.0x0.7m | | | | |
| SR02 - Defect depth / level difference (mm) | 40mm estimated for safety | | | | |
| SR03 - Position in road / footway / verge | centre c/w | | | | |
| SR11 - Additional hazards? | on junction | | | | |

| SR13 - Action required | Patch | | | | |

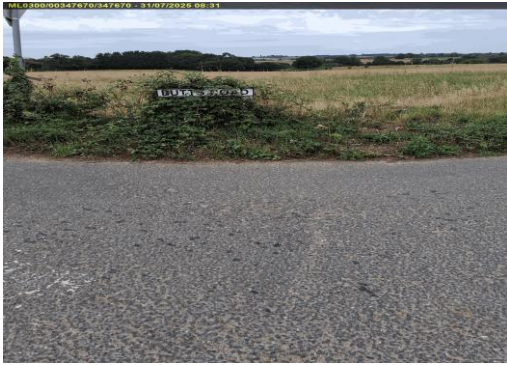
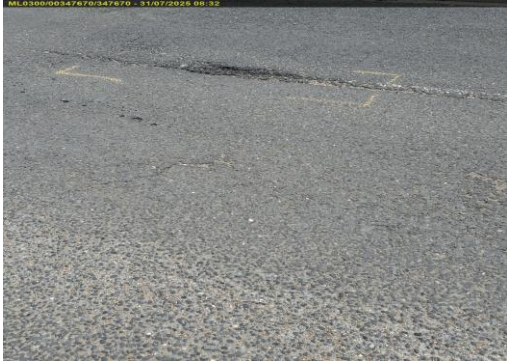
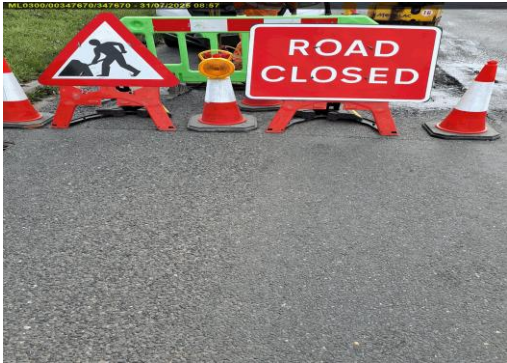
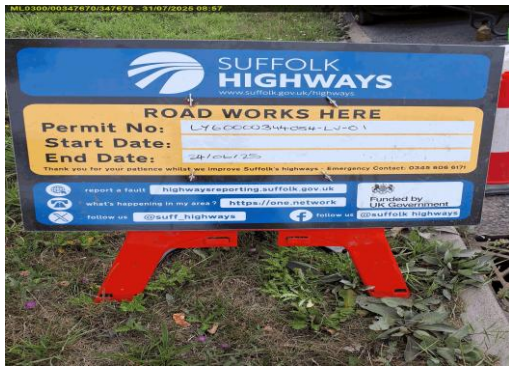
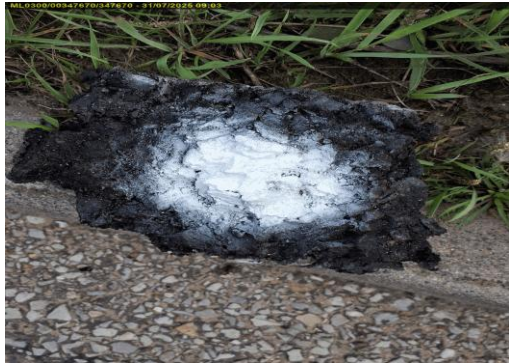
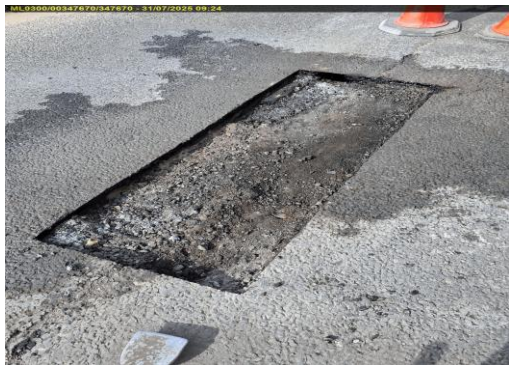
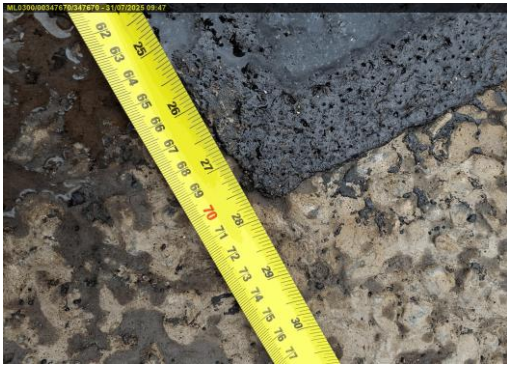
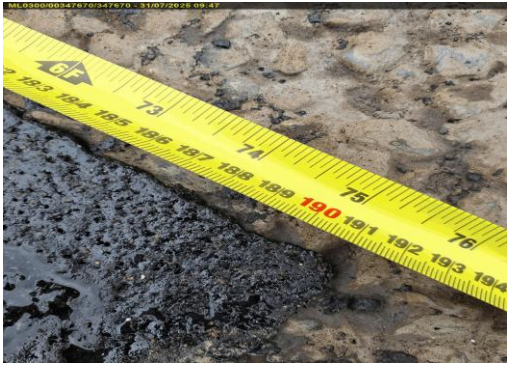
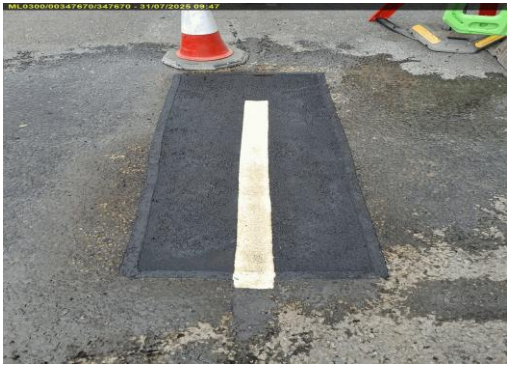
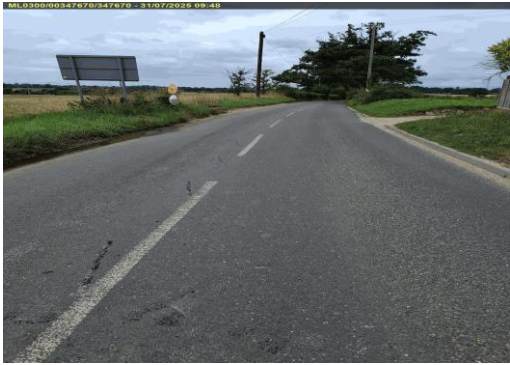
| Expenditure Code: | ET07532E73 | Defect: | RC2B | Cway Defects - Likely 40-100mm | |
| SR01 - Defect length and width (specify mm or m) | 1.7x0.6m | | | | |
| SR02 - Defect depth / level difference (mm) | 60mm estimated for safety | | | | |
| SR11 - Additional hazards? | near junction | | | | |

| SR13 - Action required | Patch | | | | |

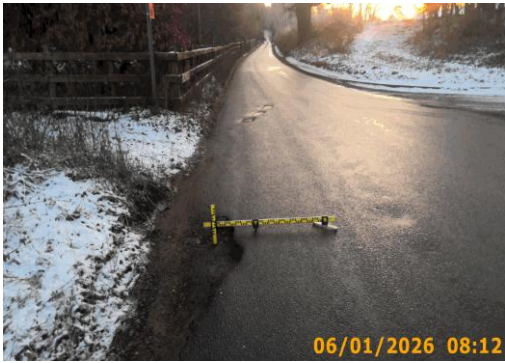
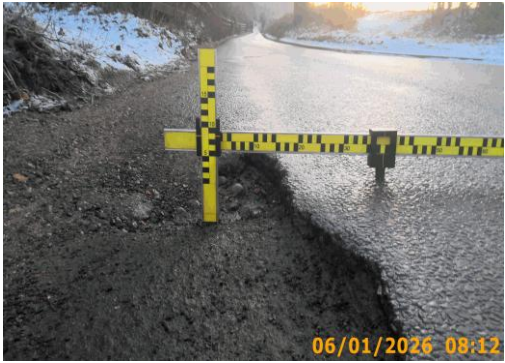
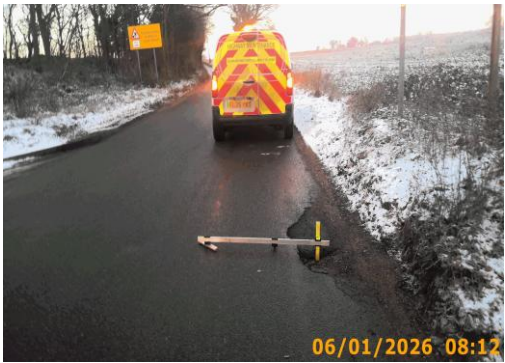
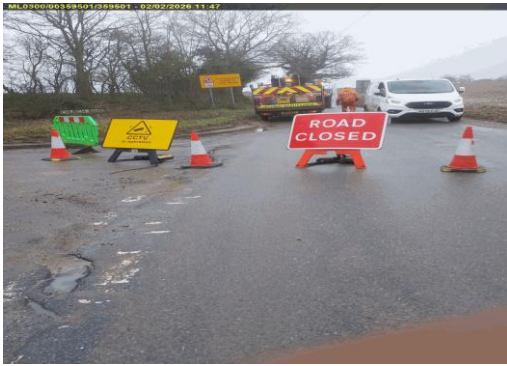
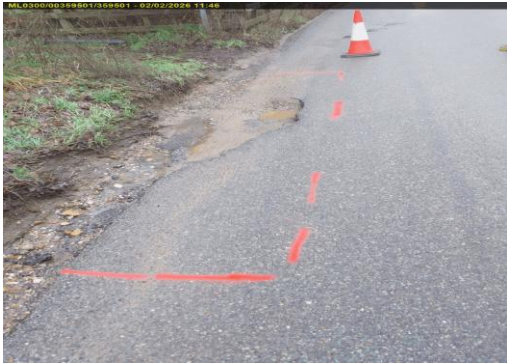
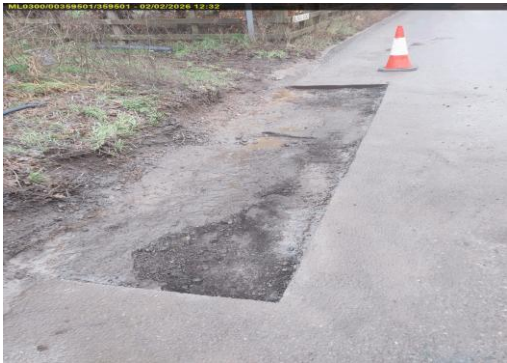
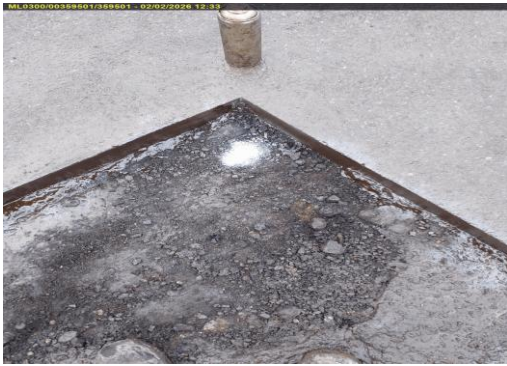
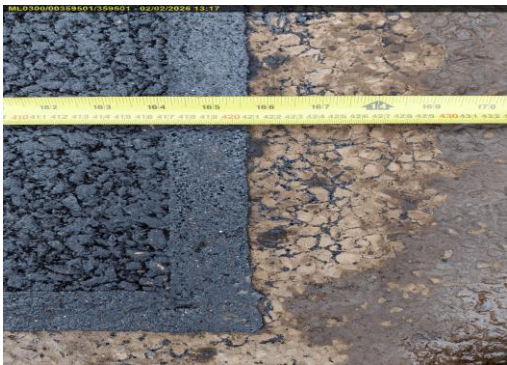
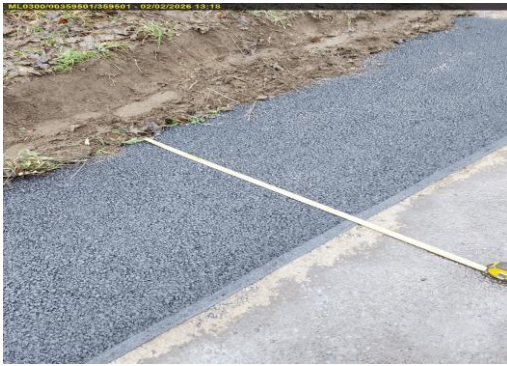
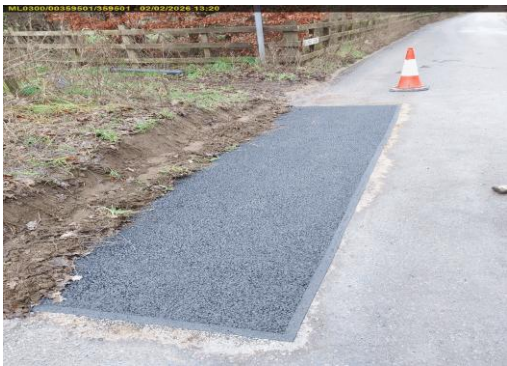
| <b>Expenditure Code:</b> | ET07532E73 | <b>Defect:</b> | RC2B | Cway Defects - Likely 40-100mm | |

| SR01 - Defect length and width (specify mm or m) | 0.9 x 0.3 |
| SR02 - Defect depth / level difference (mm) | 85mm |
| SR11 - Additional hazards? | Overheads present , opposite junction |

| SR13 - Action required | Patch |

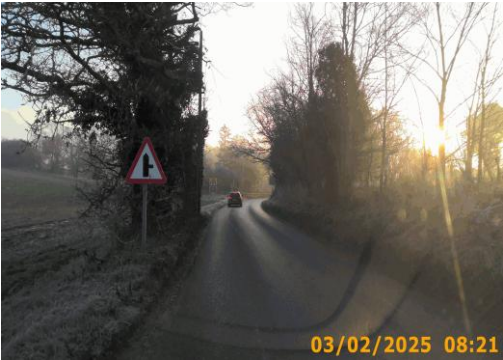
\\gyr-data-014\DOC\_SUFF\_LIVE\Objects\SF\SERV\_K\2025\_01\000504019\_0001.jpg

Multiple potholes at the edges of the road particularly on the left hand side heading towards Tuddenham. With the road being narrow it can be difficult for two vehicles to pass without hitting them. Quite large and could potentially cause damage.

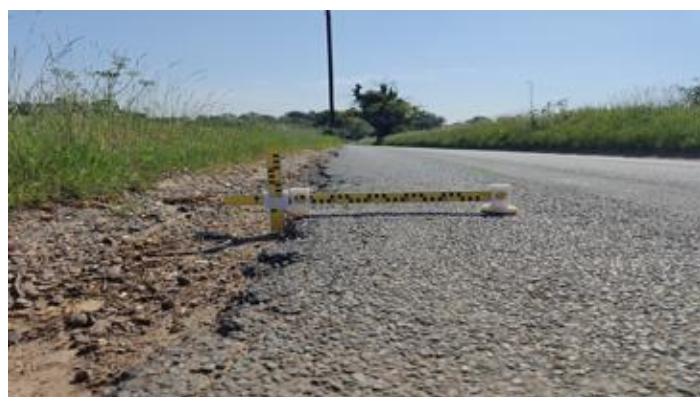
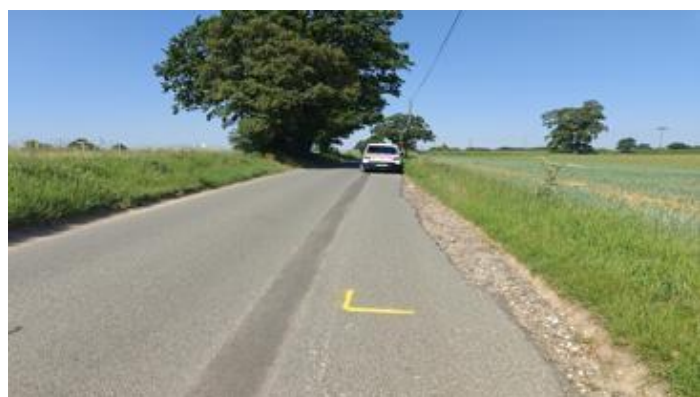
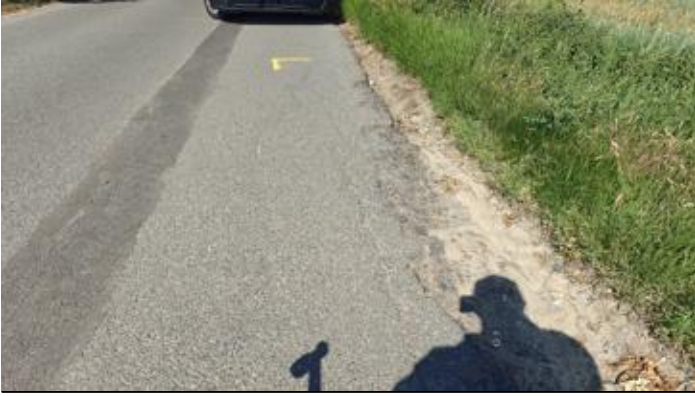
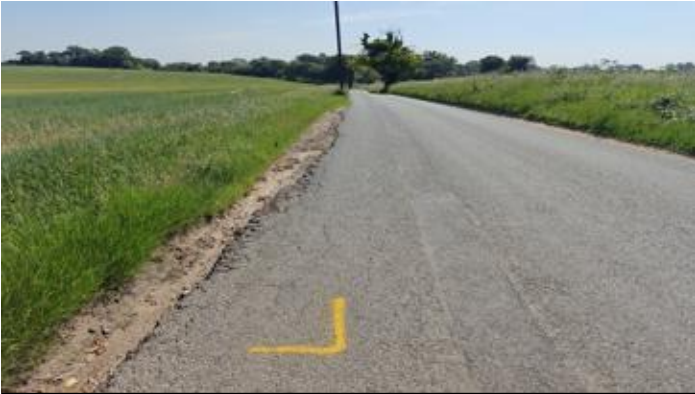
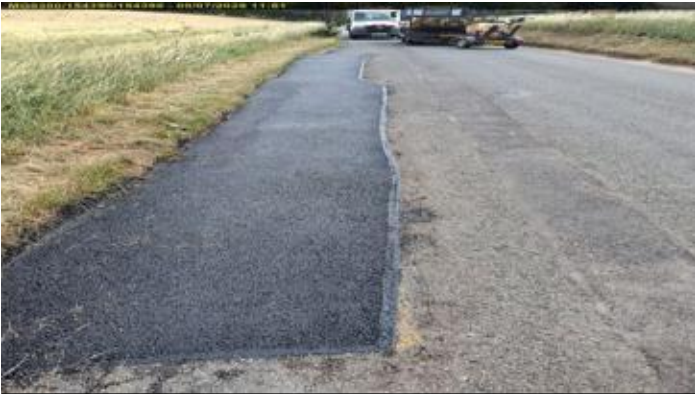
| Defect Type: | Matrix C - Carriageway Defects |

| Defect length & width (specify mm or m): | 15 x 0.4 |
| Defect depth / level difference (mm): | 55 |
| Additional hazards: | OH cables |

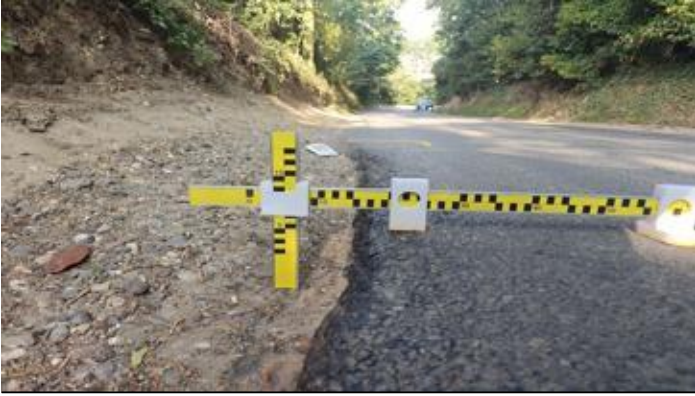
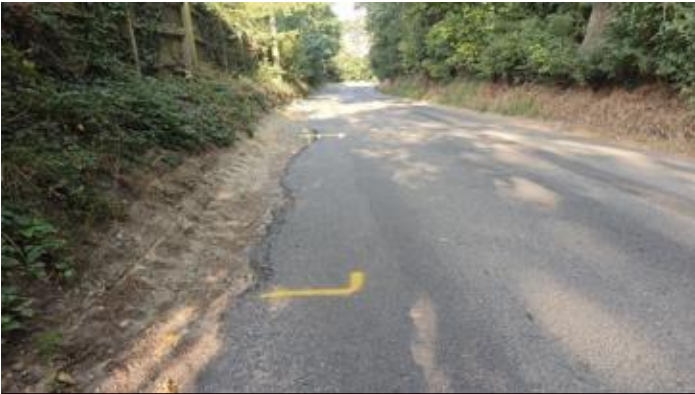
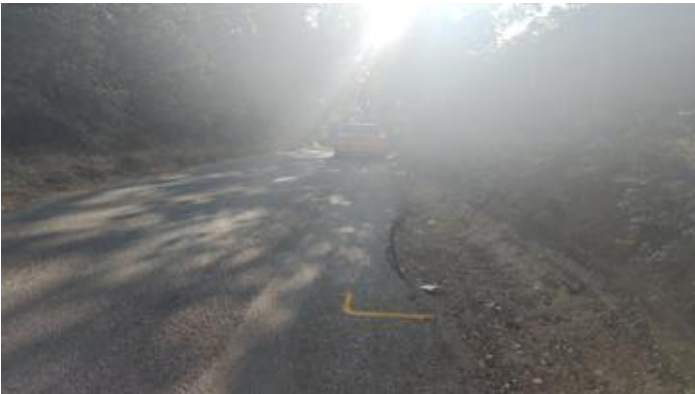
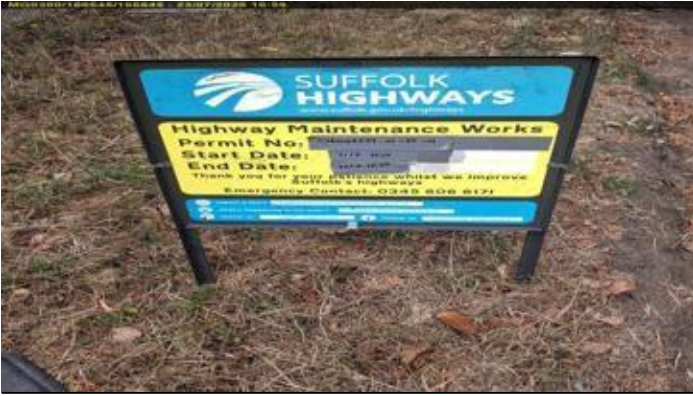
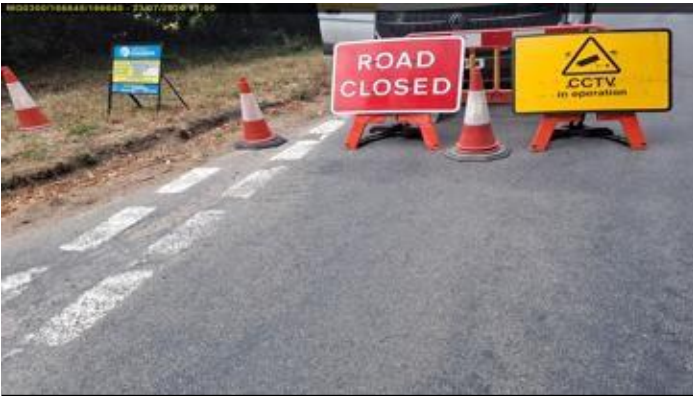
| Defect Type: | Matrix C - Carriageway Defects |
| Defect length & width (specify mm or m): | 1.8 x 0.4 |
| Defect depth / level difference (mm): | 120 |
| Additional hazards: | oh cables, hill, bends, poor visibility |

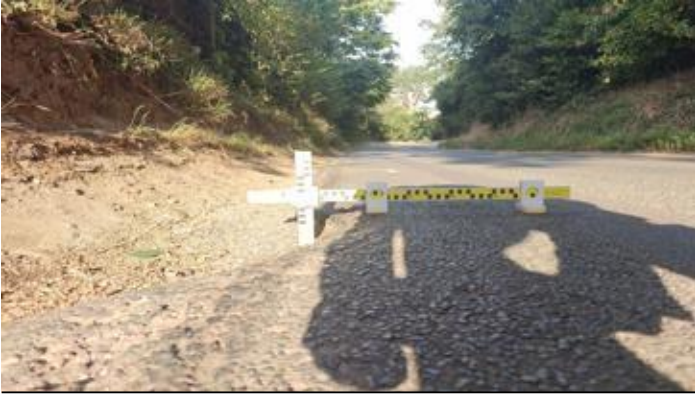
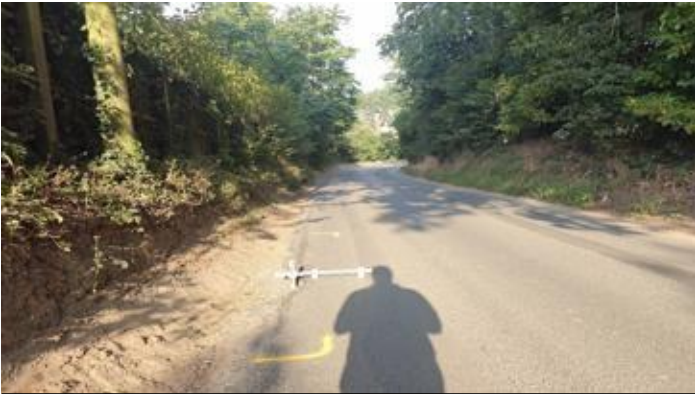
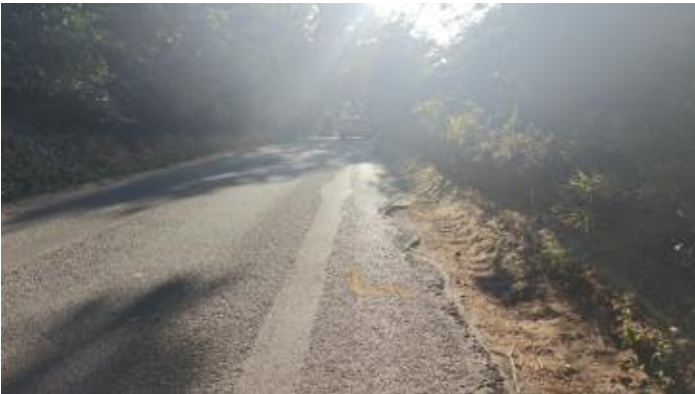
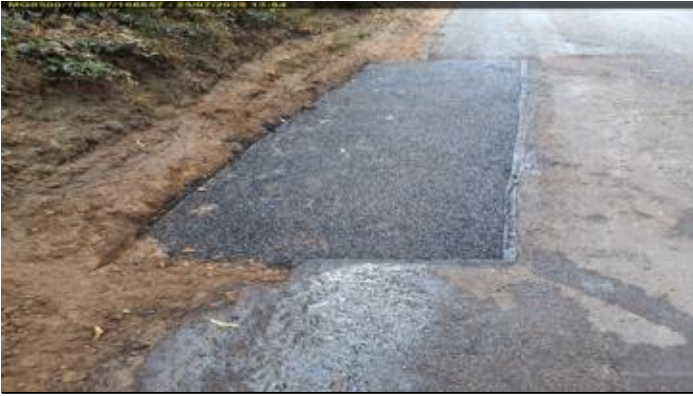
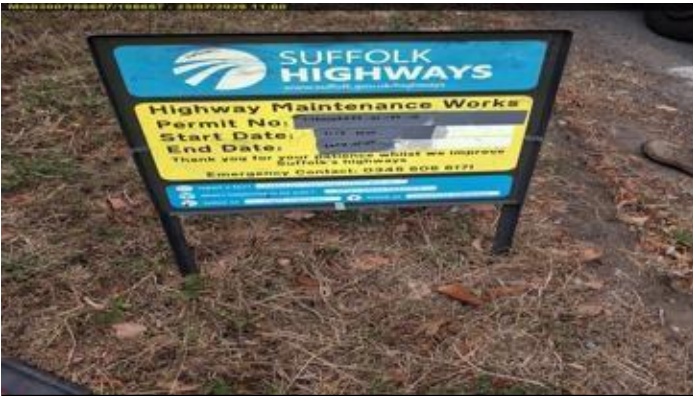
| Defect Type: | Matrix C - Carriageway Defects |
| Defect length & width (specify mm or m): | 1.2 x 0.3 |
| Defect depth / level difference (mm): | 100 |
| Additional hazards: | oh cables, hill, bends, poor visibility |

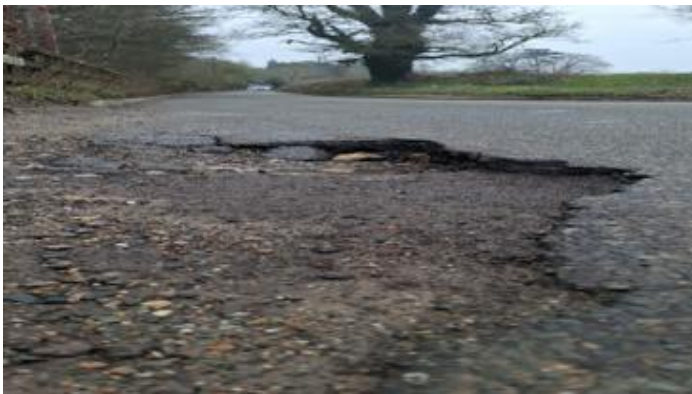
Customer Supplied Photograph:

| Description: | <p>Huge pothole around 70mm deep, unavoidable with oncoming traffic, was also full of water, completely bust my tyre and needed new wheel at £95.</p> <p>Very unsafe place to stop and impossible to change a wheel in such a dangerous spot!</p> <p>I can dsee this was reported previously when it was the size of a dinner plate, it is now HUGE and very dangerous, especially to bikers, lucky i was in a car but still bust my wheel completely!</p> |
