## Section 19 Flood and Water Management Act 2010

**Report Title: Nottidge Road, Ipswich**

**Report Reference(s): 65778**

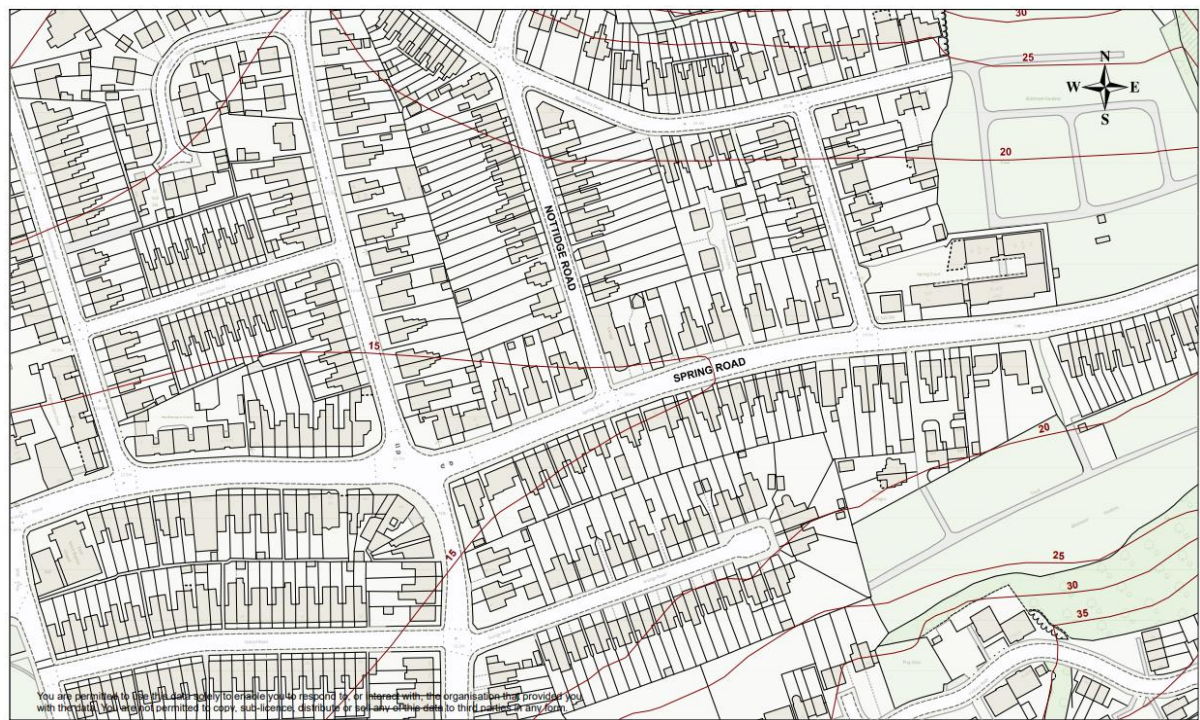
Figure 1 Flood Investigation Area

Spring Road Ipswich

| Date of incident | Incident as reported | Response |
|---|---|---|
| 2 <sup>nd</sup> June 2026 | Came from the overflowing drain from the sudden rain. The water is coming inside our property, and our cellar is flooding quick. All our items are flooded and are floating. We can't contain the water. This happens every time the drain outside our house gets blocked. The water is coming in from 2 different points. | N/A |

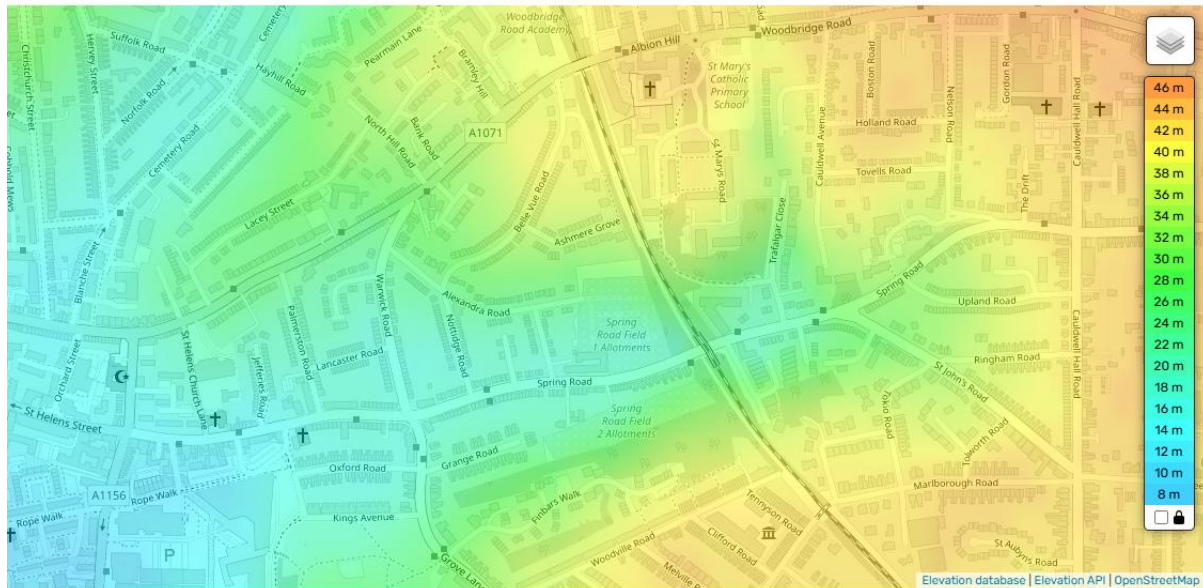
Figure 3 - Ipswich Spring Road Contours (TessaDEM as cited in topographic-map.com)

Spring Road area of Ipswich varies in topography ground levels with the East sitting higher than the West. Figure 3 shows the contours of the area. The western end of Spring Road is situated in a lower lying area where higher grounds surround it from the East while it continues to fall towards the West where the Rivers Gipping and Orwell lie. The lower-lying nature of the western end of Spring Road means that during high rain events, floodwater can become close in proximity to properties. Overwhelmed drainage infrastructure is frequently observed during these rainfall events. The catchment surrounding the property is densely urban and thus water runs off instead of infiltrating to ground during prolonged or intense rainfall events.

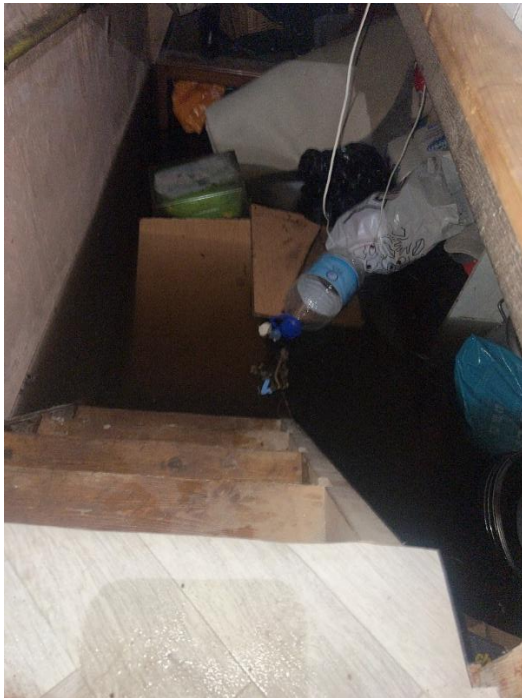
## Photo of Flooding

The flooding occurred during and after a series of intense downpours associated with thunderstorms across the East of England in early June 2026. Due to the localised nature of these storms, nearby rainfall gauges did not capture the events accurately. Significant volumes of rainfall fell in a short period of time which overwhelmed the highway drainage systems and resulted in internal flooding in a single property within the basement. A site visit revealed that the highway drainage was significantly silted up and roof runoff from the property *is directed straight to the ground within the property boundary*.

| Action | Risk Management Authority | Progress |
|---|---|---|
| Remedial works to the highway drainage immediately adjacent the property | SCC, Highways | Works ordered |

| Action | Risk Management Authority | Timescale for response | Latest Progress Update for Actions |
|---|---|---|---|
| Continue inspection and maintenance regime to ensure continued functionality' | SCC, Highways | 6 months | |
| Basement and property to be made flood resilient and/or resistant | Homeowner with support from SCC | N/A | |
