## Kirkley Stream Flood Report - October 2015

### 2. Flooding in July 2015

### **3. Why did the flooding occur and who's doing what?**

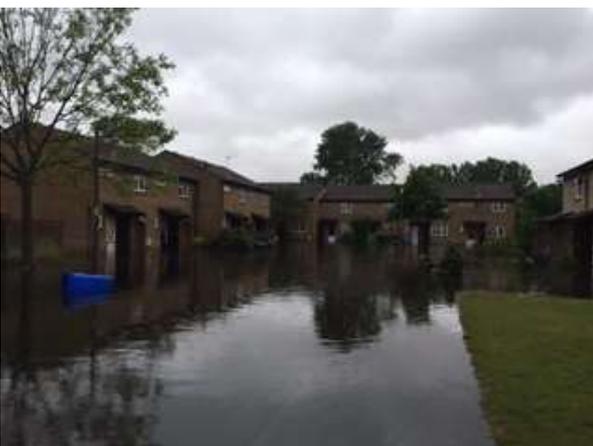
On the night of 24/25 July 2015, 82mm rainfall fell – the equivalent of twice the July average rainfall. This amount of rainfall is regarded as having a 2.5% chance of happening in any one year (also described as a 1 in 40 year event) so is unusual. This heavy rainfall appeared to overwhelm the stream and local drainage systems resulting in flooding of 33 homes in Aldwyck Way and Velda Close, affecting main living areas to a depth of some 300 - 500mm. Further reports of garages and gardens flooded were also received. About 50m of public highway in this locality was flooded to an approximate depth of 450mm.

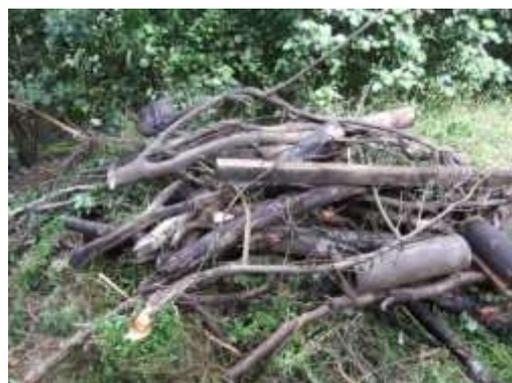
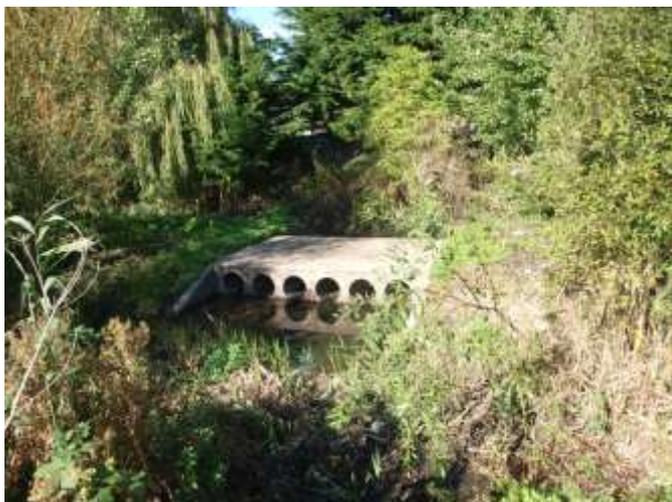
The Stream was partly blocked in places by debris washed down and catching on grilles and areas of excessive vegetation. Coupled with the amount of water flowing into the stream, this caused water to overtop the banks and directly flood into the lower areas around, eventually getting into homes and gardens. Some of the debris was natural, but a significant amount of illegally dumped garden and fly-tipped waste contributed to the problem (see photo right). Since 2002 Anglian Water has been carrying out monthly maintenance visits to Kirkley Stream to ensure all key screens along the length of the stream were kept clear of debris. There were occasions when more extensive work was required to remove trees, garden waste and various other types of materials that were dumped into stream – as in this instance.

*Piped inlet into the flood storage area (after clearance)*

There is a flood storage area between the stream and Tom Crisp Way – shown on Map 2a. This was designed to be a natural feature and was planted up with reeds after construction to enhance the natural environment and not to need any regular maintenance. We have no evidence to suggest this feature failed to work as a storage area on the night of 25/26 July in spite of a partial blockage by vegetation of the six large pipes between the stream and this flood storage area (see photo left). The blockages have subsequently been cleared and the wider LFRMP will investigate whether increasing the capacity in this storage area could be a mechanism for further reducing flood risk.

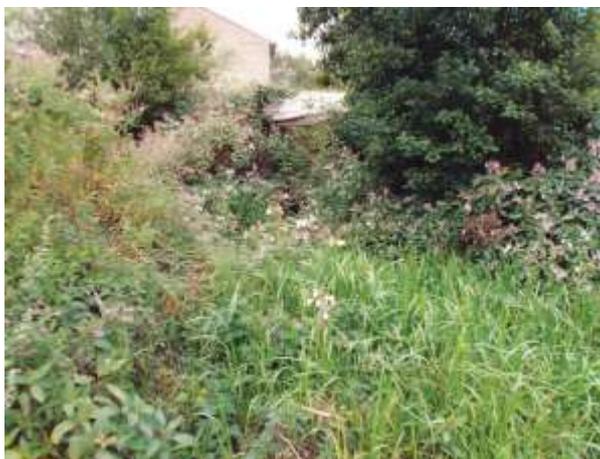
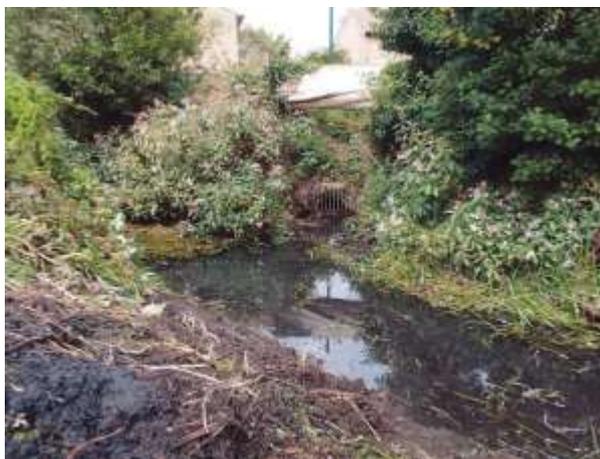
There are a number of grilles/culverts along and draining into the stream (also shown on Maps 2a/b). Suffolk County Council Highways inspect its assets regularly for structural integrity and Anglian Water ensures that blockages along the channel are cleared. After the 24 July flooding Anglian Water and Suffolk County Council recognised that there was excessive vegetation in the area and, working together, cleared access routes into the stream and removed bulrushes and other growth from the channel bed.

*Area next to Aldwyck Way before (left) and after (right) channel clearance*

Currently a survey is being undertaken to inform the hydraulic model which will ascertain whether the bed is silted up to an extent that is increasing flood risk and whether additional vegetation clearance would further reduce flood risk. This is due for completion early November. The result will determine if works are required in which case they will be undertaken as quickly as possible within the constraints of funding, health and safety and UK ecological law – overseen by the LFRMP.

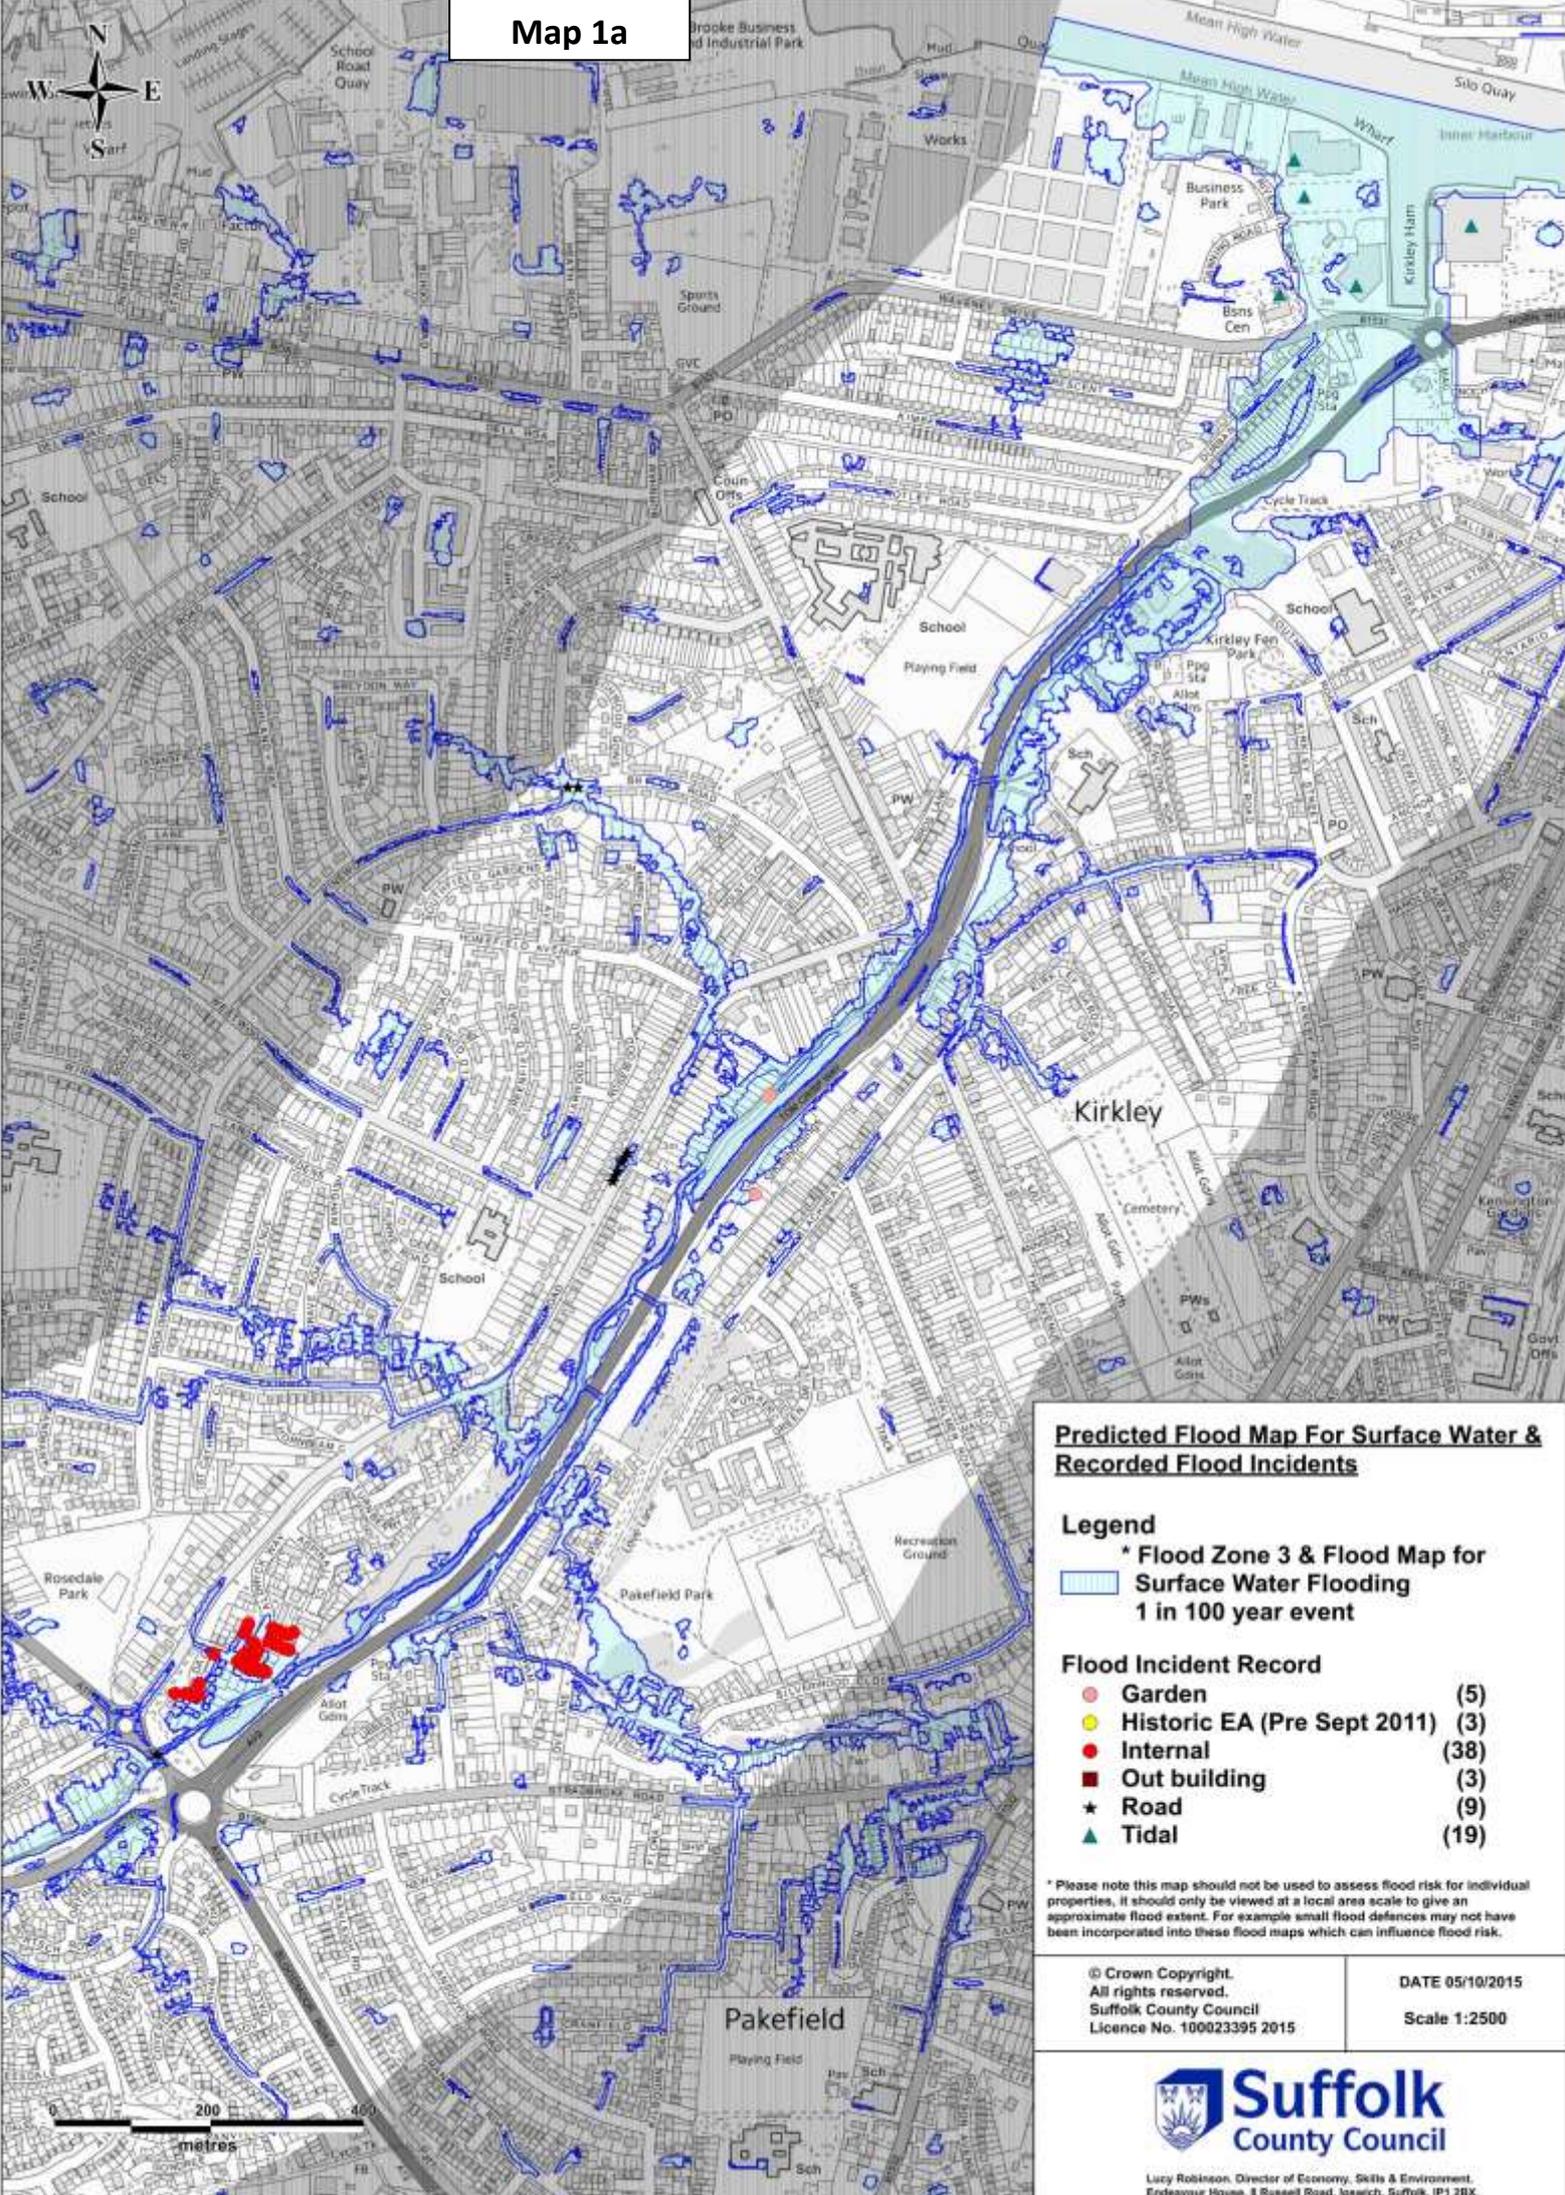
Map 1a

**Predicted Flood Map For Surface Water & Recorded Flood Incidents**

In Carlton Colville there was a report of one home and numerous roads and gardens affected by flooding, including foul sewage. Roads were reportedly flooded to a depth of about 300mm. Maps 1a and 1b identify flooding incidents reported to Suffolk County Council and its partners at the time.

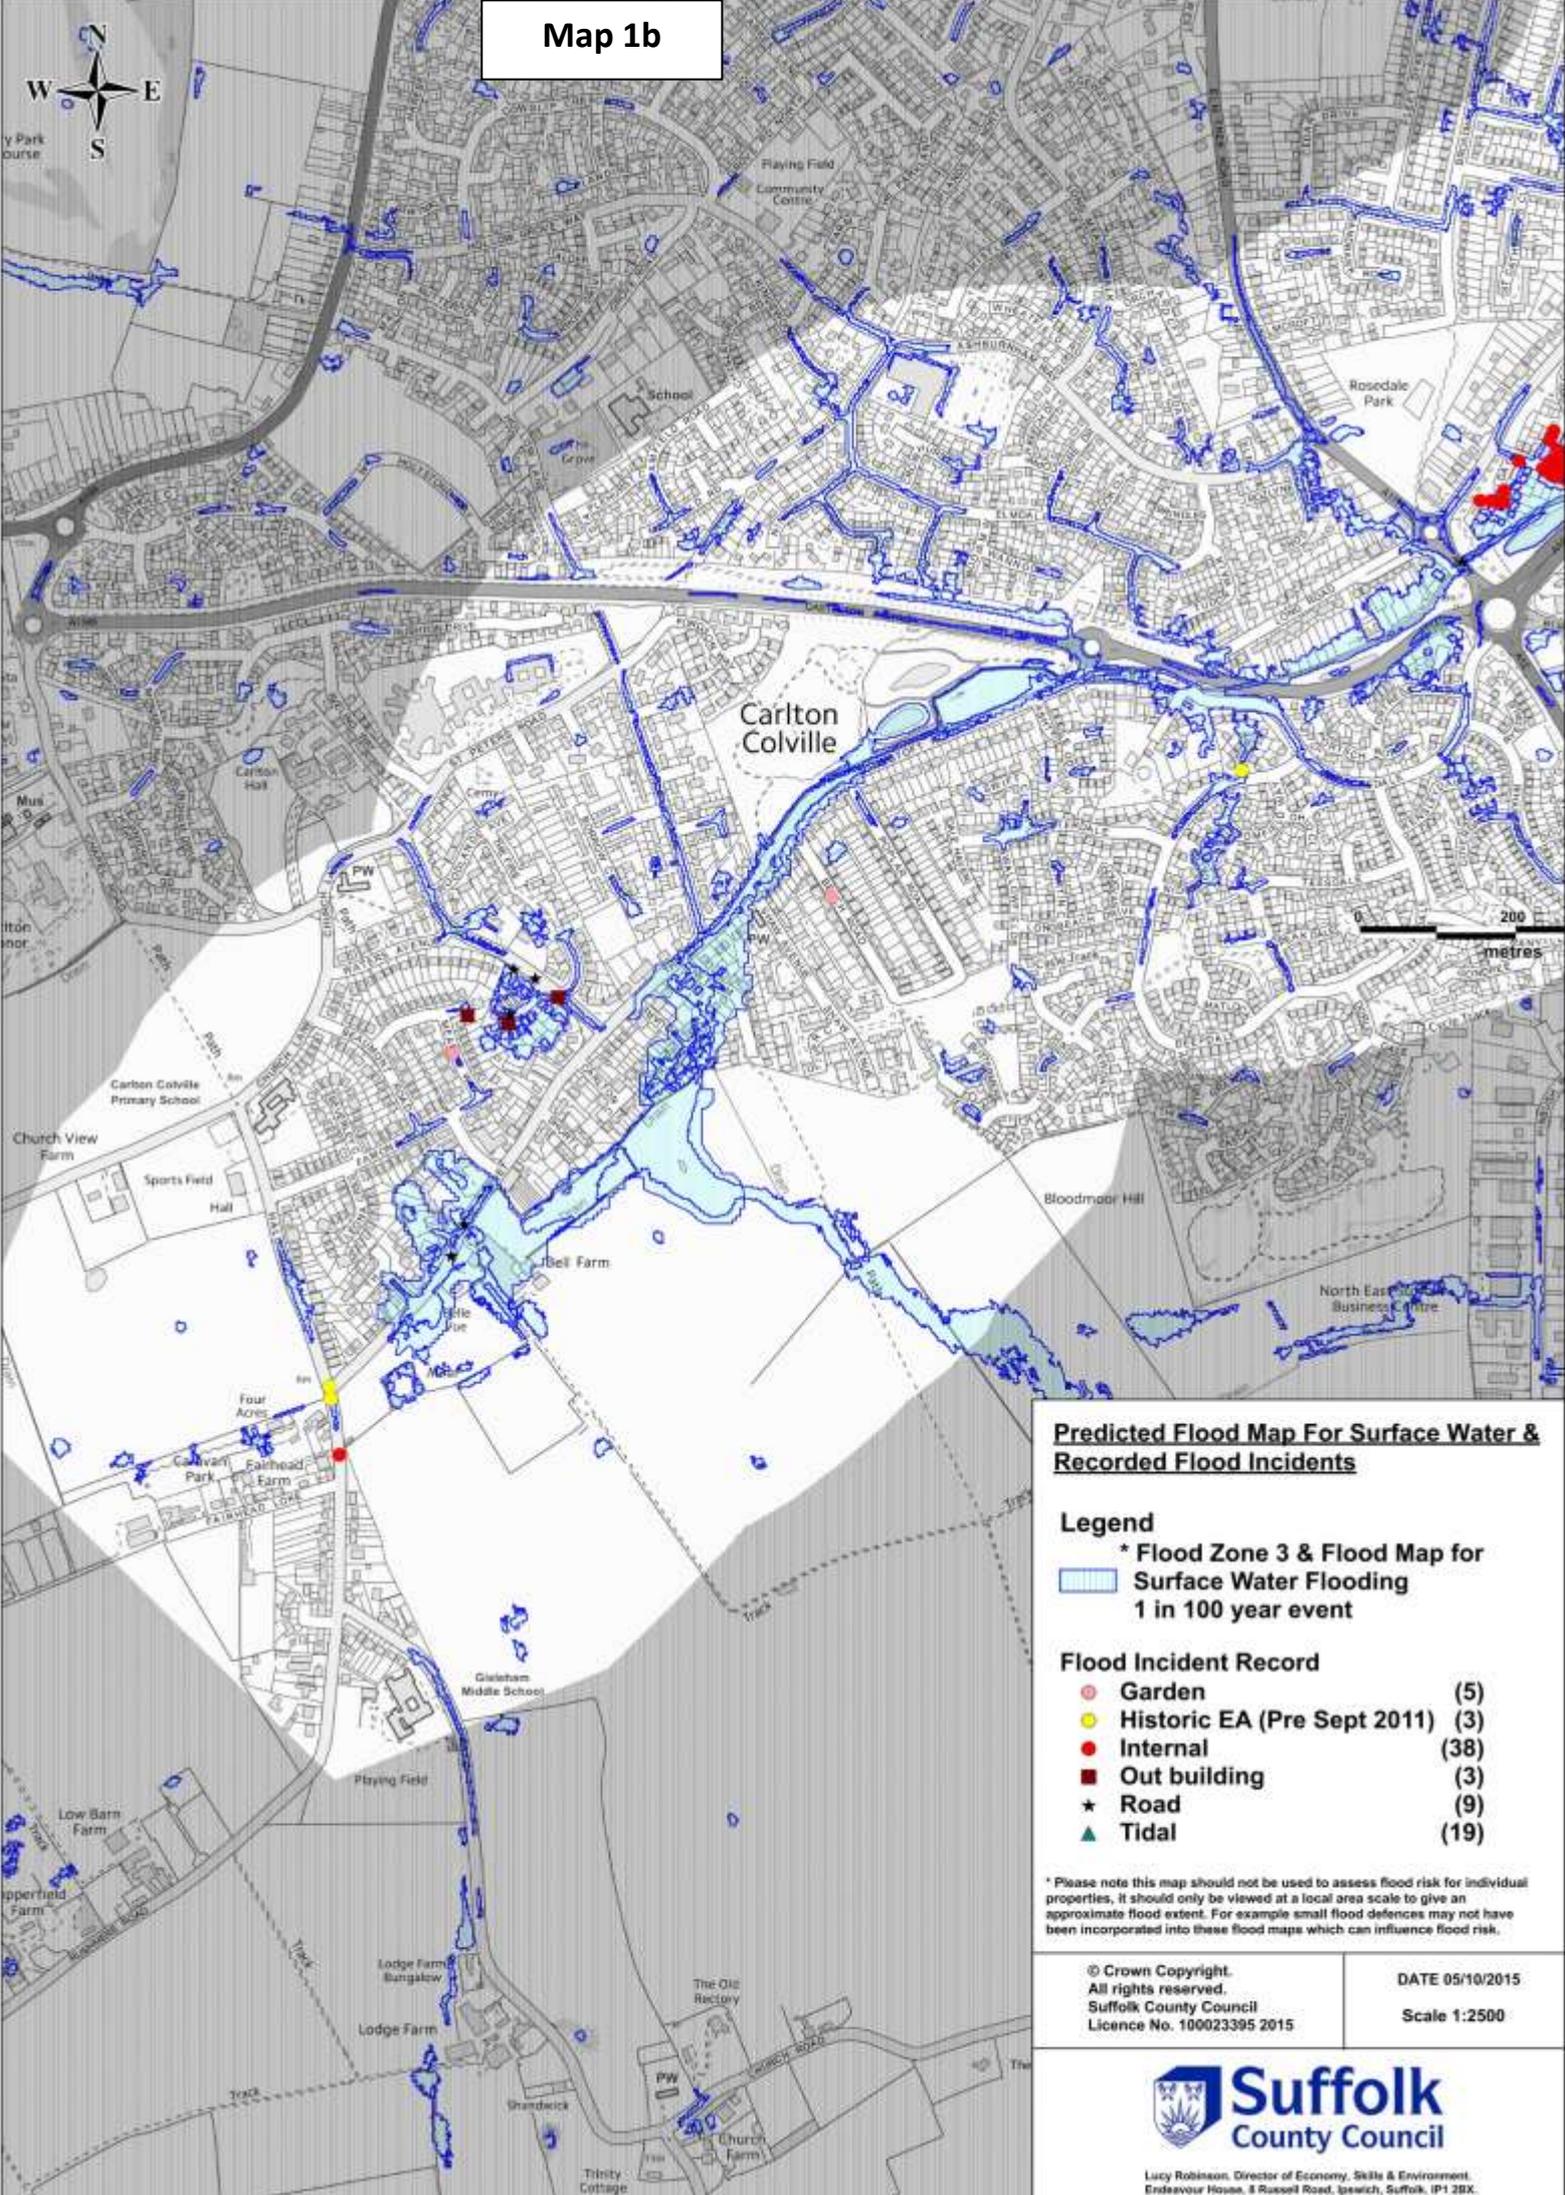
Map 1b

**Predicted Flood Map For Surface Water & Recorded Flood Incidents**

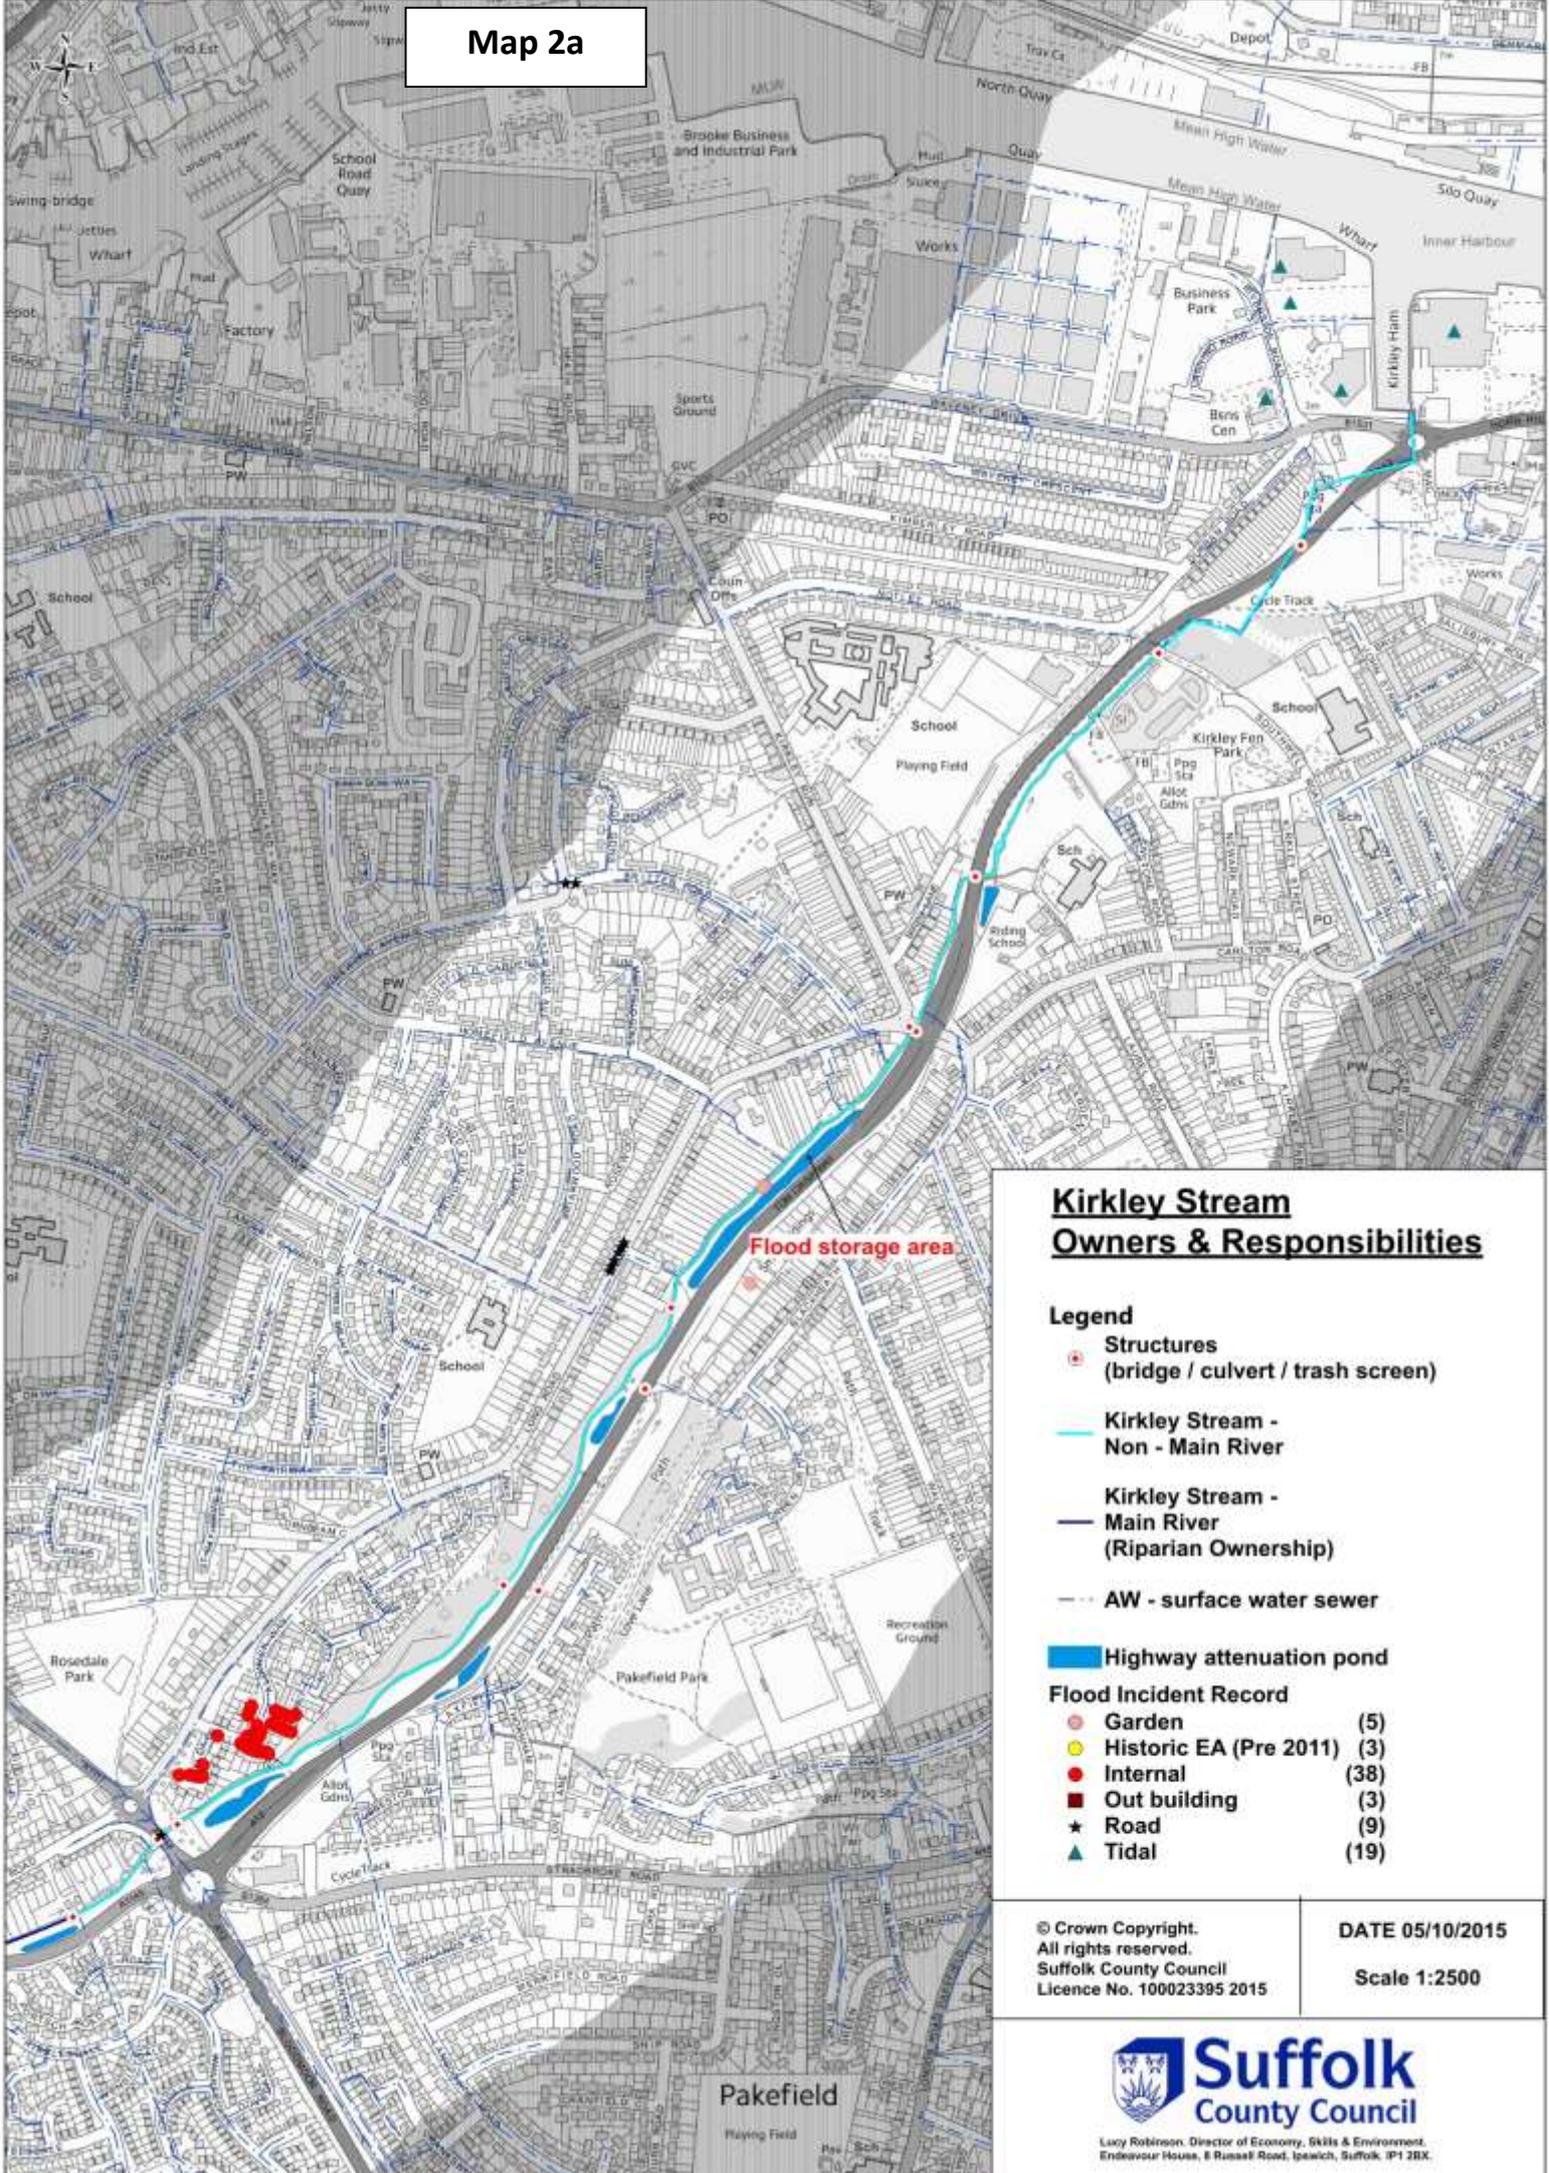
**Map 2a**

**Kirkley Stream  
Owners & Responsibilities**

Alongside Tom Crisp Way are three drainage basins/ponds, the responsibility of Suffolk County Council Highways – see Map 2a. These are solely for the collection of water draining off the road and were designed to incorporate some vegetation as another ecological feature. There is no evidence that water flowed out of these ponds during the 24/25 July event and they are not deemed to be a contributing factor to the flooding.

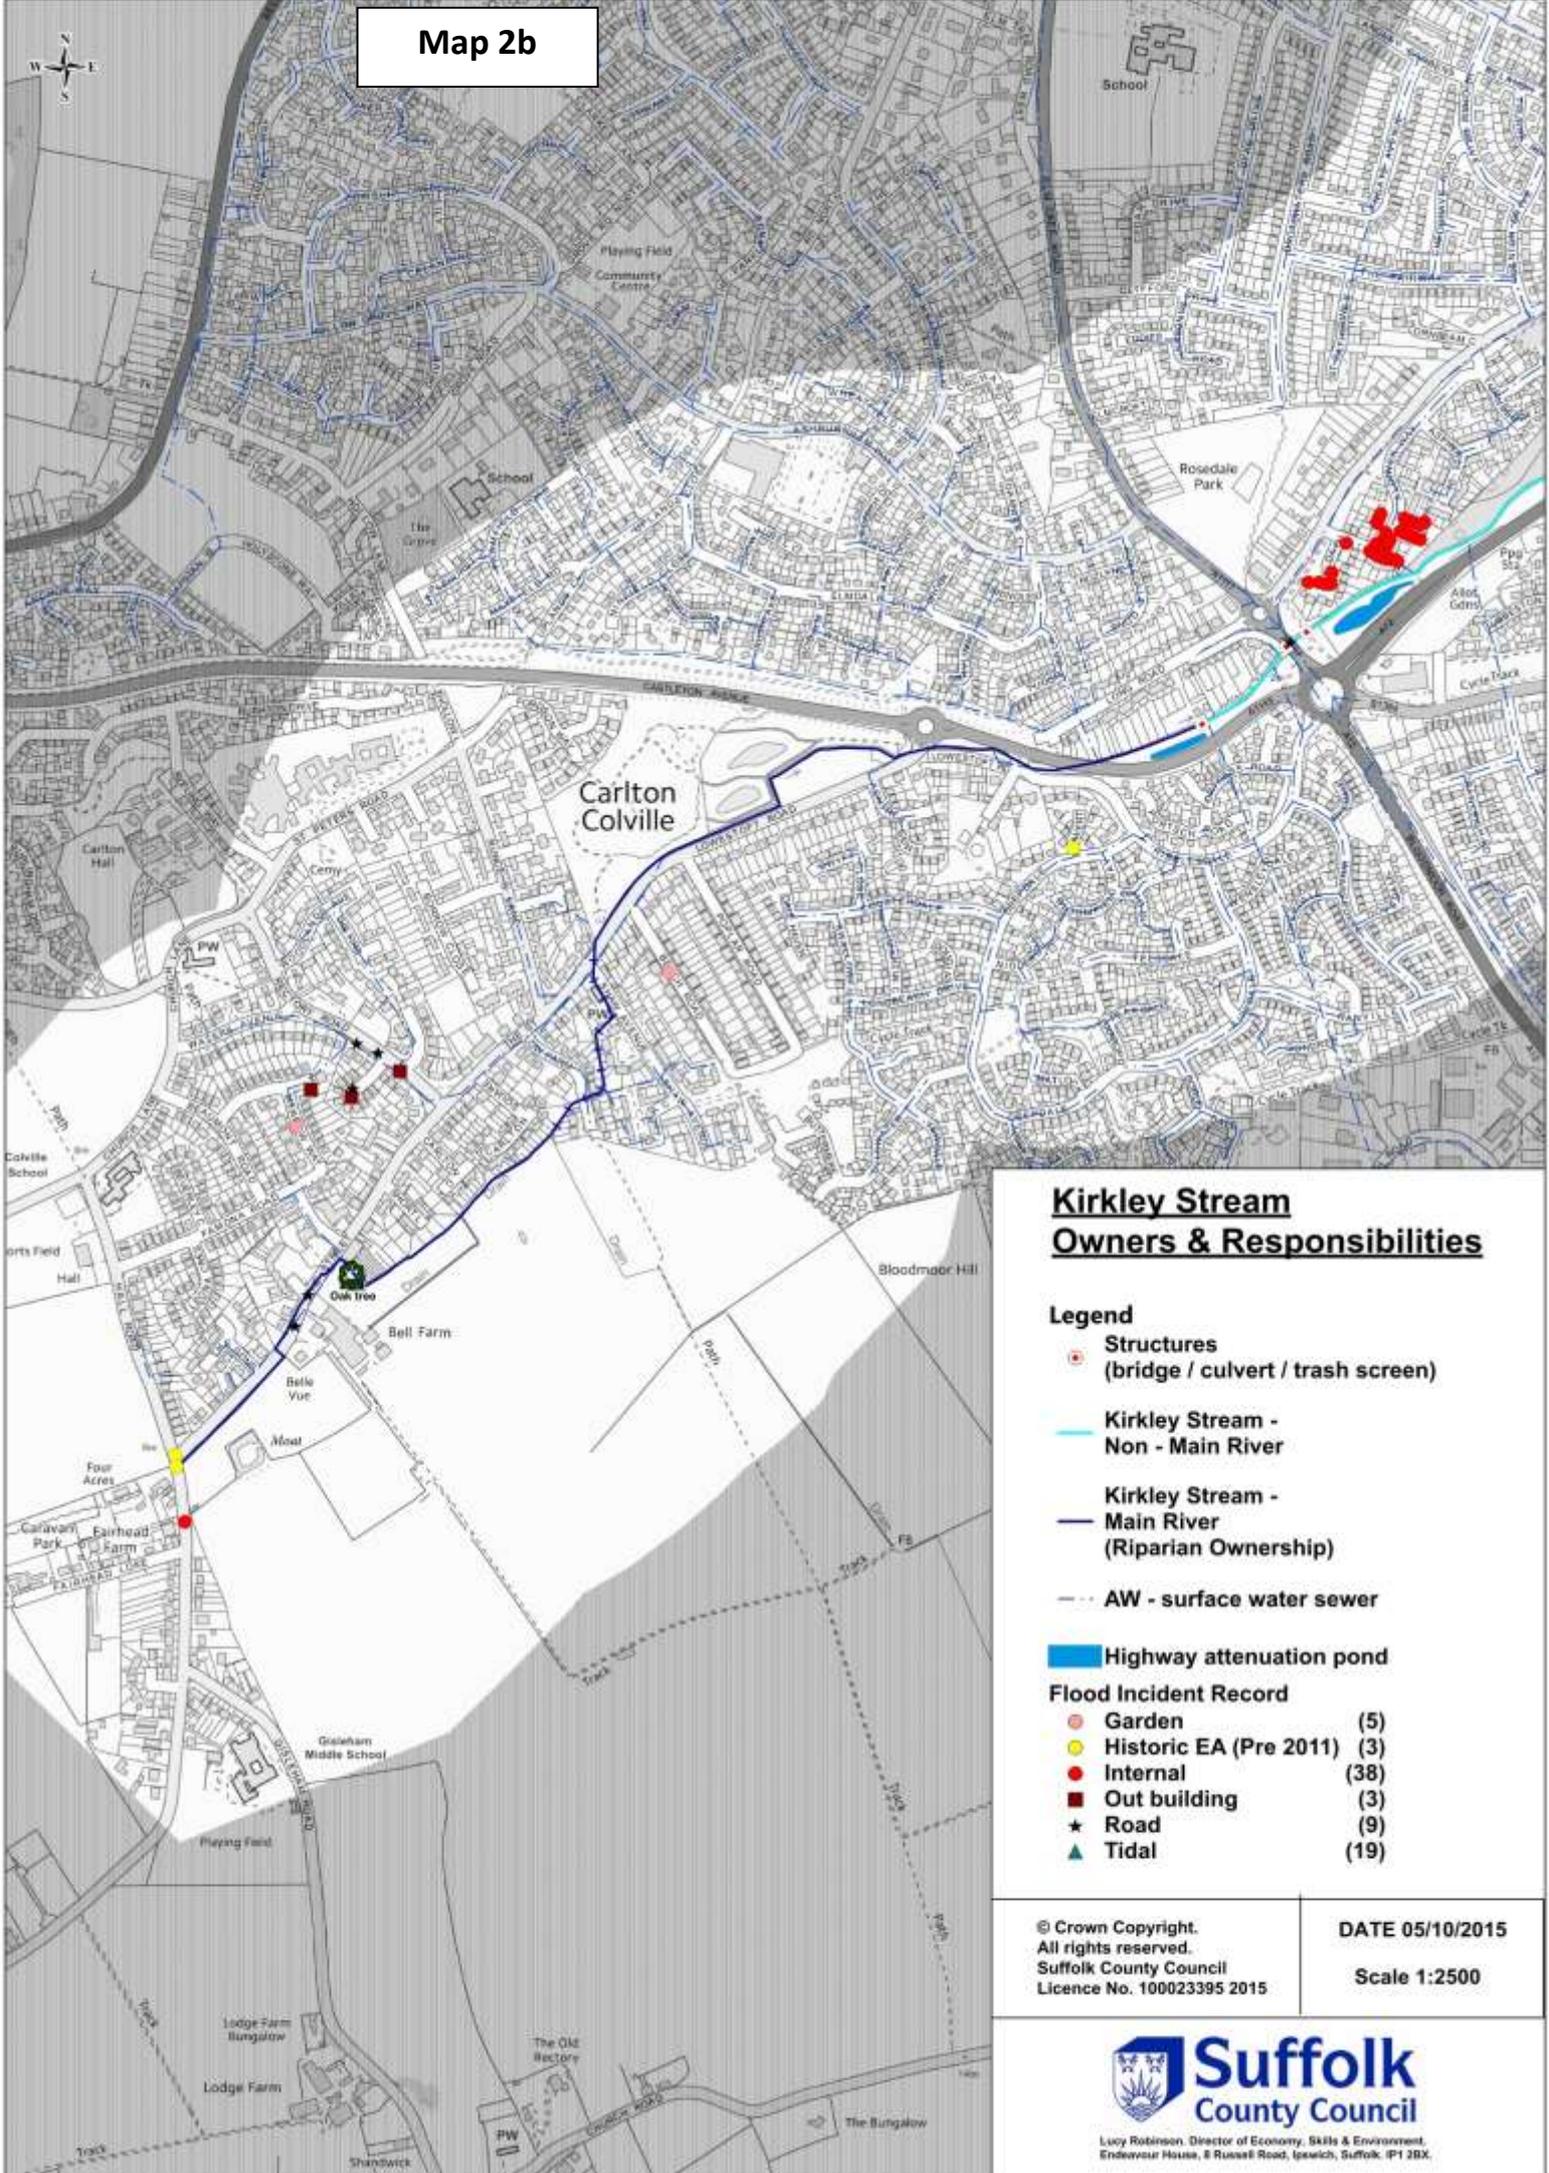
Map 2b

## Kirkley Stream Owners & Responsibilities
