### MARTELLO TOWER 'Z' **ALDERTON**

Description Martello Tower. Built c.1810-12 as part of defence line

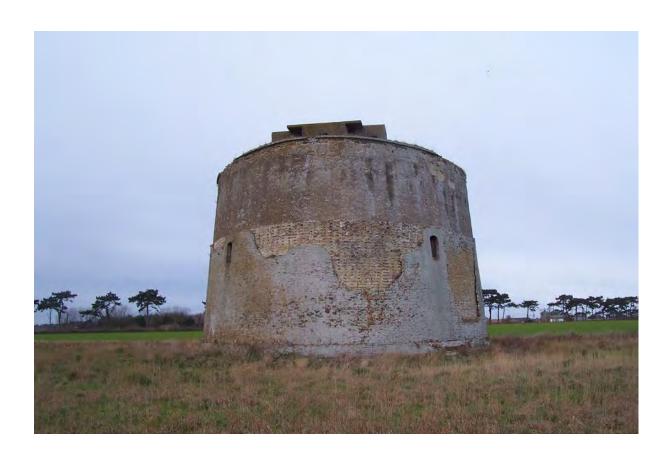
against threat of invasion by Napoleon. Brick with ashlar

dressings. Three storeys. Teardrop shaped plan.

С Risk Priority Condition Poor

Reason for Risk Outer brick skin is peeling away, leaving about 40% of inner

structure exposed.

Notes The owners are investigating potential users or uses for the

> building in order to facilitate essential repair/conservation works. The area around the tower is no longer in cultivation.

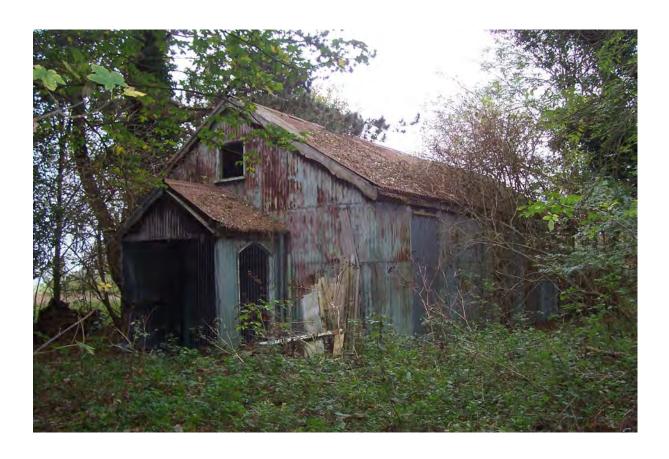
## CHAPEL, BAWDSEY MANOR BAWDSEY

Description A pre-fabricated timber-framed building with corrugated

metal covering, consisting of a porch, nave and chancel.

Condition Very bad

Reason for Risk Lack of general maintenance has led to decay of timber

frame and floor.

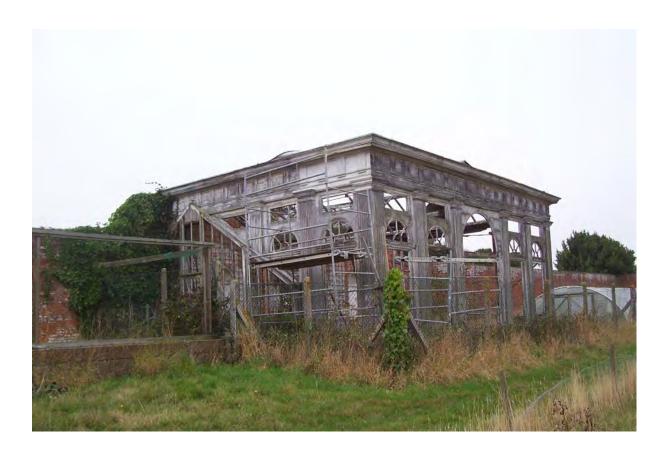
## LEMONARY 40M N OF BAWDSEY MANOR BAWDSEY

Description Timber-framed glasshouse used as a lemonary. Built c.1900

in classical design of symmetrical bays divided by fluted Roman Doric pilasters. Set within a large walled garden.

Condition Very bad

Reason for Risk Lack of maintenance has allowed decay to frame and metal

supports causing structural problems.

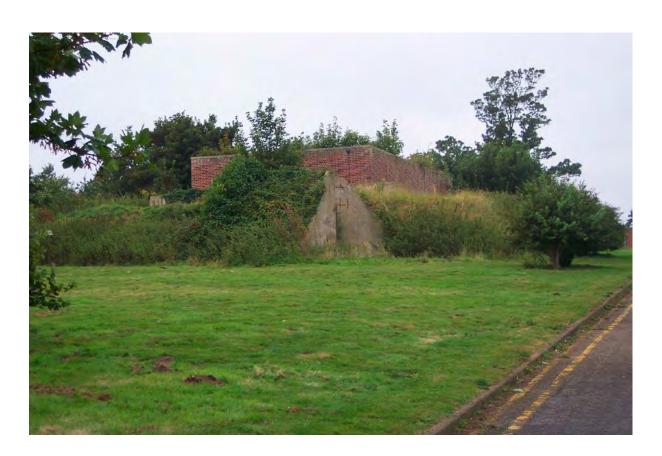
# RADAR RECEIVER BLOCK, BAWDSEY MANOR BAWDSEY

Description Concrete and brick radar block, 1937. Site of pioneering

Risk Priority C Condition Fair

Reason for Risk Metal reinforcement is rusting causing concrete to spall.

Lack of general maintenance, trees growing on earth bank.

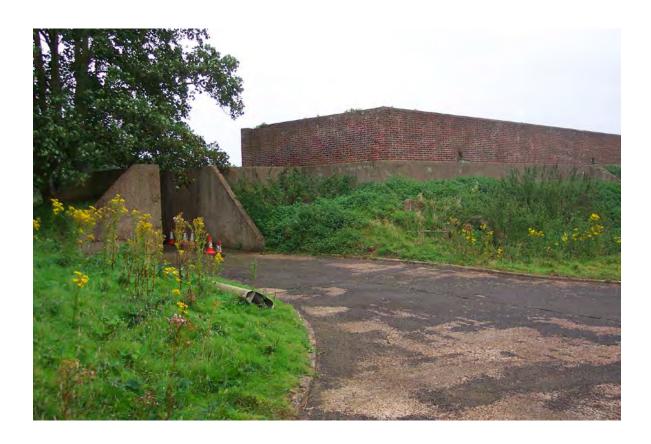
# RADAR TRANSMITTER BLOCK, BAWDSEY MANOR BAWDSEY

Description Concrete and brick radar block, 1937. Site of pioneering

Risk Priority C Condition Fair

Reason for Risk Metal reinforcement is rusting causing concrete to spall.

Vegetation growth and drainage are also issues.

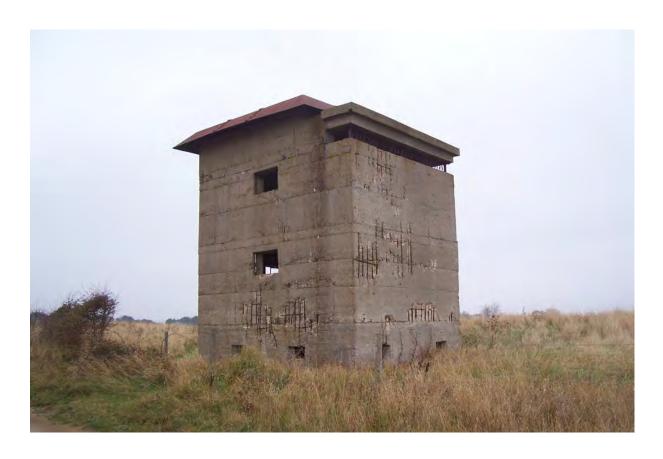
# BATTERY OBSERVATION POST, EAST LANE BAWDSEY

Description A 2-storey reinforced concrete observation post, built in

Risk Priority D Condition Poor

Reason for Risk The in situ concrete walls are badly affected by spalling /

reinforcement corrosion.

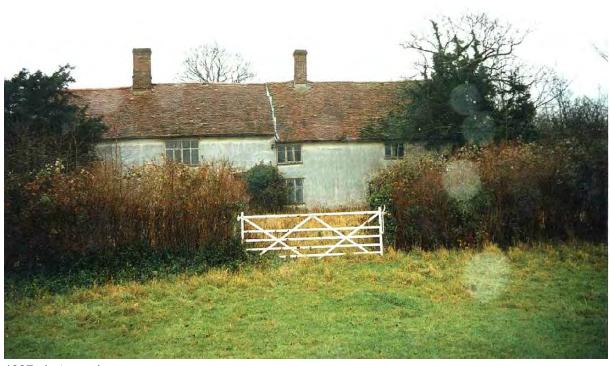
## PRIORY FARMHOUSE CHEDISTON

Description C17 timber-framed and rendered farmhouse with later

Risk Priority C Condition Poor

Reason for Risk Front wall bowing at west end, held up by brick buttress.

Notes Property is understood to be watertight following minor

repairs to roof completed in 2011.

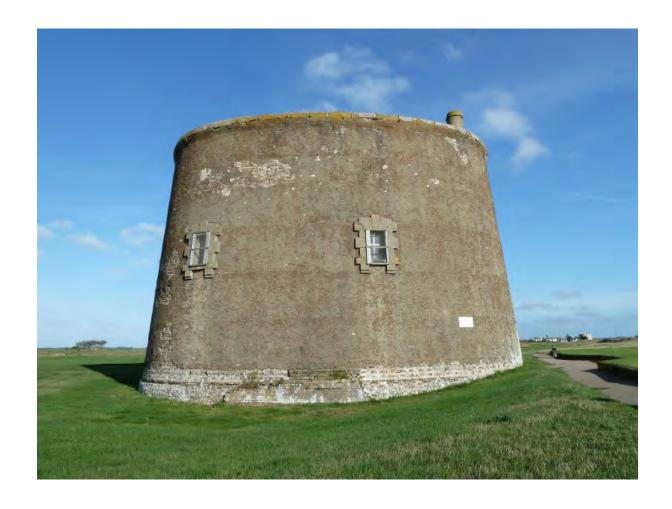
# MARTELLO TOWER 'T', FERRY ROAD FELIXSTOWE

Description Martello Tower on Felixstowe Ferry golf course. Built

c.1810-12 as part of defences against Napoleonic invasion. Brick with ashlar dressings, cement rendered. Felixstowe

Risk Priority C Condition Poor

Reason for Risk No solution agreed for future conservation and use.

Notes English Heritage is in discussion with the owners over

repairs and interpretation.

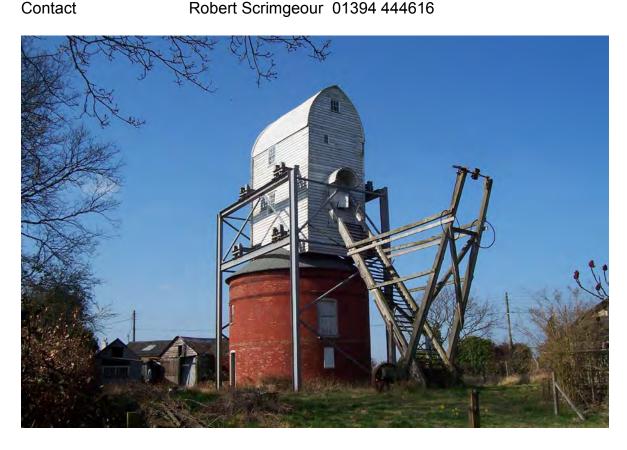
### POST MILL, MILL ROAD **FRISTON**

Description Large early C19 post mill in centre of village. 3 storey

> weatherboarded buck on 3 storey painted brick roundhouse. Last worked by engine power in 1966. Now disused but

Risk Priority Α Condition Poor

Reason for Risk Repairs required to trestle. Damage to structural timbers

from deathwatch beetle. Lack of strategy to secure future

In 2004 a steel frame was erected allowing the buck to be

supported independently off the weakened trestle. Some weatherproofing work and timber treatment carried out 2009-12. On English Heritage Register of Buildings at Risk.

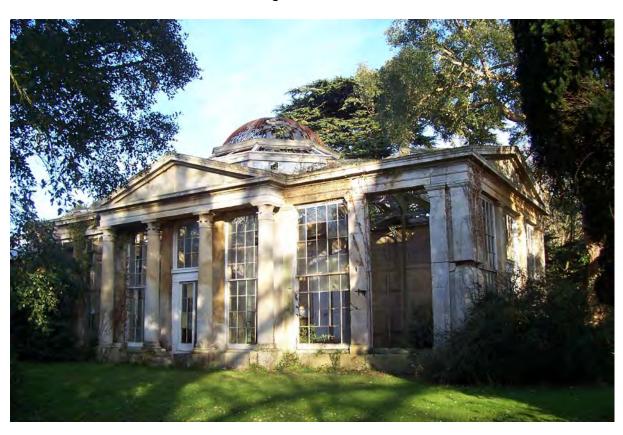
## THE ORANGERY, GLEVERING HALL, EASTON ROAD HACHESTON

Description Mid C19 Orangery in classical style with portico and

Condition Very bad

Reason for Risk Some glass missing, especially from the dome. Several

window frames are breaking up. Rusting iron cramps are

forcing off the stone facing.

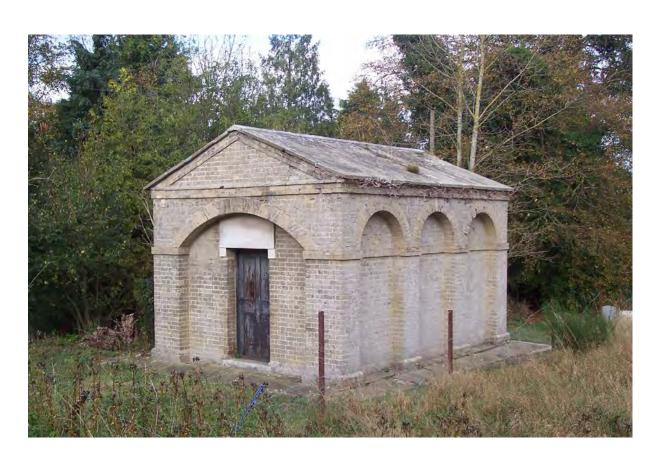
### MAUSOLEUM 25M NORTH OF CHURCH OF ALL SAINTS, THE STREET HACHESTON

Description Early C19 mausoleum to Arcedeckne family, builders of

Risk Priority C Condition Poor

Reason for Risk Damage to brickwork and roof, mainly caused by vegetation.

Missing rainwater goods.

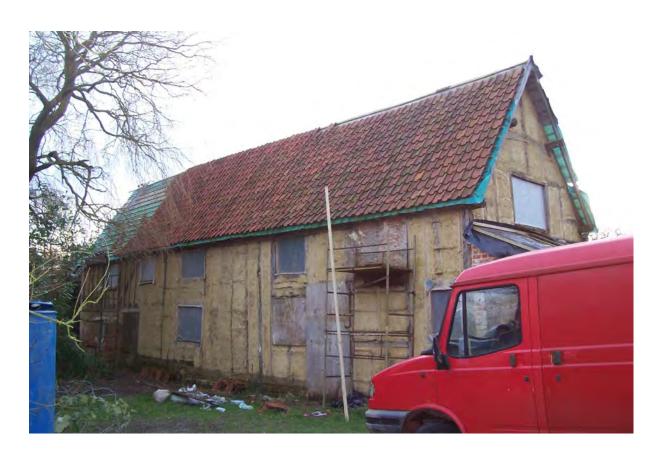
## CURLEW GREEN FARMHOUSE, CURLEW GREEN KELSALE CUM CARLTON

Description C16 timber-framed farmhouse in course of reconstruction

Risk Priority F Condition Poor

Reason for Risk Under repair from ruinous condition; roof on and partly tiled

at time of survey.

Notes Consent for rebuilding granted in 1994. Recently good

progress has been made and the timber frame, infill and roof structure are in place, and the roof partly tiled. The house

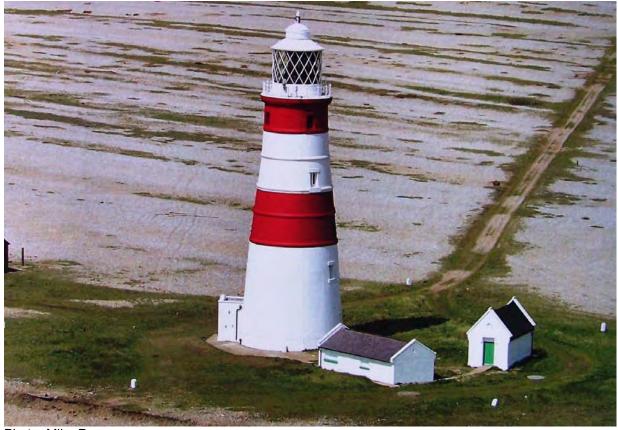
# ORFORDNESS LIGHTHOUSE ORFORD

Description Lighthouse, built in 1792, of rendered brick, surmounted by

Risk Priority E Condition Good

Reason for Risk Coastal erosion

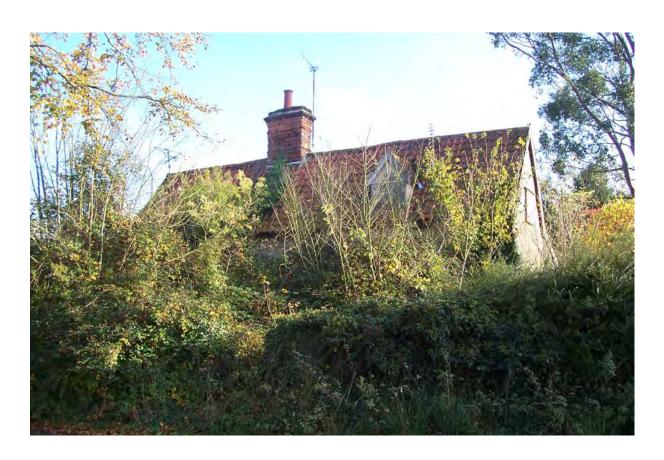
# BRIDGE COTTAGES, THE CAUSEWAY PEASENHALL

Description Pair of late C17 or early C18 timber-framed and plastered

Risk Priority C Condition Poor

Reason for Risk Prolonged lack of maintenance. Some roof tiles missing,

guttering broken. Frontage very overgrown.

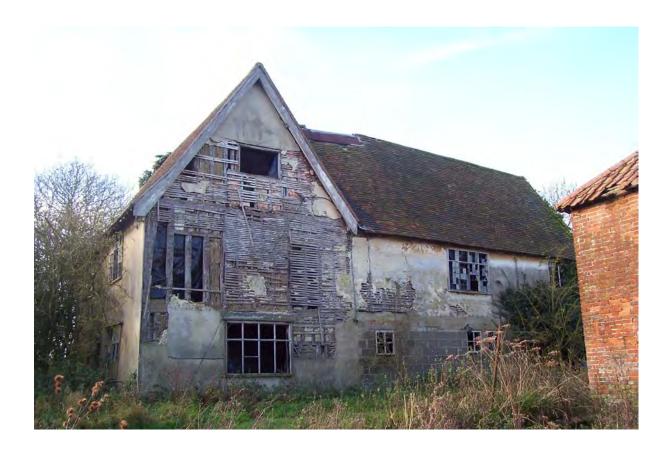
# HILL FARMHOUSE, BADINGHAM ROAD PEASENHALL

Description Early C17 timber-framed and rendered farmhouse, within a

Condition Very bad

Reason for Risk Render and lathes missing in several places. Large holes in

some walls, exposing internal frame.

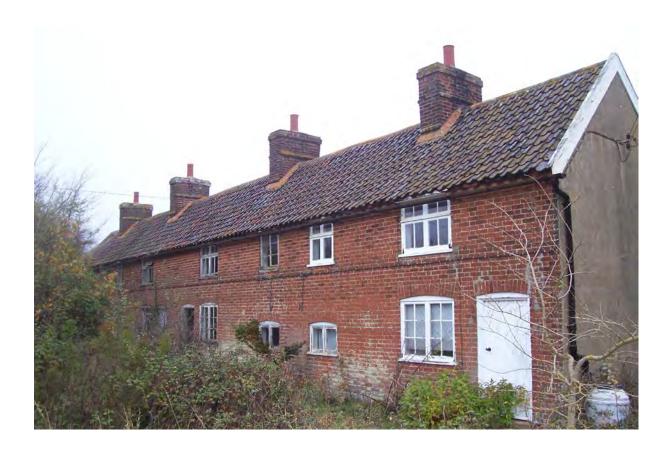
## ELM ROW RAMSHOLT

Description Terrace of four red brick cottages. Early C19 with small later

Risk Priority C Condition Fair

Reason for Risk Vacant with decaying windows and general ingress of

water/damp. Much of the frontage is overgrown.

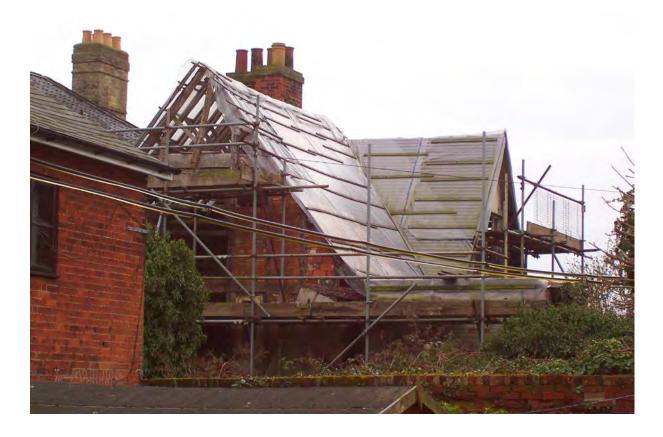
## WINGFIELD HOUSE, MARKET PLACE SAXMUNDHAM

Description C17 timber-framed and rendered house, extended and

Suggested Use Residential Condition Very bad

Reason for Risk Roof tiles and render missing. Major decay to the timber

frame.

Notes Some roof works were carried out in 2004/5, but there has

been little progress since. Suffolk Architectural Heritage Trust completed a Feasibility Study on the repair of the building in 2011-12 but the project was not pursued.

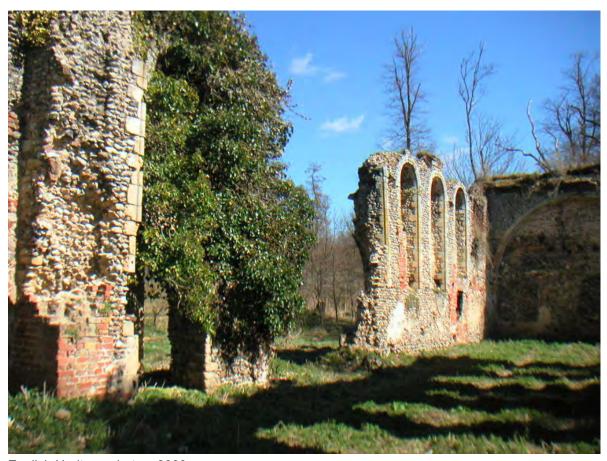
## REMAINS OF SIBTON ABBEY, YOXFORD ROAD SIBTON

Description Ruins of C12 Cistercian Abbey. Flint rubble with stone

Risk Priority C Condition Poor

Reason for Risk Damaging vegetation. Occasional trespass and vandalism.

Notes Site cleared of trees and other vegetation in March 2013. On

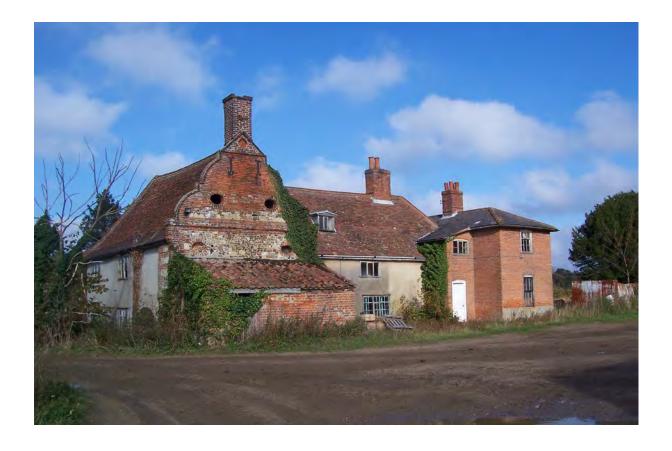
# ABBEY FARMHOUSE, YOXFORD ROAD SIBTON

Description C16 & early C17 timber-framed and plastered farmhouse

Risk Priority C Condition Poor

Reason for Risk Prolonged lack of maintenance leading to numerous failings.

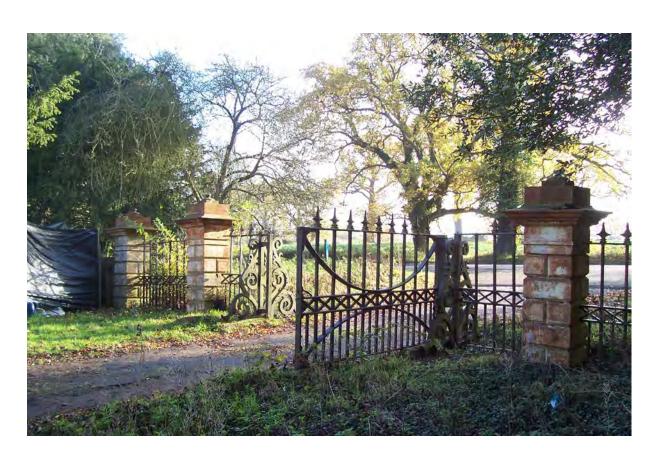
# GATEWAY 10M SOUTH OF THE LODGE, LONDON ROAD **THORINGTON**

Description Early C19 entrance gateway to the former Thorington Hall.

Four square cast iron piers, designed to imitate rusticated stonework; their cast iron urn finials are missing. Heavy cast

Risk Priority C Condition Poor

Reason for Risk Lack of maintenance coupled with damage from vehicle

impacts and vandalism.

Notes The owner is looking to carry out repair work and is currently

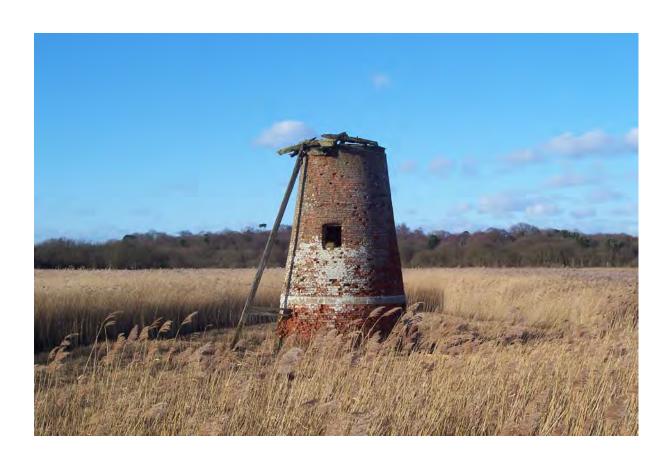
## WINDPUMP ON WESTWOOD MARSHES WALBERSWICK

Description Red brick tower of former windpump, burnt out in 1960,

Condition Very bad

Reason for Risk Disused and redundant. Open to elements after fire

damage.

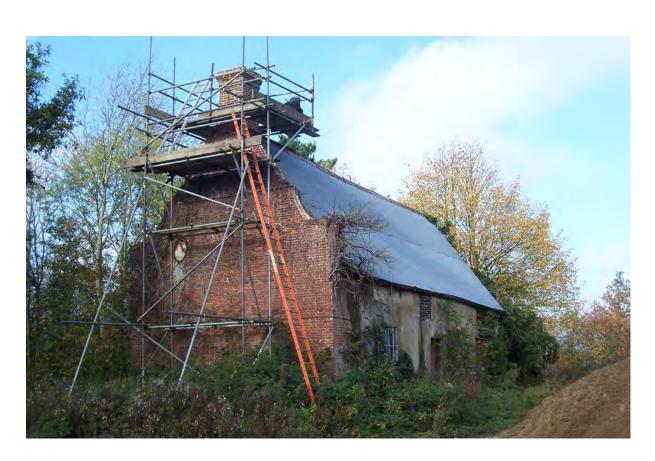
# PACKWAY FARMHOUSE WALPOLE

Risk Priority C Condition Poor

Reason for Risk In need of basic maintenance and repair to walls. Parts of

Notes Isolated within a working farm. Repairs were carried out to

the shaped parapet brick gable end and chimney stack in

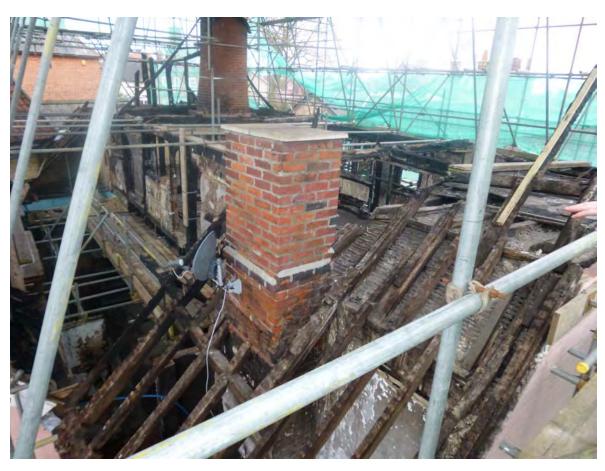
## THE GEORGE INN, HIGH STREET WICKHAM MARKET

Condition Very Bad Reason for Risk Fire damage

Notes Fire occurred in April 2013 causing loss of roof and central

section of first floor and some damage to frame. Debris has been cleared, recorded and stored, where significant. The building is repairable and detailed proposals are awaited.

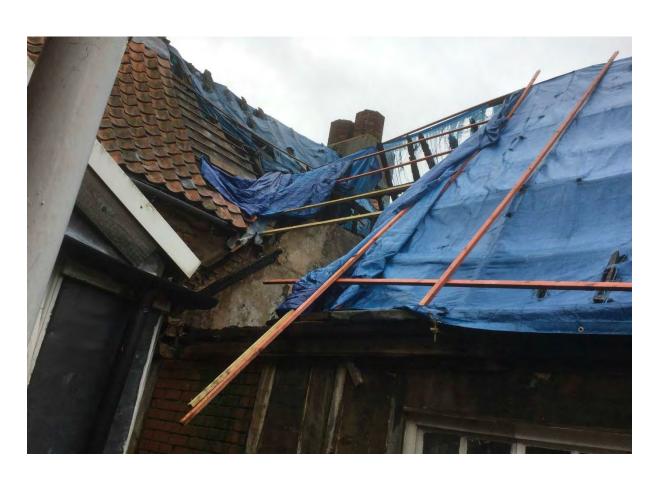
## 33 NEW MARKET BECCLES

Condition Very Bad

the building is inadequately weather protected.

Applications received May 2017 for repairs to structure and

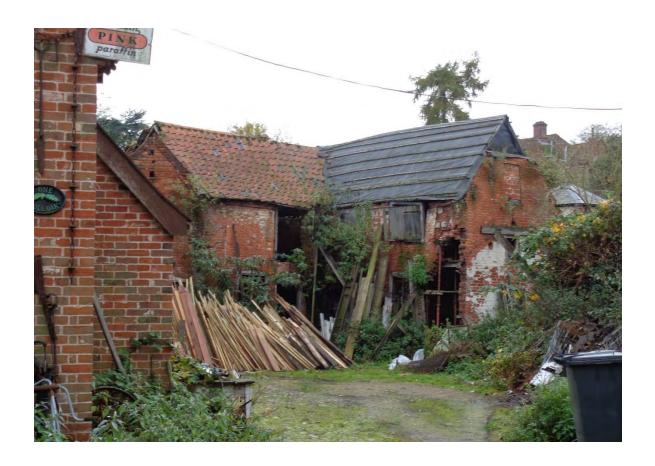
## FORMER ABATTOIR, REAR OF 26 BRIDGE STREET BUNGAY

Condition Very Bad

Reason for Risk Requires significant structural repairs.

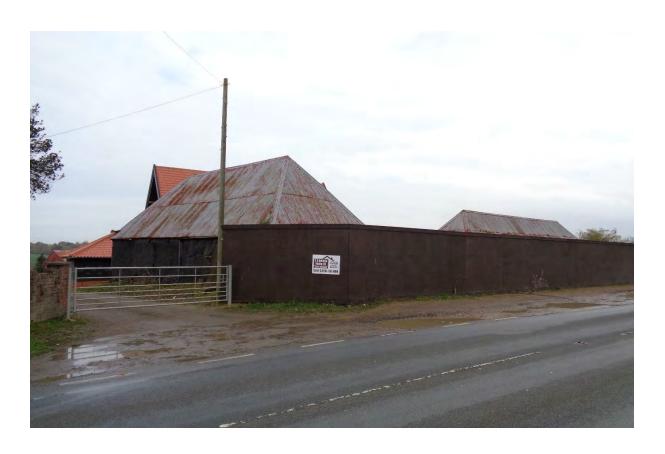
### FARM BUILDINGS AT DUKES FARM, ST JOHN'S HILL BUNGAY

Risk Priority Condition Poor

Reason for Risk Redundant buildings in need of structural repairs.

> in April 2009. Consents granted for a live-work unit on the site of this barn, retaining and repairing remaining historic buildings for light industry / storage use. Work nearing

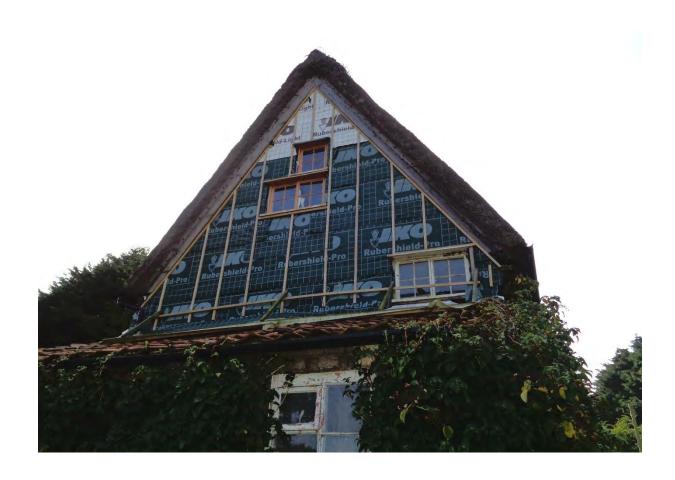
## WARREN HOUSE COVEHITHE

Risk Priority B Condition Poor

Reason for Risk East gable render has failed and been removed. Gable

frame now covered by failing membrane.

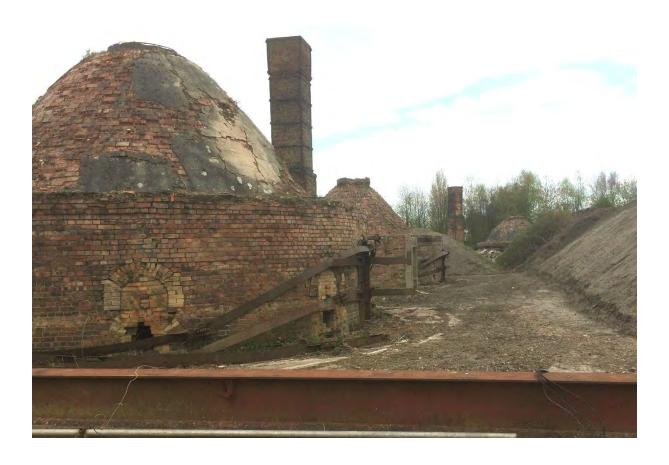
## BRICK KILNS & CHIMNEY STACKS, FORMER GISLEHAM BRICK & PIPE WORKS GISLEHAM

Condition Very Bad

are especially liable to damage from rainwater and frost.

to be erected to keep vehicles further away.

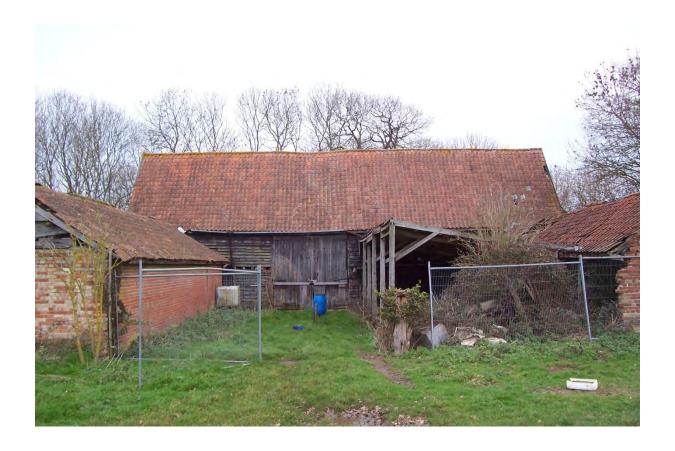
# BARN AT SHADOWBARN FARM **ST MARGARET**, **ILKETSHALL**

Risk Priority C Condition Poor

Notes Decay of adjoining ranges hastens the overall decline.

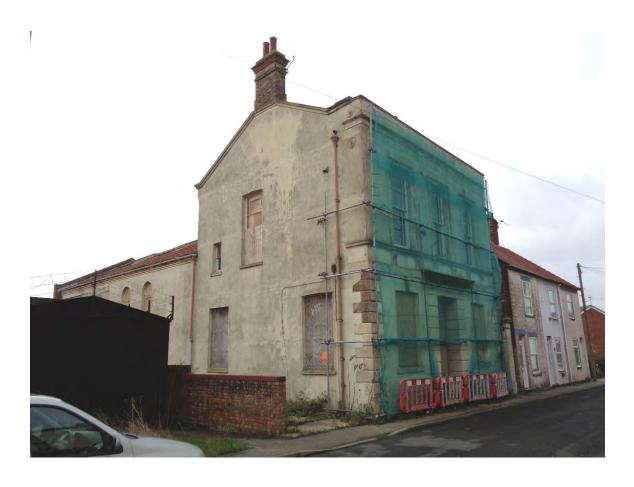
## CROWN STREET HALL, CROWN STREET WEST LOWESTOFT

Risk Priority D Condition Poor

Reason for Risk Unusable in part and deteriorating through lack of

leaking parapet gutter.

residential units. New owner expected to commence works

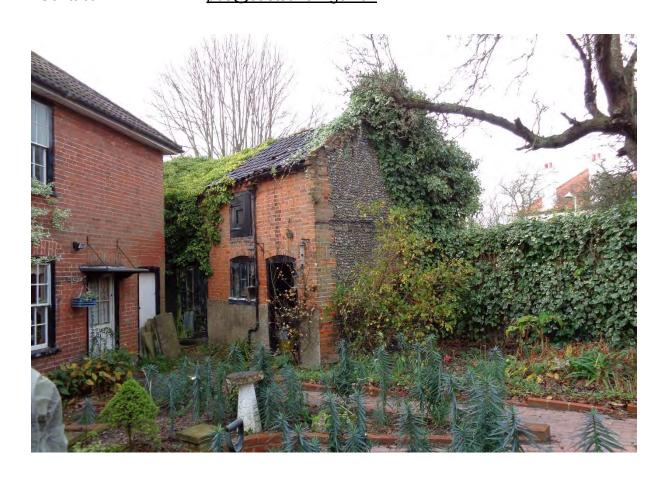
## STABLES & WALL AT WALMER HOUSE, LONDON ROAD, PAKEFIELD LOWESTOFT

Risk Priority D Condition Poor

Reason for Risk General lack of maintenance with structural cracking and

spalling brickwork.

conversion to holiday accommodation granted September 2012. The approved works have begun with a new build garage; conversion of the coach house is to follow.

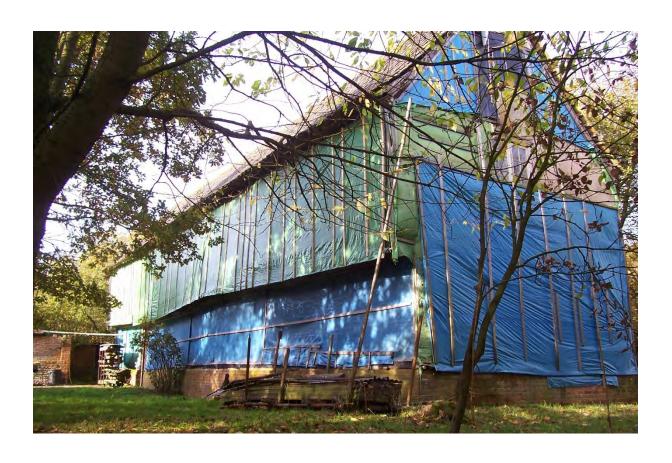
## MOAT FARMHOUSE SHADINGFIELD

Condition Very Bad

decayed plasterwork elsewhere. Major repairs required but

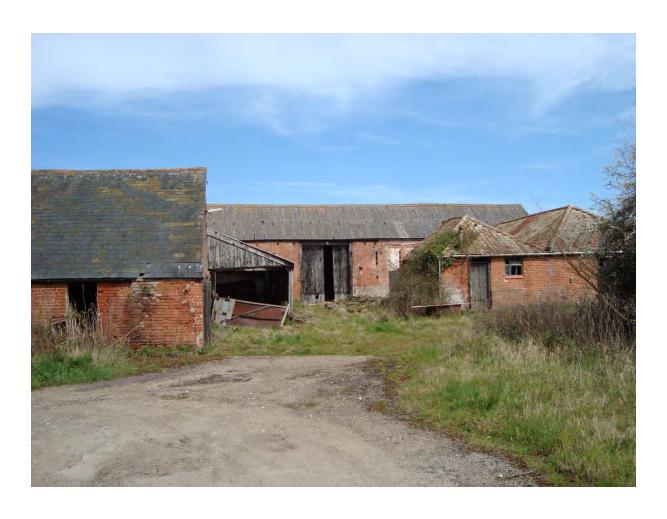
## GOLDINGS FARM BARNS, SMITHS ROAD **SOTTERLEY**

Condition Fair-Poor

repairs.

Owner/Agent Justin Henry, Norfolk Barns Ltd. (07823777747)
Current Availability For sale once development has been completed.
Notes Residential conversion under way Spring 2017.

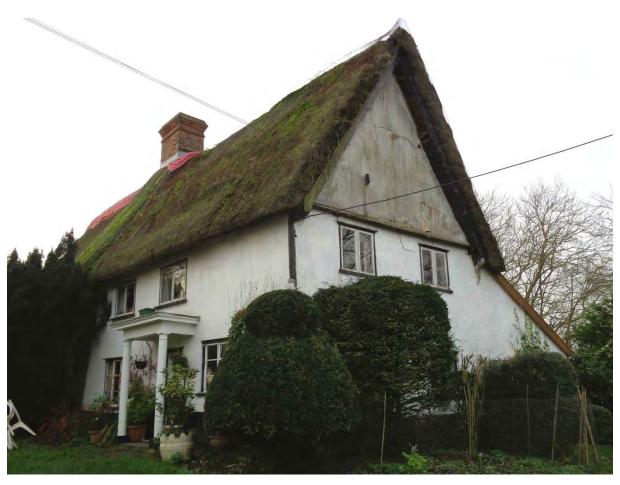
## WHALEYS, ST JAMES ROAD SOUTH ELMHAM ALL SAINTS & ST NICHOLAS

Risk Priority C Condition Poor

Reason for Risk Lack of maintenance and repair over many years.

Notes Full structural survey carried out Autumn 2016 and efforts

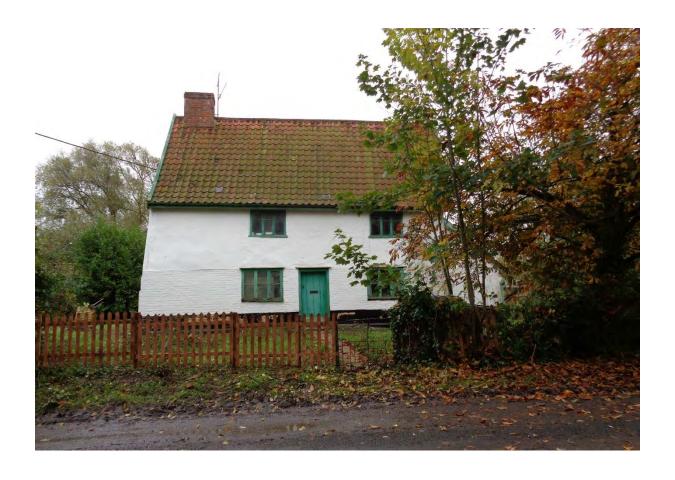
# WHITE HOUSE FARMHOUSE SOUTH ELMHAM ALL SAINTS & ST NICHOLAS

Risk Priority C Condition Poor

Reason for Risk Failing plasterwork and external joinery, partly overgrown.

Notes Some work under way December 2015 including lime render

repairs and replacement timber capping to bargeboards.

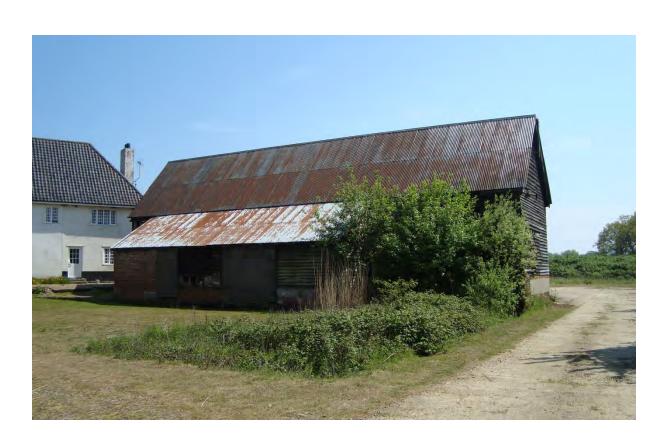
## BARN TO SW OF VALLEY FARMHOUSE WANGFORD WITH HENHAM

Risk Priority D Condition Poor

Reason for Risk Redundant structure. Areas of missing weatherboarding.

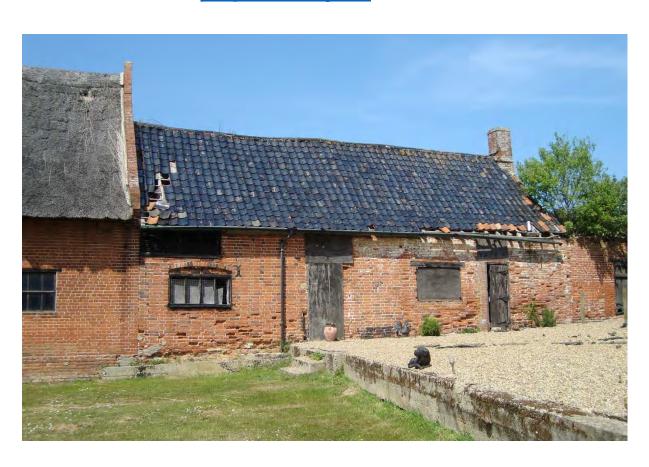
## SERVICE RANGE TO VALLEY FARMHOUSE WANGFORD WITH HENHAM

Risk Priority D Condition Poor

north side overgrown. Both roof slopes have missing tiles.

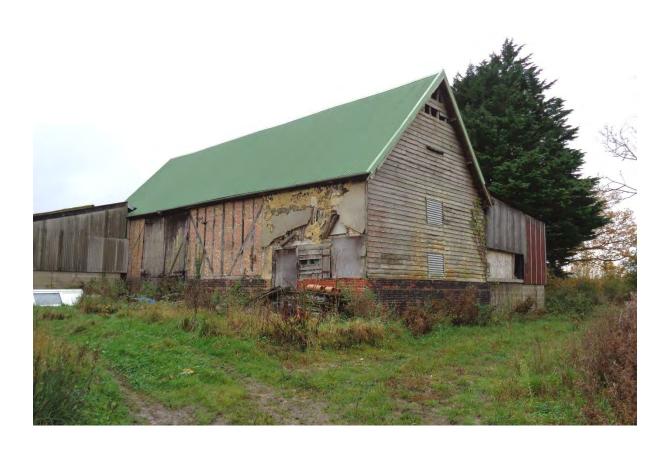
# BARN TO WEST OF BLEACH FARMHOUSE WISSETT

Risk Priority C Condition Poor

exposed and in decay.

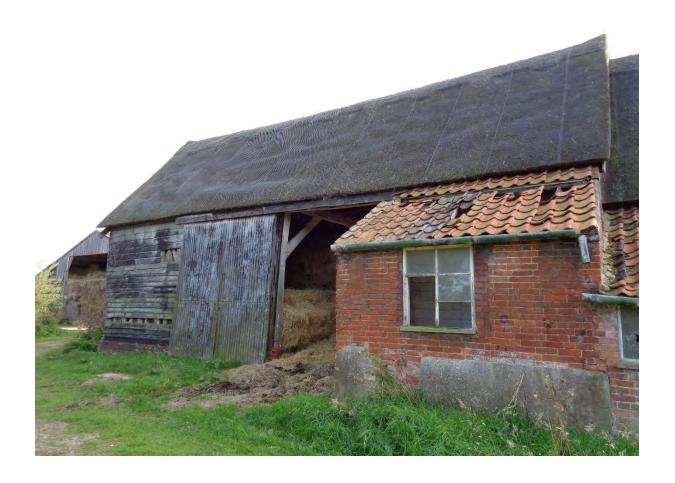
## NORTHERNMOST BARN AT PARK FARM, LOCKS LANE WRENTHAM

Risk Priority B Condition Poor

repairs.
