## BADLEY GREEN FARM COTTAGES, BADLEY GREEN BADLEY

Description A C16-C17 house last used as 2 cottages. Timber-framed

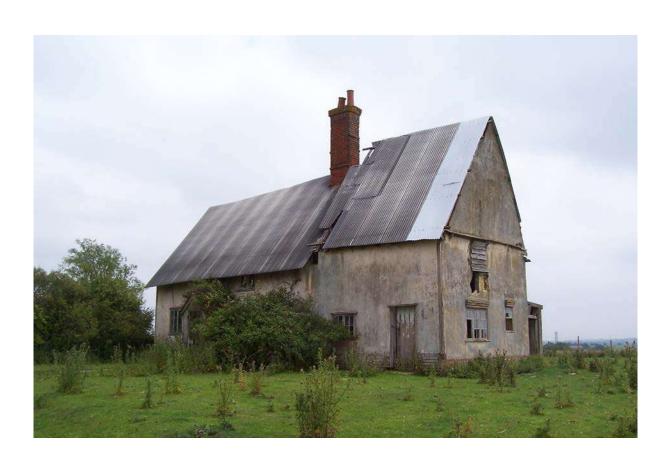
Risk Priority C Condition Poor

Reason for Risk Long term lack of adequate maintenance. Some missing

roof sheets; hole in east gable end; corbelled head of

chimney stack unstable.

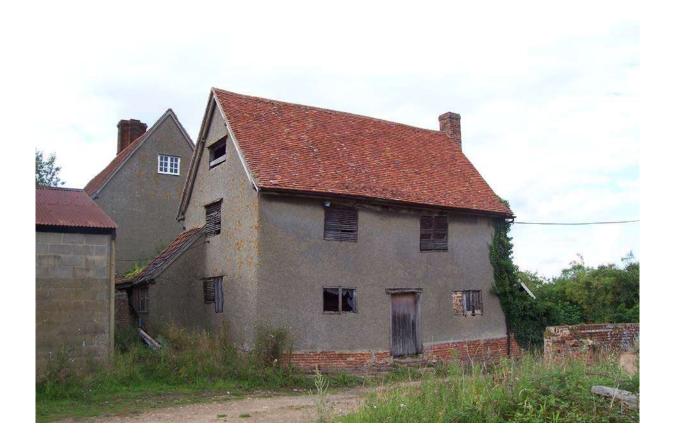
# BAKEHOUSE AT BADLEY HALL BADLEY

Risk Priority C Condition Poor

Reason for Risk In need of timber frame repairs and weatherproofing of

window openings.

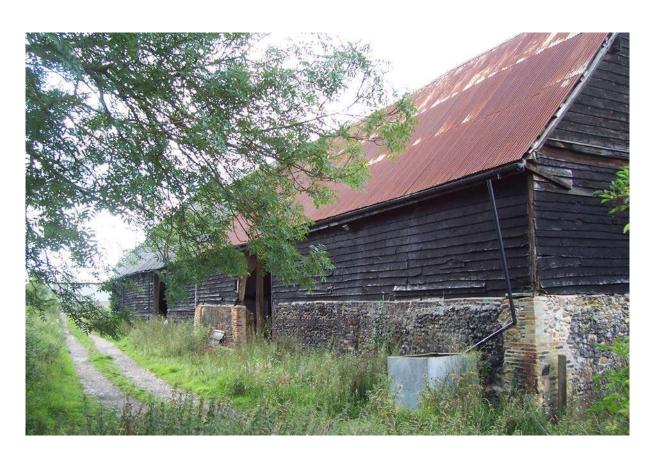
# BARN AT BADLEY HALL BADLEY

Risk Priority C Condition Poor

Reason for Risk Repairs needed to timber frame and cladding.

Notes Part of historic farmstead. Some recent repair work to plinth,

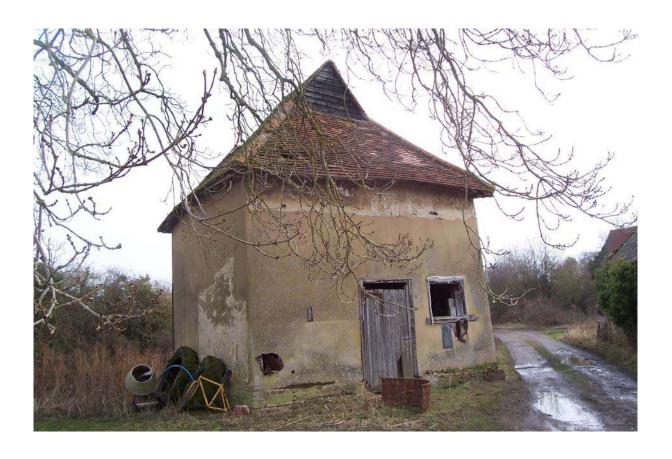
## DOVECOTE AT BADLEY HALL BADLEY

Risk Priority C Condition Poor

Reason for Risk Repairs needed to timber frame and render.

Notes Repairs to roof completed in 2012, east elevation re-

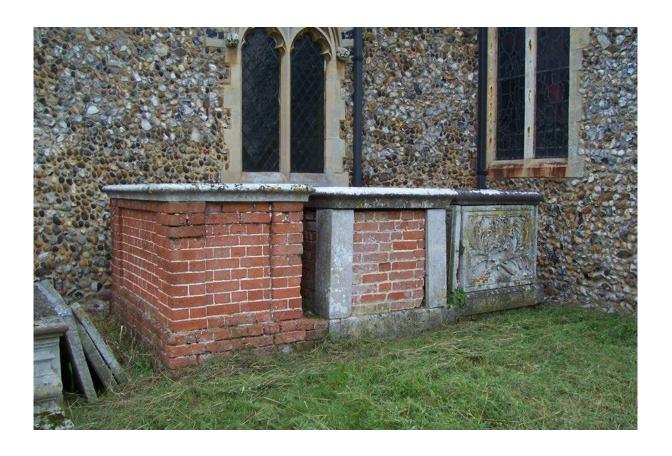
# THREE TOMBCHESTS 1M S OF CHANCEL, CHURCH OF ST PETER **BAYLHAM**

Risk Priority C Condition Poor

Reason for Risk Structural damage caused mainly by ivy growth.

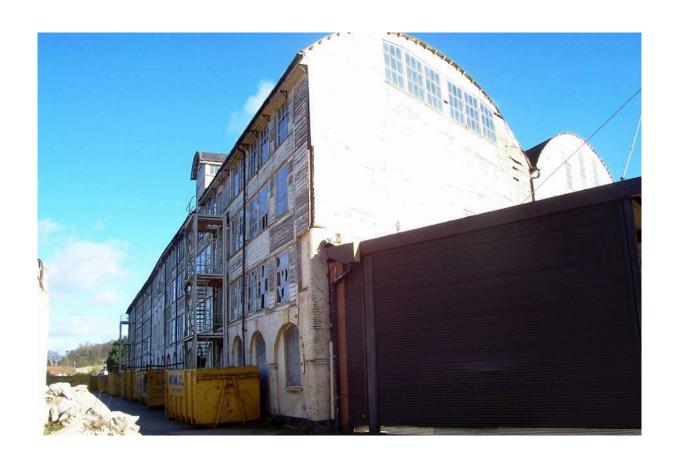
## WAREHOUSE AT FISON'S WORKS, PAPERMILL LANE **BRAMFORD**

Risk Priority C Condition Poor

Reason for Risk Lack of adequate maintenance especially to roofs. Water

ingress has resulted in areas of decay on upper floors.

Notes Current applications for a mixed use redevelopment of the

entire site. The majority of the listed building will be retained and converted to commercial, retail and residential uses.

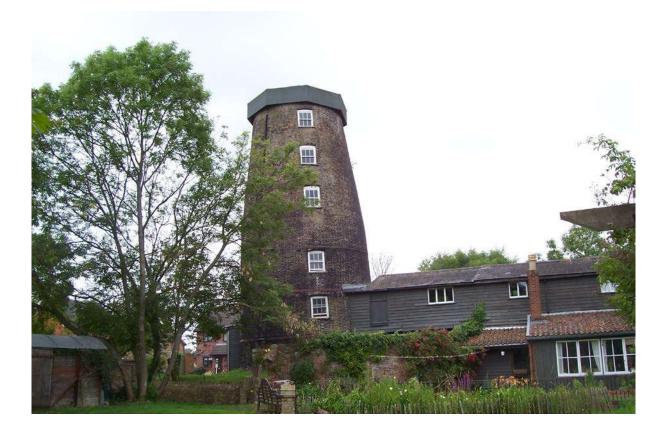
### TOWER MILL, MILL GREEN **BUXHALL**

Description Brick tower mill, 1860. Sails removed 1929, but power driven

machinery in use until c.1971. Cap and fantail missing.

Priority for Action C Condition Poor

Reason for Risk Structural movement; severe cracking in brickwork

Notes Tower now weathertight with new roof fitted 2001. New curb

fitted and floor repairs completed.

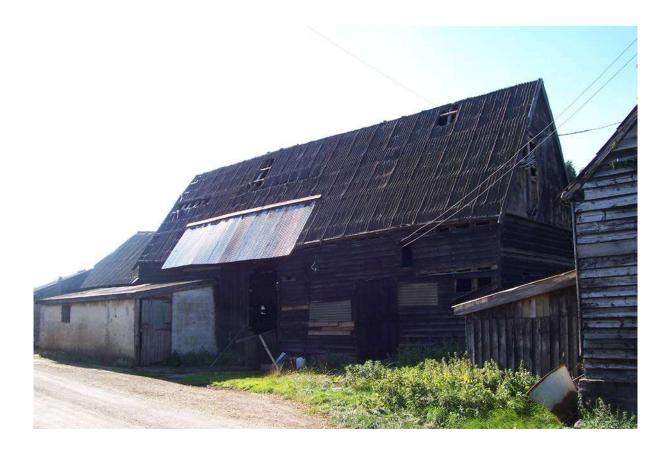
# BARN 20M S OF BLUEHOUSE FARMHOUSE, LITTLE LONDON, MOATS TYE COMBS

Risk Priority C Condition Poor

Reason for Risk Several large holes in roof owing to failure of roofing

material. Areas of boarded cladding are missing together

with some plaster from the north gable.

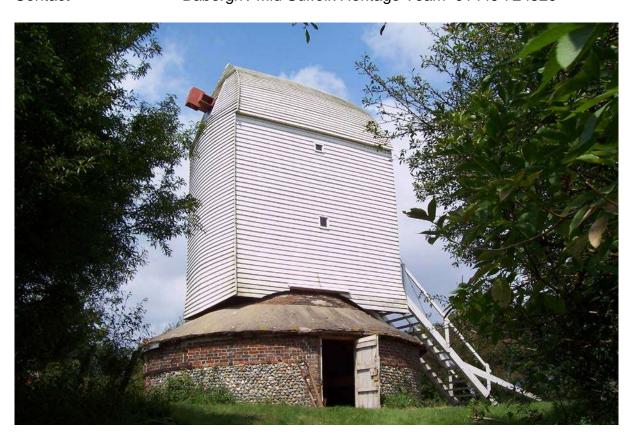
# POST MILL, WOOLPIT ROAD **DRINKSTONE**

Priority for Action C
Condition Fair

Reason for Risk The roundhouse walls and roof need extensive repair.

Repairs to buck completed 2005-6. Remainder of mill

too. Repairs to roundhouse are planned for 2015. A Conservation Plan for the Drinkstone Mills site is in preparation. On English Heritage Register of Buildings at

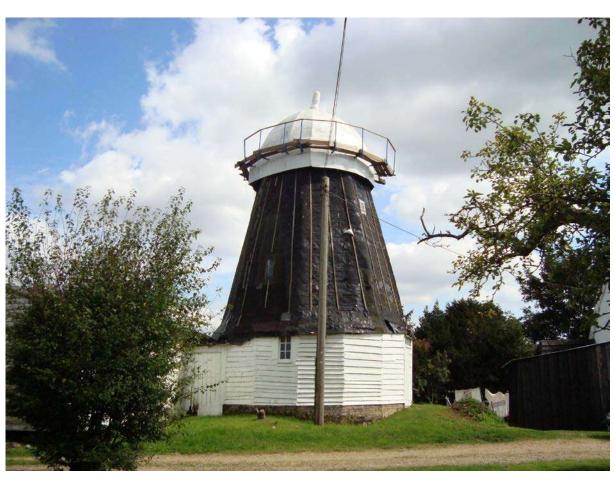
## SMOCK MILL, WOOLPIT ROAD **DRINKSTONE**

Risk Priority C Condition Poor

Reason for Risk Movement and decay in the timber frame, especially at the

junction of the smock tower with the 16-sided base.

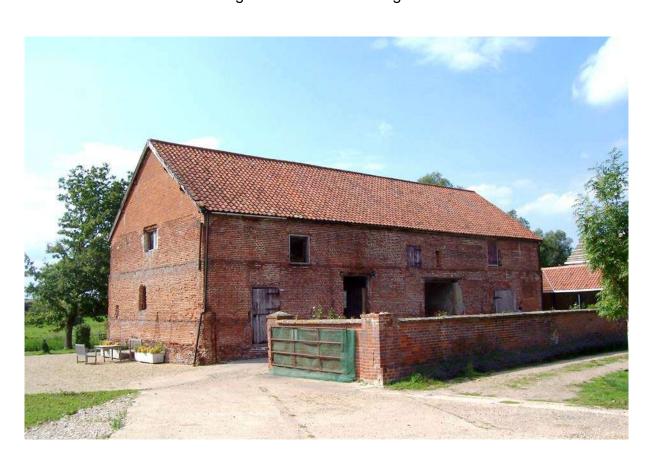
## BARN AT ABBEY FARM, HOXNE ROAD **EYE**

Condition Poor

Reason for Risk Roof appears sound but a few slipped tiles and capped

bargeboards poor. Some structural cracks and brickwork

erosion.

Notes Work in progress on approved scheme of conversion to part

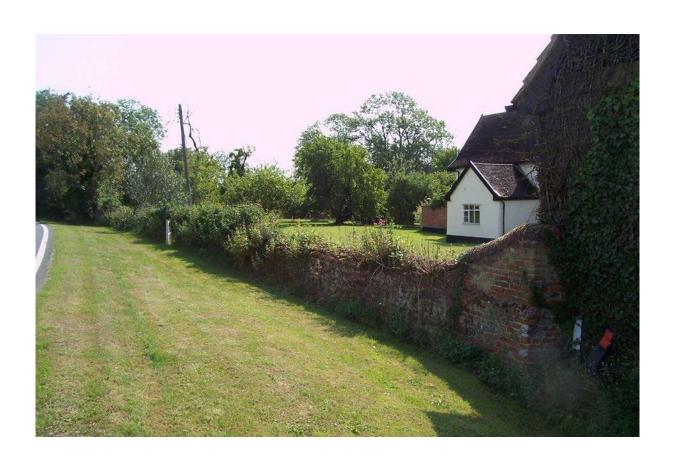
# GARDEN WALL TO BOUNDARY FARMHOUSE, PETTAUGH ROAD FRAMSDEN

Priority for Action C
Condition Poor

Reason for Risk Serious structural cracking, open brick joints and missing

and displaced copings, partly resulting from extensive vegetation growth, especially ivy. Pronounced lean over

most of length.

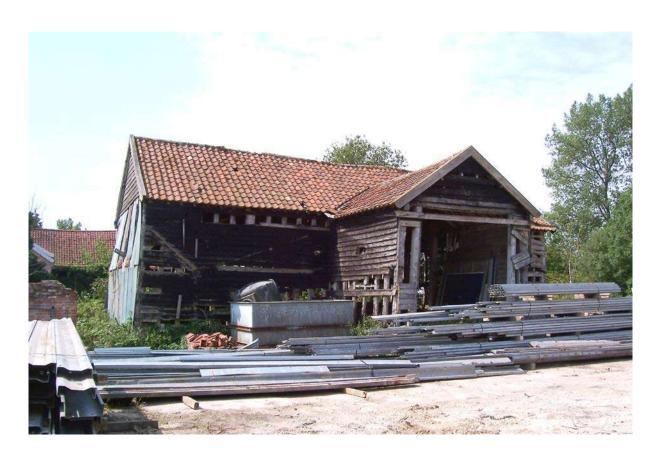
## BARN AT OAK TREE FARM, DEBENHAM ROAD **KENTON**

Condition Very bad

Reason for Risk Large areas of missing boarding, especially on south side.

Structural failures locally causing distortion of frame.

Notes Listed February 2003 in at-risk condition. Options for repair

and conversion to residential use have been discussed with

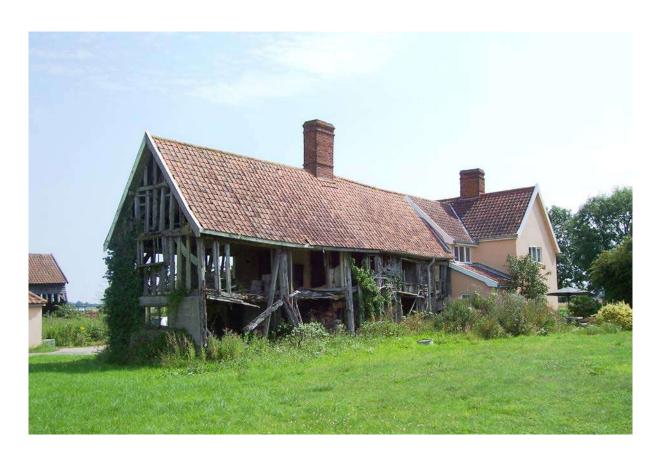
## OAK TREE FARMHOUSE, DEBENHAM ROAD **KENTON**

Condition Very bad

Reason for Risk Frame open to weather for many years, significant

deterioration and loss of timbers and infill panels

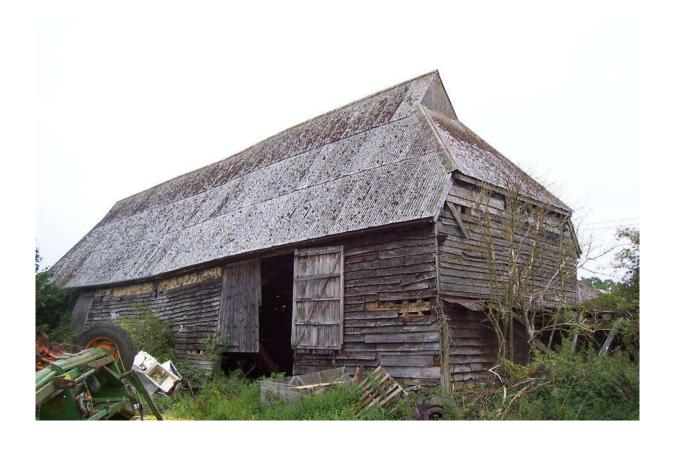
## BARN AT HALL'S FARM, HALL'S LANE **NORTON**

Condition Very bad

Reason for Risk Soleplate largely missing or encased in concrete. East wall

blown off plinth in 1987 gale, north end now leaning badly.

Notes Temporary internal shoring installed 2001. Owner is

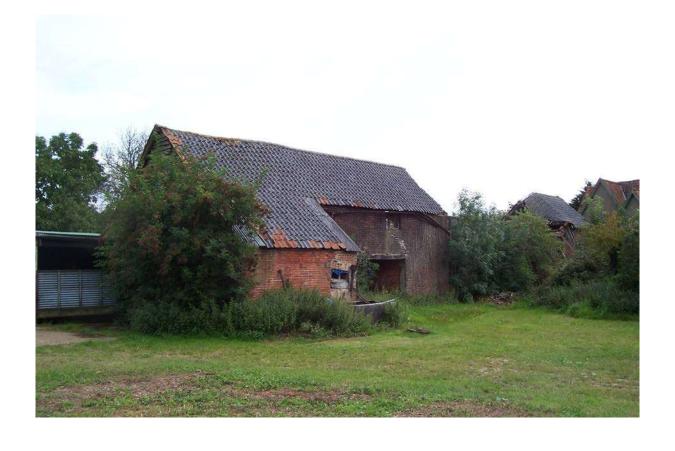
## FORMER MALTINGS IMMEDIATELY N OF STREET FARMHOUSE, THE STREET REDGRAVE

Condition Very bad

Reason for Risk Redundant. Prolonged lack of maintenance has resulted in

partial collapse of the central section of the building.

Notes Application for repair and conversion to two dwellings

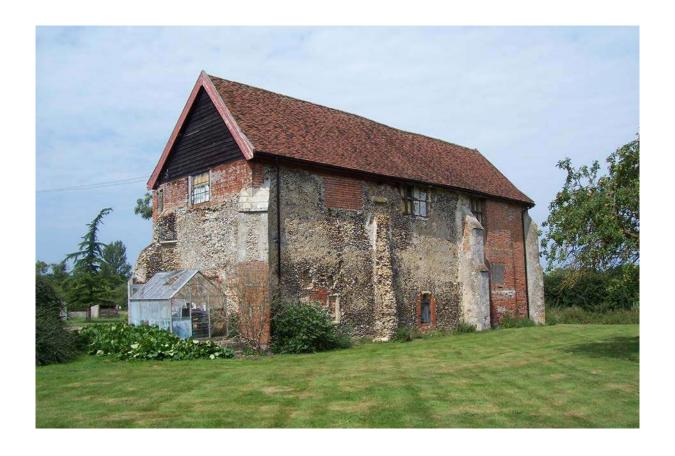
## BARN AT HALL FARM, CHURCH ROAD REDLINGFIELD

Priority for Action C
Condition Poor

cracks.

Notes Re-roofed in 1999 but no maintenance since.

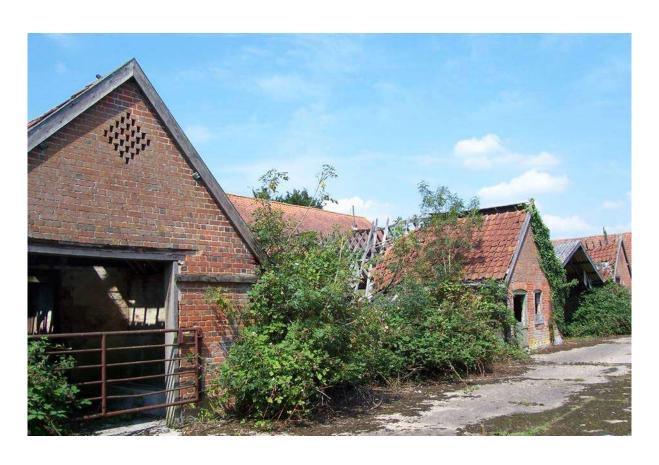
## LONG BARN AT CASTLE FARM WINGFIELD

Priority for Action C
Condition Poor

Reason for Risk Some missing pantiles especially to later outbuildings where

one roof has partly collapsed. Building largely redundant and

becoming overgrown. 2009

Some repairs have commenced, and discussion of
