Section 19 Flood and Water Management Act 2010

Report Title: Chauntry Road, Haverhill

CRNo 329967

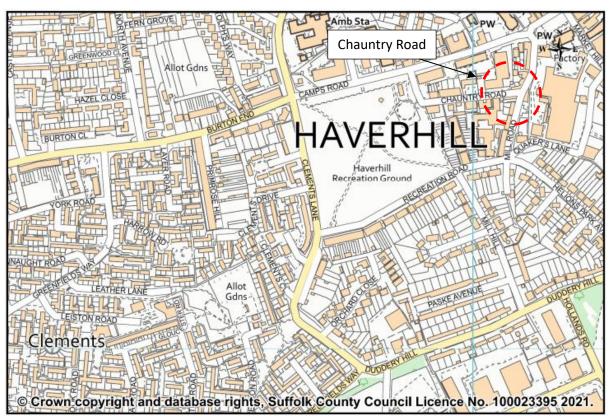
Figure 1 - Investigation Area Map ©Crown copyright and database rights, Suffolk County Council Licence No. 100023395 2021

This investigation focusses on the flood events that occurred at a single location; Chauntry Road, Haverhill. The location is shown in context on the map extract below. Chauntry Road lies immediately to the south-east of Haverhill town centre. The properties impacted were located at the junction of Mill Road and Chauntry Road.

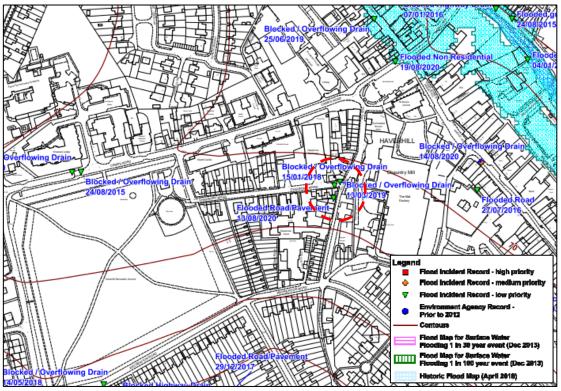
Figure 2 - Historical Pluvial Flood Incidents (to be updated once the 2021 events have been mapped)

Shown in Figure 2 below is a map extract of the recorded historical pluvial flood events as held by SCC. Please note that as not all of the above events were formally reported to SCC, they do not all appear on the following extract.

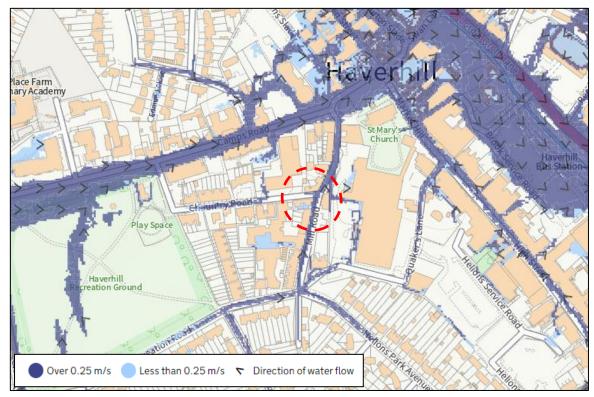
Figure 3 - Surface water flood risk: water velocity in low-risk scenario (GOV.UK mapping)

An extract of the pluvial flood mapping is shown below for reference. This extract demonstrates the direction and speed of flow during the worst-case scenario. Dark blue denotes flows faster than 0.25m/s with light blue denoting flow speeds less than 0.25m/s. The small black arrows denote direction of flow.

A route of surface water overland flow down Mill Road can clearly be identified in the above figure. This flow route travels past the properties which reported flooding on Chauntry Road. There is also an area to the rear of the properties (including the rear gardens of the flooded properties) identified to be at risk of surface water flooding.

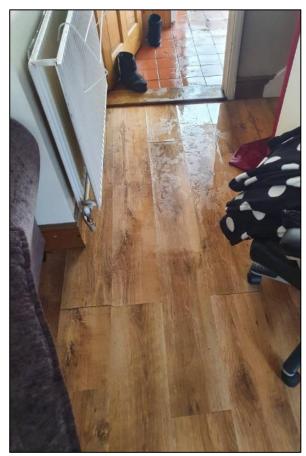
Anecdotal evidence indicates that floodwaters entered the properties through the rear doors. The occupants were not at home when the flooding occurred but have indicated that surface water runoff travelling down Mill Road within the highway jumped the kerb and entered the rear gardens before flooding the properties.

Flood water was reported to reach a depth of entered the properties throughout the ground floor to a depth of 10-20mm This caused repeated damage of internal flooring materials, furniture and personal property which has resulted in an insurance claim.

Floodwater accumulating inside the kitchen and living room of one of the flooded properties

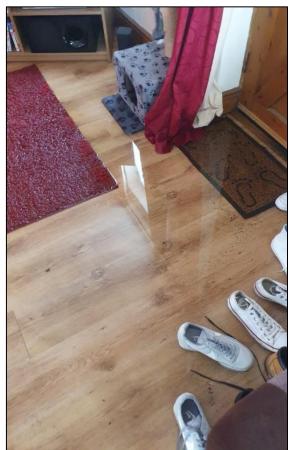
Floodwater accumulating inside the living room of one of the flooded properties

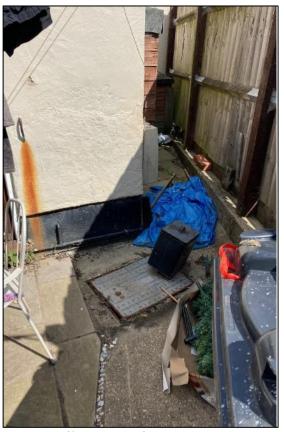
At the time of the site visit, an Anglian Water manhole was identified within the rear garden. The cover was loose, and debris indicated it may recently have 'blown' due to a surcharge within the system. Anglian Water have since confirmed this manhole is part of a foul water network that collects foul water (with some possible surface water connections) from the properties at the junction of Mill Road and Chauntry Road and directs it northwards towards the centre of Haverhill.

- Overwhelmed Anglian Water assets: the Anglian Water foul sewer located to the rear of the properties that flooded was observed to have recently surcharged during the site (Aug 2021). Further, residents reported that the floodwaters 'smelt foul'. Whilst Anglian Water have not had any flooding incidents reported to them, this is likely to be connected to the flood events. Whilst this length of sewer is classified as foul, as the flooding occurred in conjunction with a severe rainfall event, it should be further assessed as to whether this system receives any surface water.

Manhole (foul sewer) in the rear garden that had recently surcharged

Action	Risk Management Authority	Timescale for response	Latest Progress Update for Actions
Reactive jetting (where possible) of highway drainage	SCC HA	March 2022	Pending
Investigate highways drainage in Mill Road to ensure capacity and condition are sufficient	SCC HA	June 2022	Pending
Investigate to see if additional gullies should be installed in Mill Road	SCC HA	June 2022	Pending
Investigate foul sewer to rear of properties in Chauntry Road, to establish if it has receives surface water flows and if its capacity and condition is sufficient	AWS	June 2022	Pending

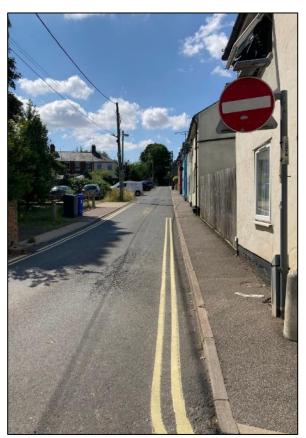
- Overwhelmed gullies/unknown highway drainage: the intensity of the rainfall is likely to been greater than the capacity of the highway gullies which capture runoff in Mill Road. Runoff from Mill Road (which is relatively steep), is likely to have contributed to the flooding as runoff was reported to have flowed off the carriageway and entered the rear gardens of the properties. Further information is required regarding the condition and capacity of the highway drainage network.

Mill Road, looking upgradient, where surface water travelled down, missing gullies and jumped the kerb into adjacent properties through rear gardens
