## Section 19 Flood and Water Management Act 2010

### Cavendish Flood Investigation –

### Storm Babet 2023

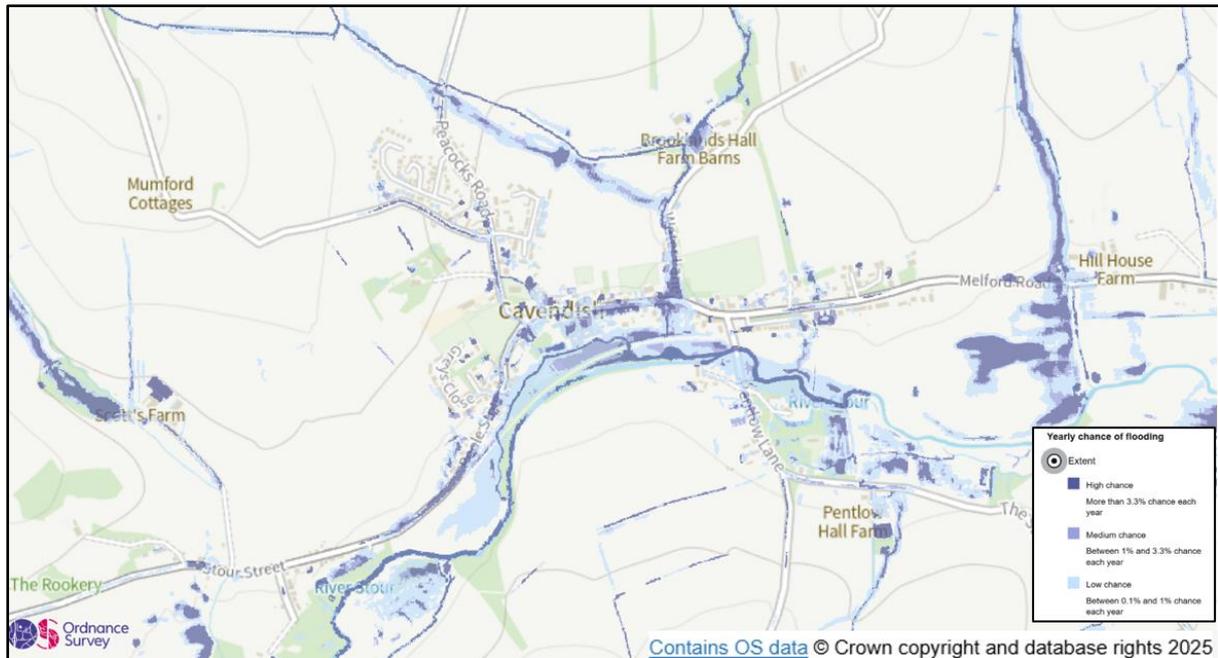
Figure 5. Surface water flood risk

Figure 5 highlights the predicted pluvial (surface water run-off from surrounding land and highways) flood risk in Cavendish, with multiple flow paths from the north coming through the village and into the river Stour to the south.

There is a high chance of surface water flooding on sections of Stour Street, Poole Street, High Street and Water Lane. These areas were all affected by flooding during Storm Babet.

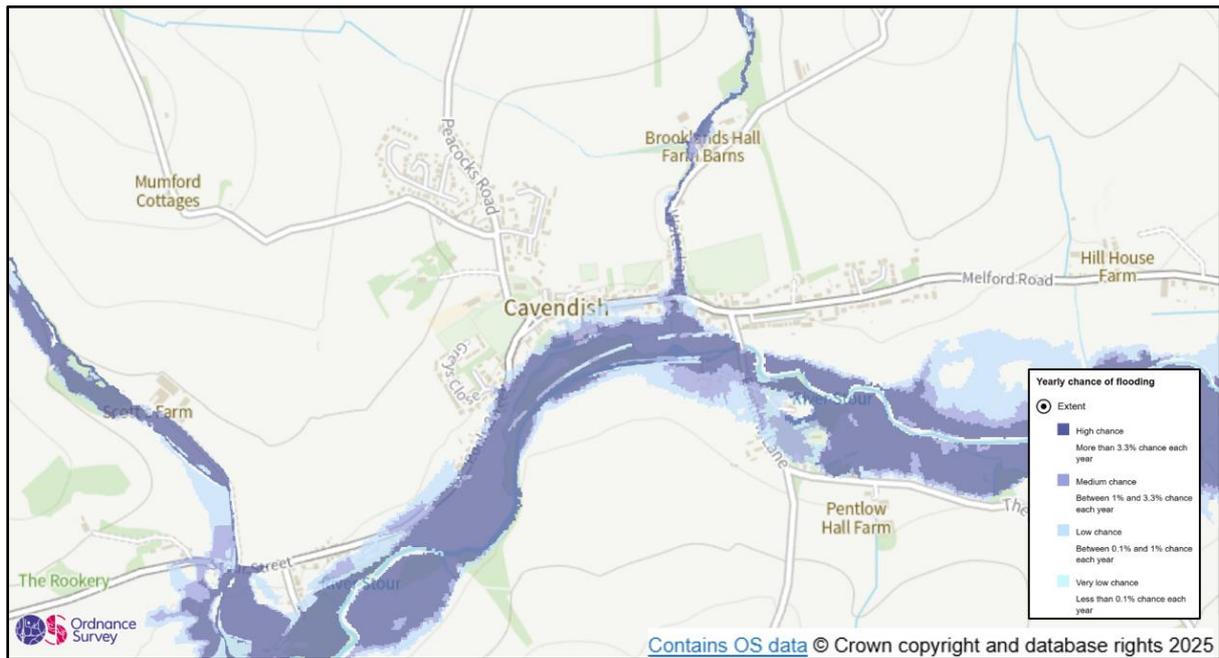
Figure 6. Flood risk from rivers and sea

Figure 6 shows the predicted fluvial (from designated main river and ordinary watercourses) flood risk in Cavendish. The fluvial flood risk in Cavendish is predominantly associated with the river Stour to the south of the village and two watercourses feeding into the Stour from the North.

There is a medium to high chance of fluvial flooding on sections of Stour Street, Poole Street, High Street and Water Lane. These areas were all affected by flooding during Storm Babet.

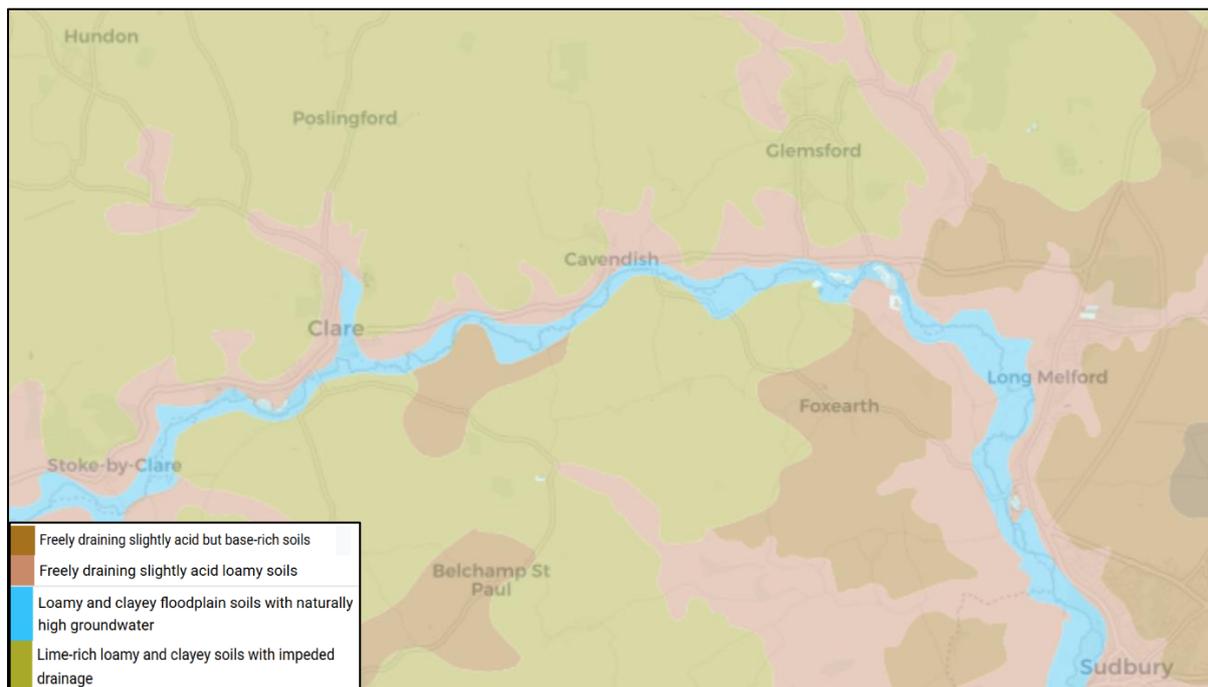
Figure 8. Soil map (LandIS Soilscales)

The soils of the higher ground surrounding Cavendish are loamy and clayey with impeded drainage, meaning that water permeates more slowly and surface water runoff is greater. The floodplain soils surrounding the river Stour are more freely draining with naturally high groundwater and tend to be wetter.

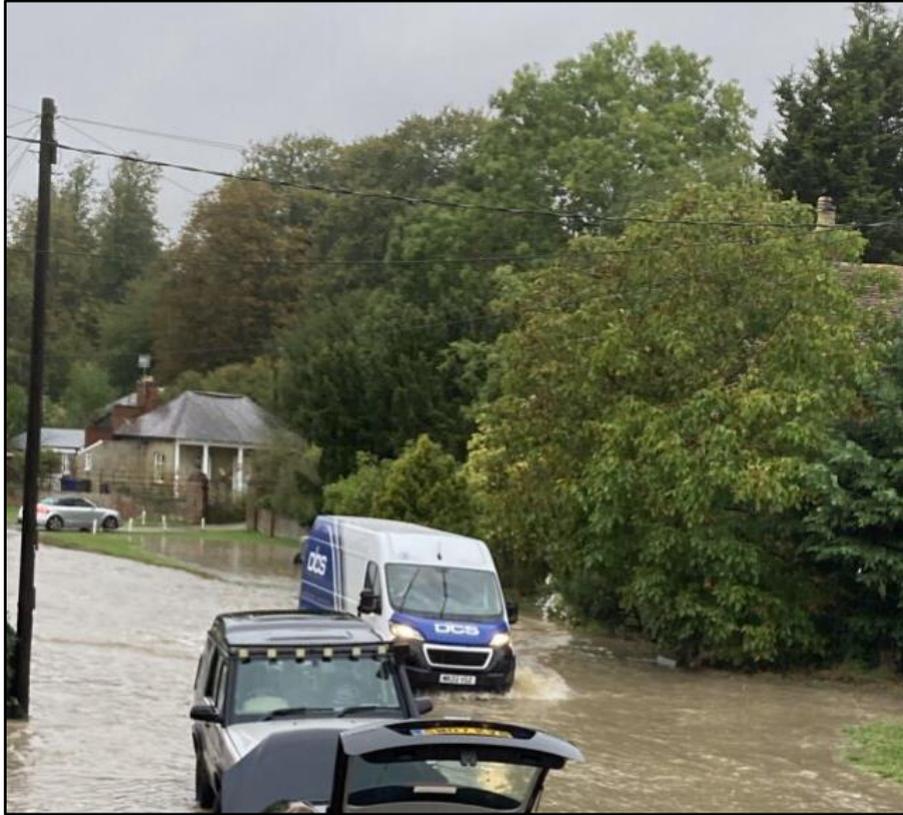
*Image 1. Flooding on Stour Street*

Following heavy rainfall on the morning of 20 October, high water levels flowed down multiple watercourses from the catchments north of Cavendish. Water levels exceeded the capacity of the channel in multiple locations and flowed across land and onto the highway. The rainfall had caused floodwater to pool in several places on the highway and these additional fluvial flows added to the extent of the flooding seen along Stour Street (see Image 1).

- Residents to install Property Flood Resilience (PFR).
- Riparian landowners to carry out appropriate watercourse maintenance to reduce flood risk as necessary as per their riparian responsibilities.
- Explore potential NFM projects to 'slow the flow' and attenuate water on overland flow paths north of Stour Street, E.g. leaky dams, woody debris installation, restoration of watercourses, storage ponds, wetland areas.
- Suffolk Highways to ensure the completion of highway drainage asset cyclic maintenance on Stour Street.
- Landowners / General public to report any observed blockages below Stour Street road bridge on the Suffolk Highways Online Reporting Tool.

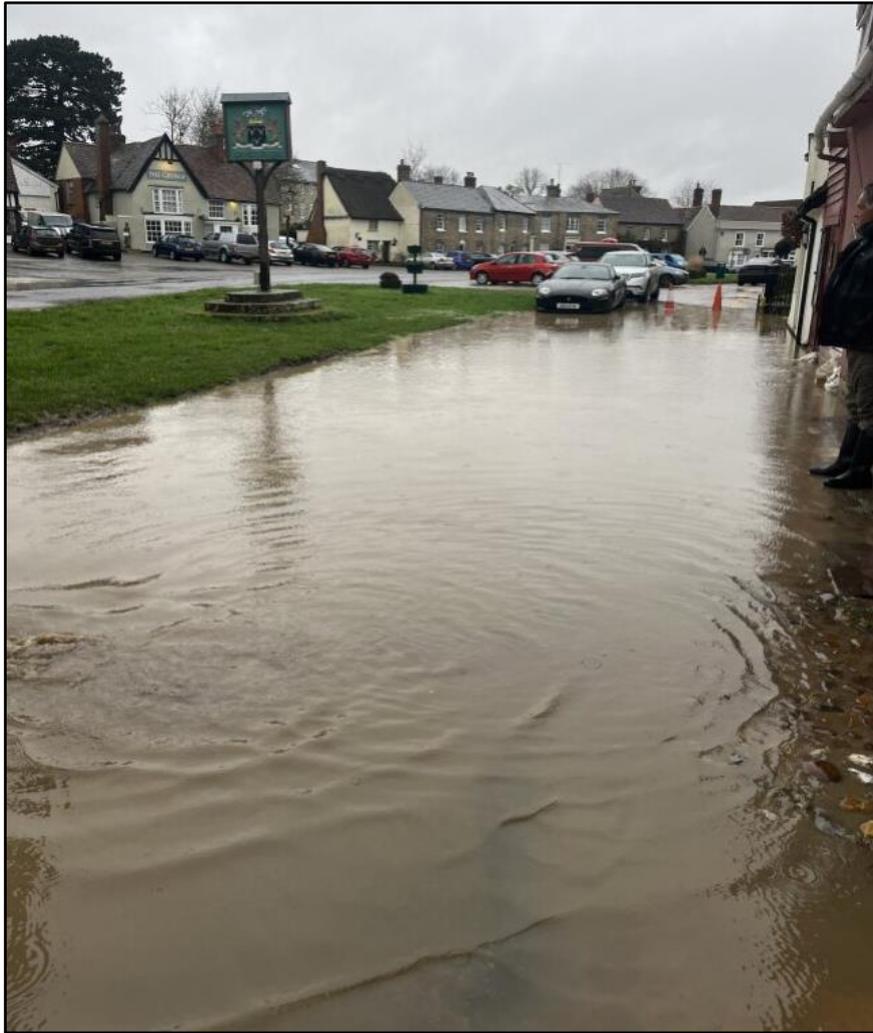
*Image 2. Flooding on Poole Street service road*

Further along Poole Street towards the village centre, opposite The Green, residents reported that the main road and the service road were submerged in floodwater (Image 2). One property was flooded from the front, with approximately 4 inches of water internally. Resident’s reports cite blocked or broken drains as being a persistent factor in flooding on the service road. Suffolk Highways are aware of issues at this location and have previously carried out underground works.

- Suffolk Highways to ensure the completion of highway drainage asset cyclic maintenance on Poole Street and High Street.
- Suffolk Highways to investigate potential blocked / broken highway drainage assets on the service road off Poole Street / High Street.
