Section 19 Flood and Water Management Act 2010

Clopton Flood Investigation –

Storm Babet 2023

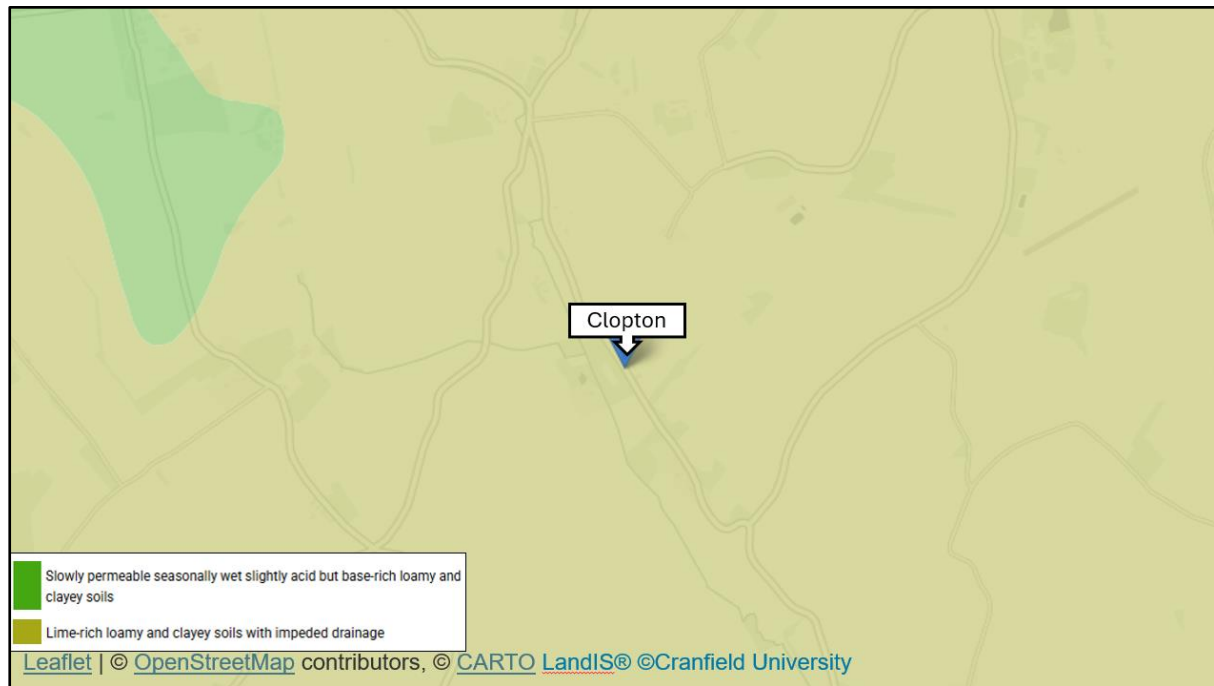
Figure 9. Soil map (LandIS Soils)

The soils of the higher ground surrounding Clopton are uniformly loamy and clayey with impeded drainage, meaning that water permeates more slowly and surface water runoff can be greater.

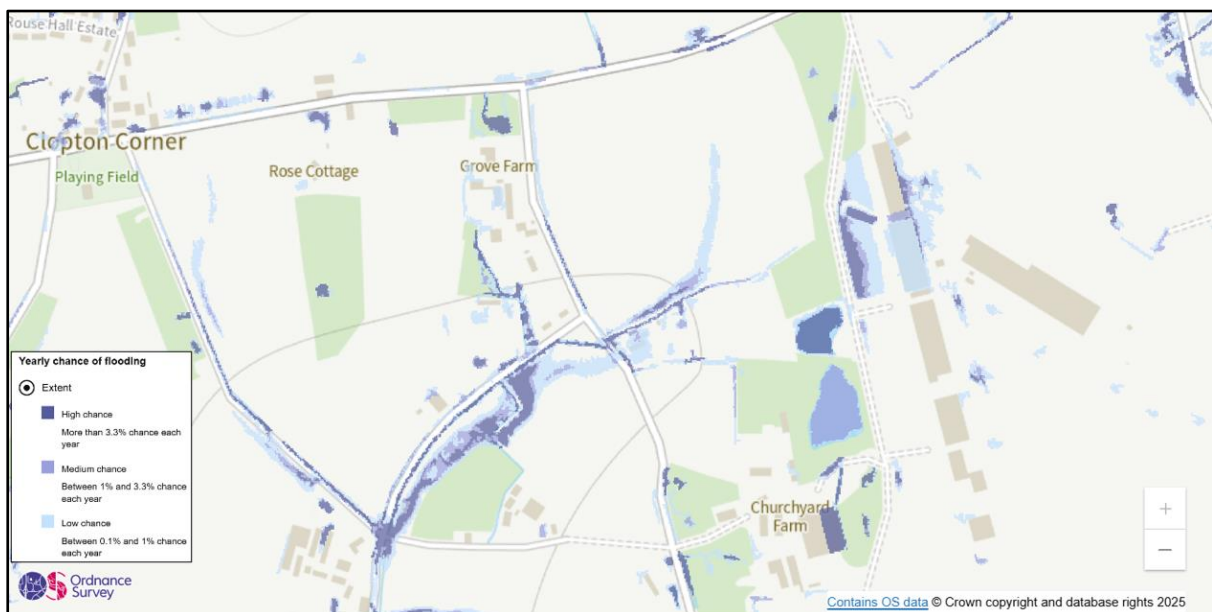
The intense rainfall during Storm Babet caused pluvial flooding on Clopton Commercial Park. Surface water runoff from the road caused internal flooding to one of the commercial units which interrupted the business for 3 days.

Figure 14. Surface water flood risk on Clopton Commercial Park

The majority of this area is shown as being at low chance of surface water flooding on the national flood risk maps (see Figure 13) however, there are isolated pockets of high yearly chance of flooding. It is assumed the flooding at this location was due to the high volume of rainfall over a relatively short period of time falling on area of hardstanding and overwhelming drainage infrastructure.

- Residents / business owners to install Property Flood Resilience (PFR).
